MINERALS PROGRAM INSPECTION REPORT
PHONE: (303) 866-3567

MINE NAME: Twin Buttes Land Co., LLC	MINE/PROSPECTING ID#: M-2023-038	MINERAL: TBD	COUNTY: Rio Blanco
INSPECTION TYPE: Illegal(Unpermitted Operation)	WEATHER: Clear	INSP. DATE: December 11, 2023	INSP. TIME: 10:30
OPERATOR: Twin Buttes land Co., LLC	OPERATOR REPRESENTATIVE: Owen Robertson	TYPE OF OPERATION: ILL - Illegal	
REASON FOR INSPECTION: High Priority	BOND CALCULATION TYPE: None	BOND AMOUNT: None	
DATE OF COMPLAINT: NA	POST INSP. CONTACTS: DRMS	JOINT INSP. AGENCY: None	
INSPECTOR(S): Amy Yeldell	INSPECTOR'S SIGNATURE:

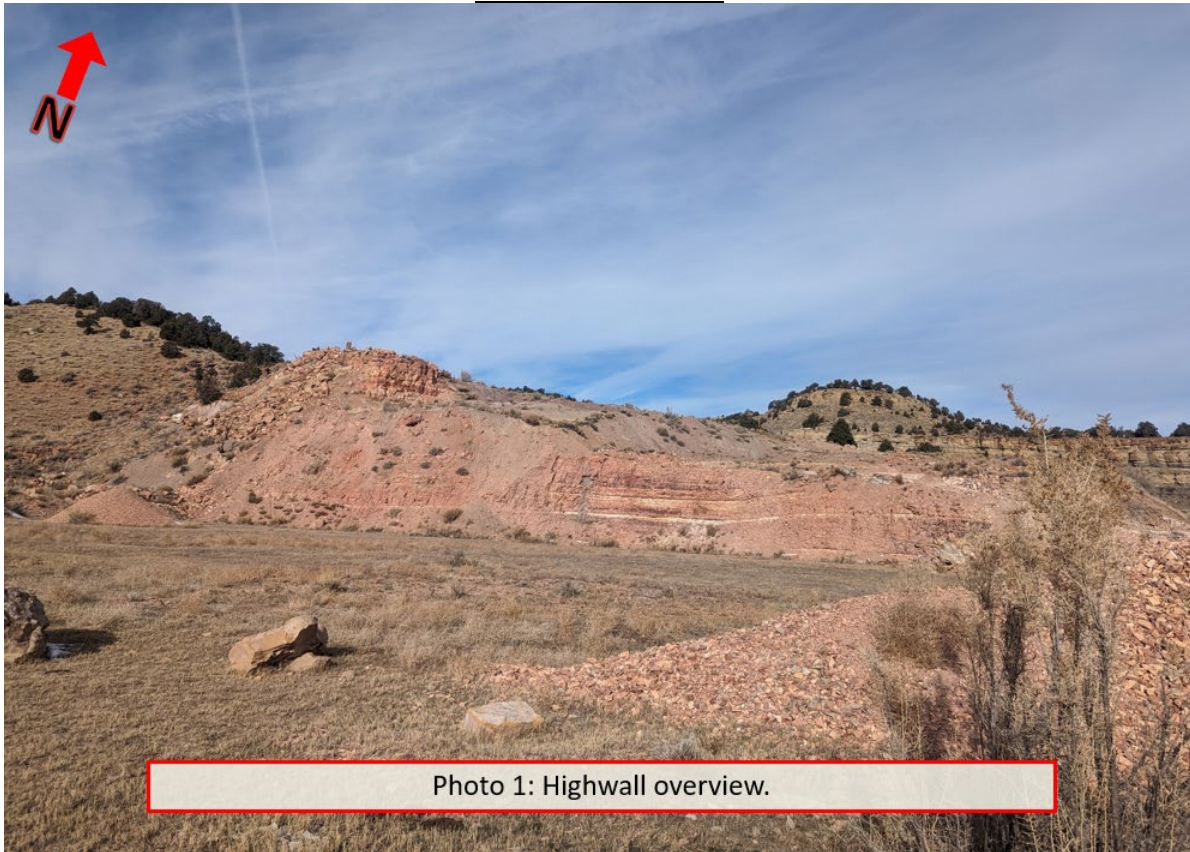
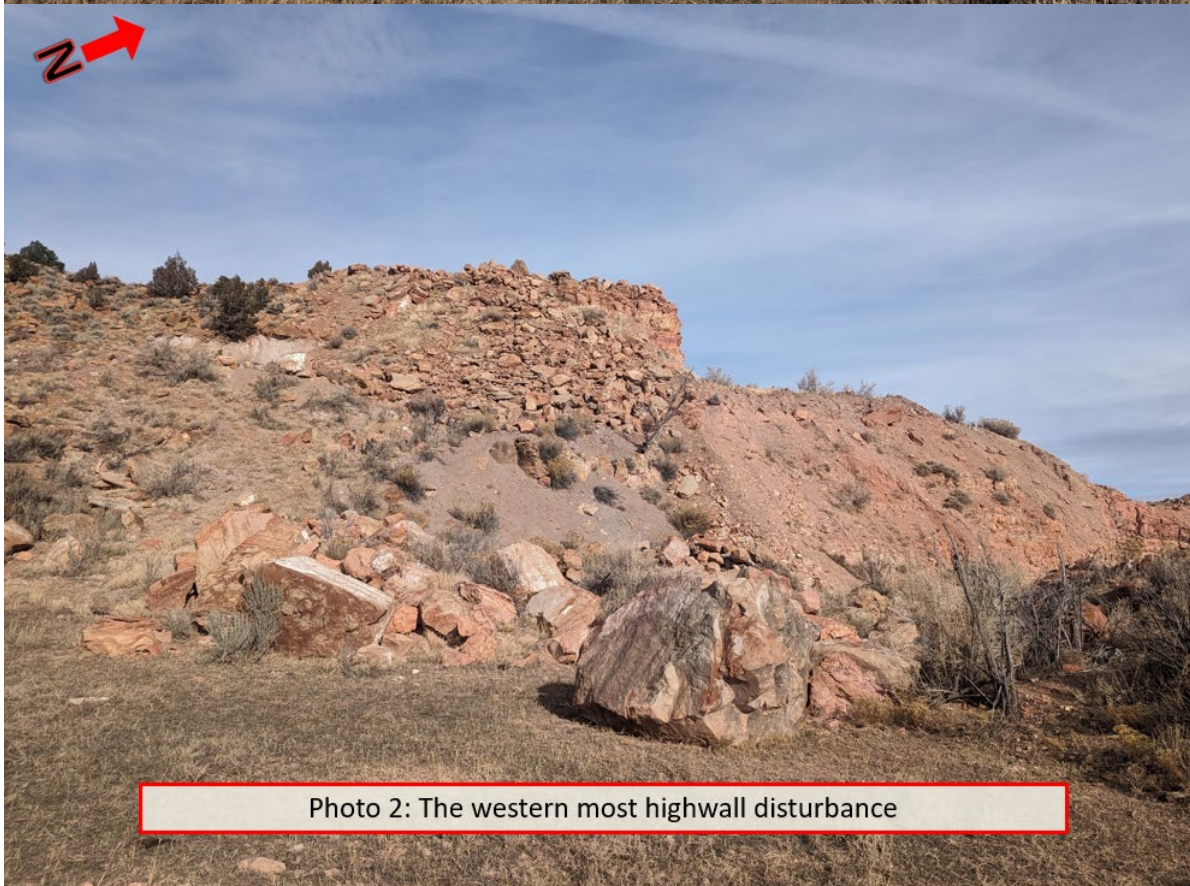
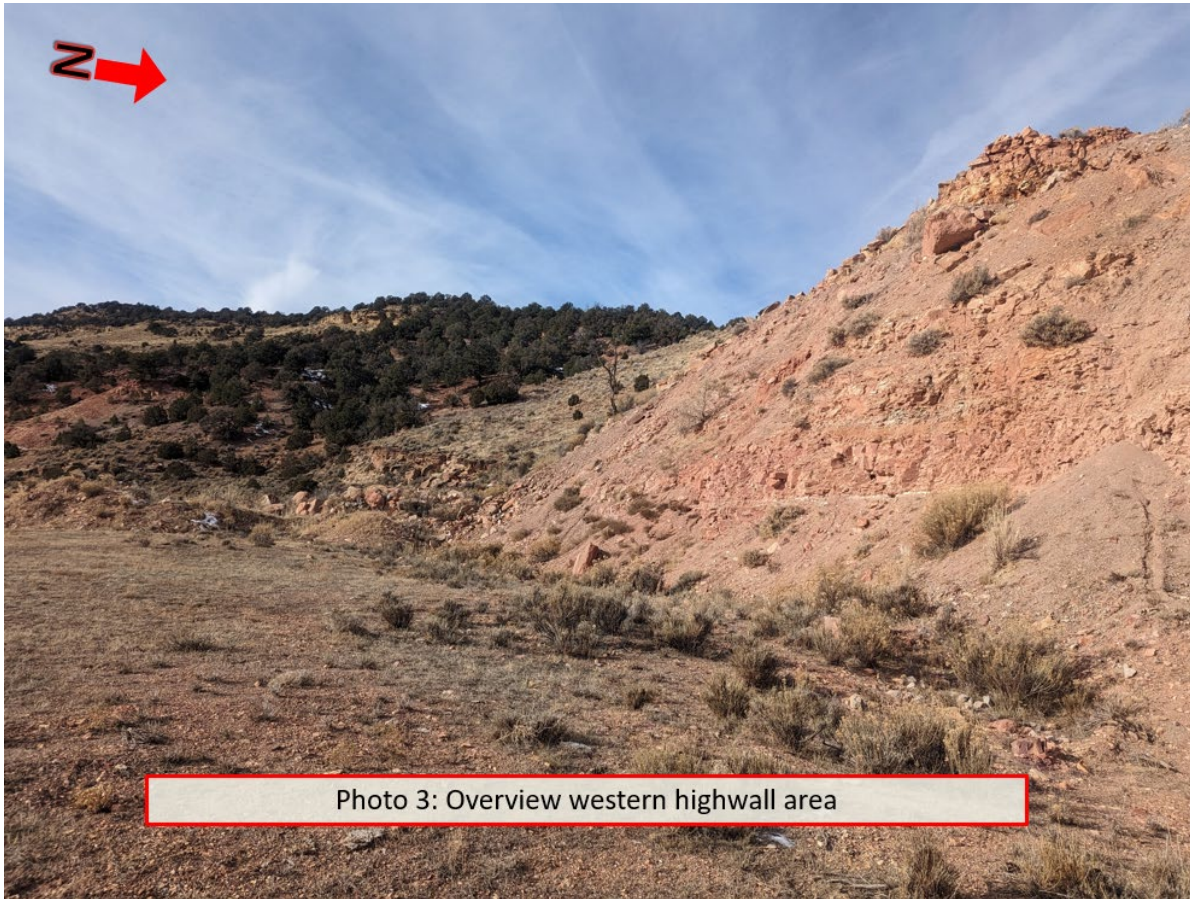
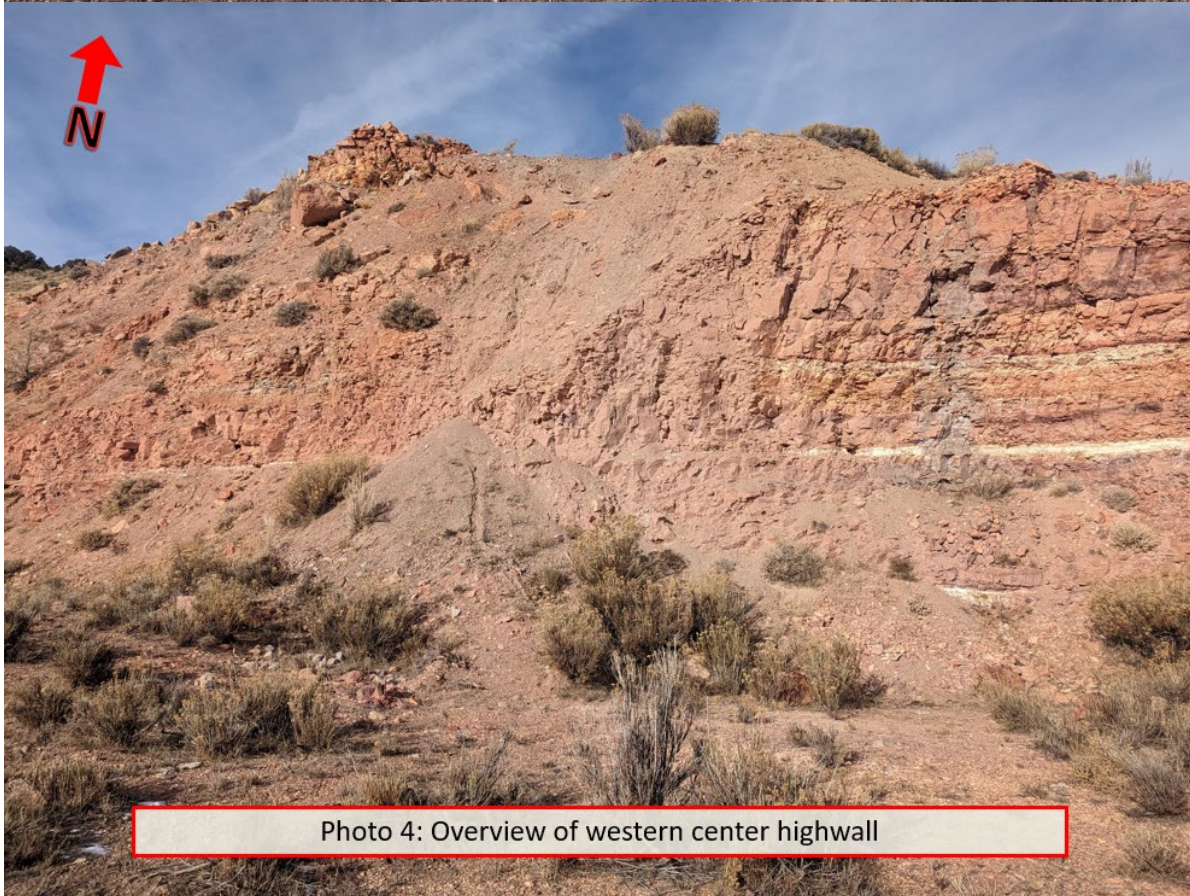
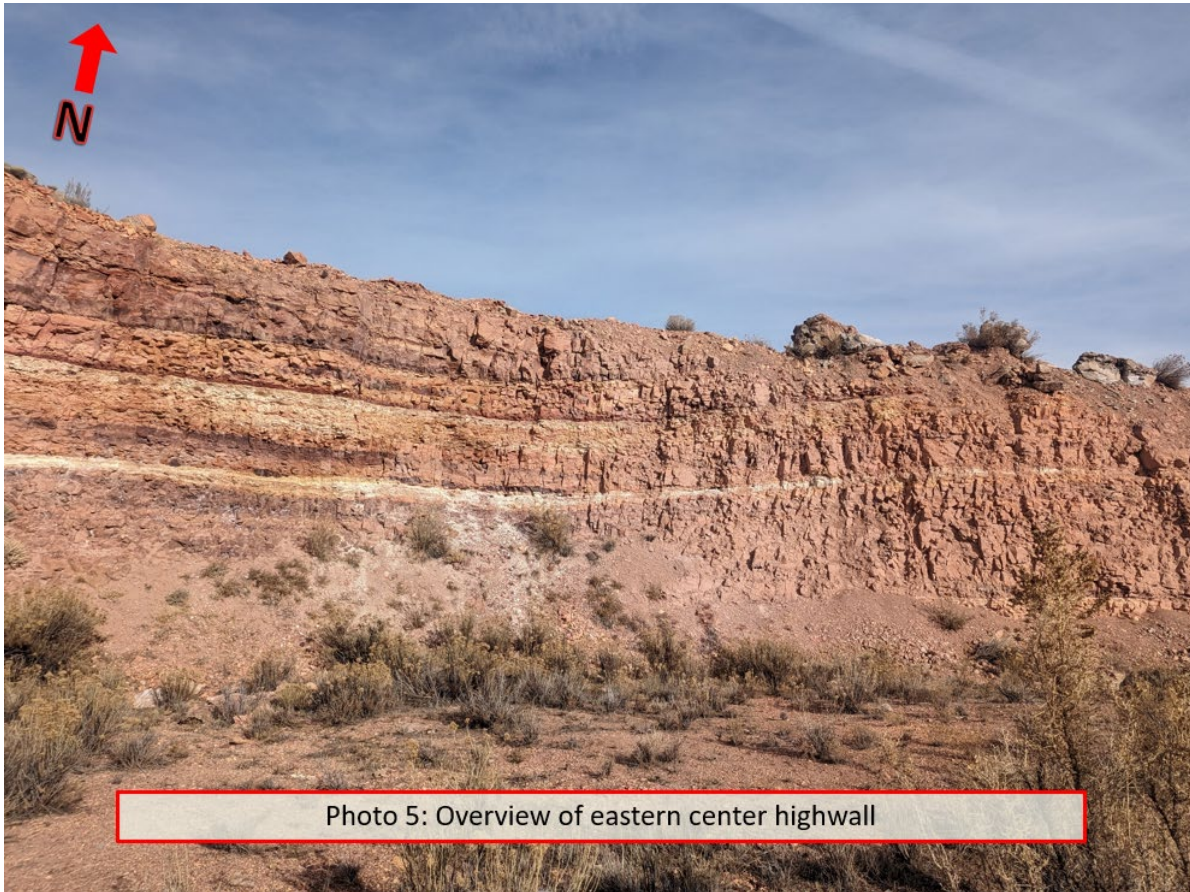
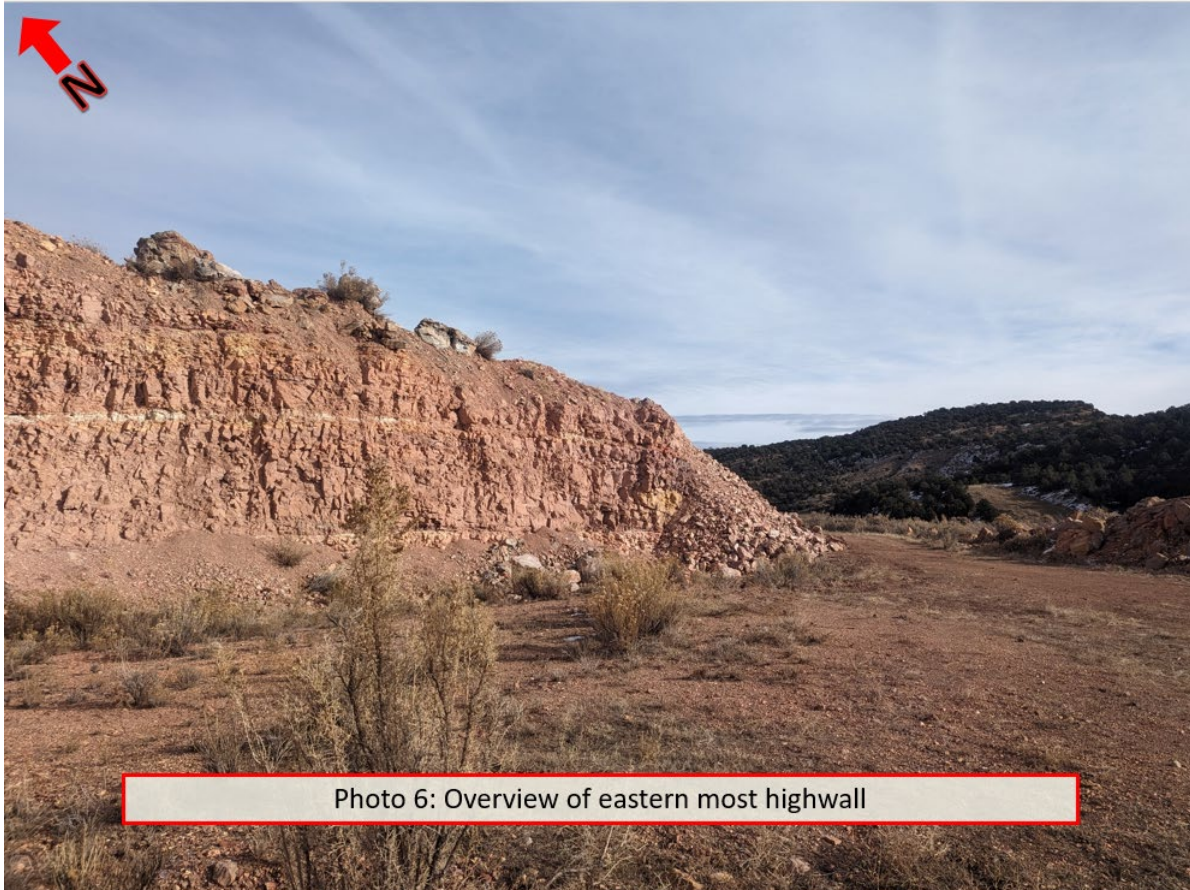
There is one main highwall which is approximately 150 LF, 30 ft high and near vertical. There is another highwall to the southwest which appears to be less frequently used. It is approximately 150 LF, 50 feet high and at a 1H: 1V slope (Photos 1-7). To the east and north of the highwall is a road to access the top of the highwalls (Photo 8).

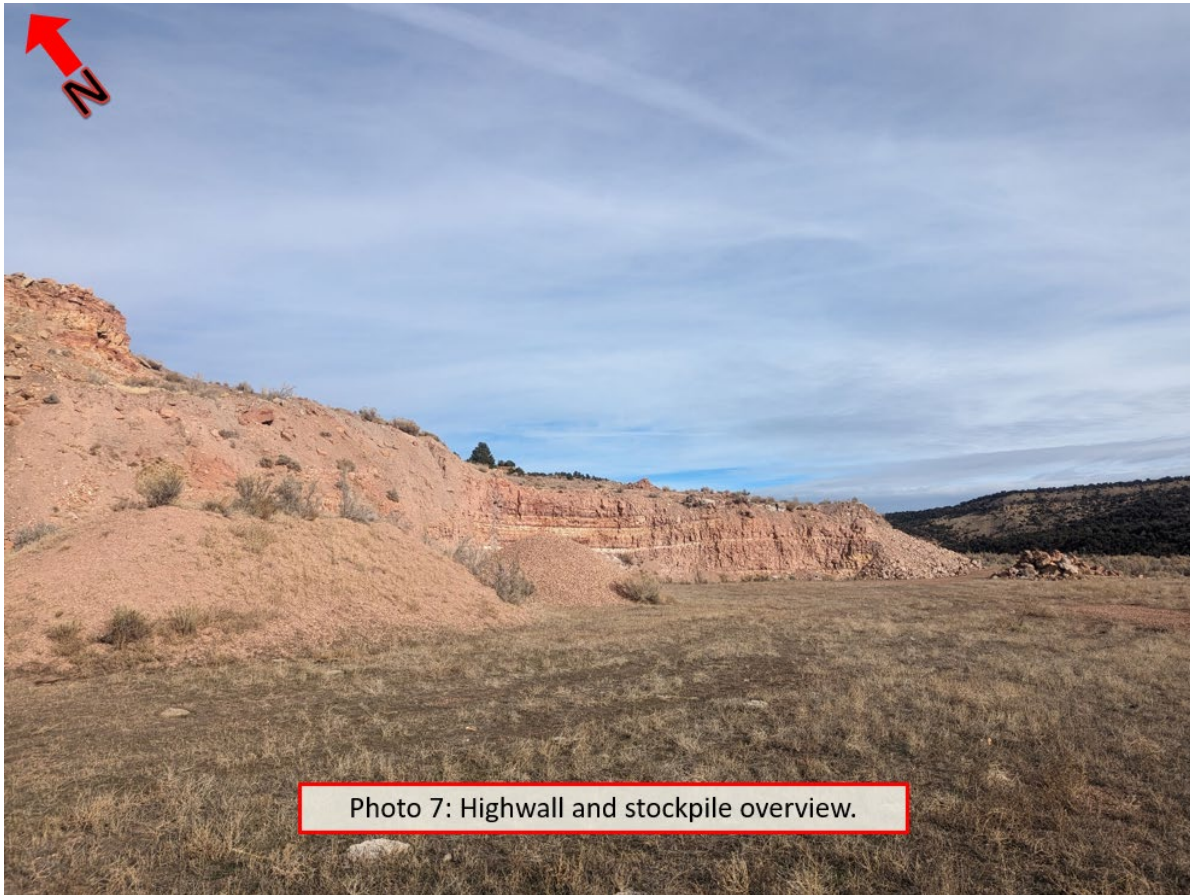
Photo 7: Highwall and stockpile overview.

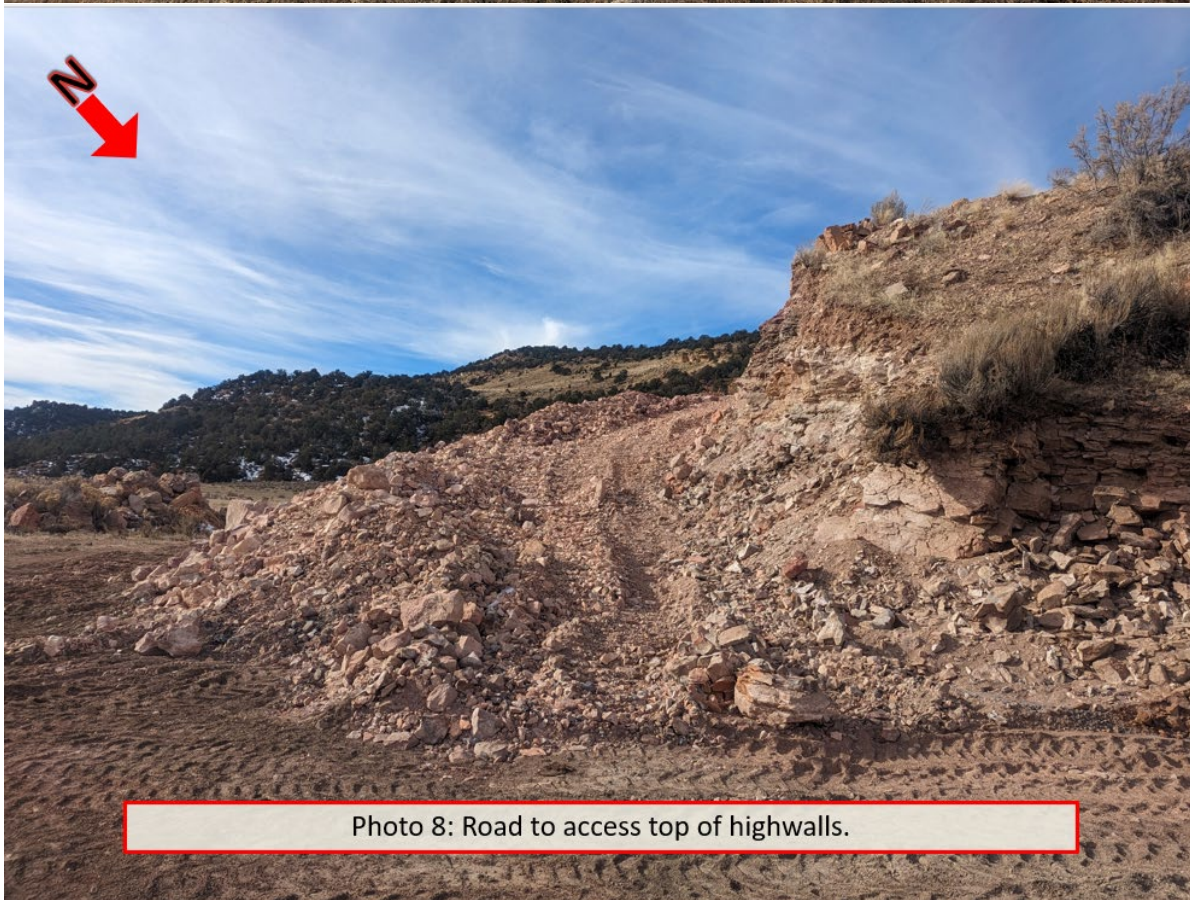
Photo 8: Road to access top of highwalls.

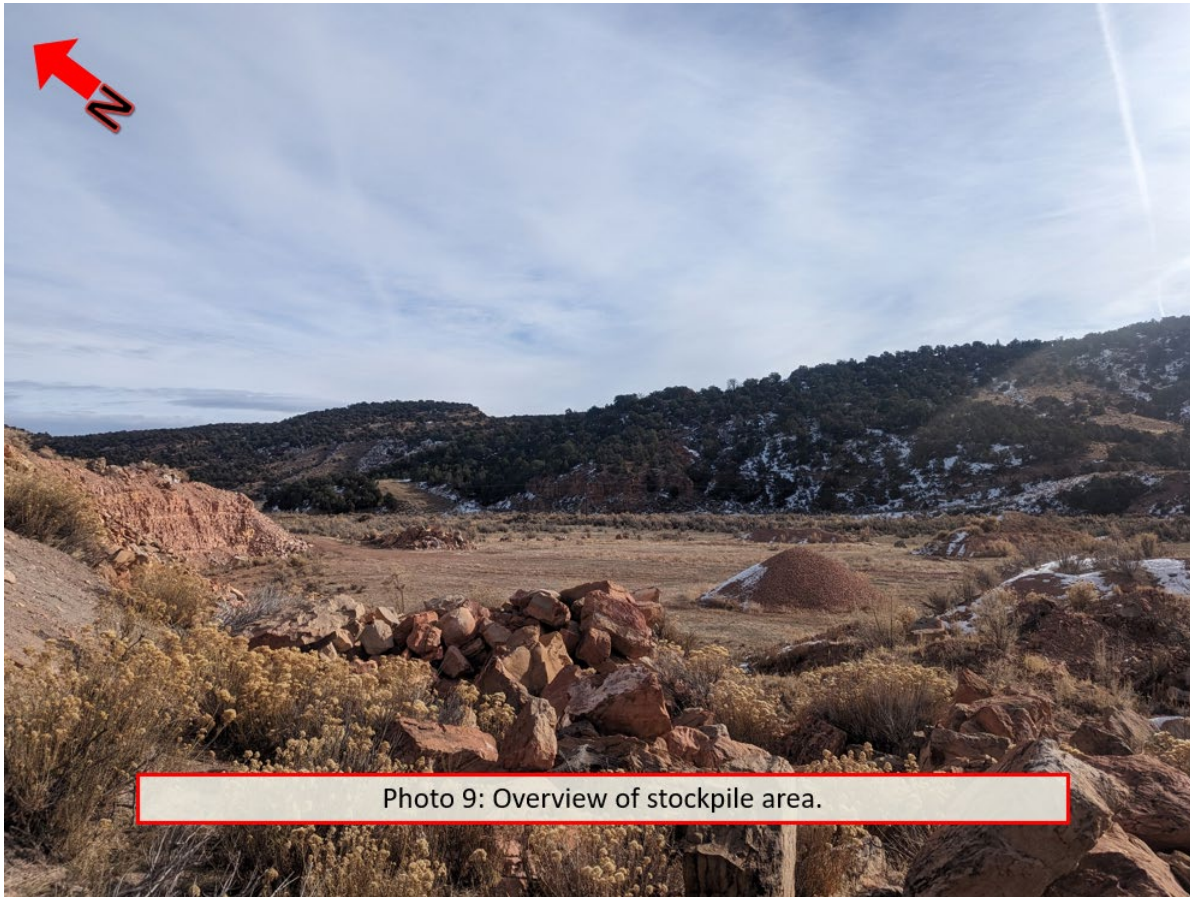
To the south of the highwalls is a flat stockpile area (Photos 9-10). Boulders delineate an area which has periodically been used for staging equipment. All stockpiles and disturbances appear to be contained within the footprint of the boulders. There is one main soil pile and several smaller rock/boulder stockpiles. Mr. Robertson indicated that no topsoil has been salvaged. From atop the highwalls the Division also observed additional boulders stockpiled on the north side of the hill (Photos 11-12). There was a dozer parked near them indicating that this area may also be used for mining purposes (stockpiling).

Photo 9: Overview of stockpile area.

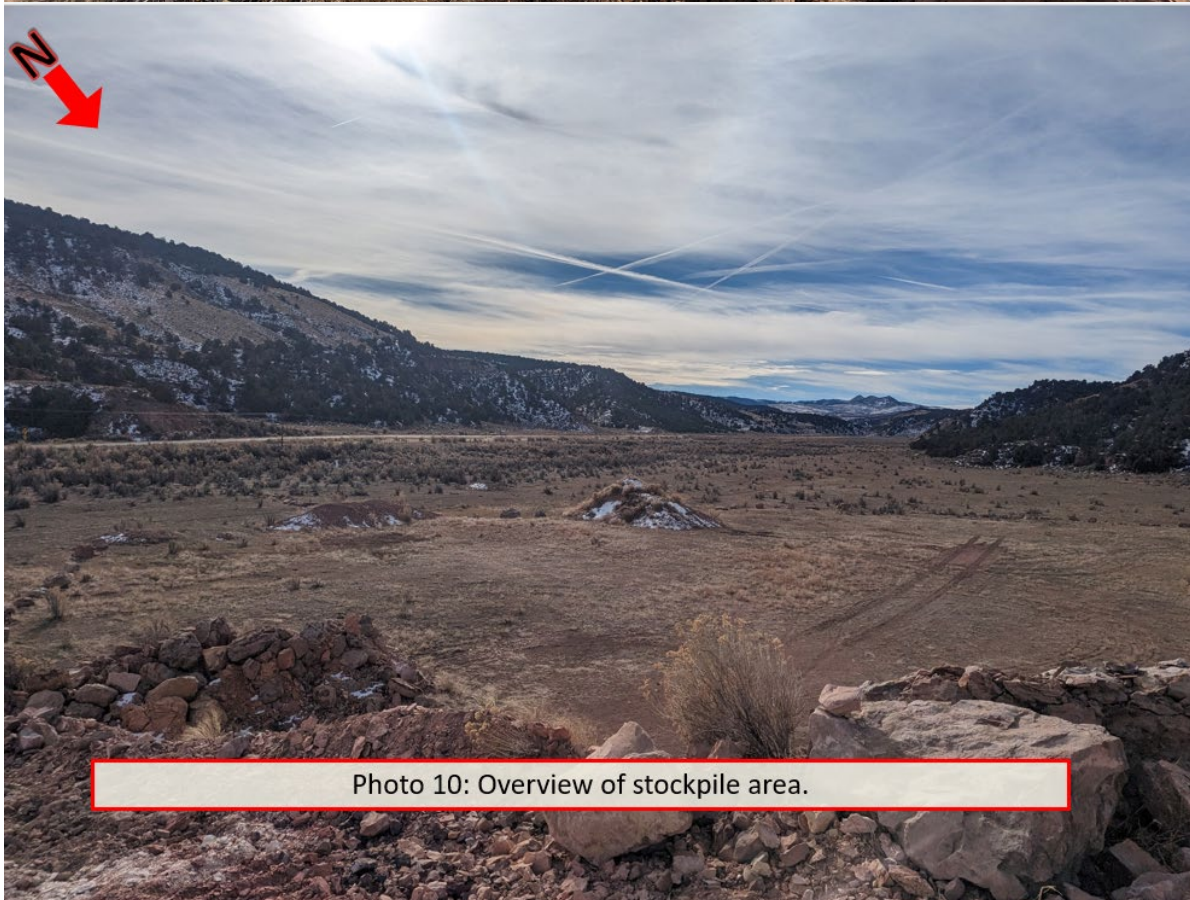
Photo 10: Overview of stockpile area.

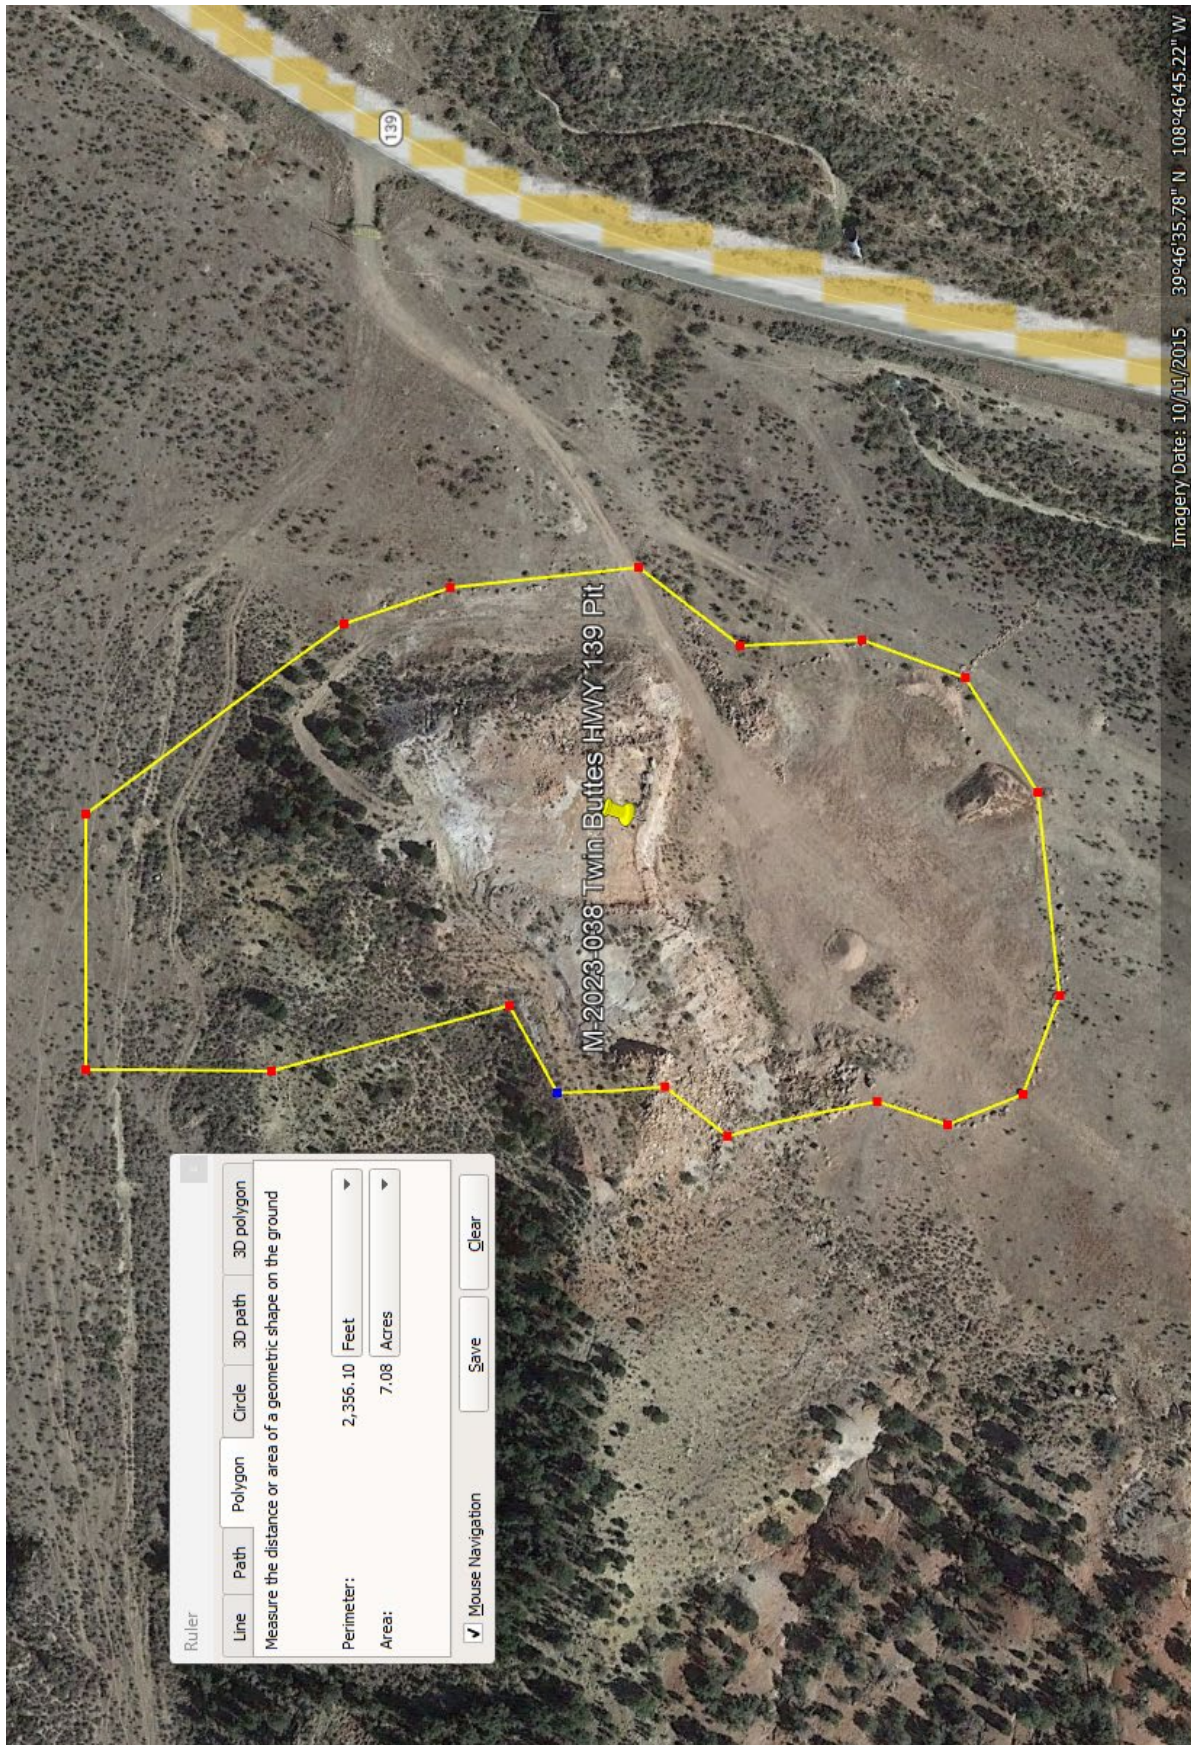
Division Staff took GPS data of the stockpile area but due to the steep topography was not able to get data for the highwalls. Based on satellite imagery obtained at the Division's office, the total affected lands are estimated to be approximately 7.08 acres (Photo 13). It is important to note to the operator, that the operation's affected land can go up to 9.9 acres while still being a permitted 110c operation. Anything 10 acres or greater would require a 112c permit application with the Division.
