RE: North of Douglas Pass, Permit No. M-1981-043, Unresolved Problem(s) Noted in a Past Inspection Report

MINERALS PROGRAM INSPECTION REPORT
PHONE: (303) 866-3567

MINE NAME: N Of Douglas Pass	MINE/PROSPECTING ID#: M-1981-043	MINERAL: Shale	COUNTY: Rio Blanco
INSPECTION TYPE: Monitoring	WEATHER: Clear	INSP. DATE: October 24, 2023	INSP. TIME: 12:40
OPERATOR: Colorado Department of Transportation	OPERATOR REPRESENTATIVE: None	TYPE OF OPERATION: 110c - Construction Limited Impact	
REASON FOR INSPECTION: Normal I&E Program	BOND CALCULATION TYPE: None	BOND AMOUNT: \$0.00	
DATE OF COMPLAINT: NA	POST INSP. CONTACTS: DRMS	JOINT INSP. AGENCY: U.S.BLM	
INSPECTOR(S): Amy Yeldell	INSPECTOR'S SIGNATURE:

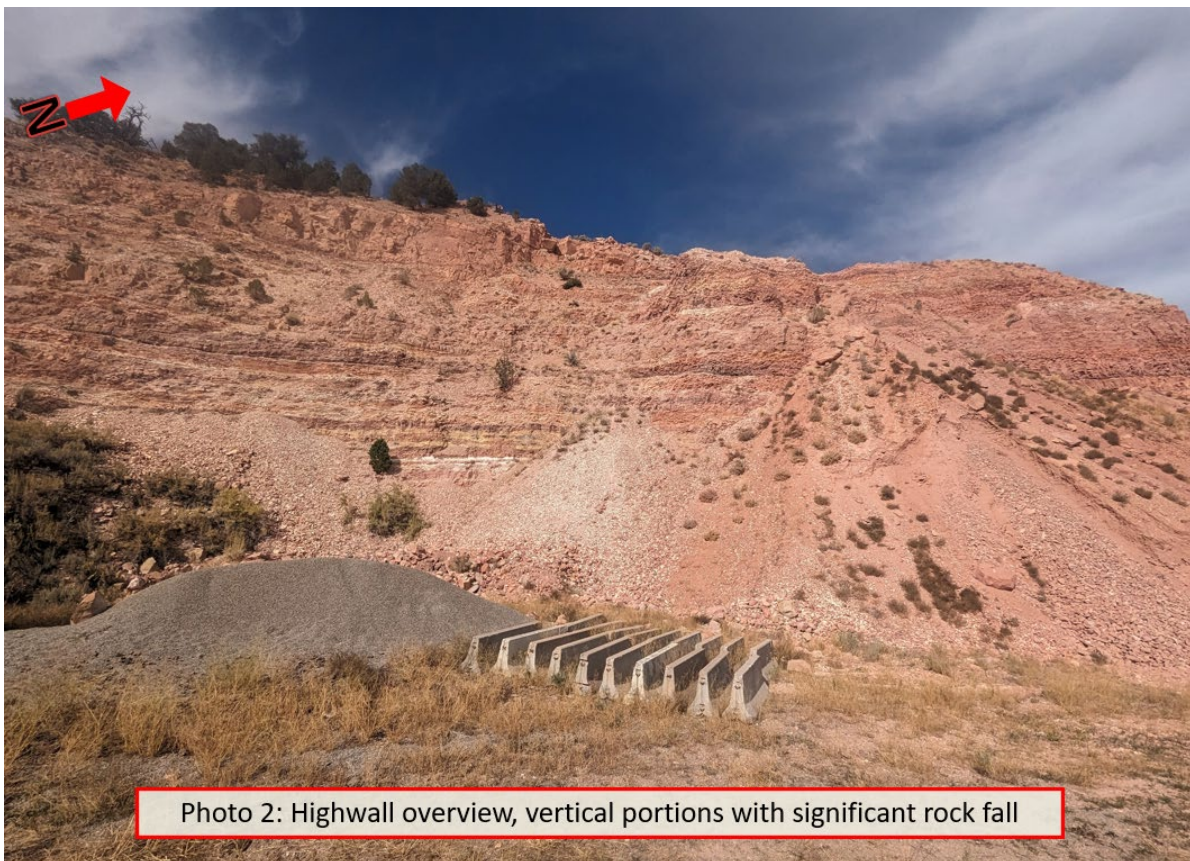
In several areas rocks and loose soils were observed falling and sloughing off throughout the inspection. A large amount of rockfall material is located at the base of the highwalls (Photo Two). It is unclear if this was by design or sloughing over time. While the site is approved to leave slopes at 1.5H: 1V they must be stable. If rock slopes are not stable catch benches may be necessary.

Photo 2: Highwall overview, vertical portions with significant rock fall

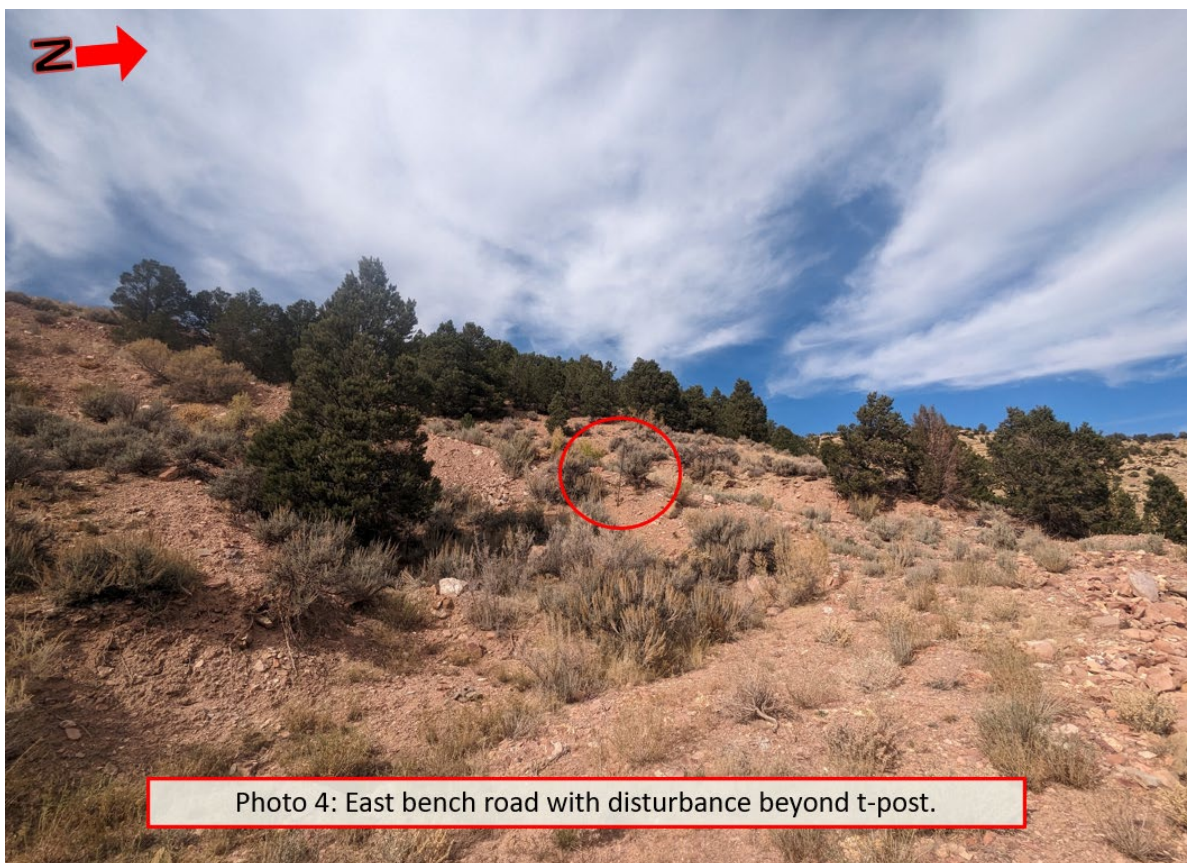
There may be off site damage. The Division was unable to fully delineate the permit boundary. However several t-posts that appeared to be boundary markers were observed. Disturbances were observed beyond those markers (Photo Four). In order to conduct reclamation activities additional land may be necessary where mining extends up to permit boundary. See additional comment under Signs and Markers section.

The permit boundary of the affected land was not sufficiently delineated as required by Rule 3.1.12(2). This is cited as an inspection problem. Only a few markers were observed. Along the west side of the highwall access road several t-post were observed on both sides of the road cut. And most notable there was a t-post on the edge of the highwall with additional disturbances to the north (behind it). In several instances disturbances were observed on both sides of the t-post markers indicating a potential for offsite impacts (Photos Four – Seven).

Please field delineate the approved 7.8 ac permit boundary (AM-1 in 1999 revised). Provide the Division with photo documentation that all boundary markers have been replaced by the corrective action deadline on page 2 of this report. Provide a map which correlates to the photographic documentation of location points. Additionally include a cover letter declaring if all disturbance were contained within the permit boundary OR if land has been affected outside of the approved permit boundary. Affected lands is defined by Rule 1.1(3)
