## DRMS inspection report

**MINERALS PROGRAM INSPECTION REPORT**  
**PHONE: (303) 866-3567**

<b>MINE NAME:</b> Arnold Pit No. 1	<b>MINE/PROSPECTING ID#:</b> M-2016-022	<b>MINERAL:</b> Borrow material for	<b>COUNTY:</b> Weld
<b>INSPECTION TYPE:</b> Monitoring	<b>WEATHER:</b> Cloudy	<b>INSP. DATE:</b> January 17, 2024	<b>INSP. TIME:</b> 08:45
<b>OPERATOR:</b> Arnolds Custom Seeding, LLC	<b>OPERATOR REPRESENTATIVE:</b> Doug Cook, Taleen Vick	<b>TYPE OF OPERATION:</b> 112c - Construction Regular Operation	
<b>REASON FOR INSPECTION:</b> Normal I&E Program	<b>BOND CALCULATION TYPE:</b> None	<b>BOND AMOUNT:</b> \$225,432.00	
<b>DATE OF COMPLAINT:</b> NA	<b>POST INSP. CONTACTS:</b> None	<b>JOINT INSP. AGENCY:</b> None	
<b>INSPECTOR(S):</b> Robert Zuber, P.E.	<b>INSPECTOR'S SIGNATURE:</b>

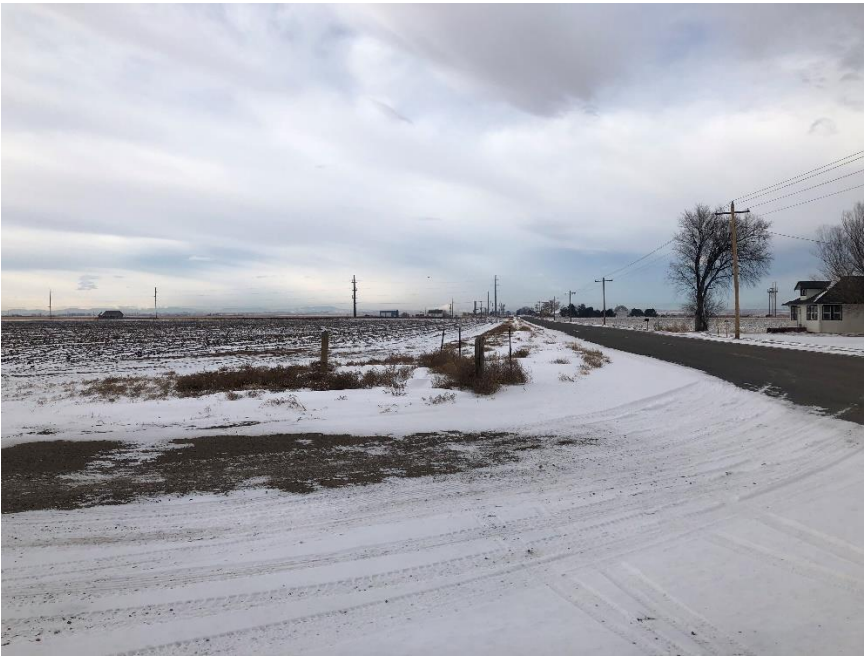
Doug Cook indicated that the 30 acres that have been newly affected in the recent reporting year (as stated in the recent Annual Report) are in the northwest corner of the site. He also indicated that topsoil has been spread on this area. Mr. Cook also indicated that the 56 acres that have been reclaimed, per the Annual Report, are in the southwest corner of the site. These 56 acres have been backfilled and covered with topsoil, seeded, fertilized, and mulched (per the report and confirmed by Mr. Cook). The vegetation in this area was not observed due to the winter conditions.

**Northwest corner of site, looking west from entrance on CR 16**

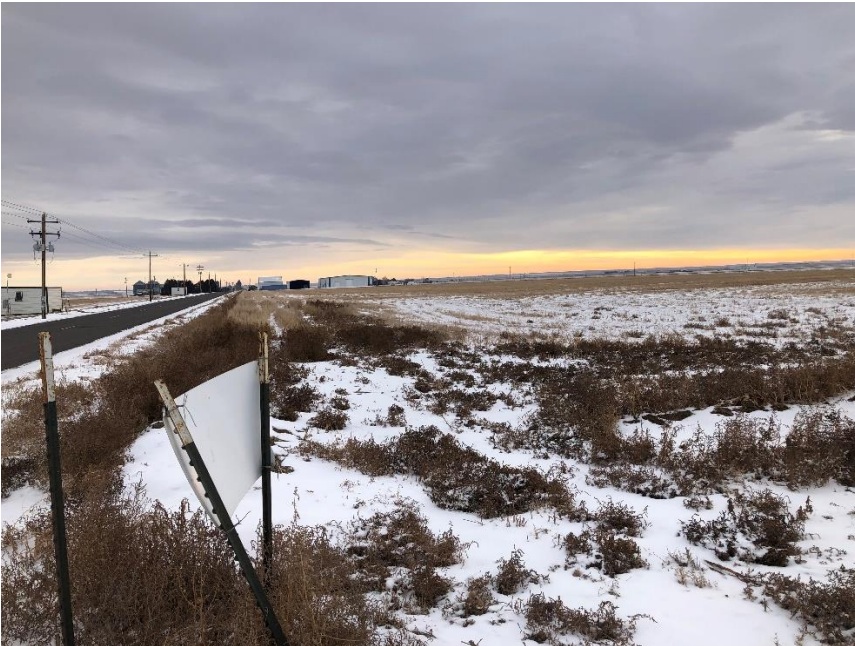
**Northeast corner of site, looking east from entrance on CR 16**

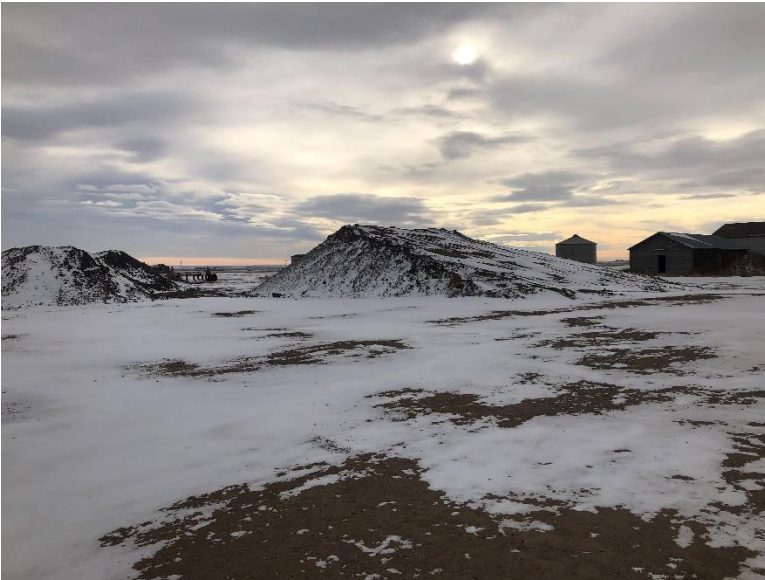
The site was observed from the road that runs north/south through the site. The site consists of cropland, which is consistent with the description of the land use in the permit, and farm buildings and equipment. No erosion or other problems were observed. Stockpiles of soil were seen near the center of the site; these were imported from another operation per Mr. Cook and are not intended for use at this site. No topsoil stockpiles for reclamation of this permit were seen; this material has been used for reclamation (also per Mr. Cook).

**Soil piles in middle of site – not related to mining operation per Doug Cook (no excavations seen at the site)**

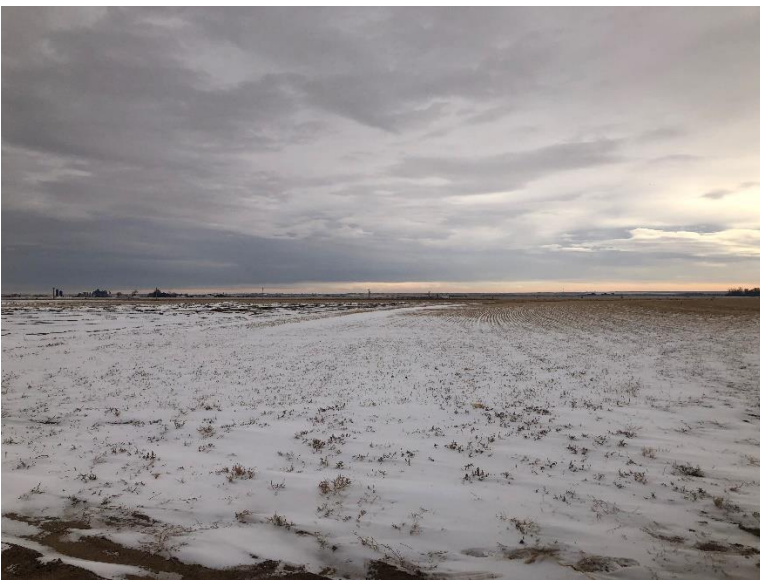
**Looking east at the southeast corner of the site**
