Subject: Summary of Instrumentation Monitoring  
4<sup>th</sup> Quarter 2023  
Bowie Coal Waste Disposal Area No. 2  
Paonia, Colorado

**SUBJECT: Summary Report, 4<sup>th</sup> Quarter 2023, Inclinator and Active Vibrating Wire Piezometer Data October – December 2023, Bowie Mine #2 Coal Waste Disposal Area (CWDA) #2**

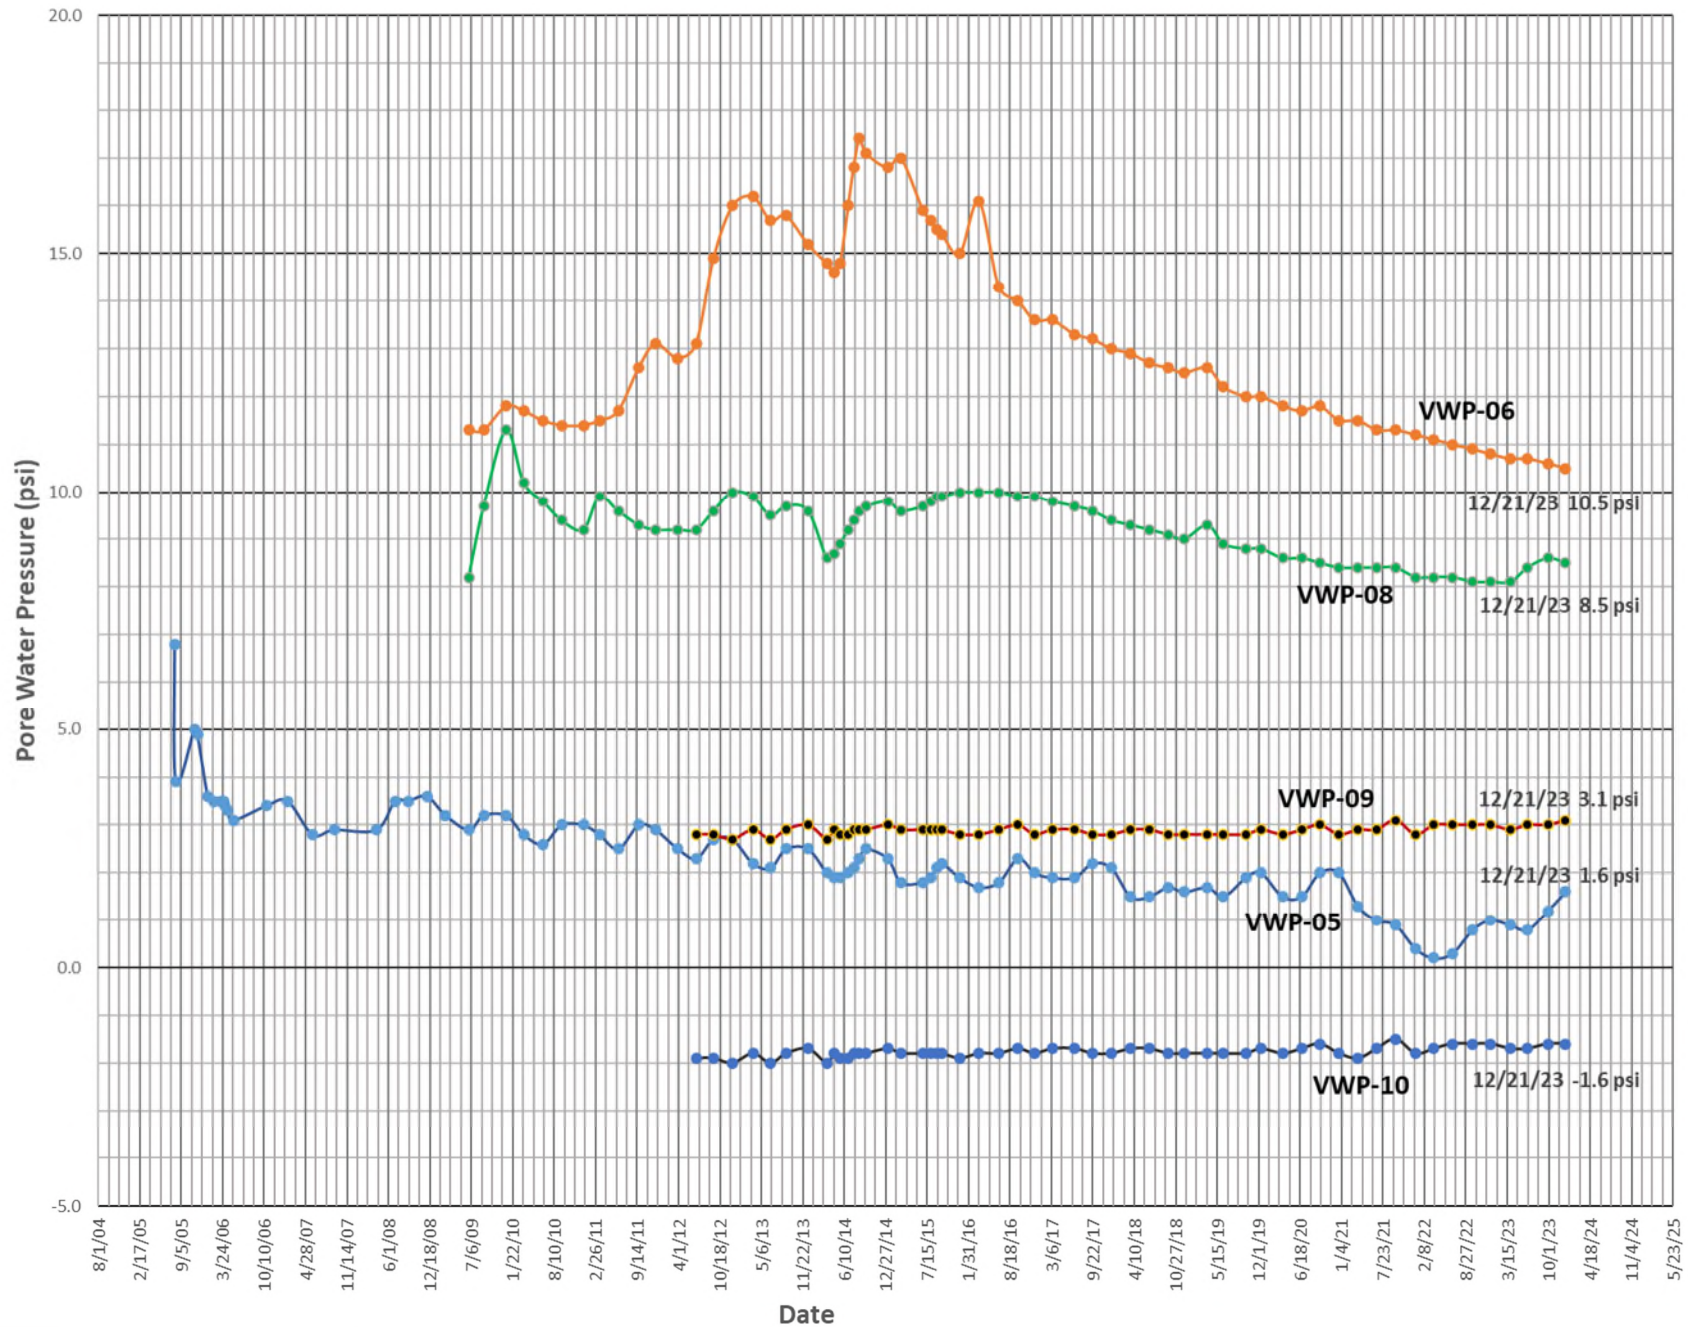
**Figure 2 - Bowie Mine #2 - CWDA #2**  
**Active Vibrating Wire Piezometer Data**

As seen on Table 1 and Figure 2, the VWP readings and trends are consistent with recent and historic readings. When compared to a year ago (Q4 2022), pore pressure readings in all the VWP's changed by small amounts (-0.3 to 0.6 psi). When compared with last quarter (Q3 2023), pore pressures also changed by relatively small amounts (-0.1 to 0.4 psi) for all five VWP's. Although four of the five VWP's remain steady or have general declining trends in pore pressure over the life of the VWP's, one of the piezometers (VWP-05) has exhibited pronounced seasonal cyclical behavior for its lifespan, except from mid-2021 to mid-2022 where there was a steady decline in pore pressures. This piezometer generally (but not always) shows low pore pressures for Q1 and Q2 and higher pressures for Q3 and Q4, with a net loss of 5.2 psi over the lifetime of that VWP. The other four VWP's have experienced net changes of +0.3 to -0.8 psi since installation, meaning current readings are very similar to initial readings. For VWP-09 and VWP-10, pressures have been consistent throughout the lifetime of the piezometers; however, for VWP-06 and VWP-08, they experienced wild fluctuations in pore water pressure in the first half of their lifetimes but have settled to pressures similar to the installation pressures in the past several years.

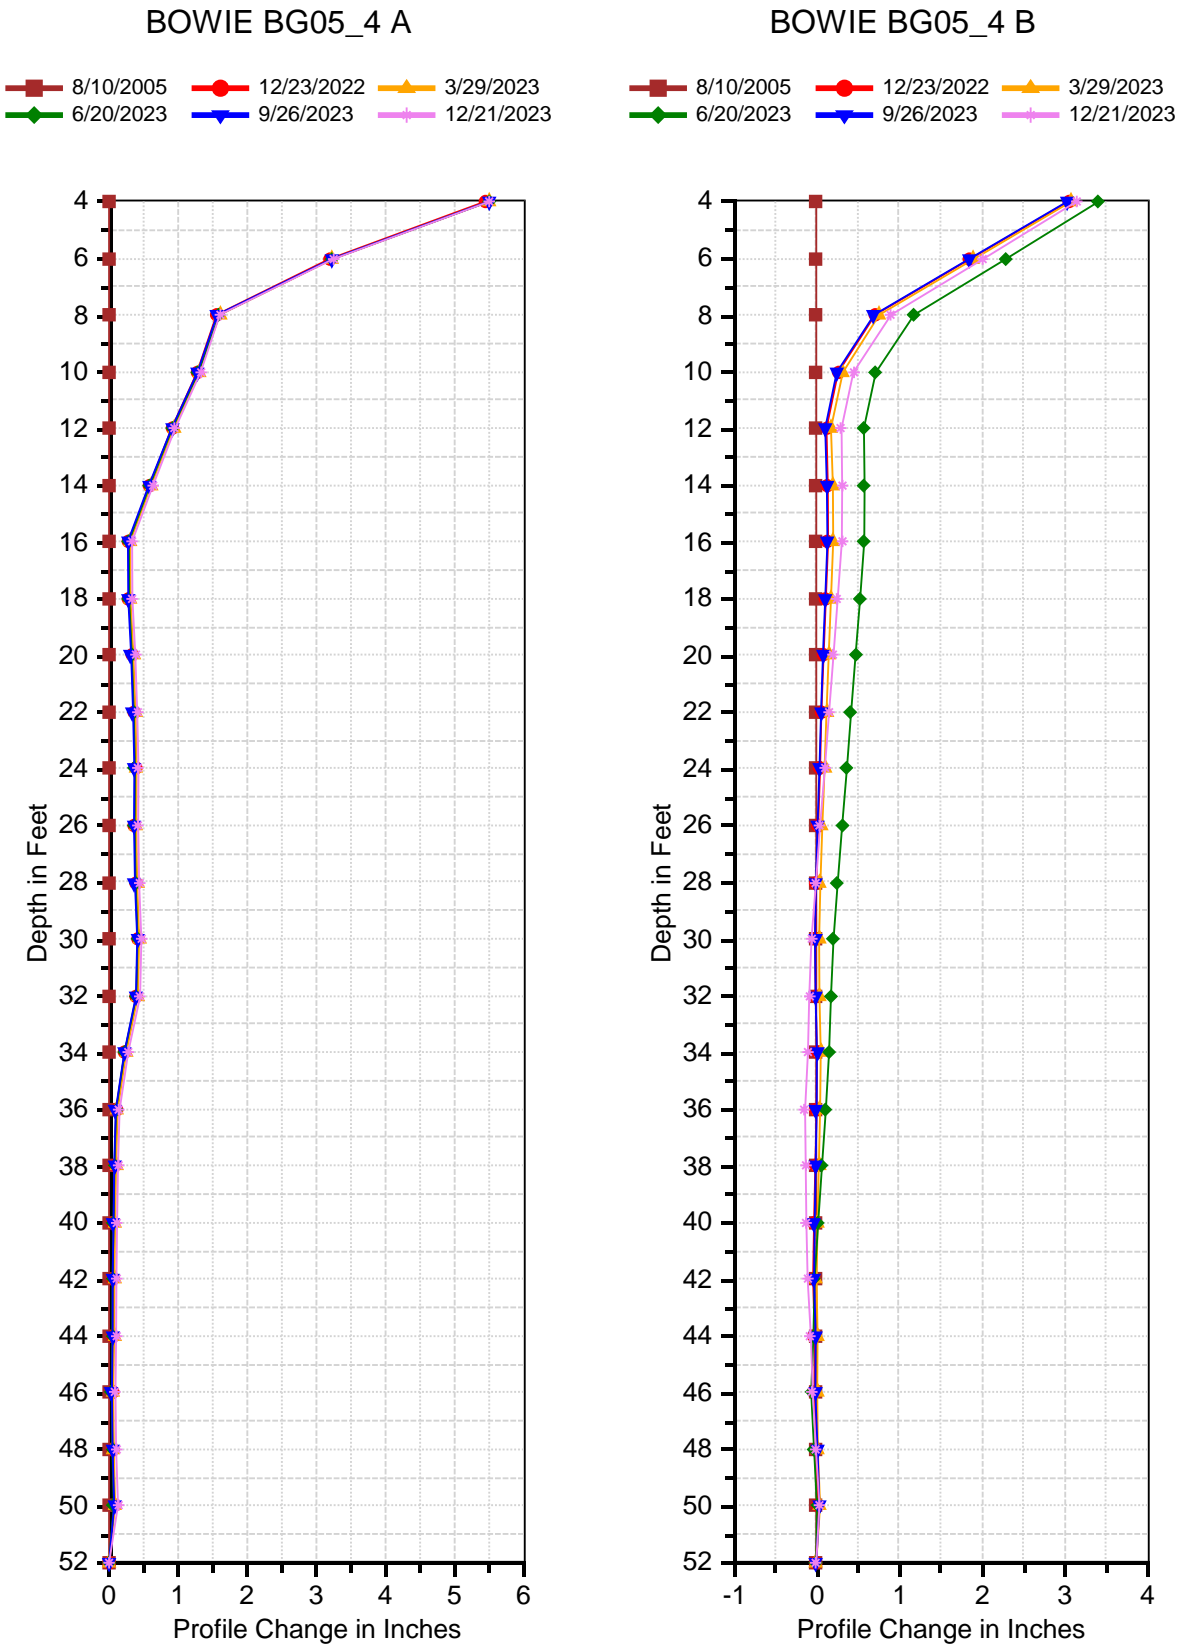
Figure 3 - Inclinometer Displacement Curves

As described in previous reports, historic displacements indicated on the plots for the approximate upper 12-14 feet of the inclinometers since installation in 2005 are due to placement of cover soil on the face of the waste pile during revegetation/regrading operations in late 2006 and early 2007. This man-caused displacement is documented in a report by Buckhorn Geotech dated December 22, 2008, to Bowie Resources called *Revised Stability Evaluations for Coal Mine Waste Disposal Area No. 2, Bowie No. 2 Mine*.

Based on the current inclinometer readings, BG05\_7 shows near perfect alignment (essentially identical readings for 18 years) with the initial reading in 2005 for the downslope direction (Axis A). Inclinometers BG05\_4 and BG05\_5, however, show a bulge of less than 1/2-inch in the inclinometer pipes (below the surface regrading). Based on our records, this bulge developed slowly from 2005 to 2010, but no movement has been recorded since then. This suggests there had been some gob pile settlement early in the lifetime of the inclinometers, but no recent or additional movement has occurred. Some "noise" which is understood to be relatively common in orthogonal direction (Axis B) readings, was observed over the past few years for all three inclinometers. This can be due to various mechanical or installation causes that are unrelated to slope movement. For example, grout voids, poor grout coverage, or soil settlement around the instrument can all contribute to vibrations and pipe movement that impacts inclinometer
