Deer Trail Pit Inspection Report

MINERALS PROGRAM INSPECTION REPORT

MINE NAME: Deer Trail Pit	MINE/PROSPECTING ID#: M-1988-090	MINERAL: Sand and gravel	COUNTY: Arapahoe
INSPECTION TYPE: Monitoring	WEATHER: Clear	INSP. DATE: December 6, 2023	INSP. TIME: 13:00
OPERATOR: 5A Aggregate LLC	OPERATOR REPRESENTATIVE: None	TYPE OF OPERATION: 112c - Construction Regular Operation

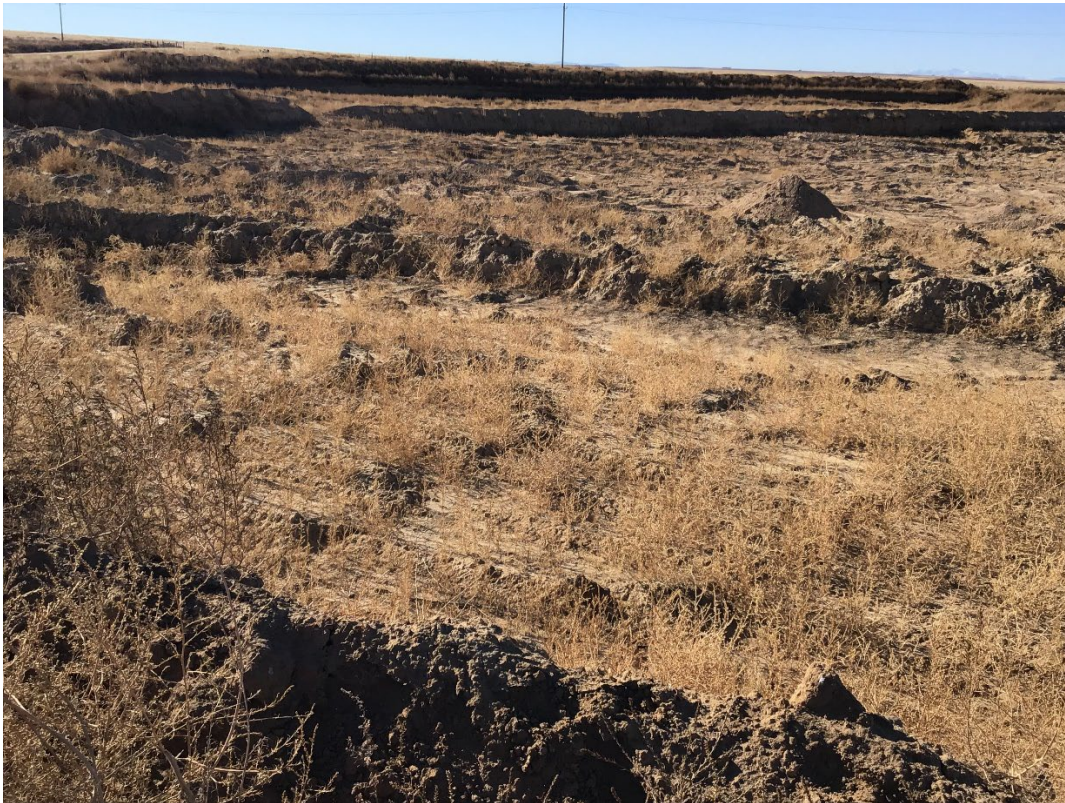
The majority of the current affected area is located in the northwest corner of the site. In 1996, the M-1988-090 permit was converted into the current 112c permit with the approval of a conversion application (CN-01). The approved mining plan for the site indicates the Operator shall actively mine 5 acres, will actively replace overburden and construct the final slopes and spread topsoil on 5 acres and will be revegetating 5 acres. The Division requested that the highwall along the County Road 213 be backfilled and reclaimed as part of bringing the mine back into compliance in 2018. The Operator had backfilled the western portions of the highwall (2019), along the County Road 213 to a 3H:1V slope or shallower. During the backfilling they were able to maintain a run on/off control berm at the top of what was the highwall. During this inspection, DRMS observed that the highwall appears to have been re-excavated adjacent to County Road 213 undoing the reclamation work that was done in 2019.

Photo 1: Looking west along the north south highwall adjacent to County Road 213

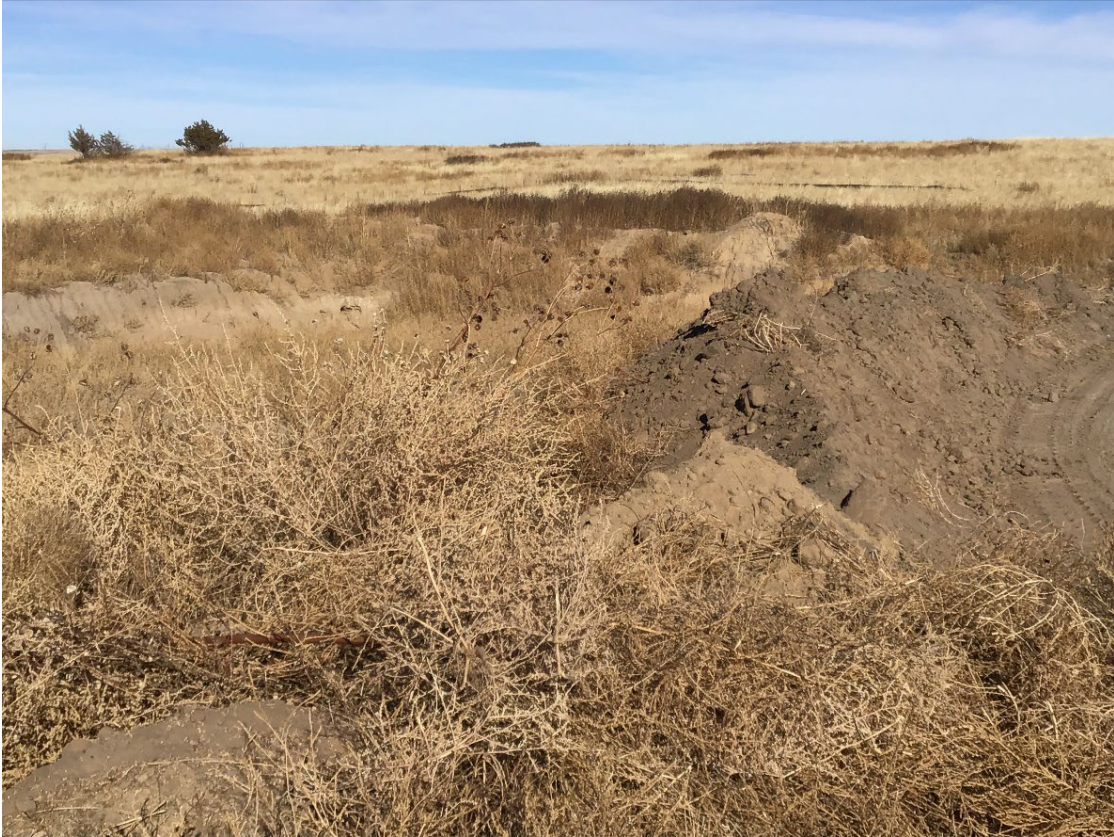
The mining and reclamation plan approved with CN-01 required the site to be mined in five acre phases (P-1 to P-5 etc.) with concurrent reclamation. At the time of this inspection, it did not appear that mining, backfilling and grading were occurring as per the mine plan. It appeared that mining was occurring in the areas approved to be affected, however more land is affected than currently allowed at one time. Further, the approved mining and reclamation plan requires the operator to salvage topsoil for use in reclamation. The operator is not salvaging topsoil in accordance with the approved plan. The operator is not complying with the approved

Photo 2: Looking east at reclaimed area in the distance and affected area in foreground.

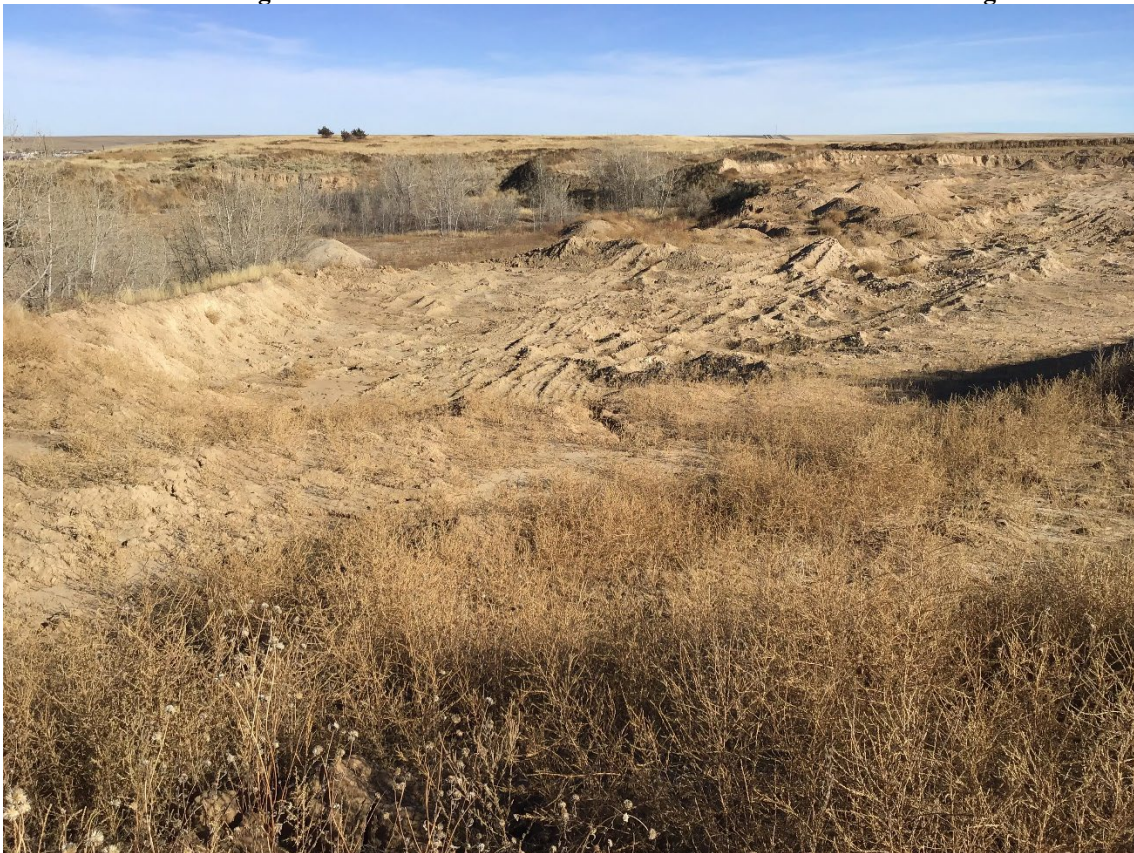
Piled overburden was being loaded and hauled off-site at the time of inspection. Reclamation did not appear to have been carried out. Mr. Carson indicated that the current plan is to dig down 50 feet over the extent of the currently disturbed area to excavate 50 to 60 thousand tons of the commodity for next year (2024). The presence of topsoil stockpiles as described in the permit were not noted during the inspection. Topsoil must be preserved for reclamation. Activity is scheduled to begin in January 2024. Currently there appears to be approximately 22 acres of affected land. The excavation consists of the western highwall of approximately 12 feet in height trending north and south, adjacent to County Road 213. During the inspection DRMS observed that the highwall appears to have been re-excavated as discussed above. The southern highwall trends east and west near the southern edge of the affected area as shown on the 2023 Annual Report Map and is approximately 16 feet in height. The 2023 annual report map did not delineate any contemporaneous reclamation.

Photo 3: Looking north east at affected area.

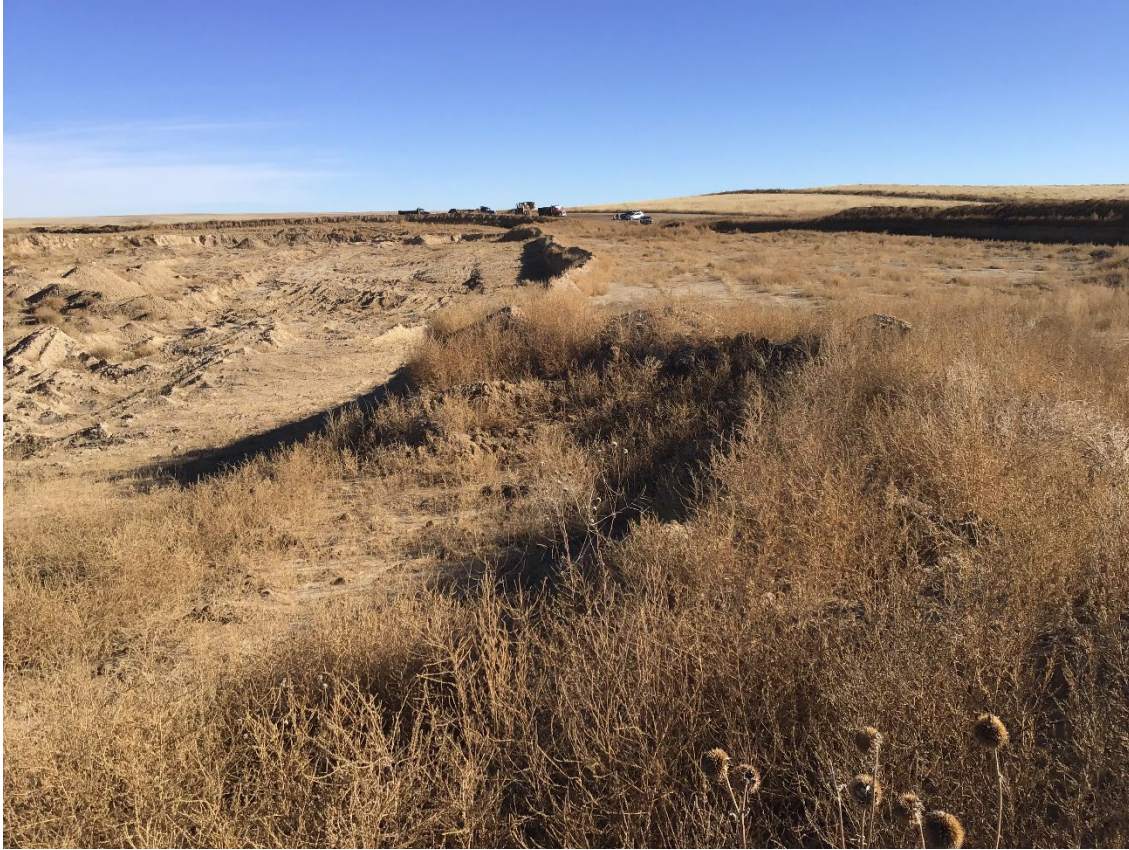
Photo 4: Looking east along the south highwall.
