**MINERALS PROGRAM INSPECTION REPORT**  
**PHONE: (303) 866-3567**

<b>MINE NAME:</b> Climax Mine	<b>MINE/PROSPECTING ID#:</b> M-1977-493	<b>MINERAL:</b> Molybdenum	<b>COUNTY:</b> Lake, Summit
<b>INSPECTION TYPE:</b> Aerial Inspection	<b>INSPECTOR(S):</b> Dustin Czapla	<b>INSP. DATE:</b> January 3, 2024	<b>INSP. TIME:</b> 14:30
<b>OPERATOR:</b> Climax Molybdenum Company	<b>OPERATOR REPRESENTATIVE:</b> NA	<b>TYPE OF OPERATION:</b> 112d-3 - Designated Mining Operation	
<b>REASON FOR INSPECTION:</b> Normal I&E Program	<b>BOND CALCULATION TYPE:</b> None	<b>BOND AMOUNT:</b> \$91,011,850.00	
<b>DATE OF COMPLAINT:</b> NA	<b>POST INSP. CONTACTS:</b> None	<b>JOINT INSP. AGENCY:</b> None	
<b>WEATHER:</b> Clear	<b>INSPECTOR'S SIGNATURE:</b>

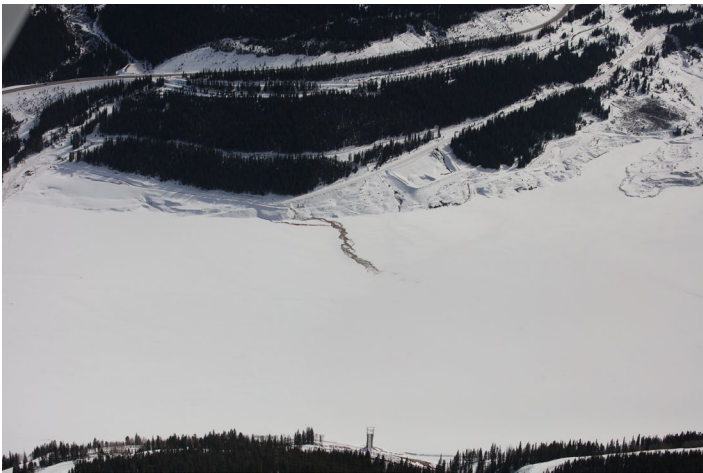
The Mayflower TSF and 5 Dam, Tenmile TSF and 3 Dam, Robinson TSF and 1 and 2 Dams, Robinson Lake, Eagle Park Reservoir and 4 Dam were observed. No abnormal conditions were noted. TSF's appear to be functioning within the established design criteria.

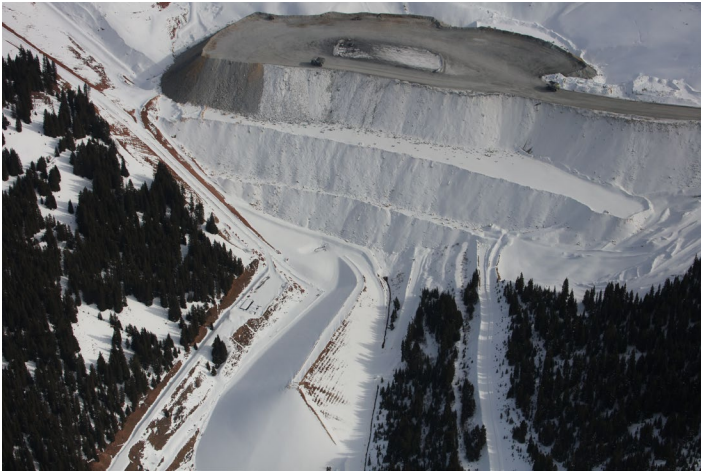
McNulty OSF

The McNulty and North 40 OSF's were observed. No abnormal conditions were noted. OSF's appear to be functioning within the established design criteria.
