MINERALS PROGRAM INSPECTION REPORT
PHONE: (303) 866-3567

MINE NAME: Hubbs Pit	MINE/PROSPECTING ID#: M-1987-088	MINERAL: Sand and gravel	COUNTY: La Plata
INSPECTION TYPE: Monitoring	INSPECTOR(S): Dustin Czapla	INSP. DATE: January 18, 2024	INSP. TIME: 09:00
OPERATOR: Hubbs III, LLC	OPERATOR REPRESENTATIVE: None	TYPE OF OPERATION: 112c - Construction Regular Operation	
REASON FOR INSPECTION: SR1		BOND CALCULATION TYPE: Complete Bond	BOND AMOUNT: \$59,905.00
DATE OF COMPLAINT: NA		POST INSP. CONTACTS: None	JOINT INSP. AGENCY: None
WEATHER: Clear	INSPECTOR'S SIGNATURE:

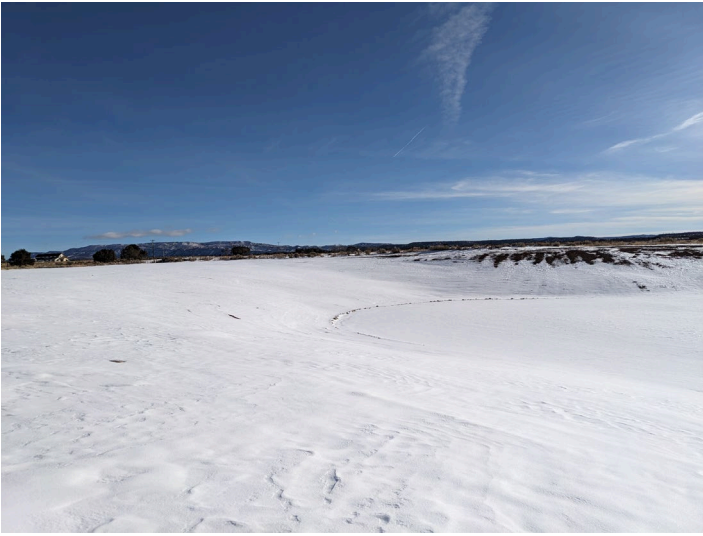
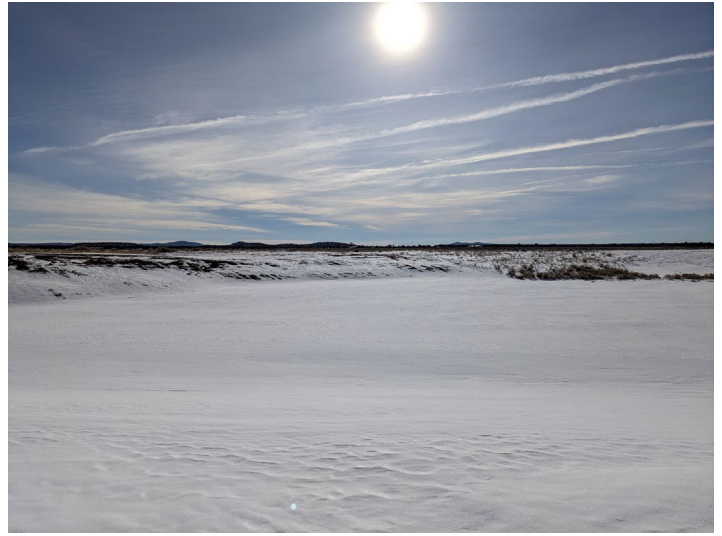
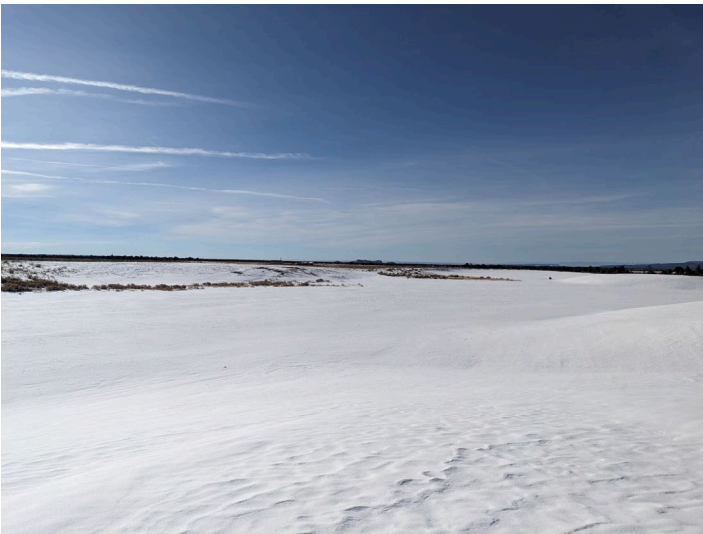
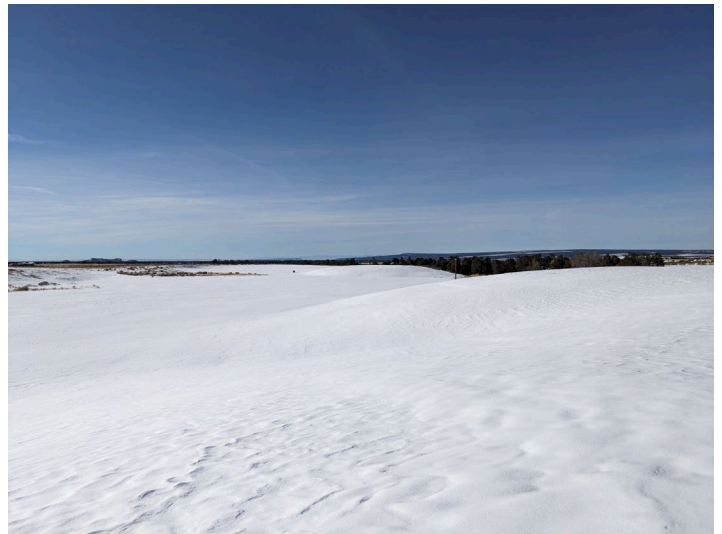
The site is in final reclamation. Final grading has been completed in accordance with the approved reclamation plan. All slopes have been reduced to 3H:1V or less.
