### MINERALS PROGRAM INSPECTION REPORT

<b>MINE NAME:</b> Houchin Gravel Pit	<b>MINE/PROSPECTING ID#:</b> M-1980-249	<b>MINERAL:</b> Sand and gravel	<b>COUNTY:</b> El Paso
<b>INSPECTION TYPE:</b> Monitoring	<b>WEATHER:</b> Clear	<b>INSP. DATE:</b> December 14, 2022	<b>INSP. TIME:</b> 10:00
<b>OPERATOR:</b> Charles W Houchin	<b>OPERATOR REPRESENTATIVE:</b> Curt Houchin	<b>TYPE OF OPERATION:</b> 110c - Construction Limited Impact

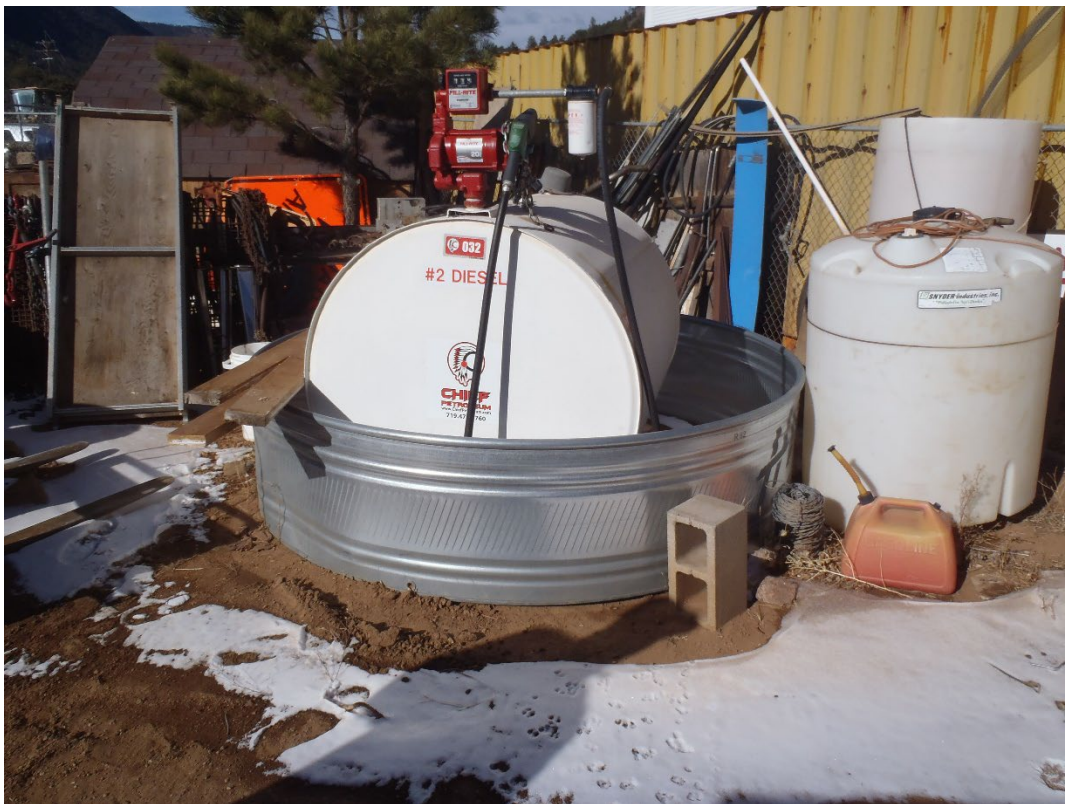
**Acid And Toxic Materials:** An above ground diesel fuel tank was observed and had adequate secondary containment (see **Photo 1**).

Photo 1. Above ground diesel fuel tank with secondary containment.

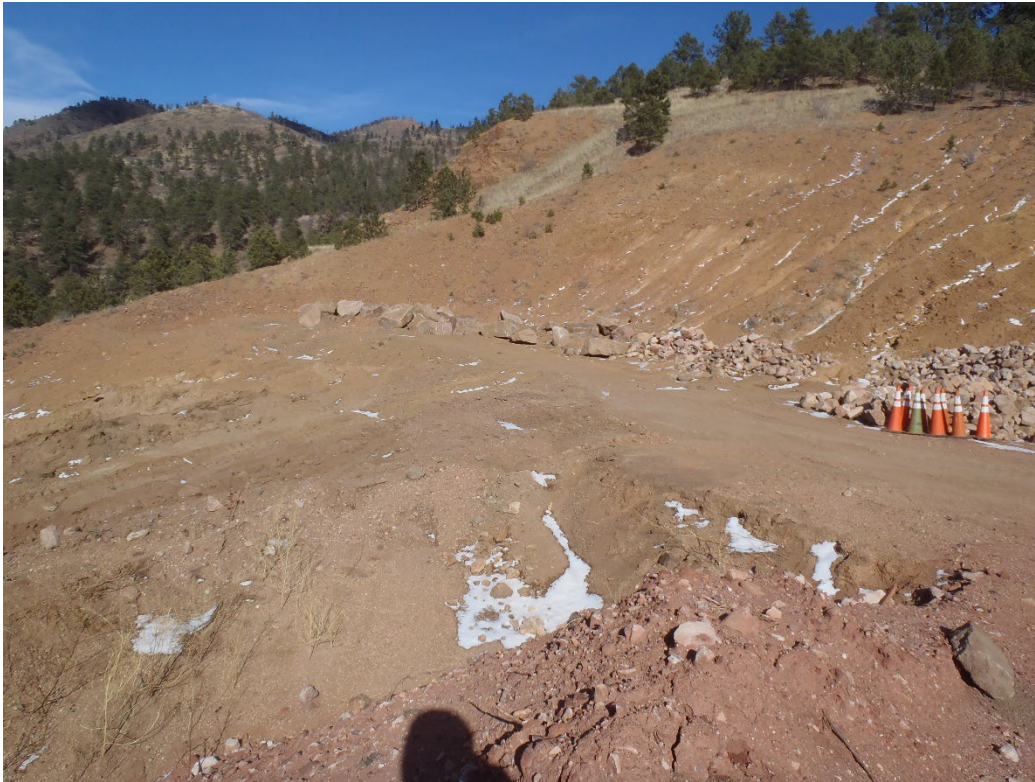
**Backfilling and Grading:** The approved final grading plan is for the site to be benched at 2H:1V. A bench was observed approximately midway up the active mine area (see **Photo 2**). Mr. Houchin indicated he was considering a revised grading plan. I informed him a technical revision would be required to modify the final grading plan. Sufficient backfill material appeared to be available.

Sediment Control: Only minor erosion rills were observed and only above the upper bench (see **Photo 2**) No erosion problems leading to offsite impacts were observed and no BMPs were needed at the time of the inspection.

Photo 2. Mine bench (note minor erosion rills above bench).

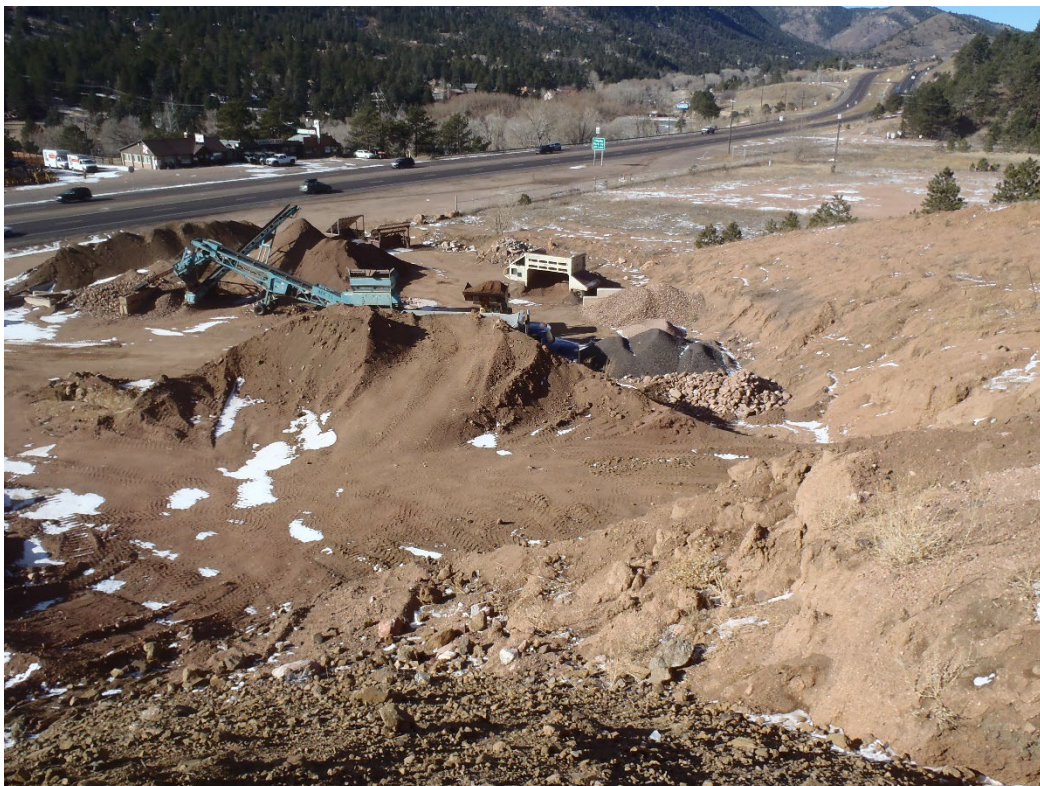
Processing Waste: No processing waste was observed. Mr. Houchin does import offsite material for processing. A large stockpile of offsite material was observed during this inspection (see **Photo 3**).

Photo 3. Stockpile of offsite material (looking WSW).

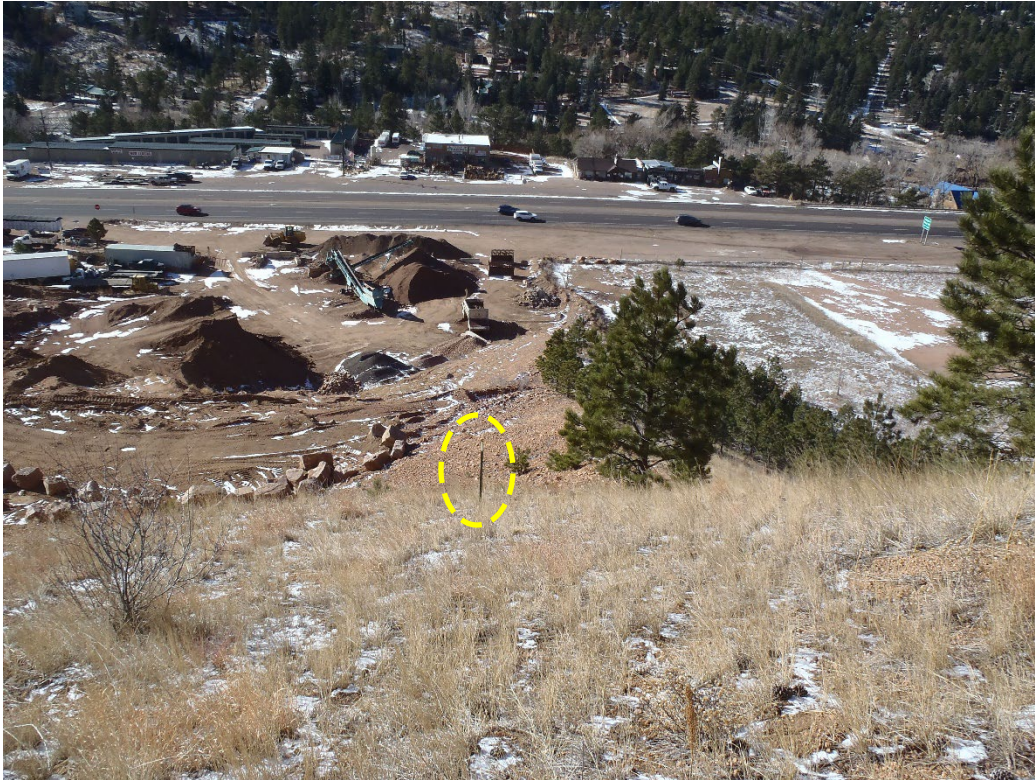
Support Facilities On-site: A screen plant and loader were observed on site (see **Photo 4**).

Photo 4. Screen and loader (looking SW, side boundary marker circled).

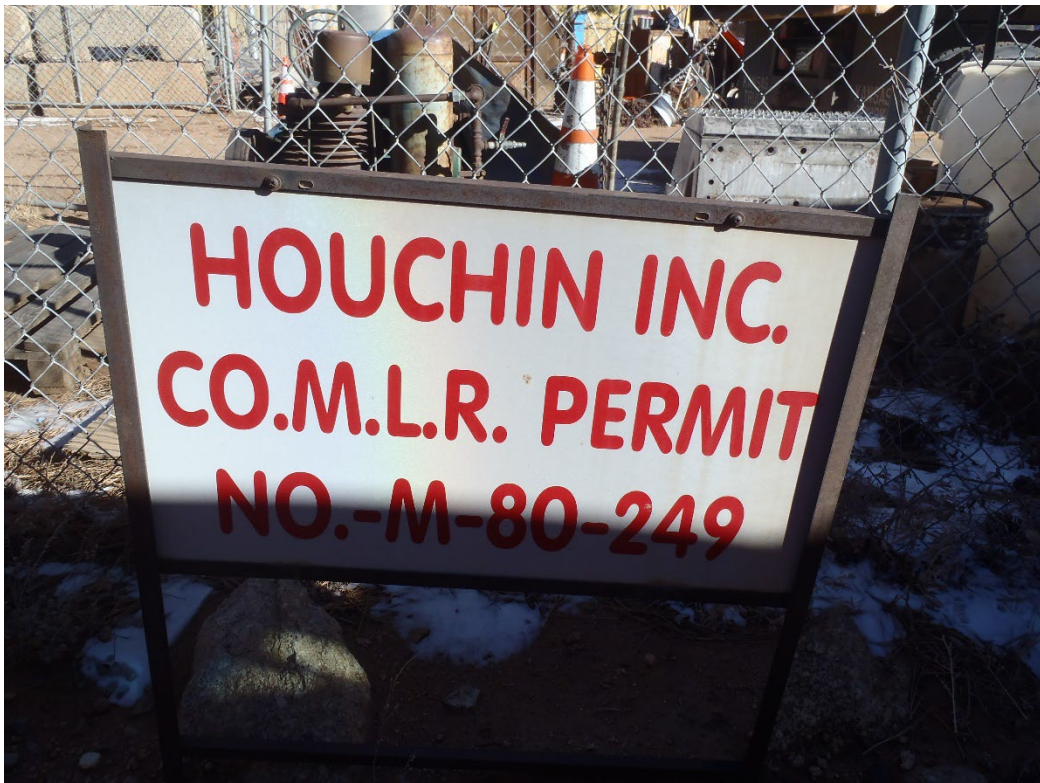
Signs and Markers: The permit sign was properly posted (see **Photo 5**) and boundary marker position data was collected using a handheld Trimble Juno 3B GPS unit (see **Photo 6**). A post-inspection map showing GPS collected corners is attached to this report. It should be noted that the SW corner location was estimated based on a fixed offset from a fence post, provided by Mr. Houchin onsite.

Photo 5. Permit sign.

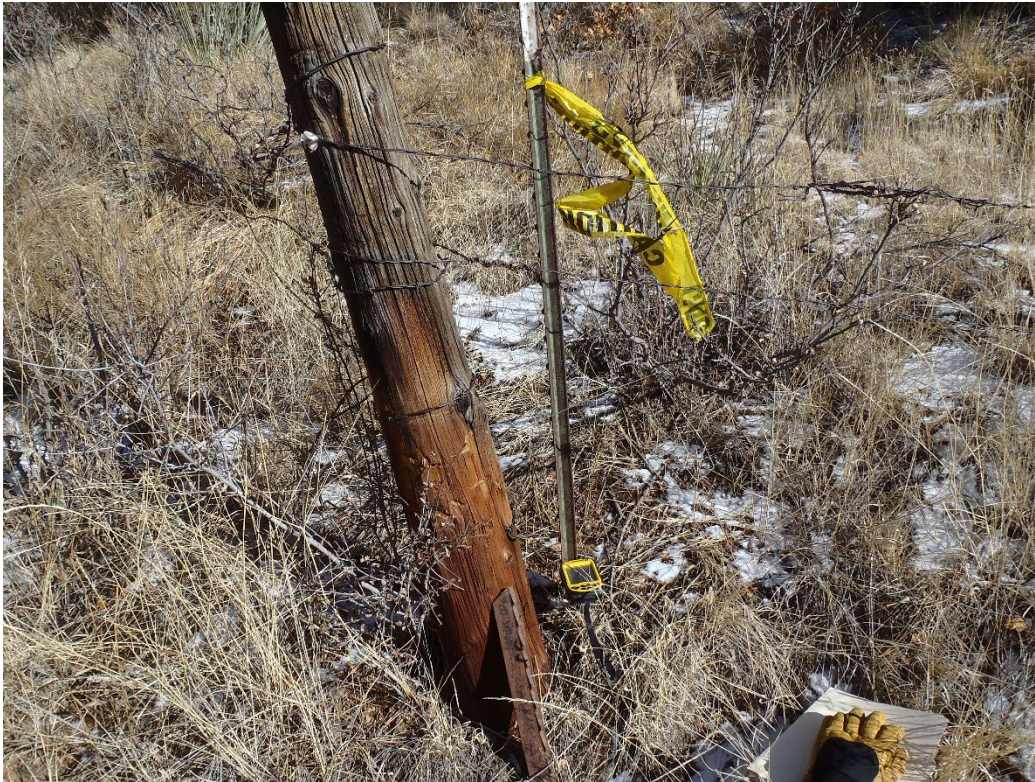
Photo 6. Typical permit boundary marker (SE corner).

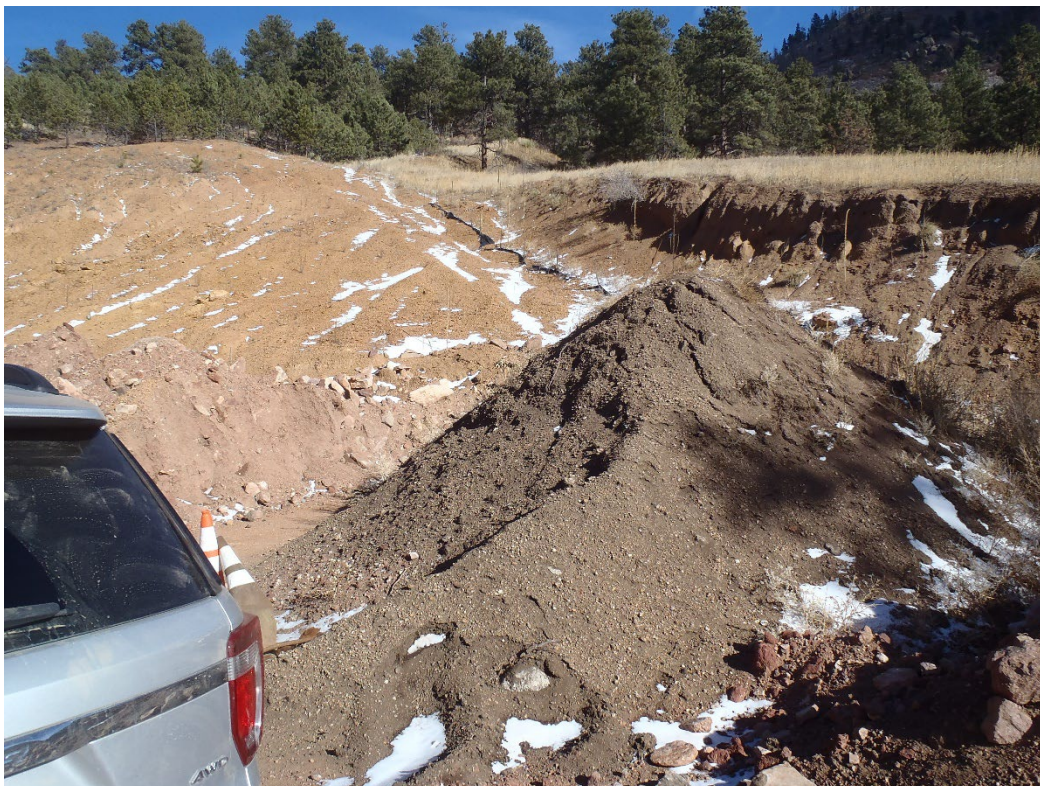
Topsoil: All salvaged growth media was stripped many years ago and was stockpiled on the east side (see **Photo 7**), as the site's disturbed footprint has not changed in quite some time. Mr. Houchin also indicated some growth media has been stored offsite for use in reclamation.

Photo 7. Topsoil stockpile (above crest of excavation).

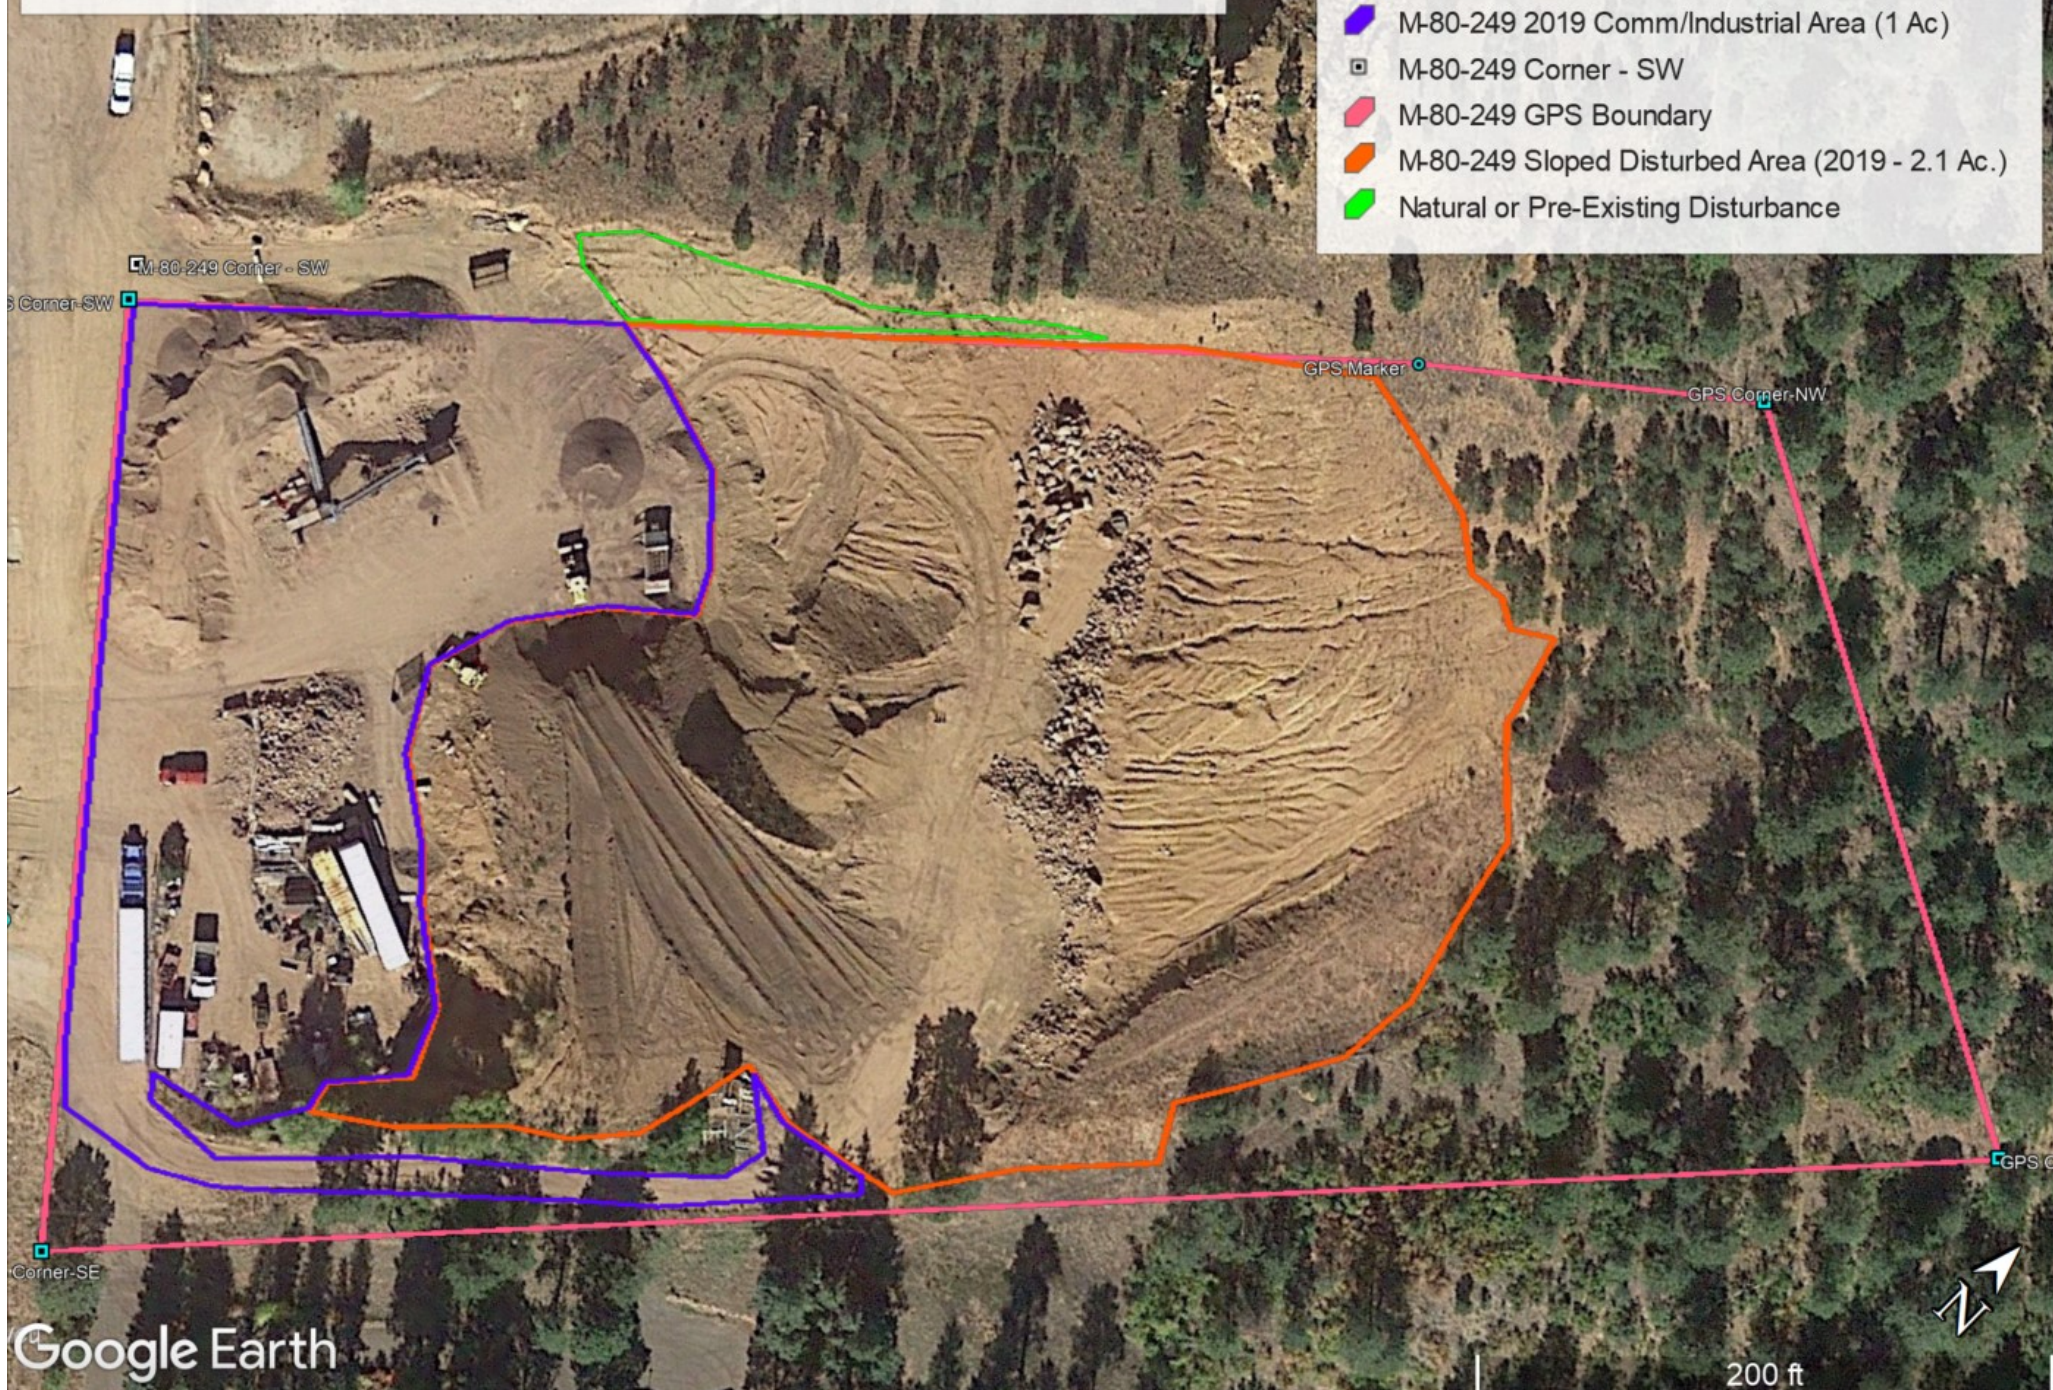
# M-1980-249 Houchin Gravel Pit Post Inspection Map

Google Earth was used to measure the disturbed area, which was about 3 acres, based on older 2019 imagery. Roughly two acres of disturbance is on the sloped portion of the mine, the other acre is relatively flat and at the same level as the adjacent Hwy 24 and is considered commercial/industrial.

There is a strip of sloped, unvegetated area along the NW boundary outside the permit boundary. A review of USGS Quad topography (Cascade Quadrangle, 1950) suggests a ridge existed in this area prior to mining. An additional review of Google Earth historic images indicates no change in disturbance to this strip since 1999 (see attached **Post-Inspection Map**). Furthermore, there is an undated letter from the El Paso County Land Use Department in the original 1980 Application stating, "extraction of gravel from this site began in the 1930's and has continued to date." As such, the DRMS has determined this area along the NW side is considered pre-law mine disturbance. However, it should not be redisturbed as part of the current operation. **If the Operator wants or needs to disturb this strip on the NW side, an amendment to the permit will be required prior to any disturbance.**
