Roadside Portals Mine, C-1981-041, January Partial Inspection Report

PERMIT INFORMATION

Permit Number: C-1981-041 Mine Name: Roadside Portals Operator: Snowcap Coal Company, Inc. Operator Address: MS Tonya Hammond 743 Horizon Court, Suite 334 Grand Junction, CO 81506	County: Mesa Operation Type: Underground Permit Status: Active Ownership: Private
	Operator Representative Present: Tonya Hammond
Operator Representative Signature: (Field Issuance Only)

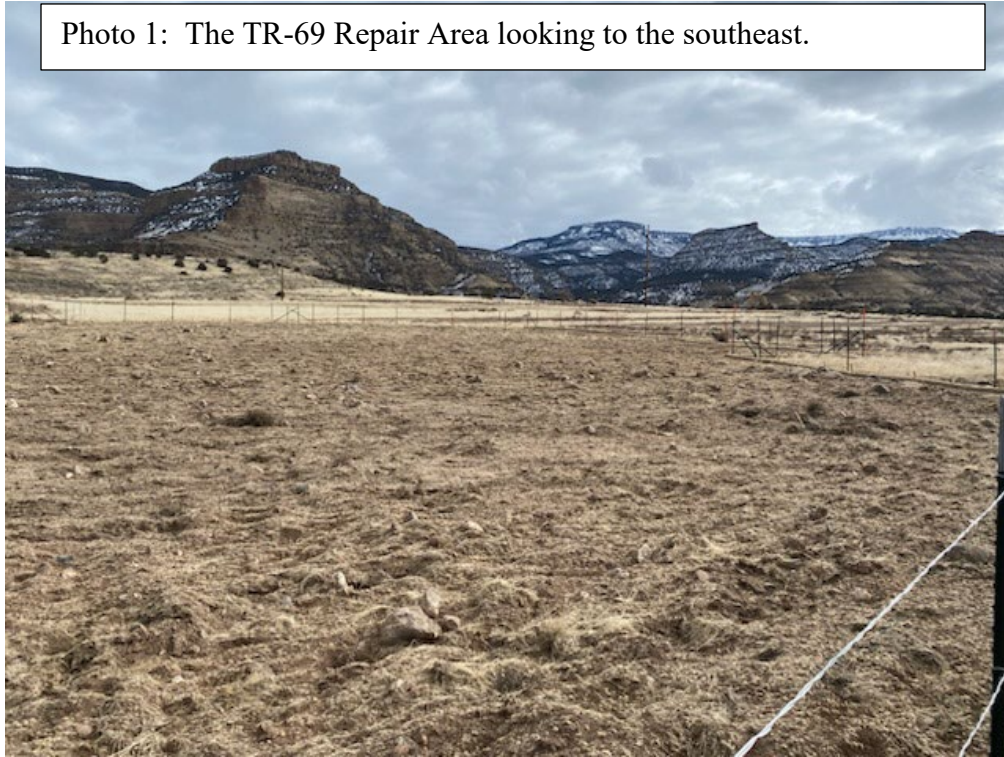
During the inspection, the TR-69 Repair Area was stable with no indications of erosional features (Photos 1 and 2). The recently repaired area has been exposed to snow and rain over the last couple of months. There was no indication of differential settling at the time of the inspection. The disturbed boundary markers and fence were intact and in good condition. A mine identification sign was observed posted on the southeast corner of the TR-69 Repair Area (Photo 3). The straw waddles were in good condition and no off-site impacts were observed (Photo 4).

Photo 1: The TR-69 Repair Area looking to the southeast.

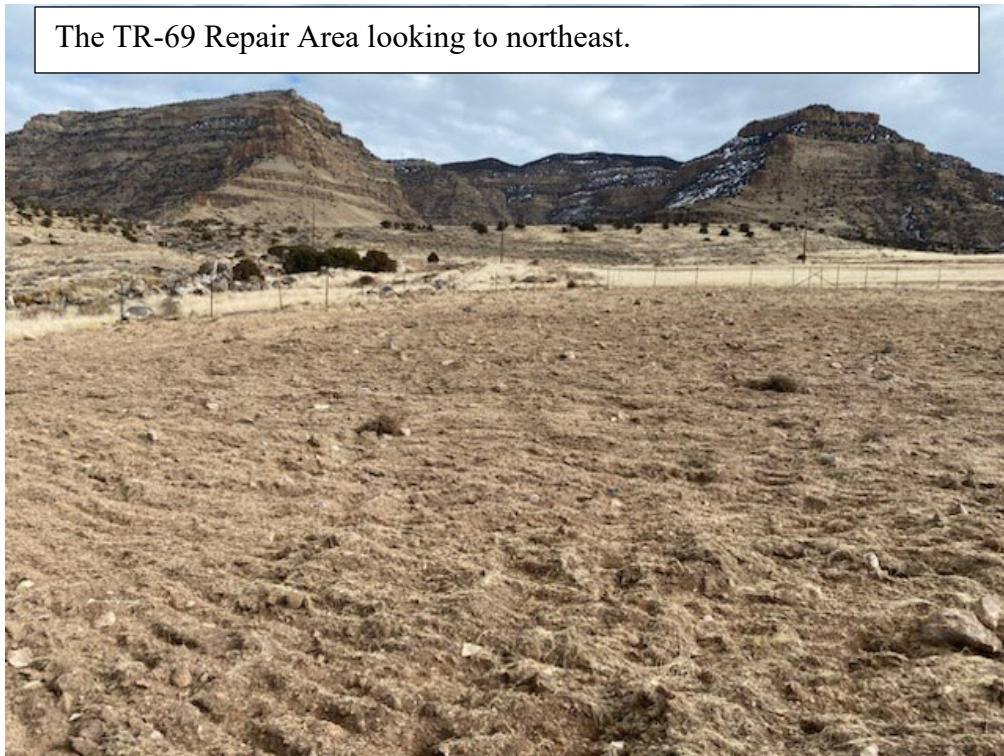
The TR-69 Repair Area looking to northeast.

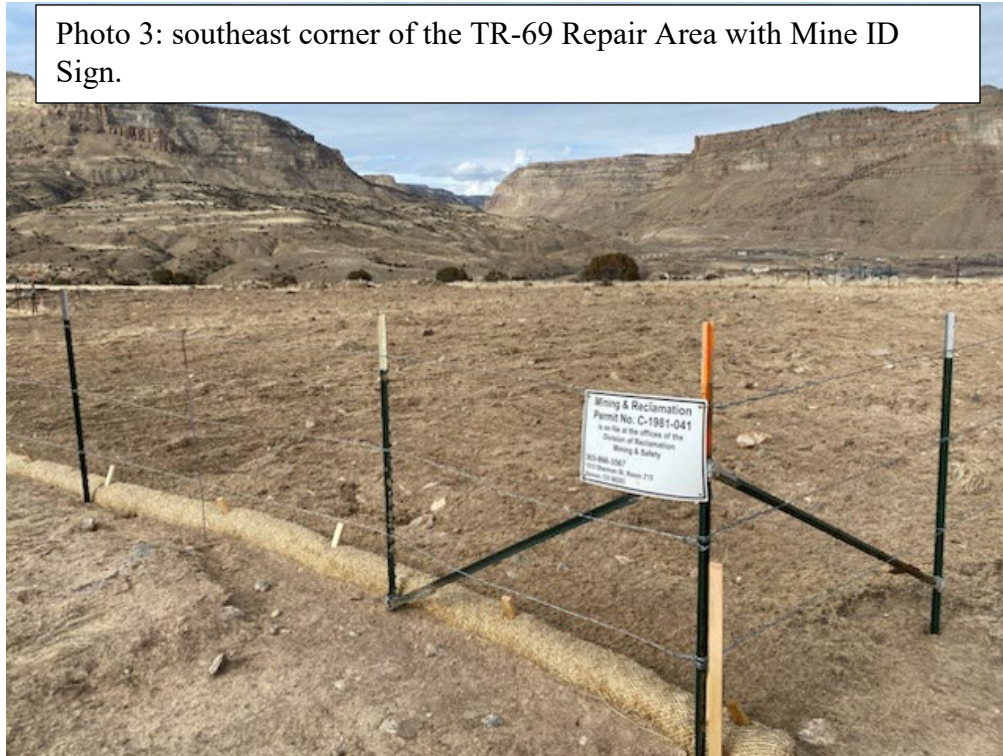
Photo 3: southeast corner of the TR-69 Repair Area with Mine ID Sign.

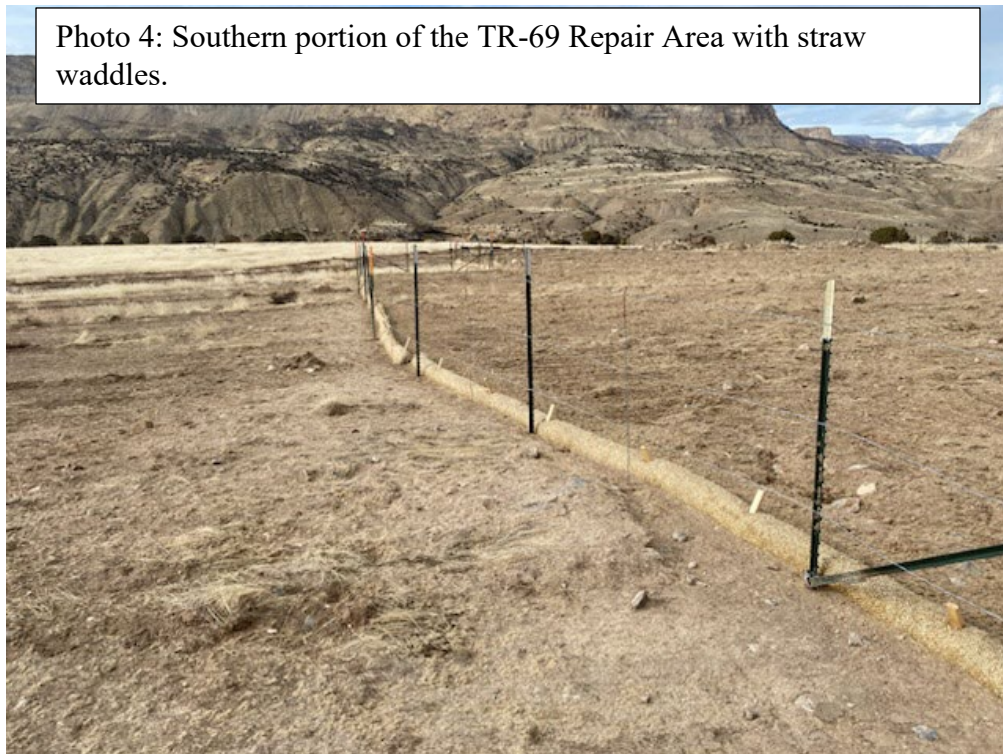
Photo 4: Southern portion of the TR-69 Repair Area with straw waddles.
