New Elk Mine, C-1981-012, Partial Inspection Report

Permit Number: C-1981-012 Mine Name: New Elk Mine Operator: New Elk Coal Company, LLC Operator Address: Mr. John Terry 12250 Highway 12 Weston, CO 81091	County: Las Animas Operation Type: Underground Permit Status: Active Ownership: Private
	Operator Representative Present: John Terry
Operator Representative Signature: (Field Issuance Only)

Inspection Start Date: January 18, 2024 Inspection Start Time: 11:40 Inspection End Date: January 18, 2024 Inspection End Time: 01:20		Inspection Type: Coal Partial Inspection Inspection Reason: Normal I&E Program Weather: Clear	
Joint Inspection Agency: None		Joint Inspection Contacts: 	
Post Inspection Agency: None		Post Inspection Contacts: 	
Inspector(s): Amber Gibson	Inspector's Signature:

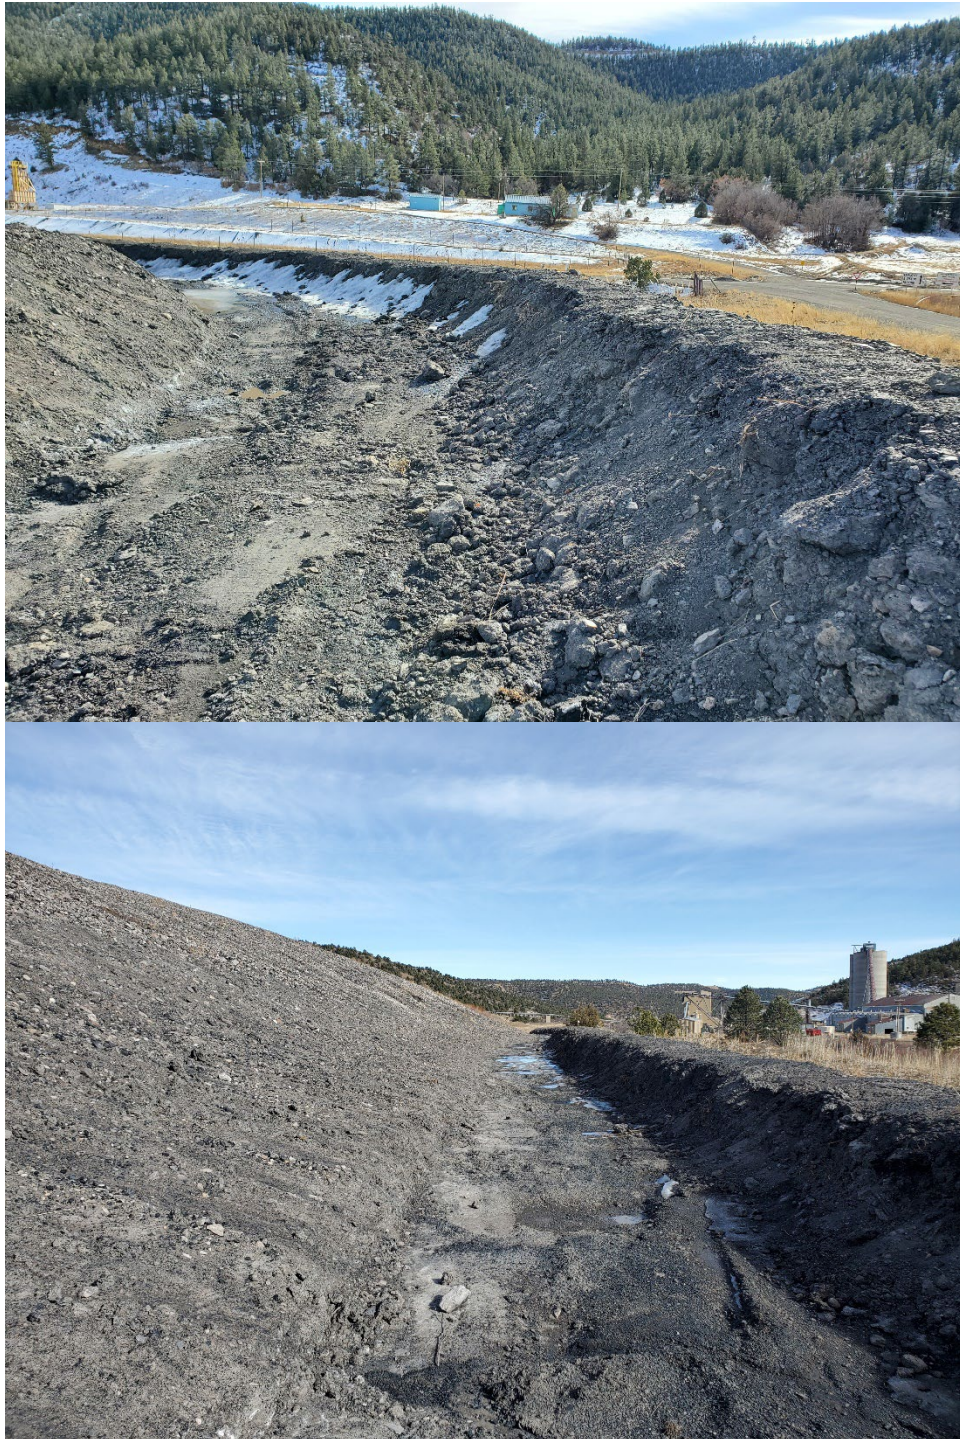
- The maintenance item regarding building up the berm around the drying area on the west side of DWDA #2, mentioned in the November 16, 2023 report, has been addressed. The berm extending from the west side of the pile and along the south side (which separates the ditch around the pile from the slope down to the Purgatoire River) has been built up (Photos 1A & 1B). Additionally, the sediment within the ditch has been cleaned out and was used along the bottom half of the pile to grade out the erosion rills. There are rills remaining from the middle of the pile to the top, but the pile appears to be stable at this time. No recent pond cleanings have been placed in the sediment drying area along the west side of the DWDA#2.

Photos 1A and 1B: 1A) Berm along the west side of DWDA#2. 1B) Berm along the south side of DWDA#2. Rills smoothed out along the bottom portion of the slope on the DWDA#2.

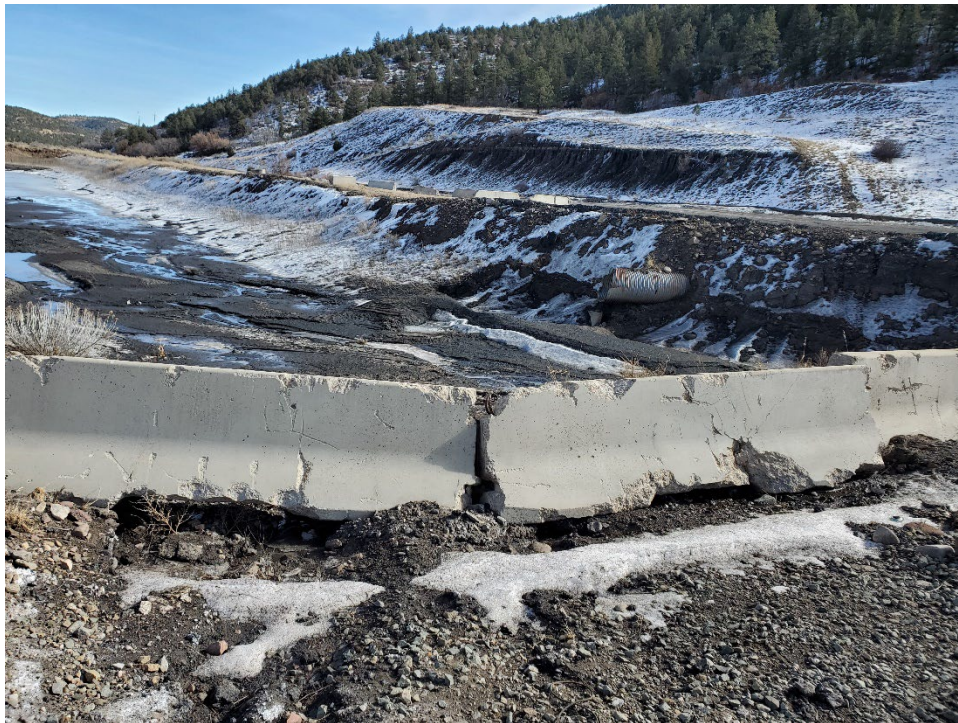
- Pond 007A contained a very small amount of frozen water but was not discharging. The emergency spillway was free of obstructions and the embankment on the north, east, and south sides appeared to be stable. However, the embankment on the west side has experienced some erosion from the road, under-cutting the concrete berms, and into the pond (Photo 2). **The Operator shall repair the erosion and stabilize the bank along the west side of Pond 007.**

Photo 2: Erosion undercutting concrete berms along the west embankment of Pond 007.

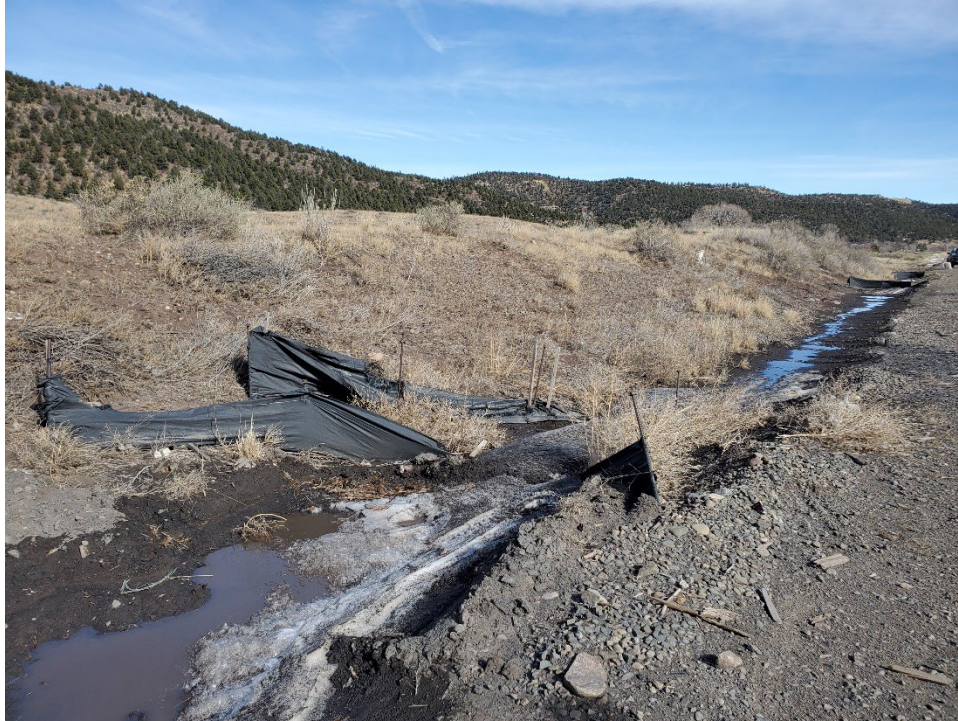
- A couple silt fences along the road in the SAE south of Pond 007 were damaged during the recent snow fall and need to be repaired. The majority are functioning as intended, but the western-most fence (Photo 3) and the north-eastern most fence need to be repaired.

Photo 3: Western-most silt fences along the north side of the road in the SAE near Pond 007.

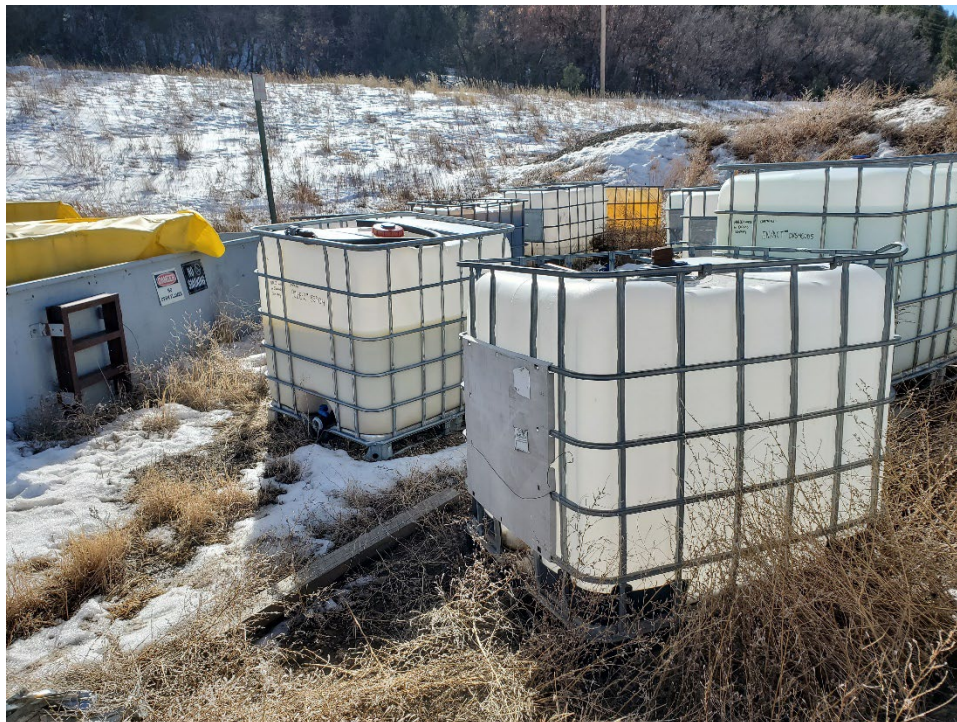
- The Portable Explosives and Chemical Storage area was overall stable. However, the Division observed leaking from one of the tanks during the previous November 2023 inspection. The Operator placed an empty replacement tank next to the tank with the leak (Photo 4). The Operator had tried to lift the leaking tank to empty the contents into the new tank, but was unable to do so because the contents had frozen solid, and lifting put the tank's structural integrity at risk. The valve on the leaking tank was determined to be broken and is sealed shut. Therefore, the only material that is able to leak from the tank is the small amount that has already leaked, and that is trapped in a spill tray under the valve. The Operator stated that they also inquired about having the tank and the contents recycled, but could only find one company that disposes of these materials. The recycling company is located in the eastern United States, and had informed the Operator that they will not travel for only one tank. The Operator will need to re-address this item once the tank's contents have had a chance to thaw.

Photo 4: Portable Explosives and Chemical Storage area. The tank on the left is the leaking tank, the tank on the right is the new empty tank.
