Lorencito Canyon Mine, C-1996-084, Complete Inspection Report

Permit Number: C-1996-084 Mine Name: Lorencito Canyon Mine Operator: New Elk Coal Company, LLC Operator Address: Mr. John Terry 12250 Highway 12 Weston, CO 81091	County: Las Animas Operation Type: Surface Permit Status: Permanent Cessation Ownership: Private
	Operator Representative Present: John Terry
Operator Representative Signature: (Field Issuance Only)

Inspection Start Date: January 18, 2024 Inspection Start Time: 11:40 Inspection End Date: January 19, 2024 Inspection End Time: 10:00		Inspection Type: Coal Complete Inspection Inspection Reason: Normal I&E Program Weather: Cloudy	
Joint Inspection Agency: None		Joint Inspection Contacts: 	
Post Inspection Agency: None		Post Inspection Contacts: 	
Inspector(s): Amber Gibson	Inspector's Signature:

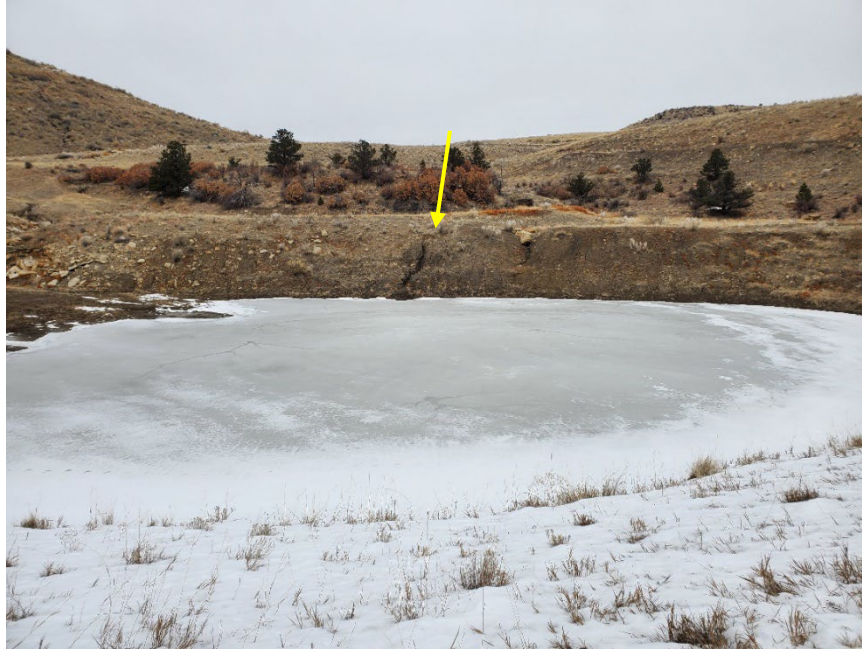
- Pond 005 was observed. The primary and emergency spillways were clear and functional. The pond was dry and was not discharging. The pond embankment was stable and vegetated.
- Pond 006A was holding some frozen water, but was not discharging. The pond embankment was stable and vegetated around the majority of the pond, however, erosion rills are forming on the north and west banks (Photos 1 and 2). The erosion on the north bank appears to have been addressed at some point, because rebar is placed above the rills. However, it appears that the prior BMPs are no longer functioning adequately. **The Operator shall address the erosion and repair the north bank.** The erosion on the west bank appears to have been caused by runoff from the road located east of Pond 006A. **The Operator**

Photo 1: Rills forming on the north bank of Pond 006A.

shall address the erosion and repair the west bank. The primary and emergency spillways appeared clear and functional.

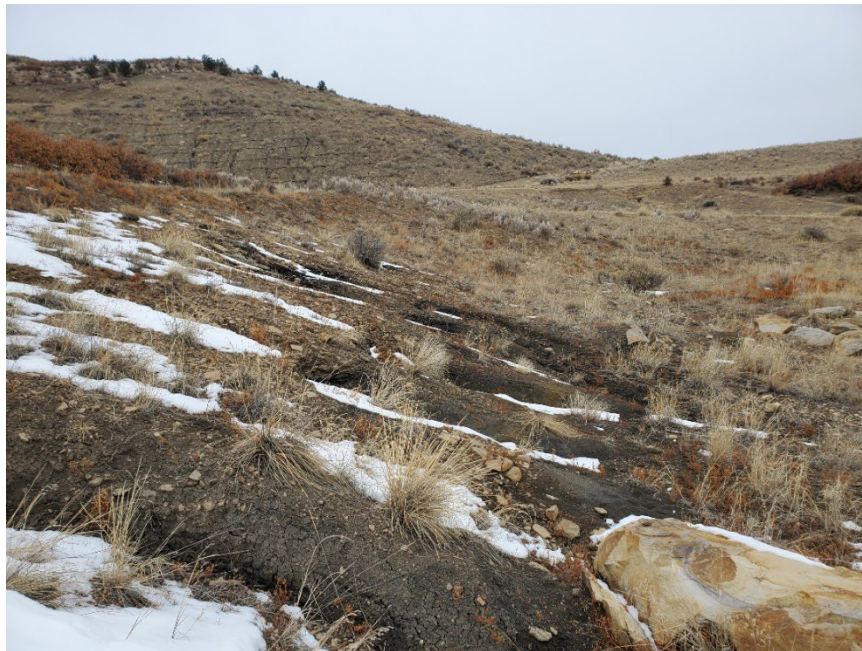
Photo 2: Erosion leading down from the east side of the road and into the west bank of Pond 006A.

- The road along Pond 006A is washed out in the area between the reclaimed area and Pond 006A, **and needs to be repaired**. The road leading down into Pond 008 has some ruts that will **require repairs**.
*These are planned to be addressed at the time the west bank is stabilized.
- The road leading to Pond 005 has significant snow cover. The Operator and Division were able to descend the road to Pond 005, but ascending the hill proved to be difficult. It is not advised that accessing Pond 005 is attempted again until most of the snow melts.

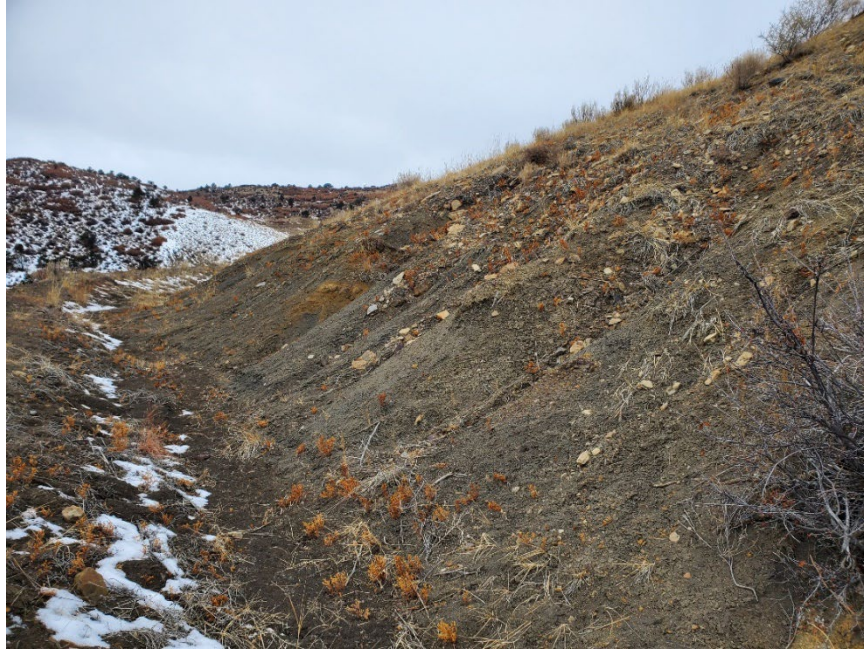
- The Division walked west from Pond 007A to Pond 006A via ditch D75 (Photo 3). D75 appears stable, clear of excess sediment build up, and free of obstructions.

Photo 3: Looking west across D75.

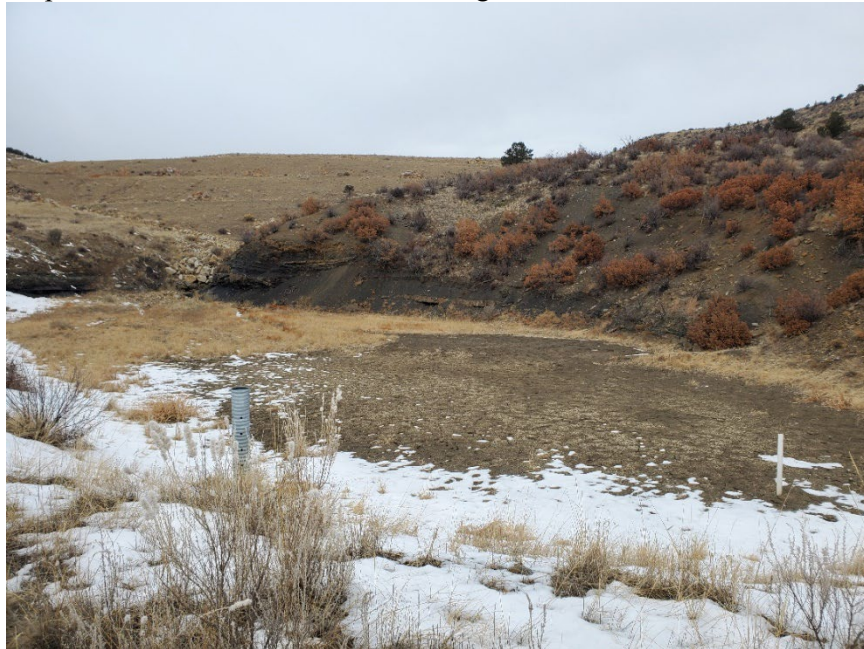
- Pond 007A was dry and not discharging (Photo 4). The primary and emergency spillways were clear and functional. The pond embankment was stable and vegetated.

Photo 4: Pond 007A

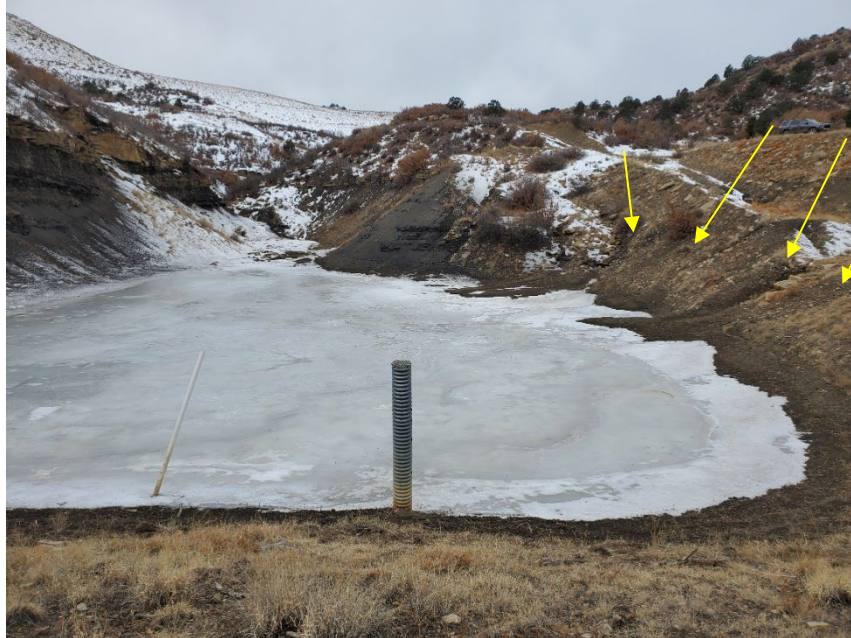
- Pond 008 was holding some frozen water. The flume at the discharge point was full but appears to be due to snow melt above, and in, the flume. Pond 008 was not discharging at the time of the inspection. The majority of the pond embankment was stable and vegetated, however, the west bank contains some erosion rills and gullies. The erosion appears to have been caused by run-off from the roads above and

Photo 5: Pond 008 holding some frozen water. The arrows point to places where erosion rills have formed from run-off from the road located above and to the west of the pond.

down to the pond (Photo 5). **The Operator shall repair the erosion and stabilize the west bank of Pond 008.** The Operator stated that they will likely install additional rock berms along the western-most road to help prevent run-off from running down the slopes and into the pond. The Operator also stated that they plan to remove the sediment (deposited as a result of the bank erosion) along the west bank of Pond 008. The primary and emergency spillways appeared clear and functional.

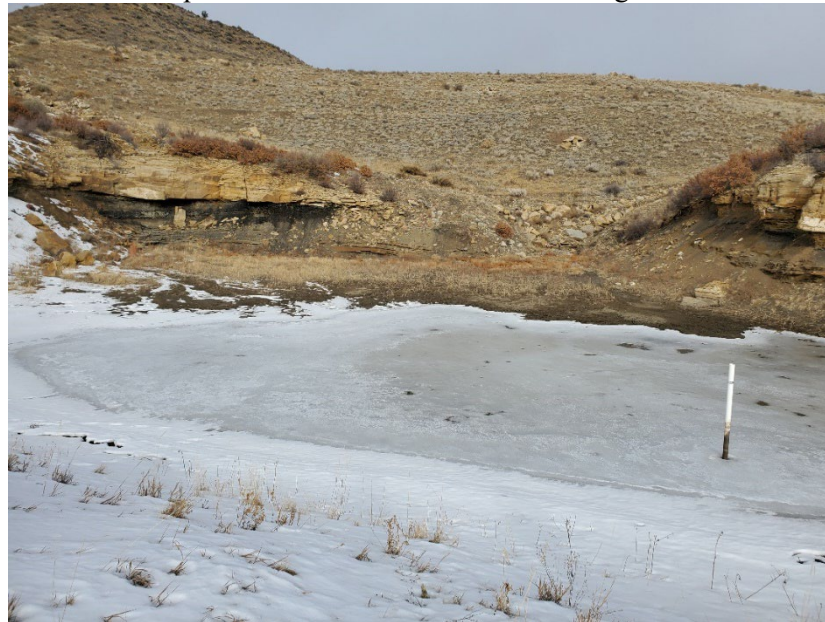
- Pond 009A contained some frozen water, and was not discharging. The primary and emergency spillways were clear and functional. The pond embankment was stable and vegetated.

Photo 6: In the foreground, Pond 009A holding some frozen water. Fill 009 is in the background.

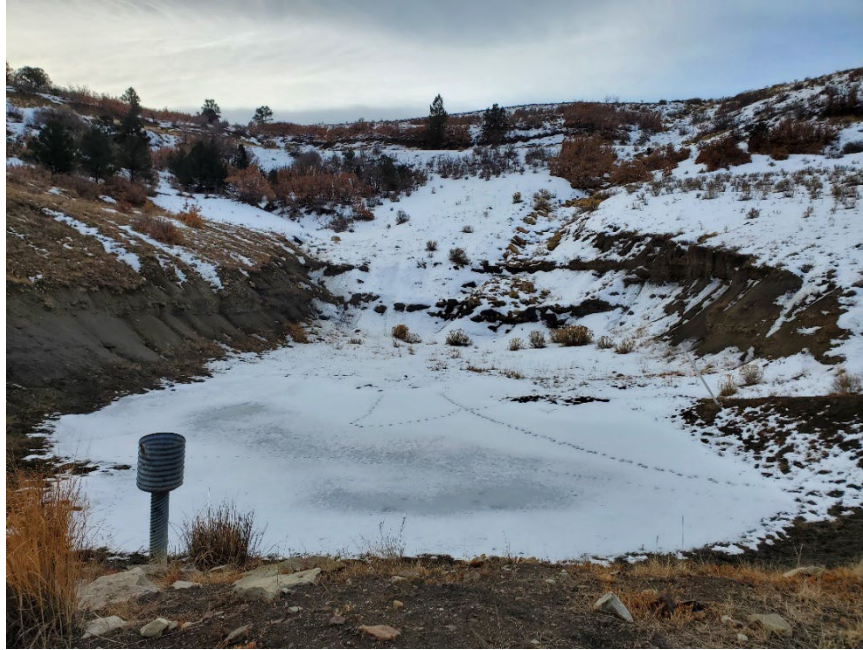
- Pond 009 contained some frozen water, and was not discharging. The primary and emergency spillways were clear and functional. The pond embankment was stable and vegetated.

➤ **Photo 7:** Pond 009A holding some frozen water.

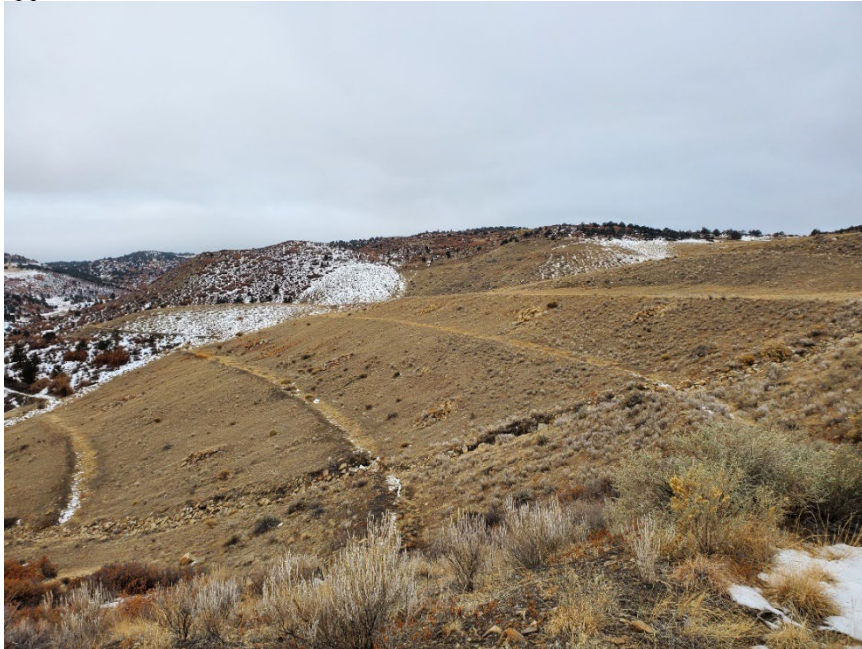
- **The following items pertain to ongoing maintenance issues, cited in previous reports for the area in and around the reclaimed area above Pond 006A:**
 - The many erosion rills which have undercut the wattles on the reclaimed area.
 - The ditch along the road leading to Pond 006A that is eroding, nearly full of sediment, and needs to be cleaned out and repaired.
 - The check dams leading to Pond 006A that are nearly full of sediment that need to be cleaned to prevent excess sediment from entering the pond.
- *The Operator stated that they plan to have equipment and a crew at the site within a week of this inspection report to address these issues and the pond embankment issues mentioned earlier in the report.
- Fill 7 – The Division walked down the east side of Fill 7 to access Pond 007A (Photo 8). Fill 7 was well

vegetated and appeared stable.

Photo 8: Looking west across Fill 007.

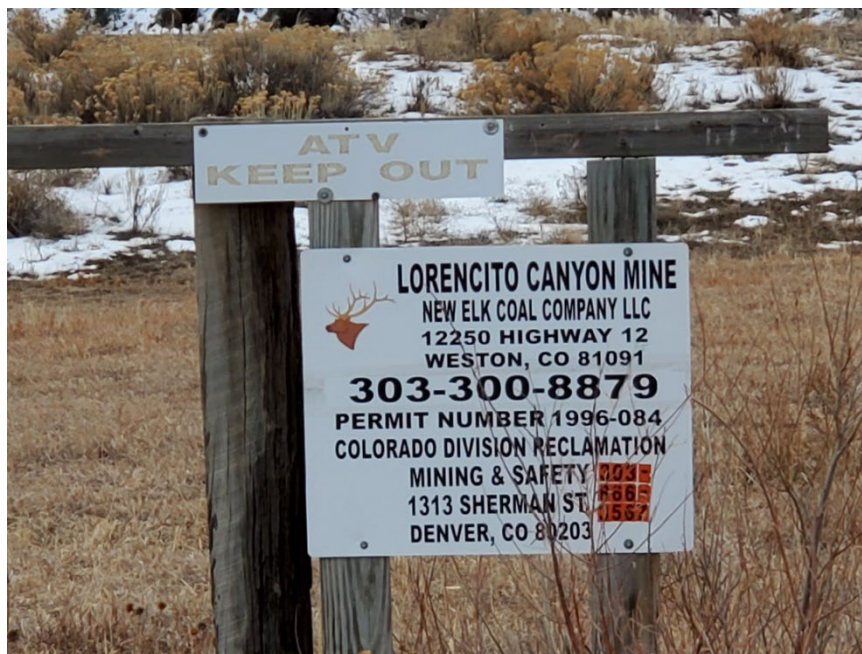
- Mine signs were posted at road entrances (Photo 9) and at the entrance to permit boundary in compliance with Rule 4.02.

Photo 9: Permit sign
