MINERALS PROGRAM INSPECTION REPORT
PHONE: (303) 866-3567

| MINE NAME: Patton Clay Mine | MINE/PROSPECTING ID#: M-1998-067 | MINERAL: Clay (general) | COUNTY: Fremont |
| INSPECTION TYPE: Monitoring | WEATHER: Clear | INSP. DATE: February 23, 2023 | INSP. TIME: 12:40 |

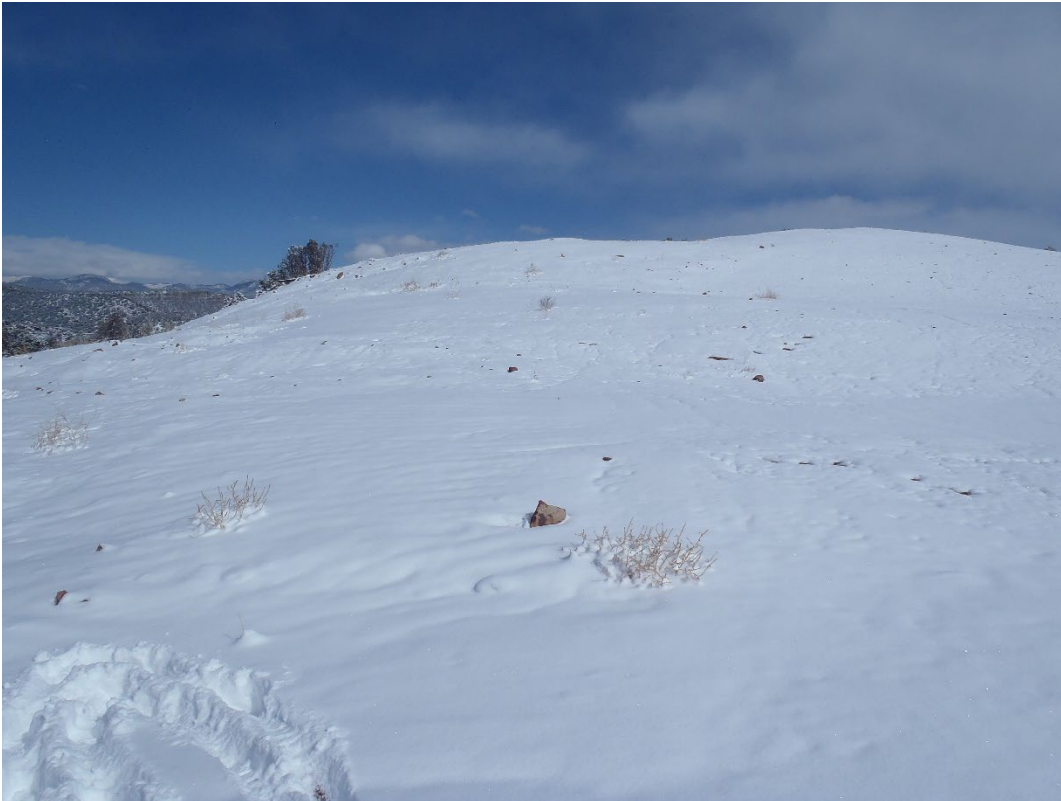
Backfilling and Grading: Backfill and grading for Area F, the only area disturbed to date, appeared to have been completed (see **Photos A and B**).

Reclamation Success: Only Area F was inspected. Grading appeared to be completed at 3H:1V or flatter. Mr. Jesik stated the stockpiled topsoil had been spread over the site and that it had been seeded in 2022. This could

Photo 1. Regraded Area F highwall (looking NE).

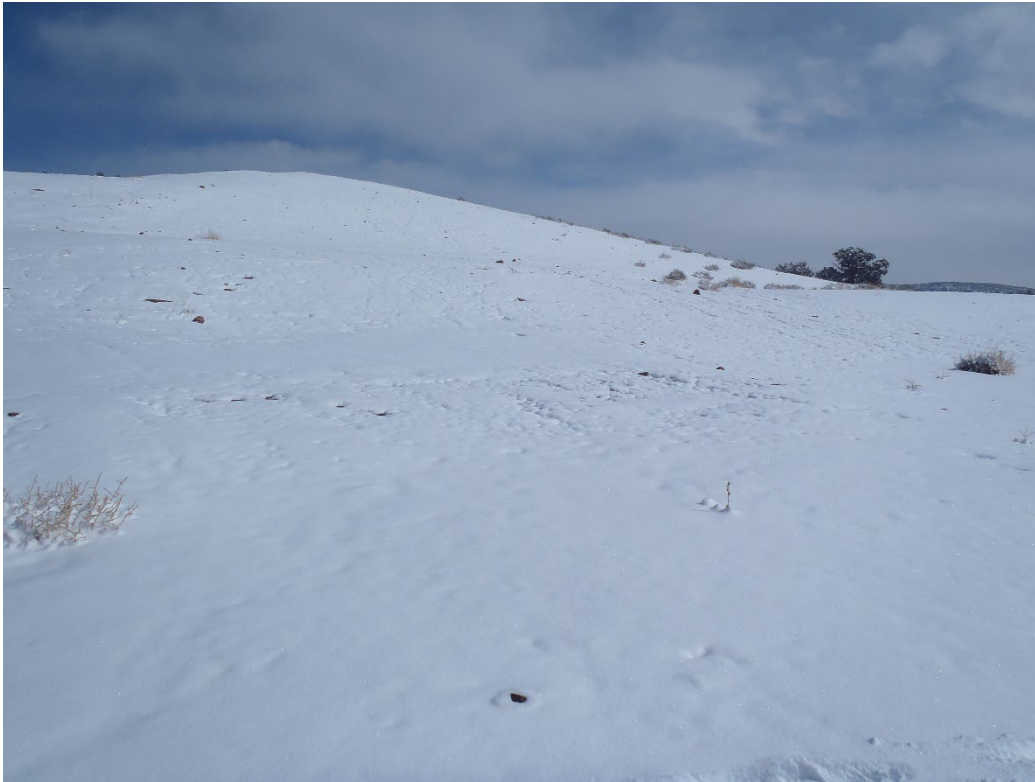
Photo 2. Regraded Area F highwall (looking east).
