Re: GCC Energy, LLC, King II Mine CDRMS Permit # C-1981-035 Stoner Engineering: Quarterly Inspection: King I Water Quality Improvements Inspection 4th Quarter 2023

Re: King Coal I – Quarterly Water Quality Improvements Inspection

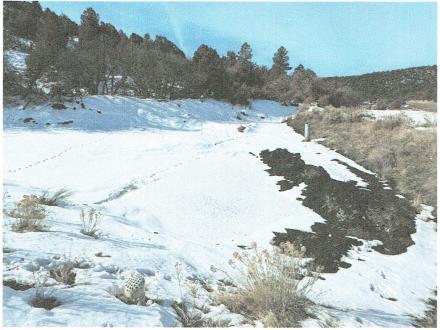
Both ponds held some water (frozen) at the time of the inspection. The water levels in the ponds appeared to be slightly less than the previous inspection though it was difficult to ascertain due to the drifted snow and ice (see Pic. 1). The removal of the excess waste material within the West pond appears to be at the same level of completion, likely due to the water levels within the pond this fall. As conditions improve and the pond dries out, the excess material (sediment) should be removed. While the excess material should be removed as soon as possible to ensure adequate pond capacity for runoff/storm events, the ponds overall capacity appears adequate. The sedimentation traps at the entrance to the site are generally in good condition.

Pic. 1 – Water/snow level, West pond.

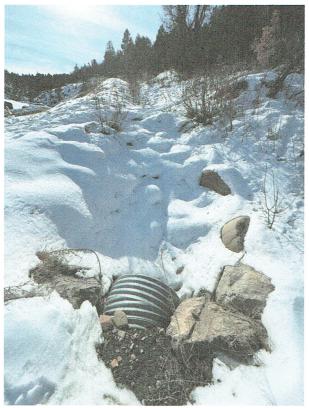
The existing ditches and culverts appear to be generally in good condition though most are covered with snow (see Pic. 2). The visible culverts were clear of sediment (see Pic. 3). The culvert for the West clear water ditch (Reaches 3 & 6) which discharges into the North clear water ditch appears to still be in need of cleaning. The only ditch not covered with snow was the lower section of the North clear water ditch (see pic. 4).

Pic. 2 – West clear water ditch.

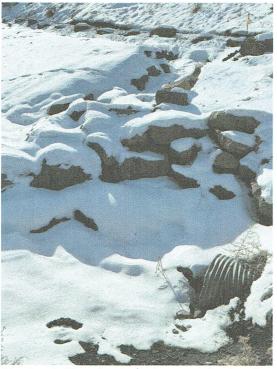
Pic. 3 – Stilling basin/culvert under haul road, base of lower pile.

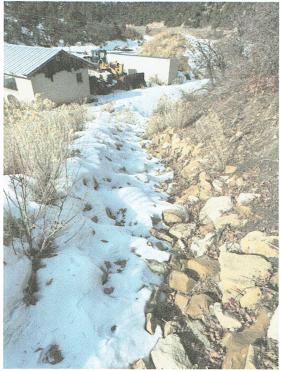
Pic. 4 –Lower section of the North clear water ditch.
