Re: GCC Energy, LLC, King II Mine
CDRMS Permit # C-1981-035
Stoner Engineering: Quarterly Inspection: King II Water Quality Improvements
Inspection 4th Quarter 2023

Re: King Coal II - Quarterly Water Quality Improvements Inspection

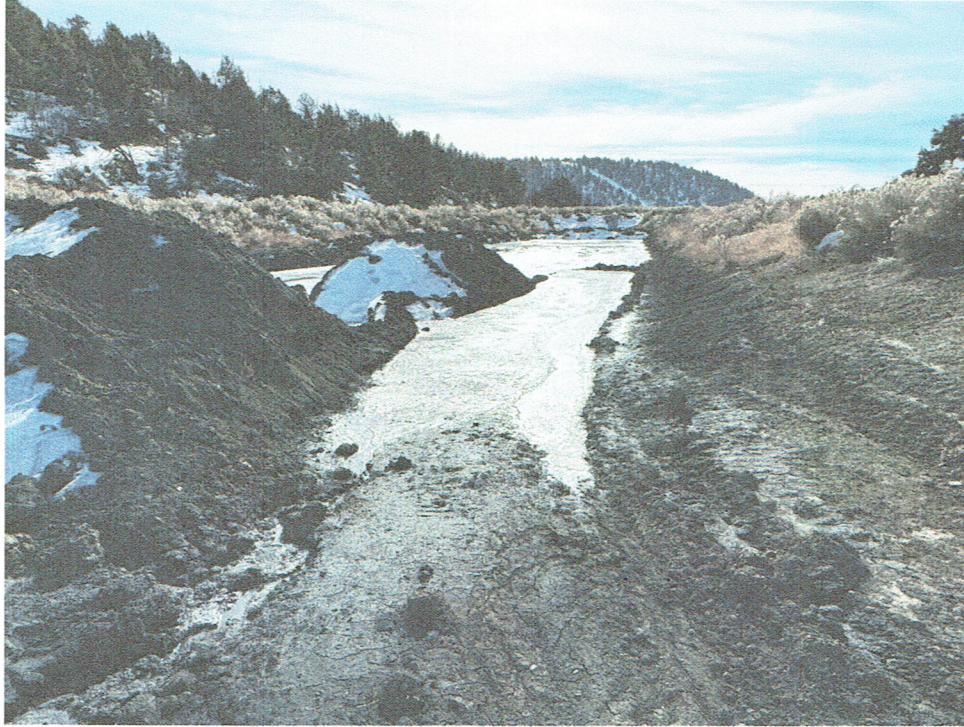
The water quality pond held water at the time of the inspection though the elevation at the bottom of the pond could not be determined due to water/ice within the pond (see Pic. 1). The removal operations appear to be at a similar stage of completion noted during the previous inspection. Removal of sediment from the pond is on hold due to current water levels. It is anticipated that the remainder of the excess sediment will be removed from the detention pond as soon as site conditions allow. Water is currently being diverted to the south side of the pond via ditch in an attempt to help dry out the upper section of the pond. The lower section of the pond has been isolated via a cut in the existing sediment level to allow for drying of the sediment (see Pic. 2).

Pic. 1 – Detention Pond-sediment removal progress to date.

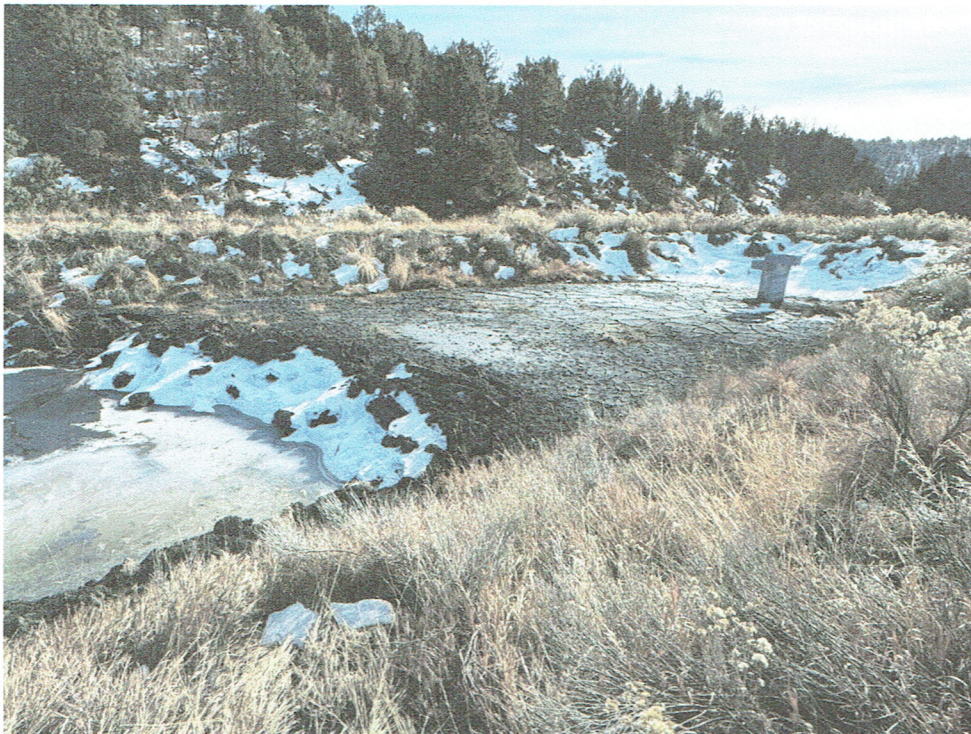
Pic. 2 – Sediment removal upstream of outlet structure allowing drying of sediment at pond outlet.

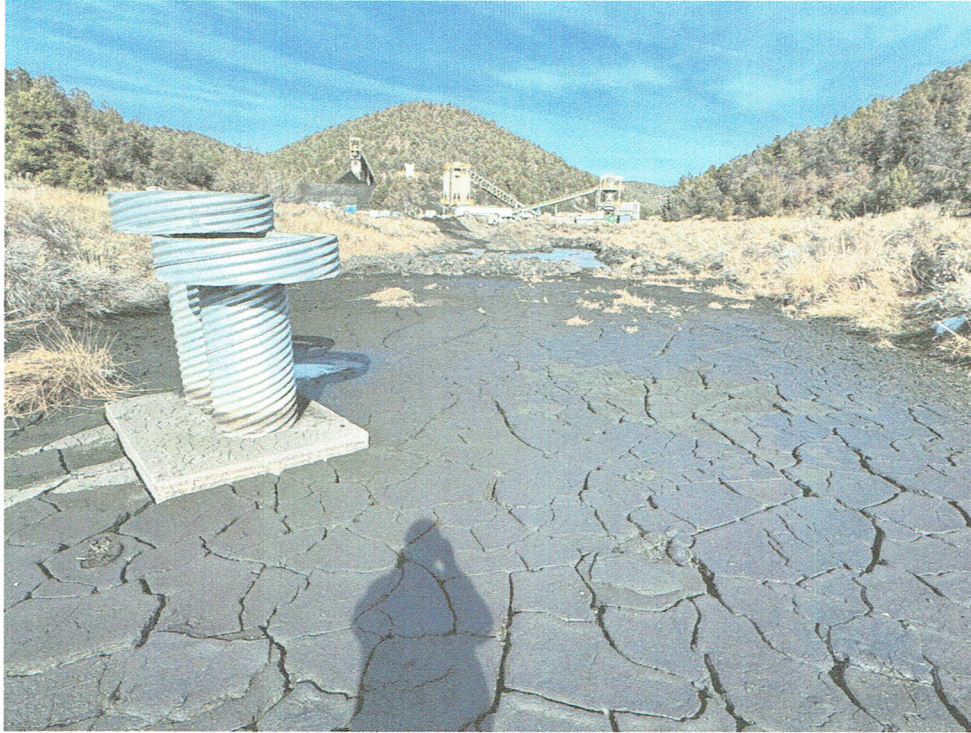
The vegetation both inside and out of the pond and embankments is well established to minimize the erosion impacts of storm runoff. The outlet structure shows no signs of damage and was functioning as designed at the time of the inspection (see Pic. 3). The outlet pipes were free from debris, sediment and excessive vegetation (see Pic. 4). The water quality pond appears to be in generally good condition even with the sediment removal temporarily on hold. There were no signs of weakness or distress to either the outlet structure or the embankment material. The water quality pond appears to have the storage capacity to function as designed.

Pic. 3 Outlet structure culverts in good condition, sediment drying out.
