Re: GCC Energy, LLC, King II Mine
CDRMS Permit # C-1981-035
Stoner Engineering: Quarterly Inspection: Refuse Pile 4th Quarter 2023

Date: December 12, 2023

Re: King Coal I – Quarterly Waste Pile/Embankment Inspection

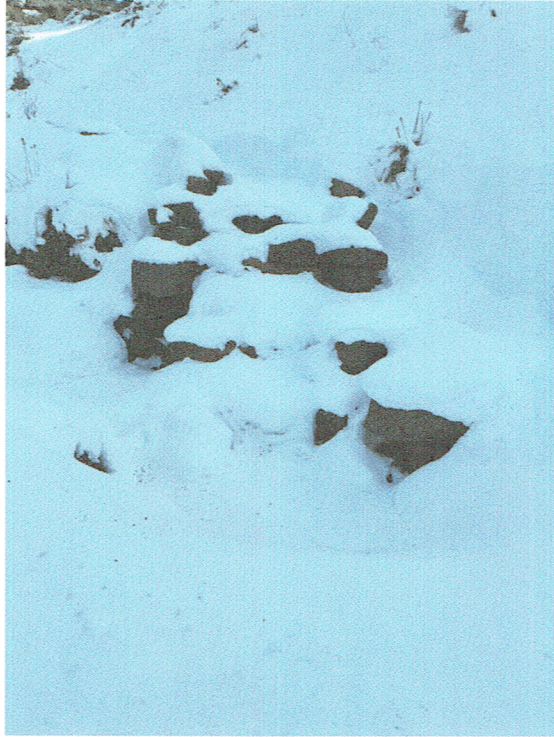
The south treated water ditch (Reach 10) was covered in snow while the north clear water ditch (Reach 1) was found to be in generally good condition (see Pic. 1 & Pic. 2). The visible culvert under the haul road (North switchback main pile) was in good condition.

Pic. 1 –Upper section Reach 10.

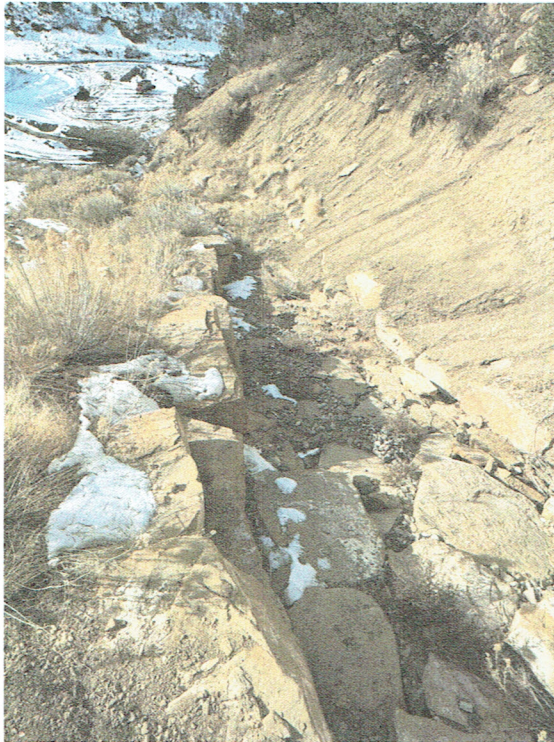
Pic. 2 –Upper section Reach 1.

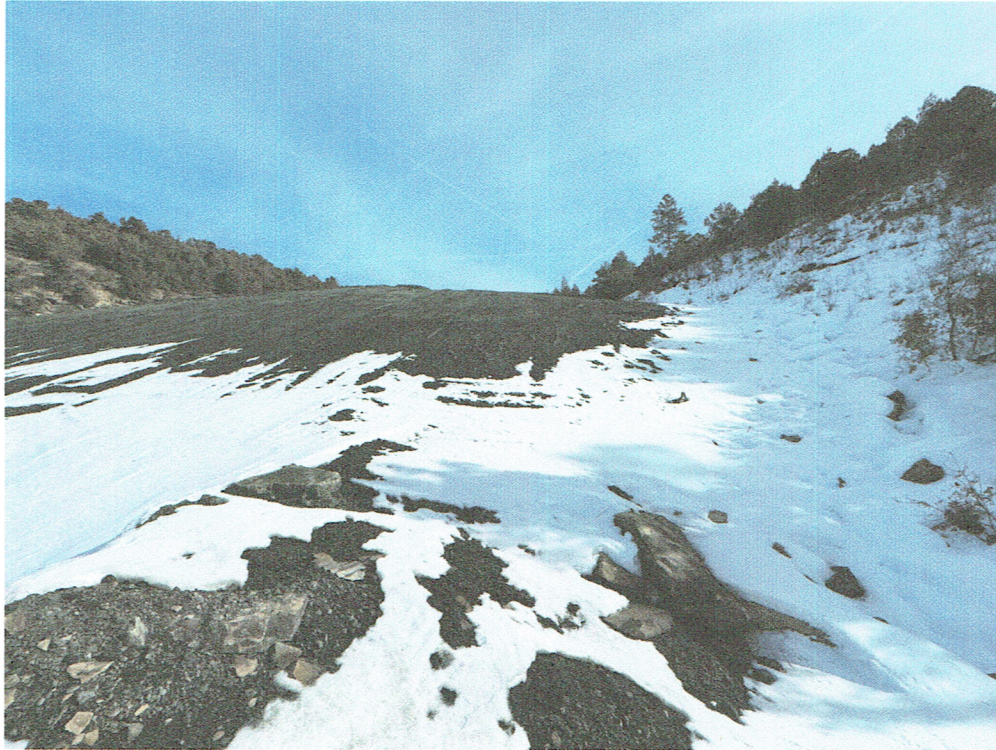
There has been additional waste material placed at the top of the main waste embankment pile since the previous inspection. The waste material along the top face of the main pile has been compacted and the upper section of Reach 10 appears to have been extended to the top waste pile (see Pic. 3). The grading of the waste embankment piles appear to direct surface runoff away from the face of the piles and the required berming is in place. The slope of the top of the existing pile is close to that defined in the Waste Bank Design produced by Don May, 1997.

Pic. 3 – Reach 10 appears extended to top of existing pile and embankment face recompacted.

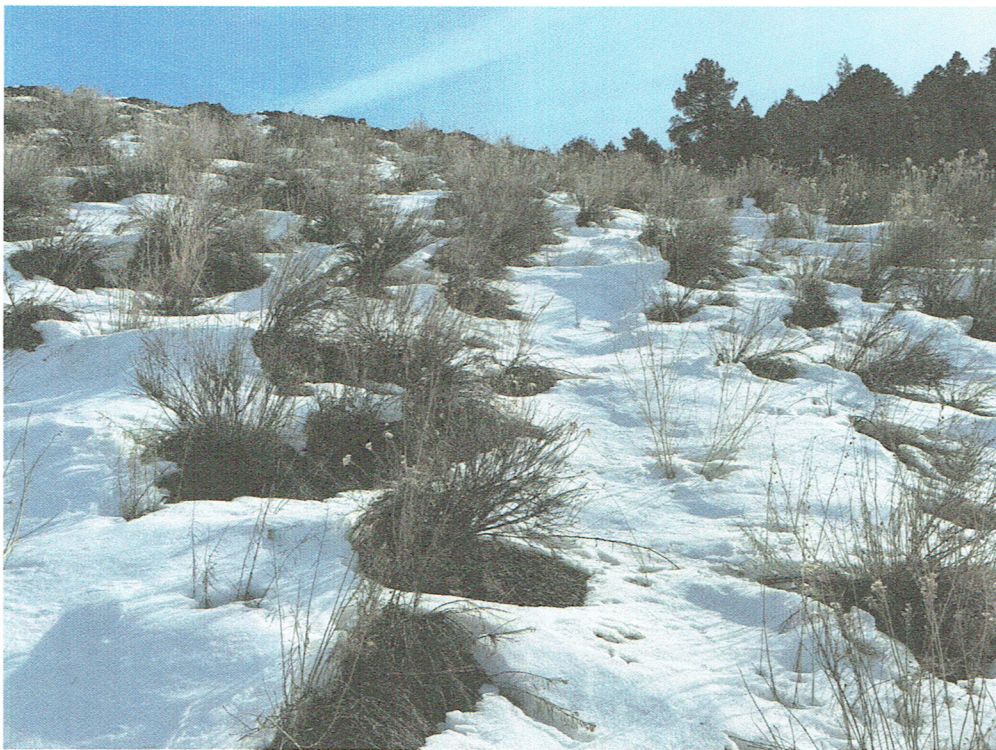
The face of the upper and lower waste embankments were not observable due to the existing snow levels (see Pic. 4). There were no signs of instability or sloughing observed on either waste embankment pile at the time of the inspection.

Pic. 4 – Face of the main embankment waste pile.
