MINERALS PROGRAM INSPECTION REPORT
PHONE: (303) 866-3567

MINE NAME: Orton Borrow Pit	MINE/PROSPECTING ID#: M-2022-031	MINERAL: Borrow material for	COUNTY: El Paso
INSPECTION TYPE: Monitoring	WEATHER: Clear	INSP. DATE: January 23, 2024	INSP. TIME: 12:30
OPERATOR: Castle Rock Construction Company of Colorado	OPERATOR REPRESENTATIVE: Travis Bell	TYPE OF OPERATION: 111 - Construction by Government Agency	
REASON FOR INSPECTION: Normal I&E Program	BOND CALCULATION TYPE: Complete Bond	BOND AMOUNT: \$45,417.00	
DATE OF COMPLAINT: NA	POST INSP. CONTACTS: None	JOINT INSP. AGENCY: None	
INSPECTOR(S): Hunter Ridley	INSPECTOR'S SIGNATURE:

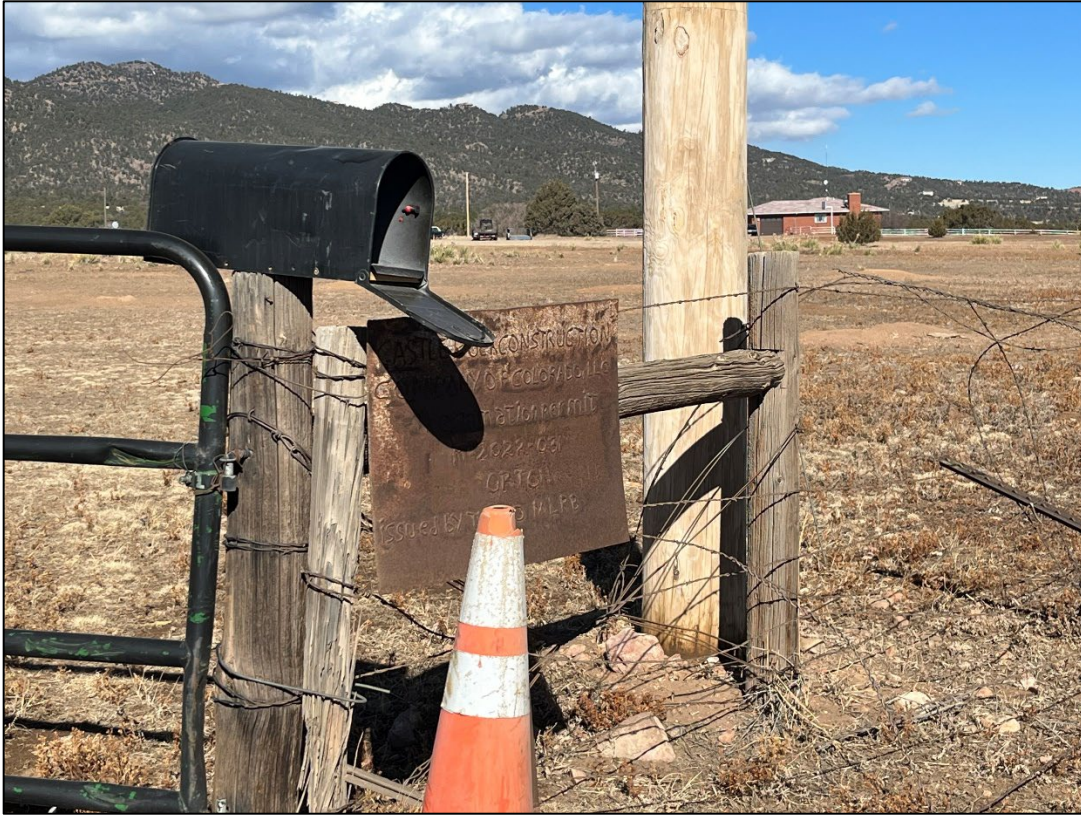
A permit sign (Photo 1) and boundary markers (Photo 2) were posted in accordance with Rule 3.1.12. Mr. Bell provided the Division with recent aerial imagery ([attached below](#)) of the site which details the current acreage of disturbance. When considered with on the ground observations, the acreage of current disturbance appears to be just over 6 acres; this is well within the permitted 10.24 acres. Additional t-posts have been placed along the site's southern slope to delineate an ~30 ft offset from the permit boundary (Photo 3). This slope, while vegetated, has not yet been seeded and will be disturbed as topsoil is removed from its eastern end (Photo 5) and spread throughout the rest of the site.

Photo 1: Mine sign located at the entrance to the access road off Hwy 115.

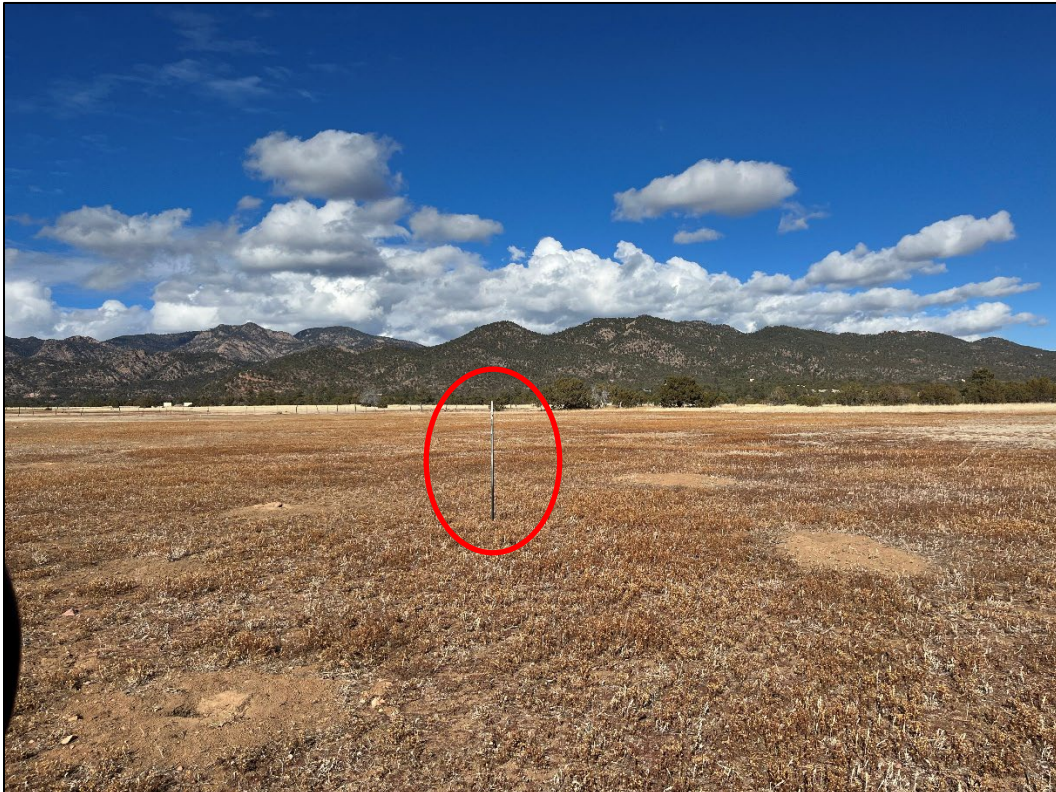
Photo 2: Permit boundary marker for the northwestern corner. Markers were observed for all boundary corners.

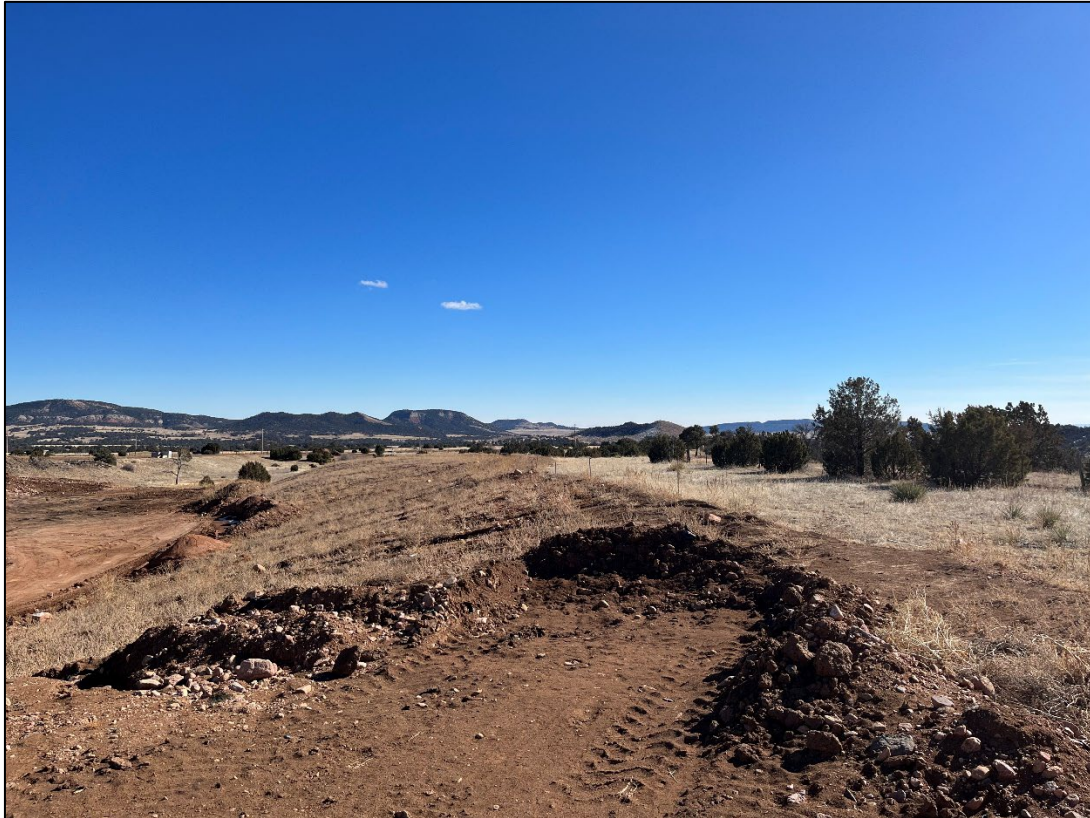
Photo 3: View east of the site's southern slope, covered with volunteer vegetation. T-posts are along a 30 ft offset from the permit boundary.

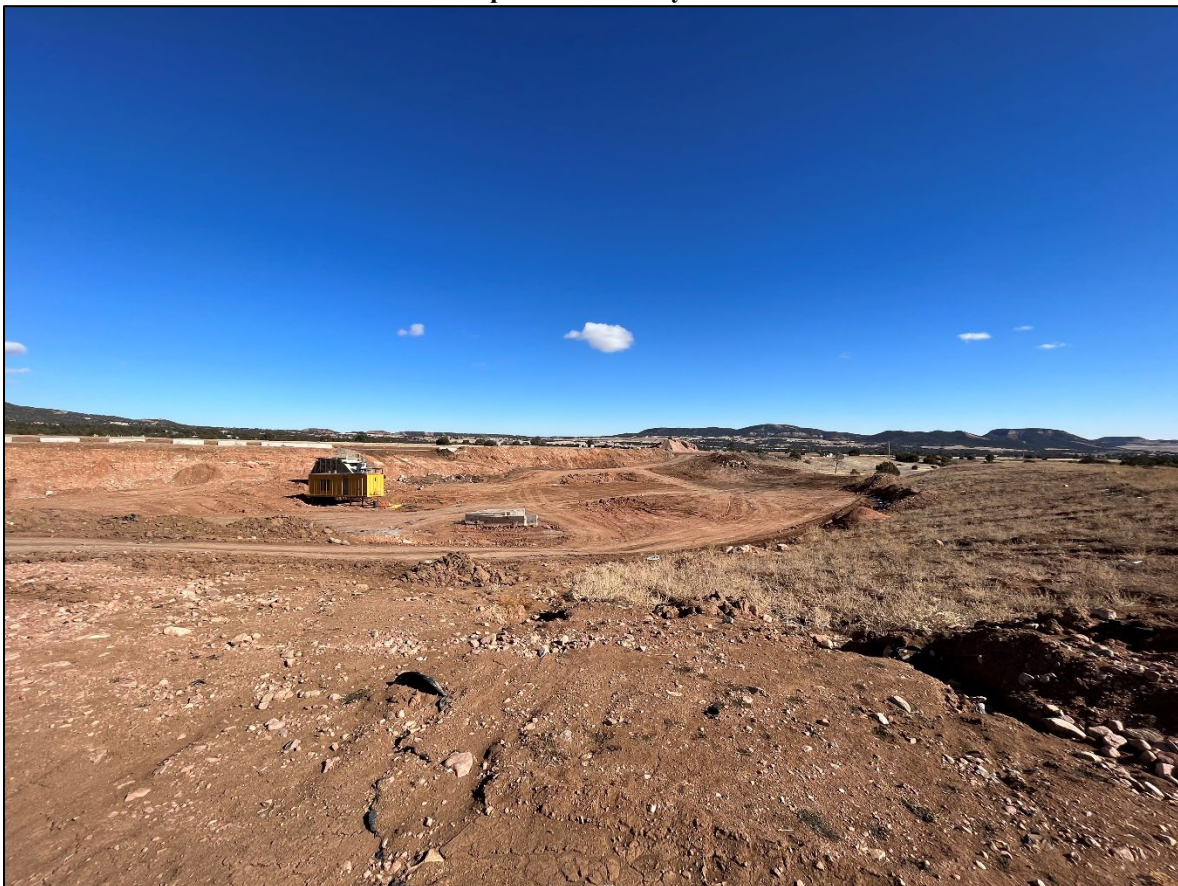
The site was active at the time of inspection, though activities mostly included work towards final reclamation of the site. The pit floor was still open and highwalls, which reached a maximum height of 20 ft, were in the process of being graded to their final reclamation slopes of 4H:1V or shallower (Photo 4 and 6). The stormwater berm which surrounds all sides of the permit boundary is to remain after reclamation is complete. A silt fence is currently in place at the eastern, downgradient edge of the site to help with any erosion (Photo 5). No erosional issues were noted anywhere at the site.

Photo 4: View east into the pit, highwalls are currently being graded out for final reclamation.

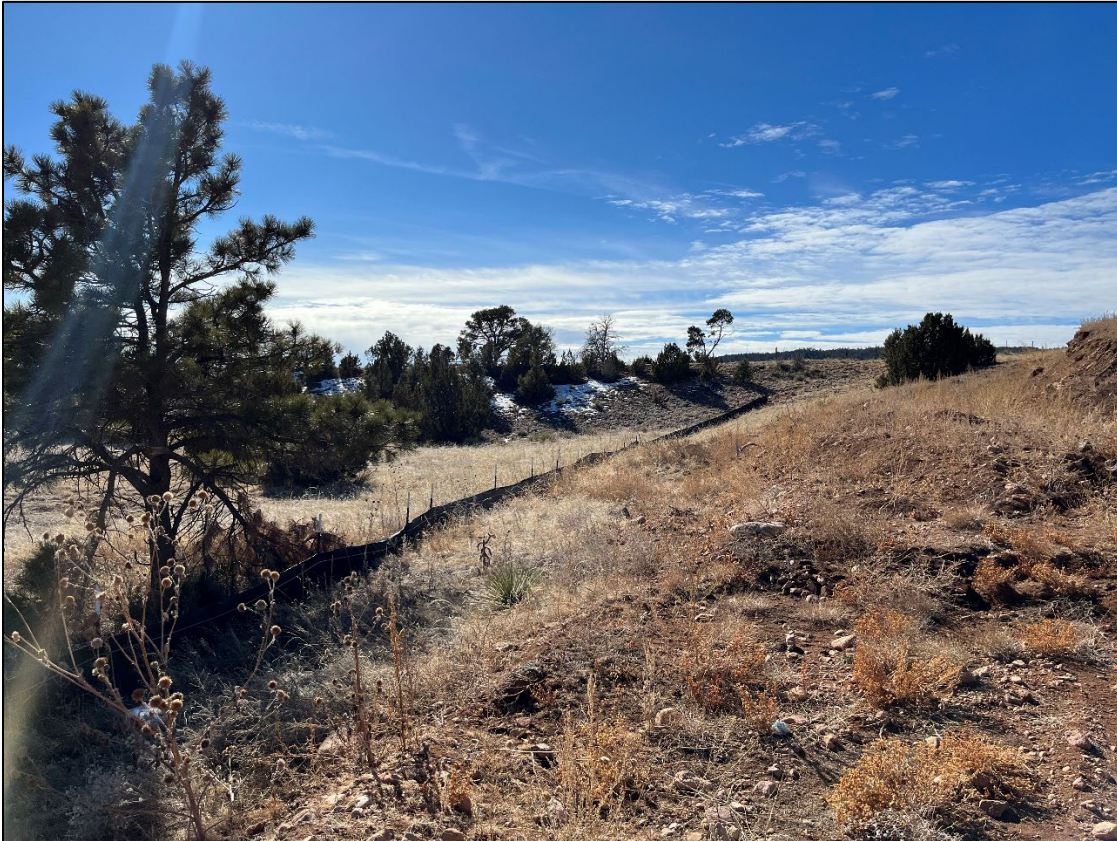
Photo 5: View south along the eastern edge of the permit boundary, a silt fence is in place to control erosion, a topsoil pile is located to the west.

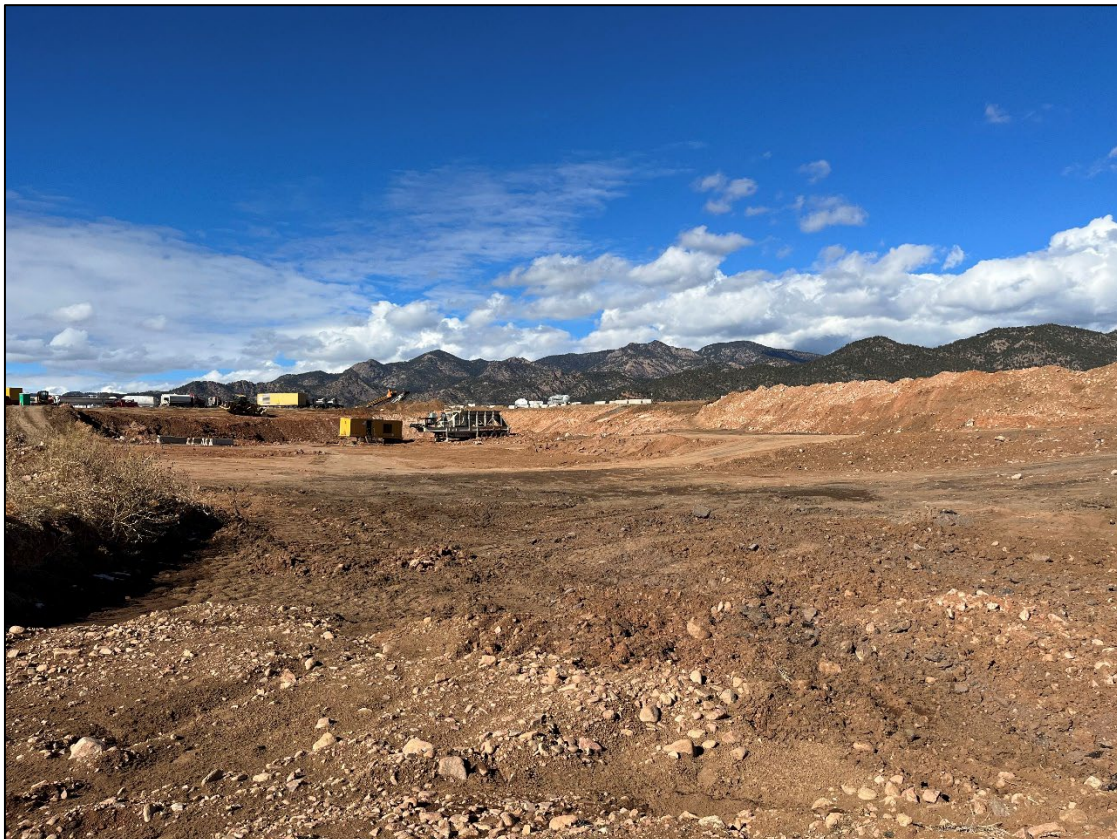
Photo 6: View north into the pit, actively reclaiming.

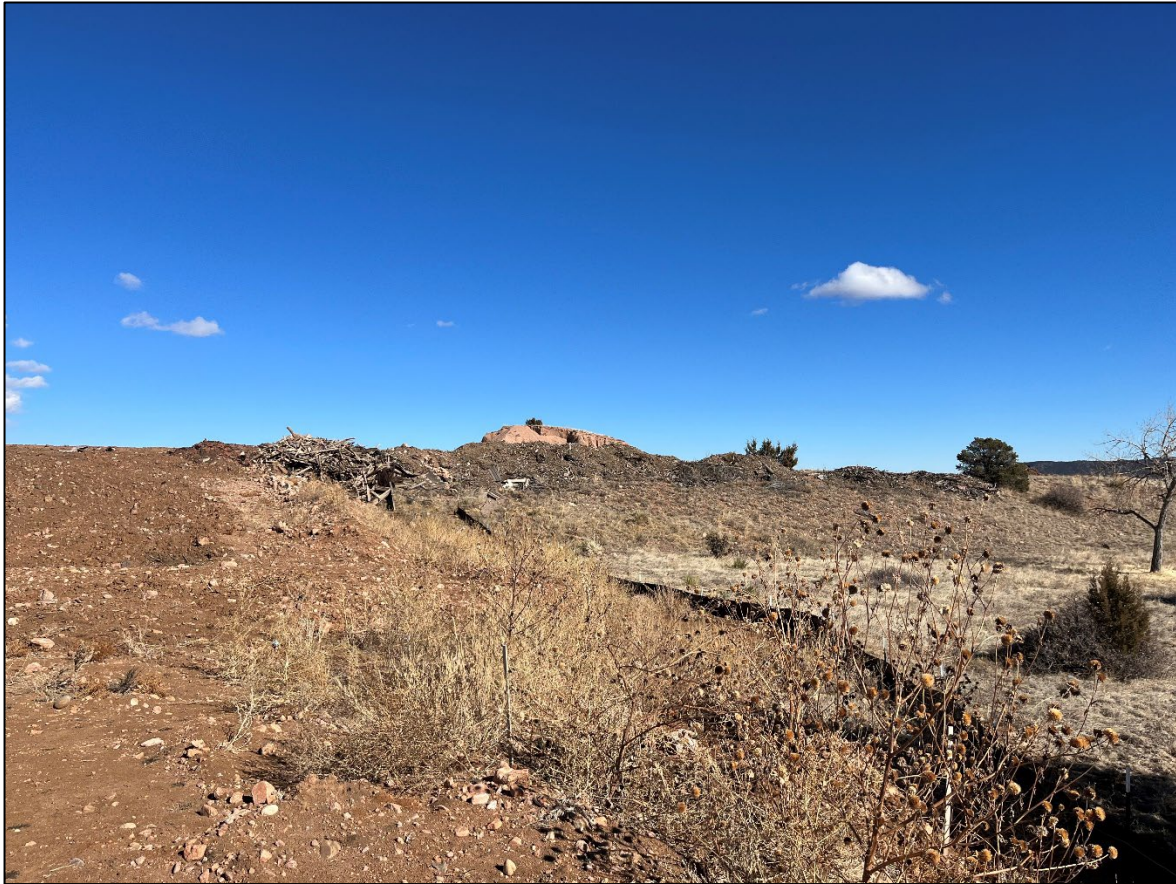
The slash pile located in the NE corner of the site and noted in the last inspection report remains (Photo 7). The Division acknowledges that the slash pile was pre-existing to the site, but a large part of the pile is currently located within the permit boundary. Therefore, all material within the boundary must be removed in final reclamation as it exists within an area which has been disturbed by the mining operation.

Photo 7: View northeast of the slash pile which remains in the eastern corner of the pit, will need to be removed in final reclamation.
