MINERALS PROGRAM INSPECTION REPORT
PHONE: (303) 866-3567

MINE NAME: La Veta Town Gravel Pit	MINE/PROSPECTING ID#: M-2016-018	MINERAL: Sand and gravel	COUNTY: Huerfano
INSPECTION TYPE: Monitoring	WEATHER: Cloudy	INSP. DATE: January 11, 2024	INSP. TIME: 09:00
OPERATOR: Town of La Veta	OPERATOR REPRESENTATIVE: Chris and Tom Knowles	TYPE OF OPERATION: 110c - Construction Limited Impact	
REASON FOR INSPECTION: Normal I&E Program	BOND CALCULATION TYPE: None	BOND AMOUNT: \$0.00	
DATE OF COMPLAINT: NA	POST INSP. CONTACTS: None	JOINT INSP. AGENCY: None	
INSPECTOR(S): Amber Gibson	INSPECTOR'S SIGNATURE:

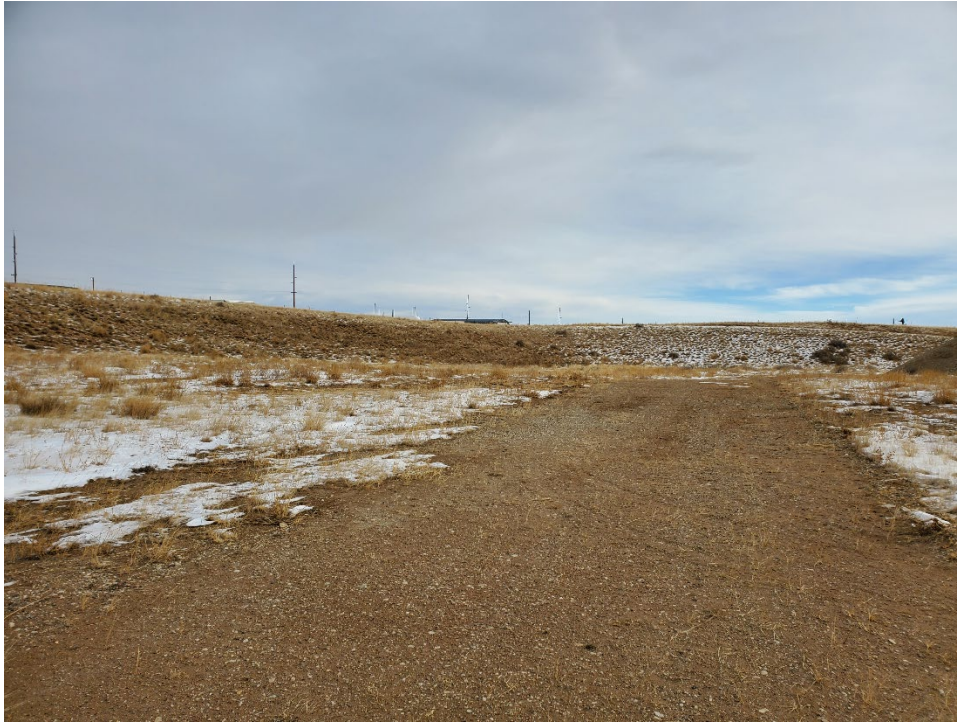
As mining progresses, the slopes are reclaimed contemporaneously. The slopes located in the eastern portion of the permit have been reclaimed to a 3H:1V slope, seeded, and have an established vegetative cover (Photos 1-2). No noxious weeds were observed during the inspection. The Operator has overburden stockpiles placed around the perimeter of the pit to reduce the push and haul distances required to backfill the slopes to aid in facilitating concurrent reclamation (Photos 3-4).

Photo 1: Looking east at the boundary of the current permitted pit area, and beyond. The slopes have been backfilled and graded from mining conducted previously in the permitted area and during a prior gravel operation.

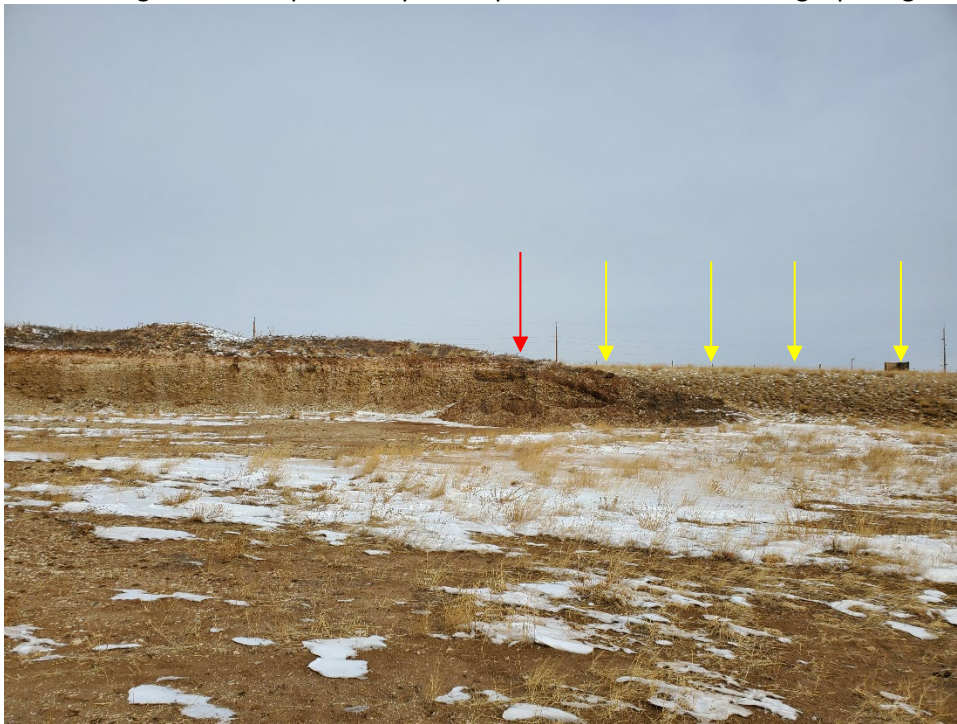
Photo 2: Looking north at the current eastern extent of the pit walls (red arrow), and the backfilled, graded, and vegetated slopes where the area has been mined-out to the east (yellow arrows).

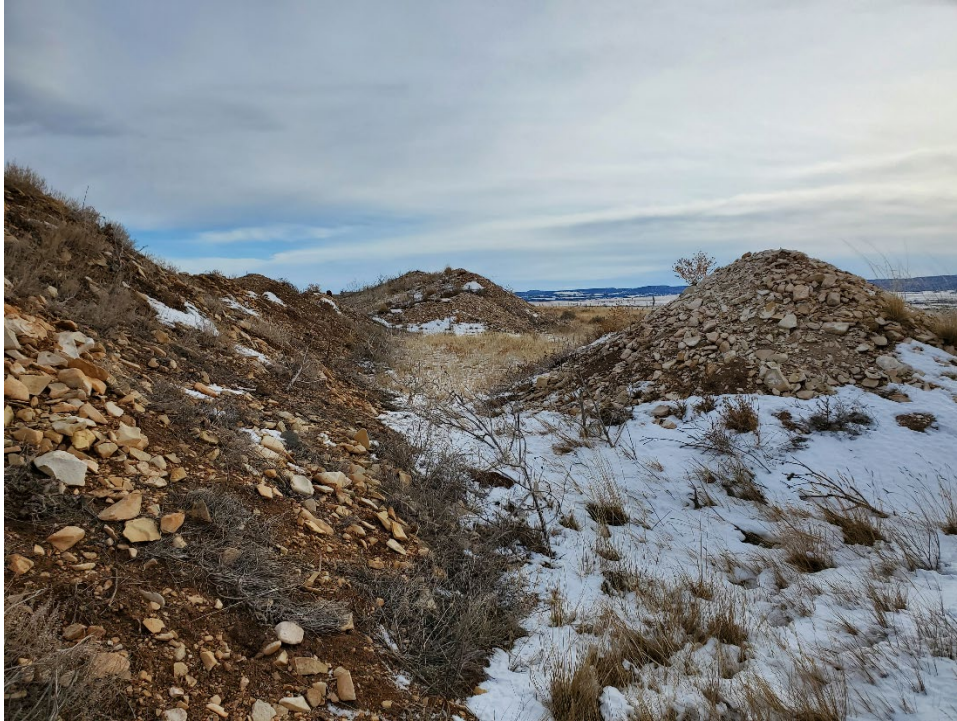
Photo 3: Looking east across the southern disturbance boundary. Overburden piles placed along perimeter of the pit.

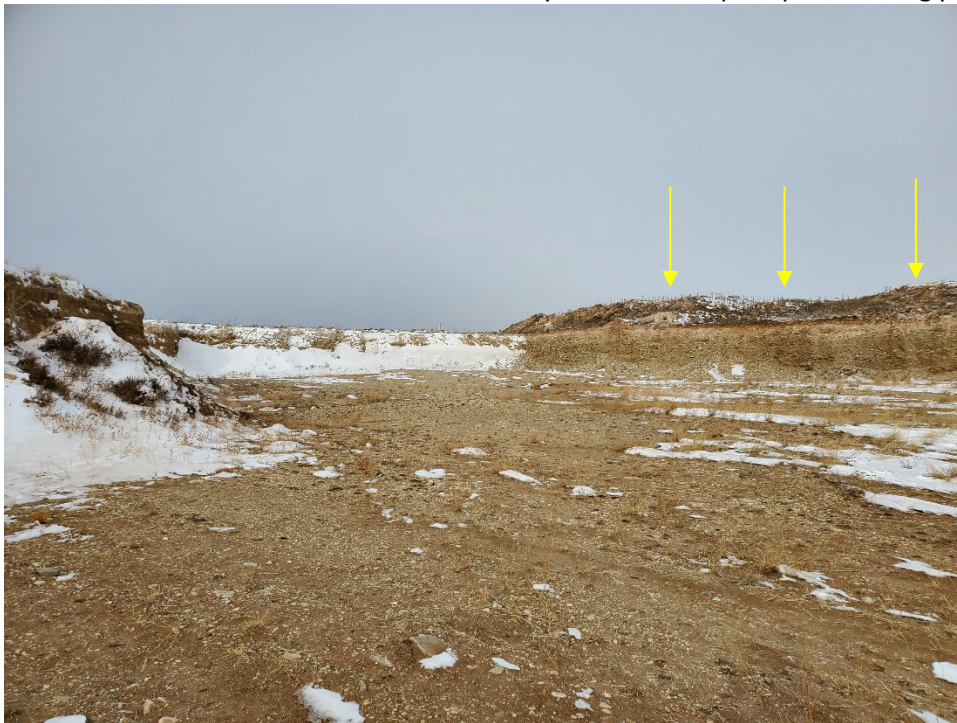
This operation is permitted over, and adjacent to, a previous gravel pit. Since permitting, the mining is progressing from east to west in accordance with the approved mining plan (Photos 4-8). The Operator stated that the last activity at the site was during September 2023, and consisted of hauling product off-site. The last time that excavating and crushing was conducted at the site was July 2020. There are highwalls along the north, west, and south sides of the pit (Photo 4). The highwalls appear to be stable and are approximately

Photo 4: Looking north-west at the pit. Overburden piles located along the pit perimeters (arrows).

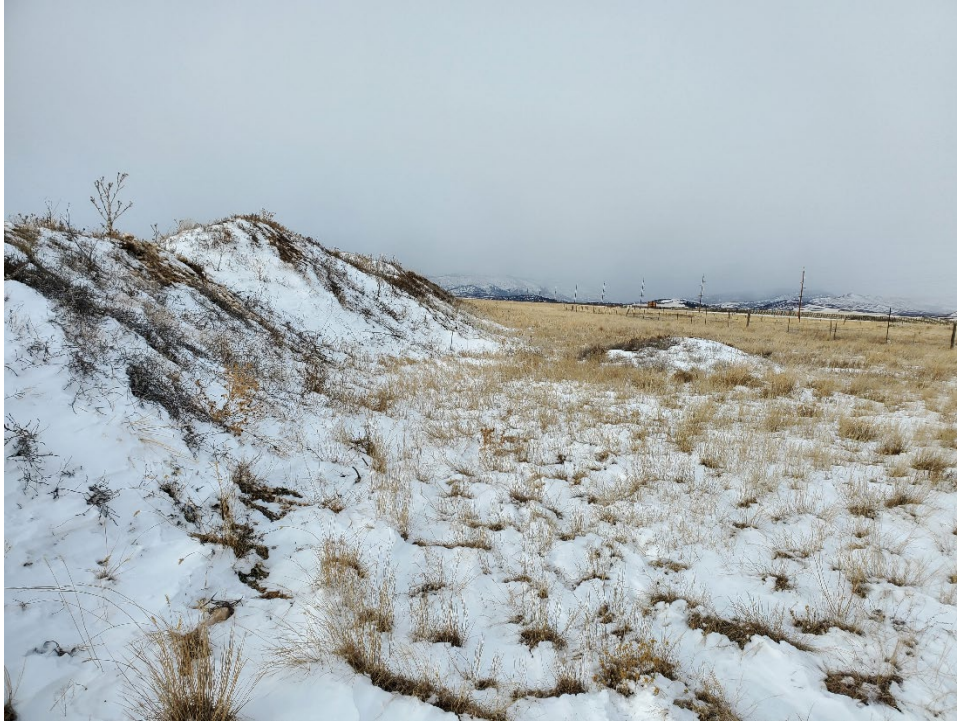
The topsoil pile is located above and behind the northern and southern sides of the pit, behind and adjacent to the overburden piles (Photos 5 and 11). The topsoil stockpiles are stored in locations where disturbance by ongoing mining operations will be minimized, in accordance with Rule 3.1.9(3). At the time of the inspection, the piles were partially covered in snow, but appeared to have stabilizing vegetative covers established.

Photo 5: Looking west along the northern disturbance boundary.

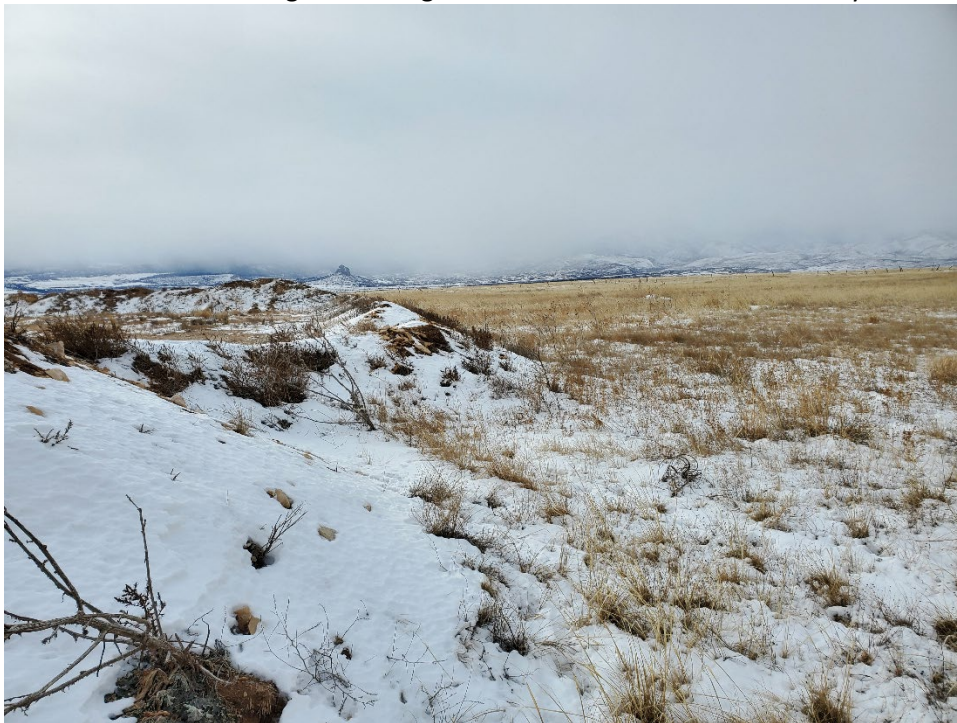
Photo 6: Looking south along the western disturbance boundary.

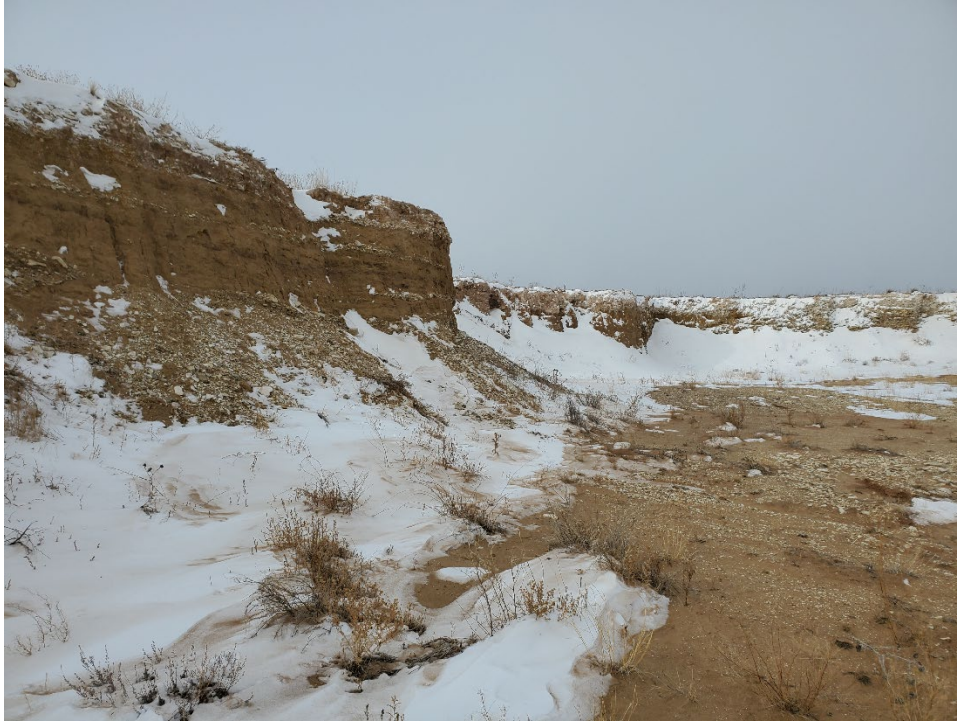
654.26 feet long with a maximum height between 13 and 15 feet. There is a product stockpile located in the south-east corner. This pile is extremely close to the boundary, but the disturbance mapped during the inspection indicated that the pile is within the permit boundary. The Operator is advised to proceed with caution, and to consider placing additional boundary markers in the east and along the tapering north and south edges to aid with line-of-sight when active excavation resumes.

Photo 7: Looking north-west at the highwalls around the pit.

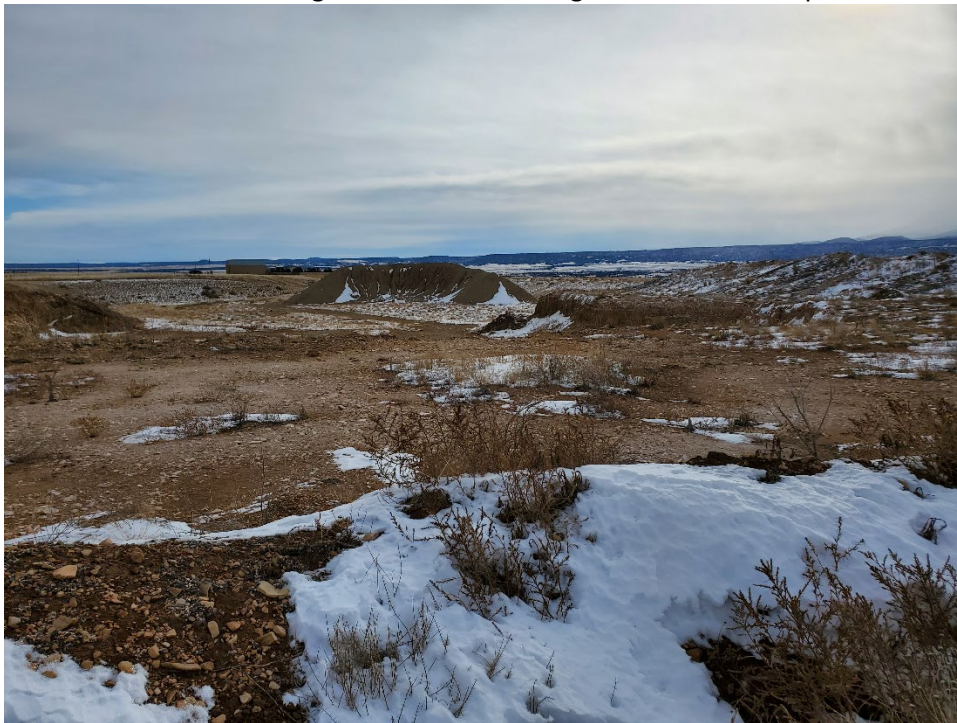
Photo 8: Looking east across the pit from the western disturbance boundary.

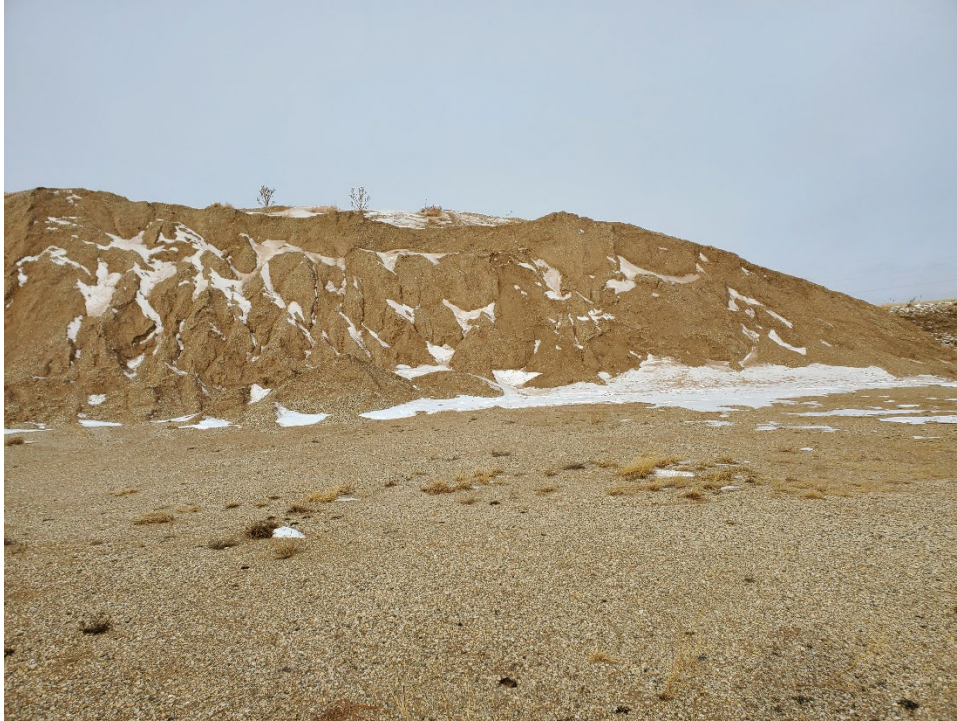
As noted in the *Gen. Compliance with Mine Plan* section above, the eastern boundary is encroached upon by the product stockpile. Additionally, as mining progresses west, the pit boundaries will need to narrow to stay within the tapering northern and southern boundaries (see Map 1 below). As a reminder, no disturbance is permitted outside of the permitted affected area boundary, including reclamation activities. Pursuant to Rule 3.1.5(3), the Operator shall protect areas outside the affected land from slides or other damage. Failure to do so may be cited as a Possible Violation and the matter may be brought before the Mined Land Reclamation Board (MLRB) for an enforcement hearing.

Photo 9: Looking west at the product stockpile located along the east boundary. The Division walked along the base of the pile to map the disturbance boundary (see pink lines on Map 1).

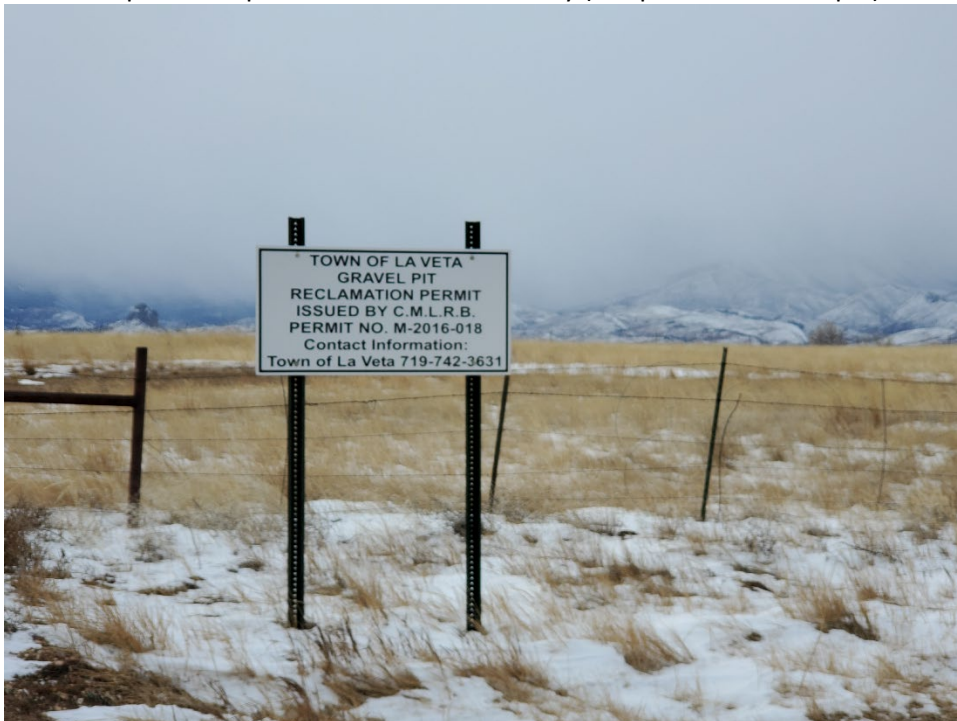
A mine sign was posted at the entrance to the site (Photo 10), in compliance with Rule 3.1.12(1). The affected area boundary was marked in compliance with Rule 3.1.12(2). The markers were observed during the inspection, and the coordinates were collected during the Division's previous inspection (see blue flags on Map 1).

Photo 10: Mine sign posted at the entrance gate.

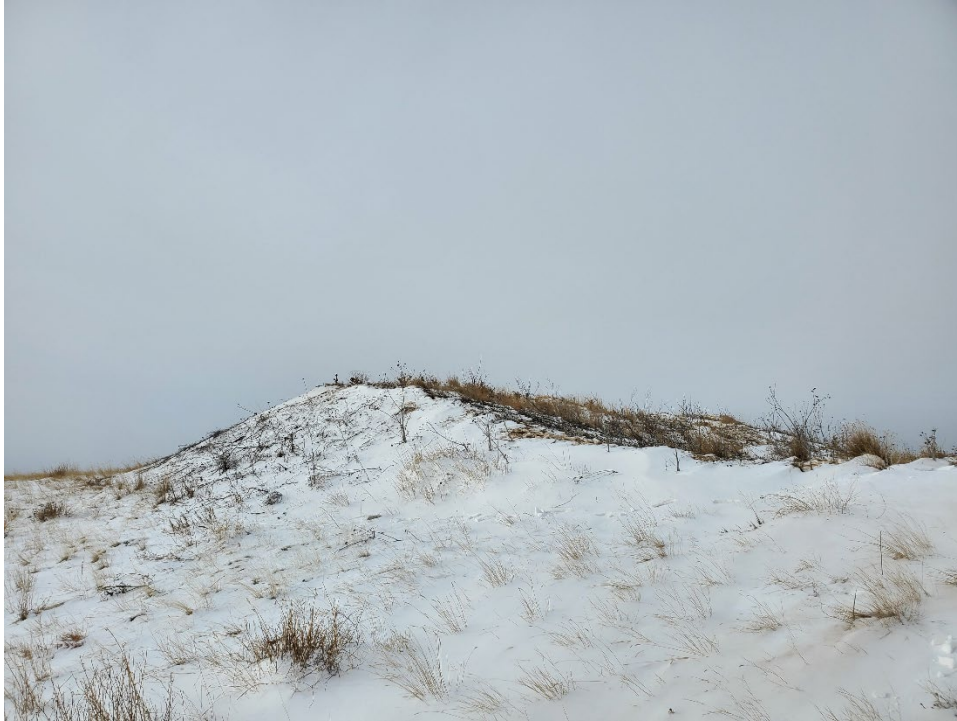
Photo 11: Looking south-west at the southern topsoil pile.

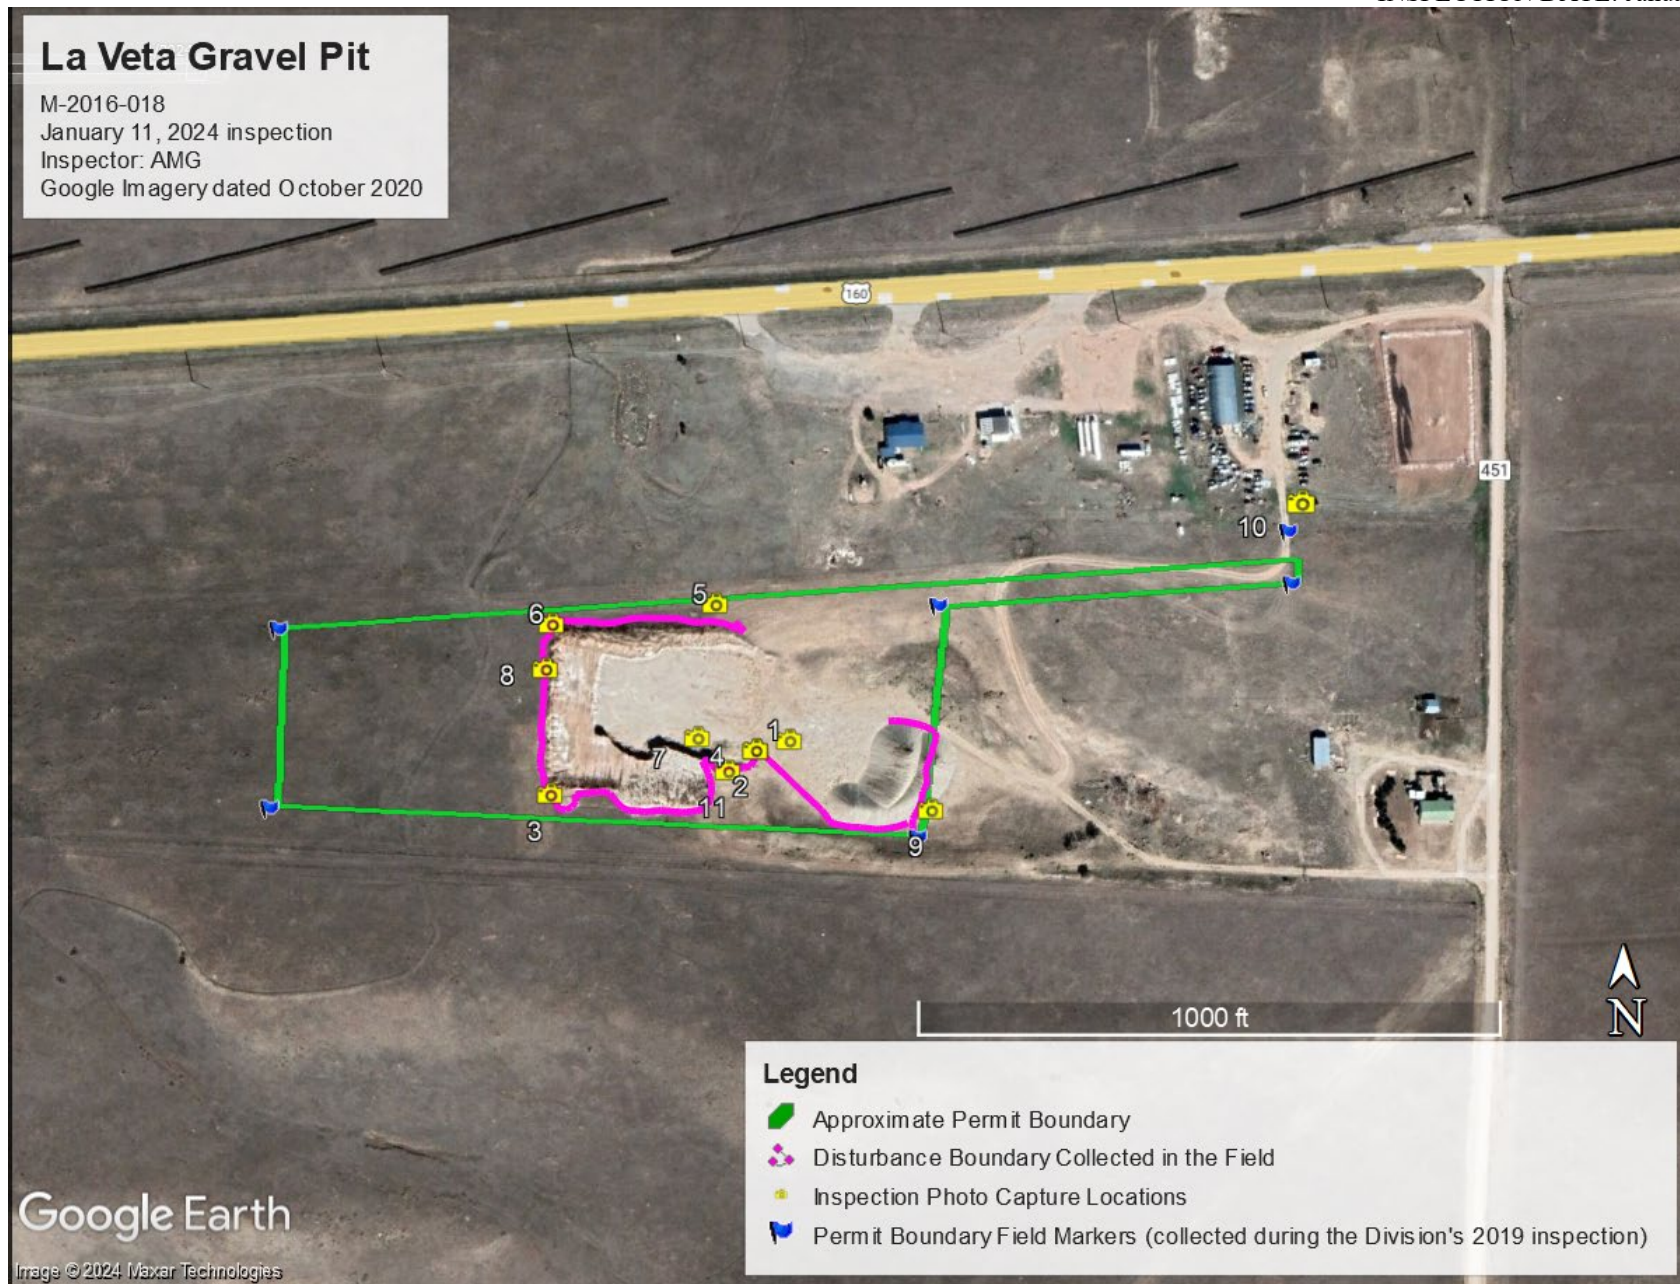
Map 1: Map generated in Google Earth to display the locations where photos were taken and where the disturbance boundary was walked during the January 11, 2024 inspection of the La Veta Town Gravel Pit. Google aerial imagery dated October 2020.
