C-1981-008 New Horizon January Partial Inspection Report

PERMIT INFORMATION

Permit Number: C-1981-008 Mine Name: New Horizon Mine Operator: Elk Ridge Mining and Reclamation, LLC Operator Address: Mr Tony Tennyson P.O. Box 628 27646 West 5th Avenue Nucla, CO 81424	County: Montrose Operation Type: Surface Permit Status: Active Ownership: Private
	Operator Representative Present: Mindy Sickles
Operator Representative Signature: (Field Issuance Only)

Inspection Start Date: January 23, 2024 Inspection Start Time: 11:30 Inspection End Date: January 23, 2024 Inspection End Time: 11:55	Inspection Type: Coal Partial Inspection Inspection Reason: Normal I&E Program Weather: Clear
Joint Inspection Agency: None	Joint Inspection Contacts:
Post Inspection Agency: None	Post Inspection Contacts:
Inspector(s): Lucas West	Inspector's Signature:

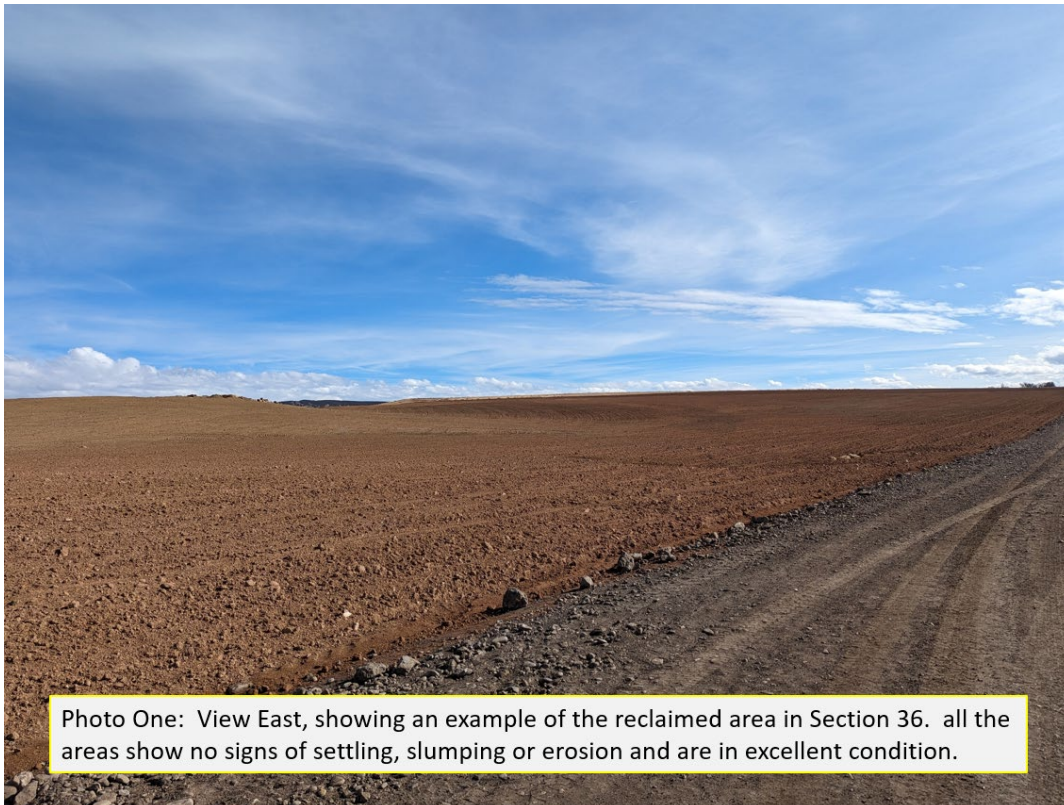
The main focus of this inspection was to observe the condition of the backfilling, topsoil replacement and seeding efforts that were recently concluded in the Section 36 area. At the time of the inspection all reclamation work in this area had been completed and no equipment was present on site. Of all the areas observed from the vantage point of the Pond 13 access road due to muddy conditions, there were no signs of settling, slumping or erosion. The reclaimed areas are in excellent condition and were seeded in the fall of 2023 prior to snowfall. Evidence of seeding was visible and undisturbed. Examples of the reclaimed area can be seen in Photos One through Three. The reclaimed topography consists of gently sloping hills with storm water control structures installed.

Photo One: View East, showing an example of the reclaimed area in Section 36. all the areas show no signs of settling, slumping or erosion and are in excellent condition.

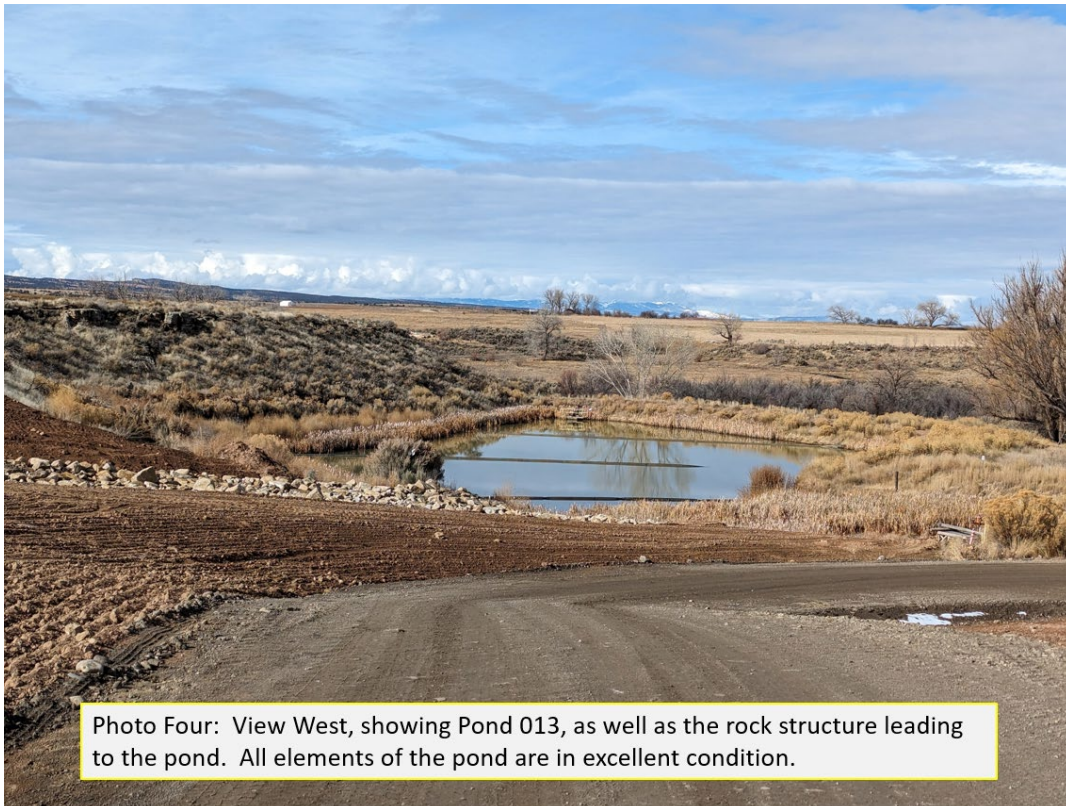
At the end of the access road, Pond 013 was observed to be in good condition and can be seen in Photo Four. Water was flowing into the pond via the aeration structure, which was functioning as designed. The pond banks and baffle curtains appeared stable at the time of the inspection, and the vegetation in the surrounding area was also in good condition.

Photo Four: View West, showing Pond 013, as well as the rock structure leading to the pond. All elements of the pond are in excellent condition.

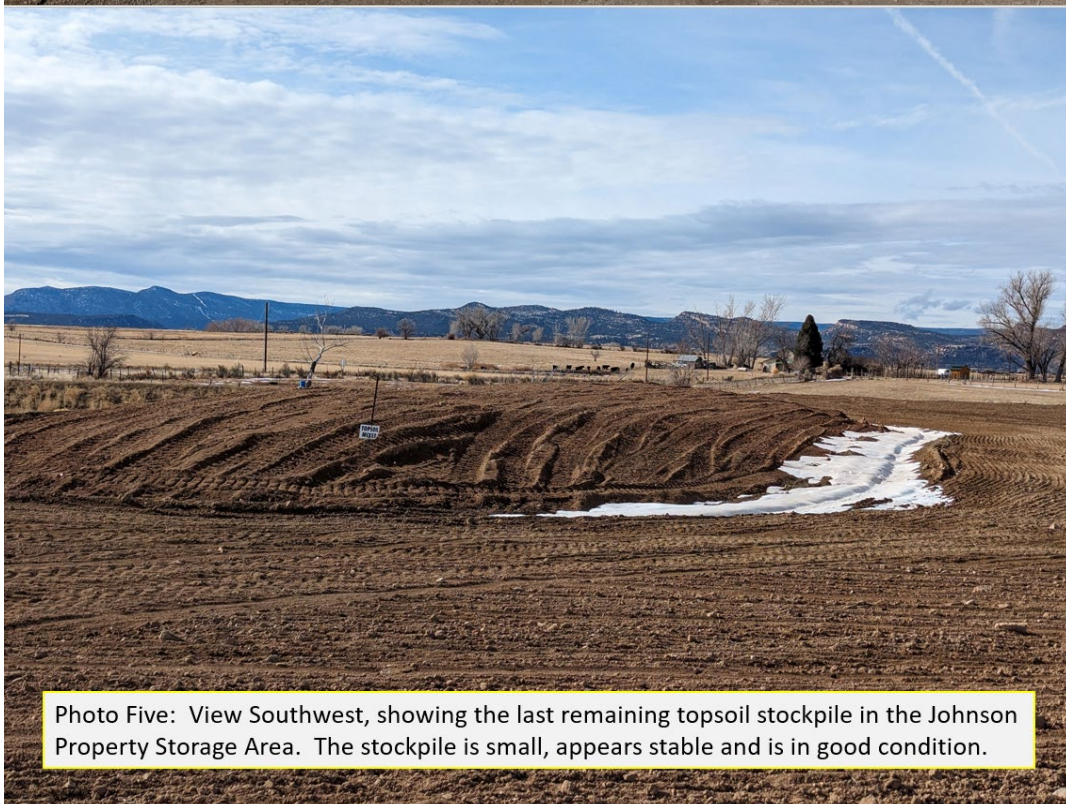
At the Johnson Property Topsoil Stockpile area, almost all the material was utilized during the reclamation efforts. Only one small stockpile of mixed topsoil, shown in Photo Five, remains. The stockpile appears stable and shows evidence of seeding for stabilization. A portion of the ring berm around the stockpile was visible and functioning as designed, however due to muddy conditions, the entire perimeter of the pile was not observed.

Photo Five: View Southwest, showing the last remaining topsoil stockpile in the Johnson Property Storage Area. The stockpile is small, appears stable and is in good condition.
