MINERALS PROGRAM INSPECTION REPORT
PHONE: (303) 866-3567

| MINE NAME: Climax Mine | MINE/PROSPECTING ID#: M-1977-493 | MINERAL: Molybdenum | COUNTY: Lake, Summit |
| INSPECTION TYPE: Monitoring | WEATHER: Cloudy | INSP. DATE: January 19, 2024 | INSP. TIME: 10:00 |

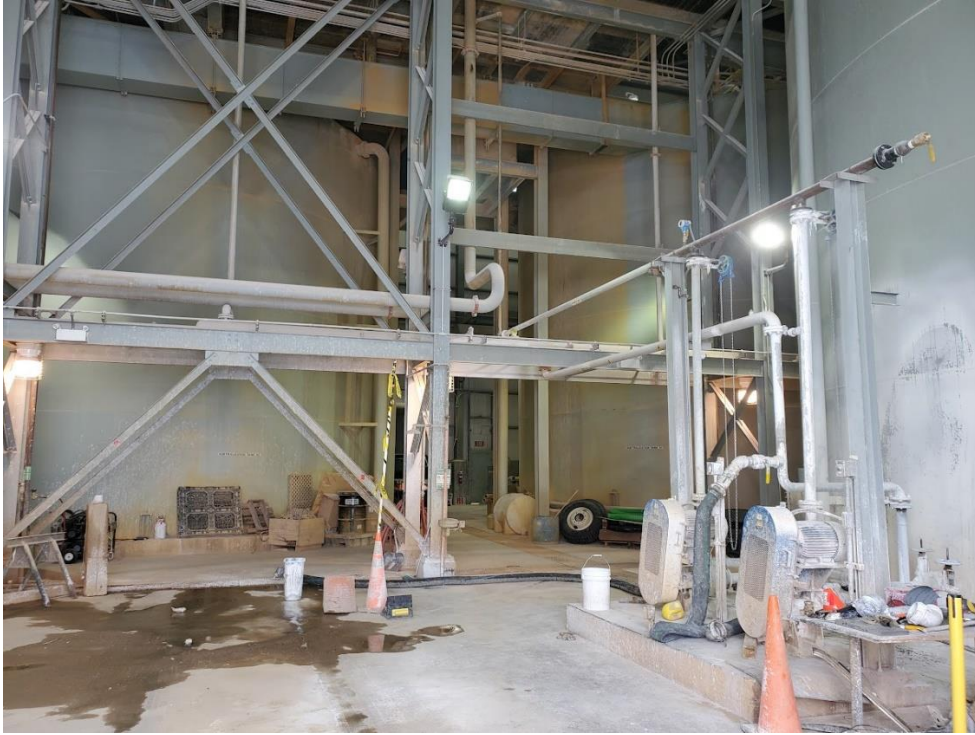
The SDP was not active at the time of the inspection. Crews were performing maintenance on the plant. When operating, the SDP provides first stage metals treatment for a significant portion of the mine's affected water. The plant creates a sludge that is deposited in a sludge cell on the Tenmile tailing storage facilities. The sludge cell was snow covered and there was no observed discharge into the cell during the inspection. When operating the plant utilizes lime and flocculant as reagents in the water treatment process. The interior of the facility was in good condition and well kept (Photo 1). Observed materials were properly stored. Reactor tanks used in the treatment process were empty at the time of the inspection (Photo 2). Tanks appear to be in good condition. Floor sumps and troughs that provide secondary containment were free of obstructions and appear to be in proper condition. The clarifier was not operational but was holding water. No problems were noted.

Photo 1 – View to the east showing the interior of the SDP with tanks, pumps, and other equipment. The interior of the facility is clean and orderly.

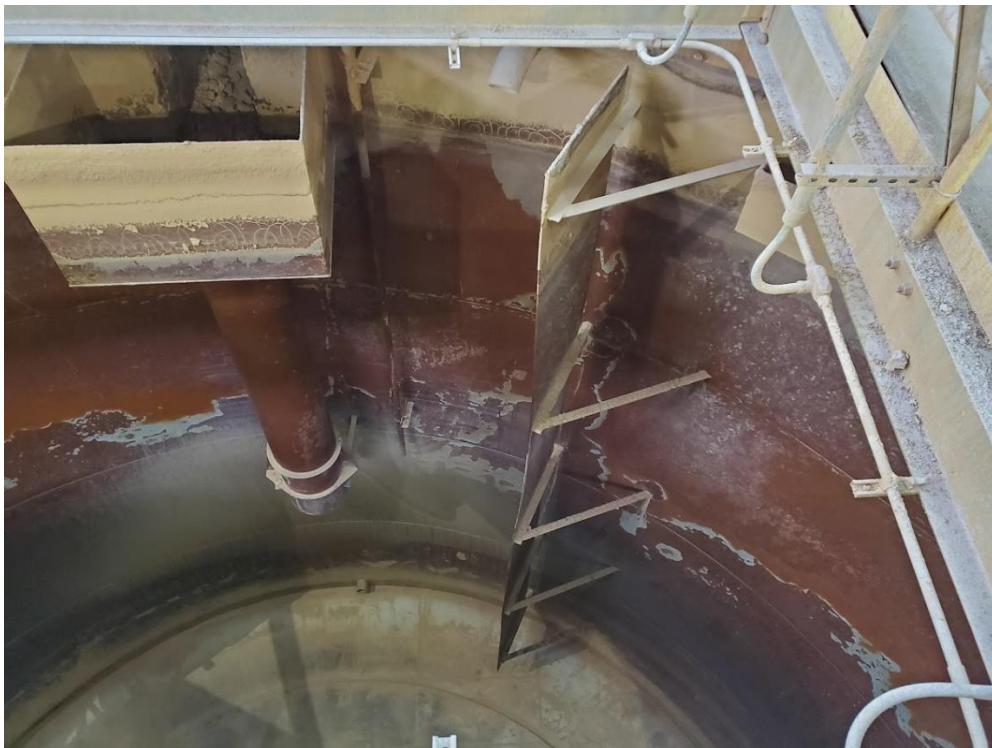
Photo 2 – View to the south of empty tank in the SDP. The facility is not active for maintenance.

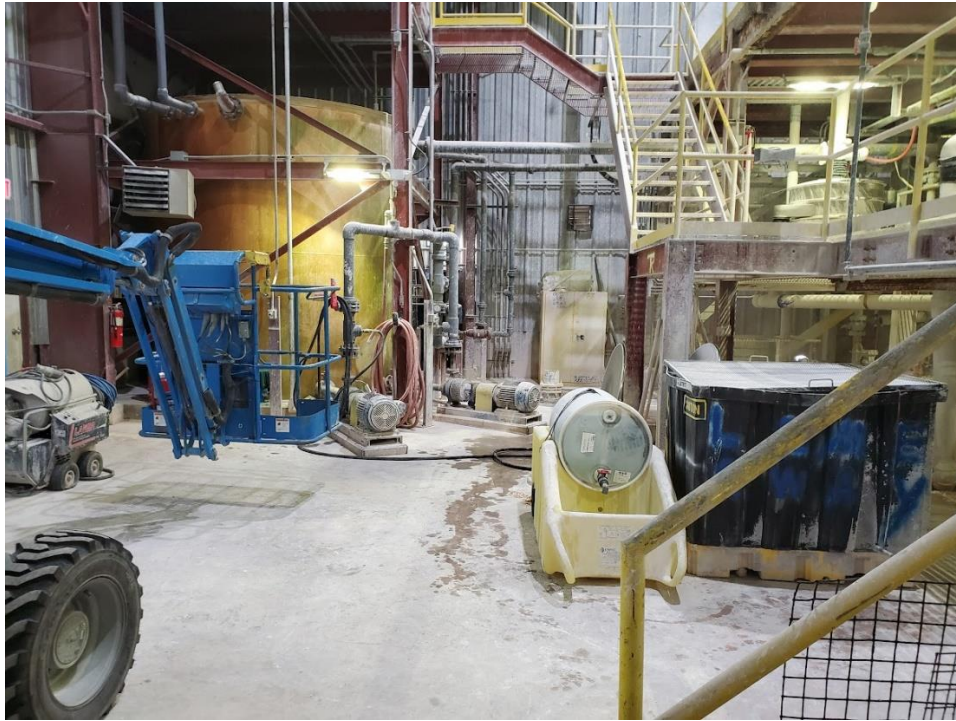
The SDP Lime Station was not active at the time of the inspection. When active the facility stores and mixes large quantities of hydrated lime for water treatment at the adjacent SDP. Lime is fed from the silos to create a slurry that is utilized in the SDP. The interior of the facility was in good condition (Photo 3). Residual dried lime is present throughout the building. Floor sumps and troughs that provide secondary containment were free of obstructions and appear to be in proper condition (Photo 4). All materials in the SDP Lime Station were properly stored and in good condition. A backup generator is located within the SDP Lime Station which appears in good working order (Photo 5) and there were no signs of spills or leaks around the equipment. No problems were noted.

Photo 3 – View to the north showing the interior of the SDP Lime Station. The facility is currently not operational for maintenance.

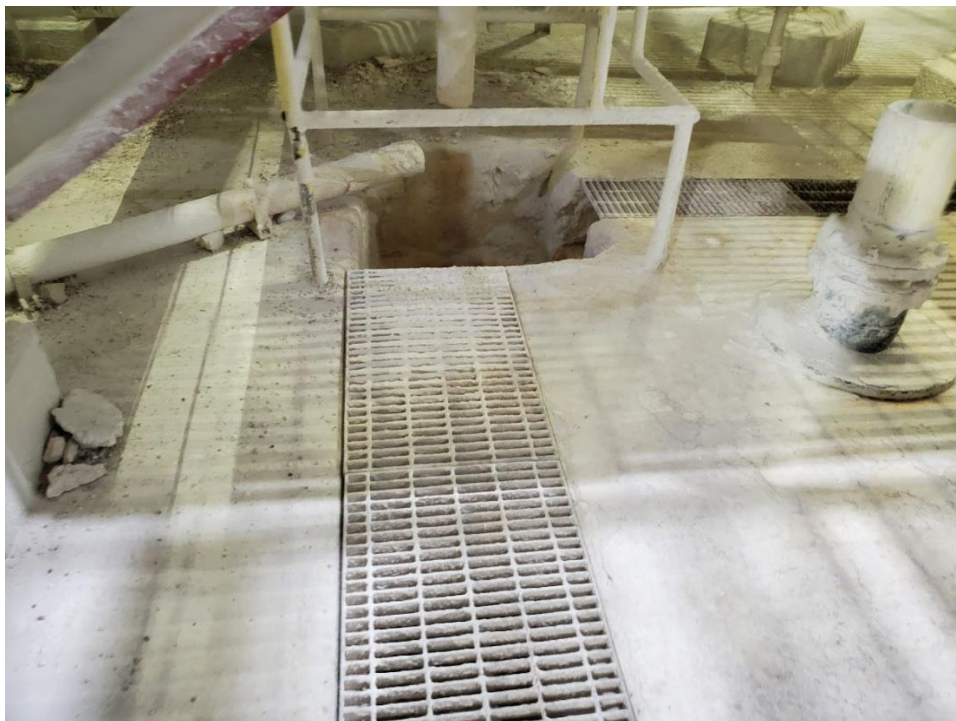
Photo 4 – View to the east of troughs and sumps in the SDP Lime Station.

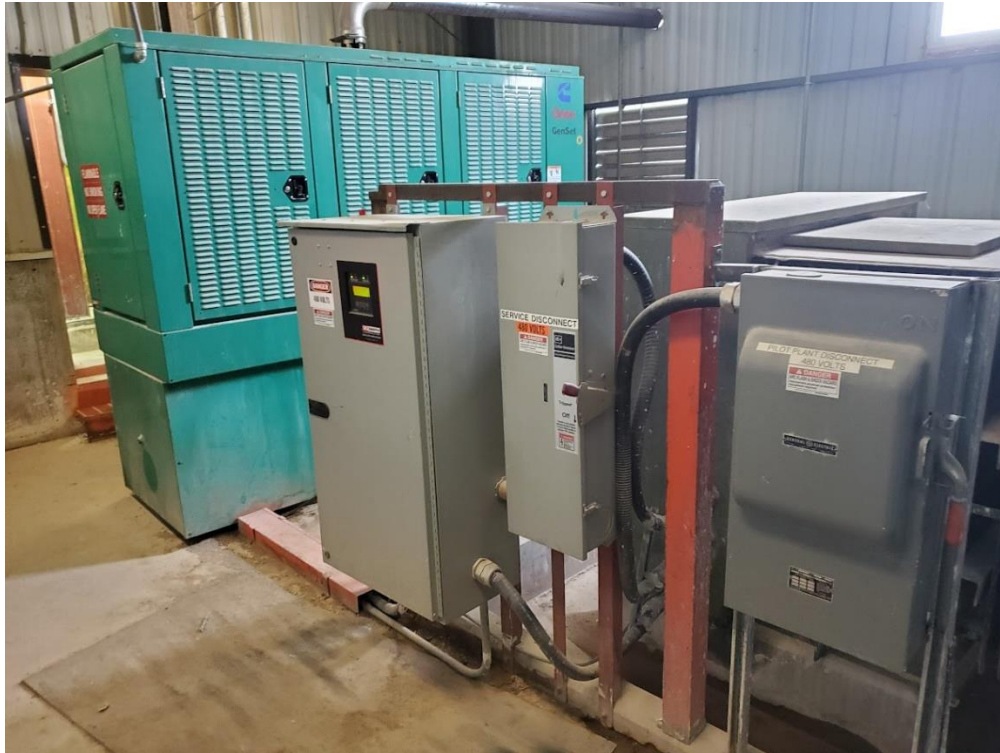
Photo 5 – View to the South of backup generator in the SDP Lime Station.

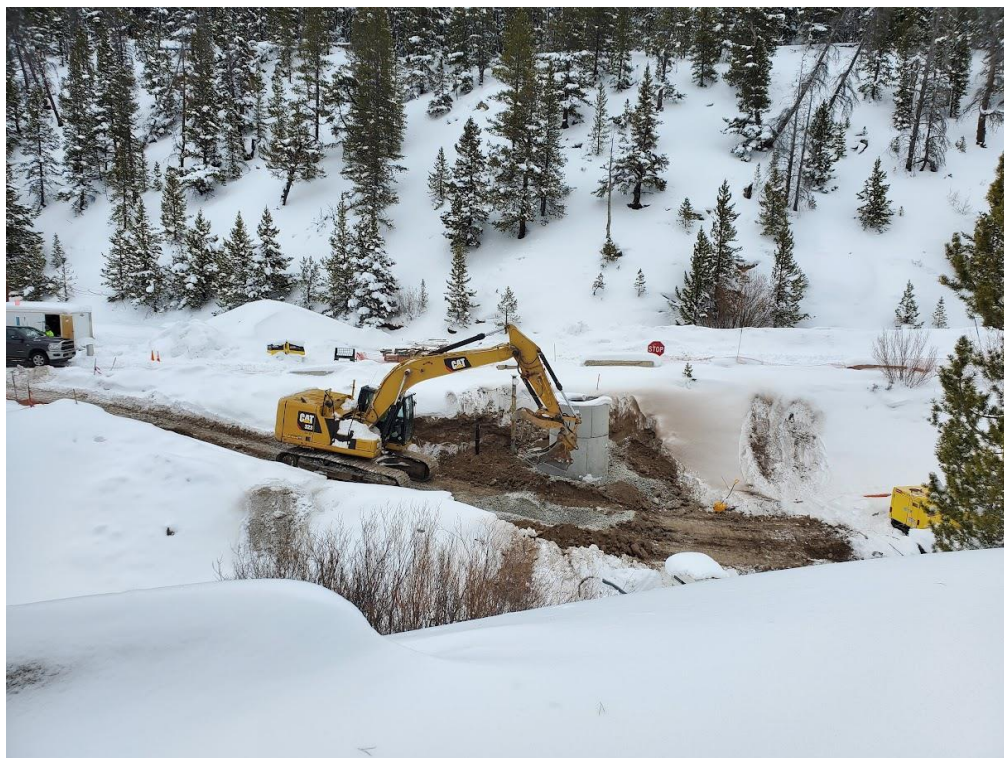
Construction continues on the 5 Dam Seepwater Collection System, approved under TR-36. The project is delayed due to difficulty procuring a transformer. Work has also been slowed by recent inclement weather. The Operator is working with their contractor to complete items that can be constructed in winter conditions before the transformer arrives. Contractor crews are currently working on the 72" RCP Wet Well below the Secondary Seepage Pump Station (Photo 6). The completed work appears to be consistent with the approved designs and

Photo 6 – View to the east of progress at 5 Dam Seepwater Collection System. Excavator is packing material around the well.

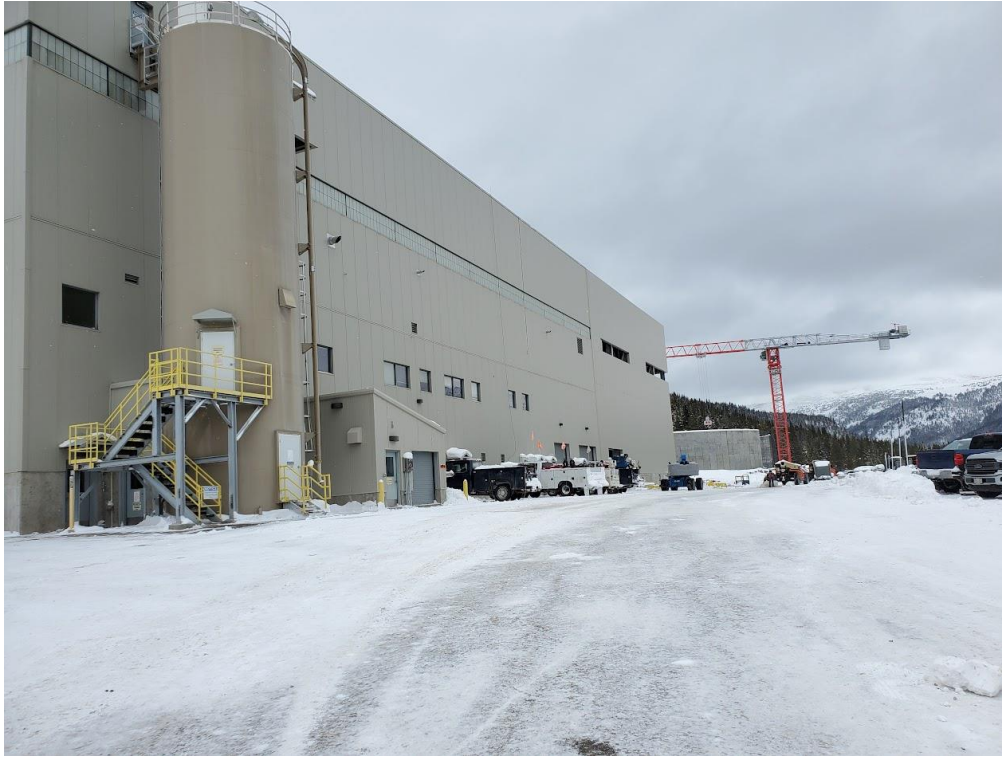
Construction continues on the new MRWTP building approved under TR-34. This is a supplementary process to Climax's PDWTP. The exterior walls of the steel structure now have siding and a crane is on site to continue work on the thickener. Once online, raw water will first go to the Moly building before being sent to the PDMWTP. The building is slated to be online in the first quarter of 2025. Construction progress can be seen in Photo 7.

Photo 7 – View to the north of PDWTP. Lime storage can be seen in the foreground. Siding can be seen on the MRWTP in the background along with a crane that is constructing the thickener.

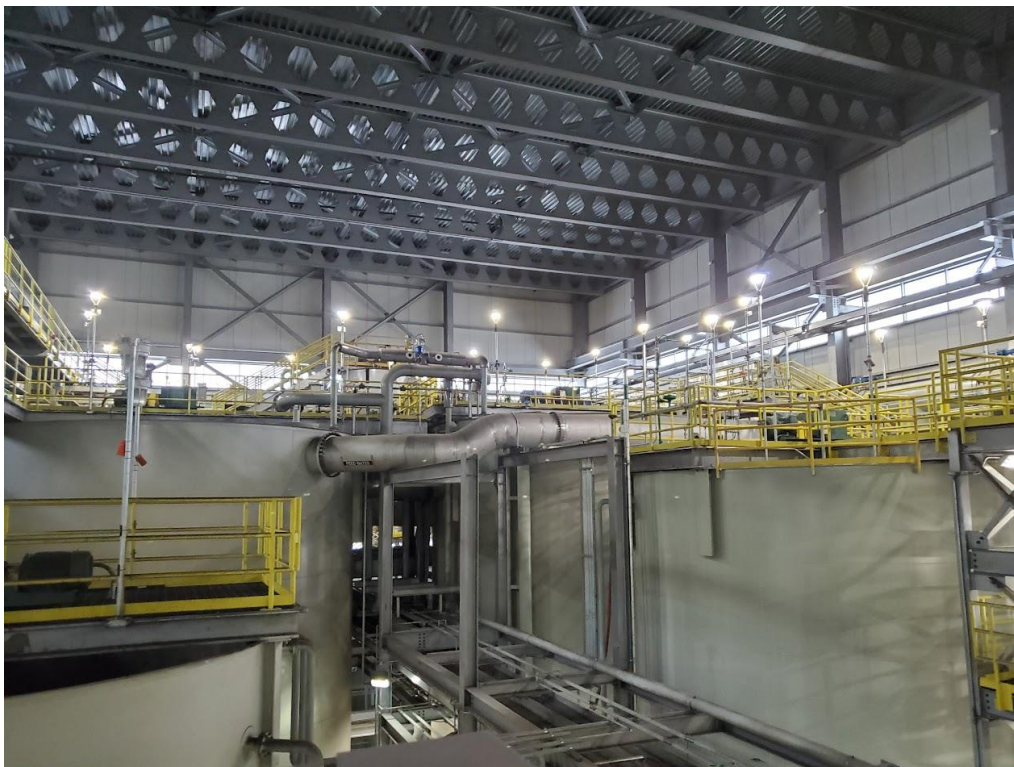
The PDWTP was operational at the time of the inspection. The PDWTP is located below 5 Dam and is intended to remove metals such as manganese, iron, copper, and zinc. The plant discharges to Tenmile Creek and provides final treatment before affected water leaves the property. The facilities were clean and well kept. Secondary containment is adequate and floor drains/sumps appear free of obstruction. The treatment process utilizes lime, flocculant, and sulfuric acid as reagent chemicals. Reagent lines and containers were clearly labeled. A lime storage area is located on the exterior of the building and can be seen in Photo 7. The lime is turned into a slurry and mixed with affected water in reactor tanks to raise the pH. The Slurry and Reactor Tanks are in good condition (Photo 8). Solids from the PDWTP are transported via a cement truck to the sludge cells. The filter press in the facility is not being utilized. Once the water leaves the reactor tanks it enters clarifiers and is dosed with flocculant. The clarifiers were in good working conditions and operating at the time of the inspection. Adjacent to the clarifiers is the Filter Building which houses a series of sand filters. Filter tanks appear in good condition. Sulfuric acid is also used in this facility to lower the pH before water is discharged. The sulfuric acid storage is isolated from the rest of the plant and located in an epoxy coated containment area (Photo 9). No spills or other problems were noted within the PDWTP during the inspection.

Photo 8 – View to the south of Slurry and Reactor Tanks in PDWTP.

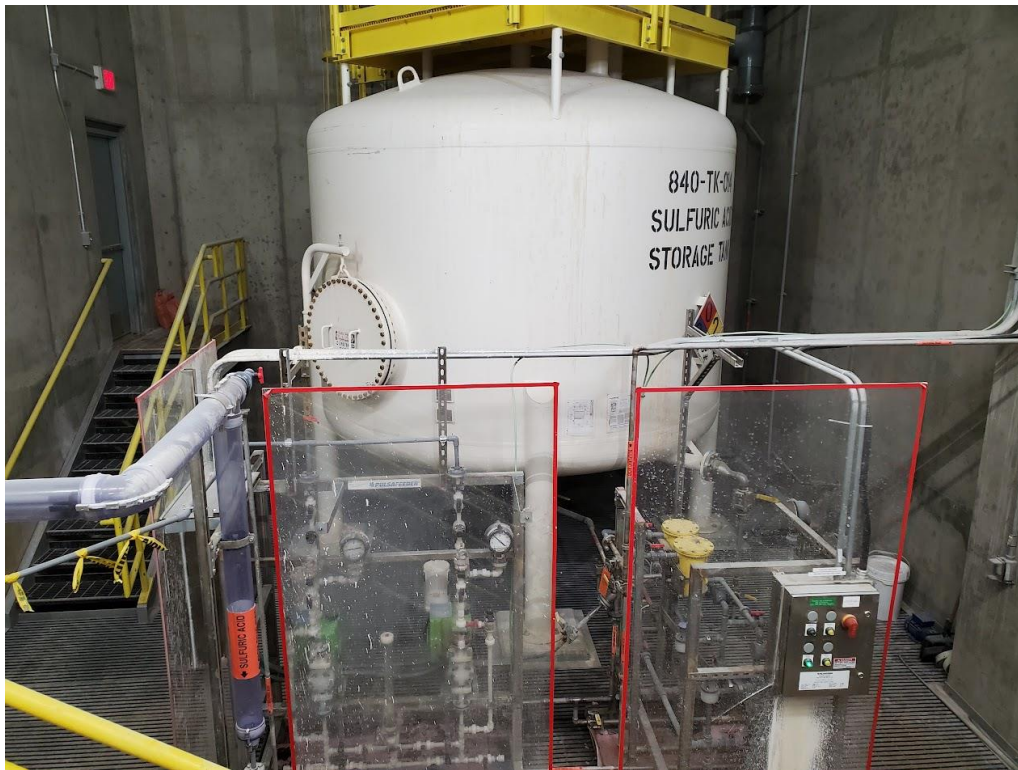
Photo 9 – View to the west of sulfuric acid storage in Filter Building of PDWTP.
