MINERALS PROGRAM INSPECTION REPORT
PHONE: (303) 866-3567

MINE NAME: 32.5 Road Gravel Pit	MINE/PROSPECTING ID#: M-2009-035	MINERAL: Gravel and sand	COUNTY: Mesa
INSPECTION TYPE: Monitoring	WEATHER: Clear	INSP. DATE: January 24, 2024	INSP. TIME: 11:30
OPERATOR: M.A. Concrete Construction, Inc.	OPERATOR REPRESENTATIVE: Andy Azcarraga	TYPE OF OPERATION: 112c - Construction Regular Operation	
REASON FOR INSPECTION: Normal I&E Program	BOND CALCULATION TYPE: None	BOND AMOUNT: \$88,155.00	
DATE OF COMPLAINT: NA	POST INSP. CONTACTS: DRMS	JOINT INSP. AGENCY: None	
INSPECTOR(S): Amy Yeldell	INSPECTOR'S SIGNATURE:

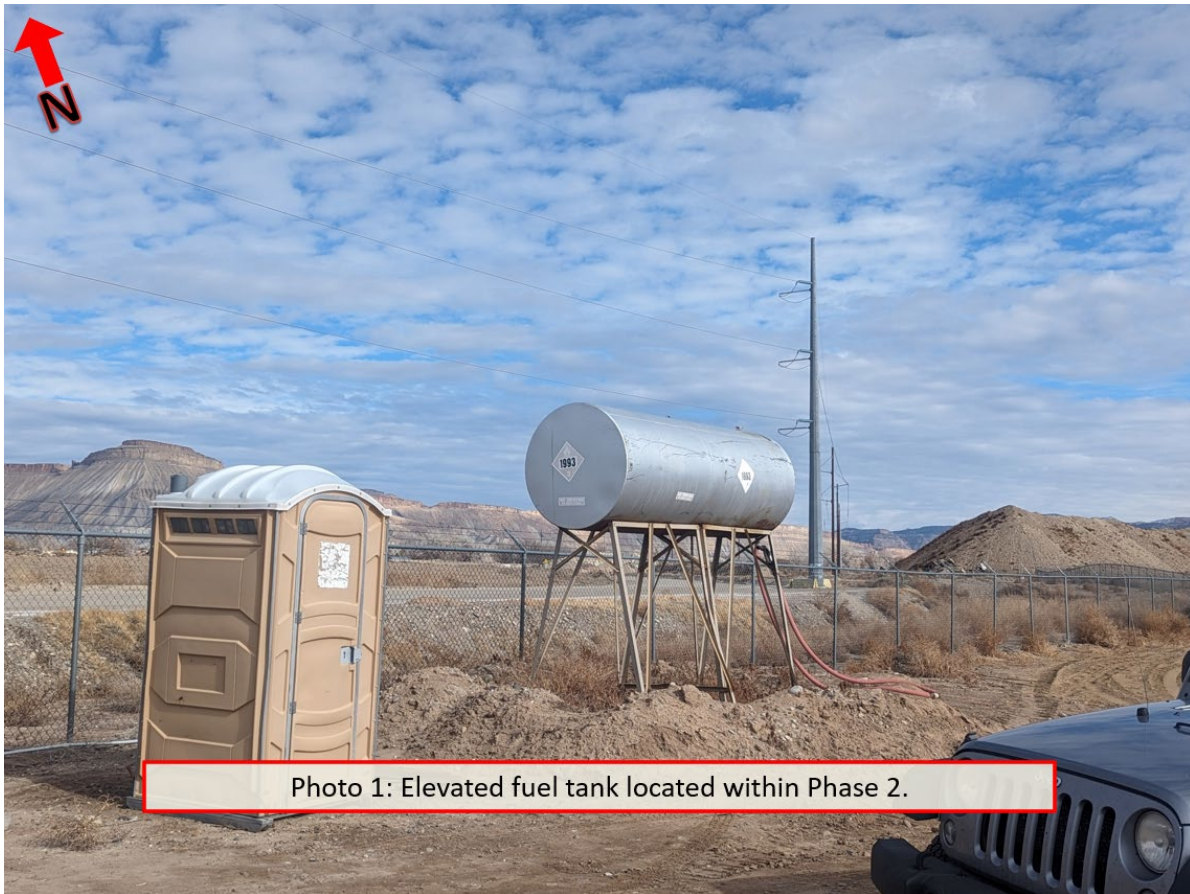
An elevated fuel tank remains on site in Phase 2 (Photo One). It is located within an earthen embanked secondary containment. Given that mining has concluded on site the tank should be removed as soon as practical for reclamation purposes. No other acid or toxic materials were observed on site.

Photo 1: Elevated fuel tank located within Phase 2.

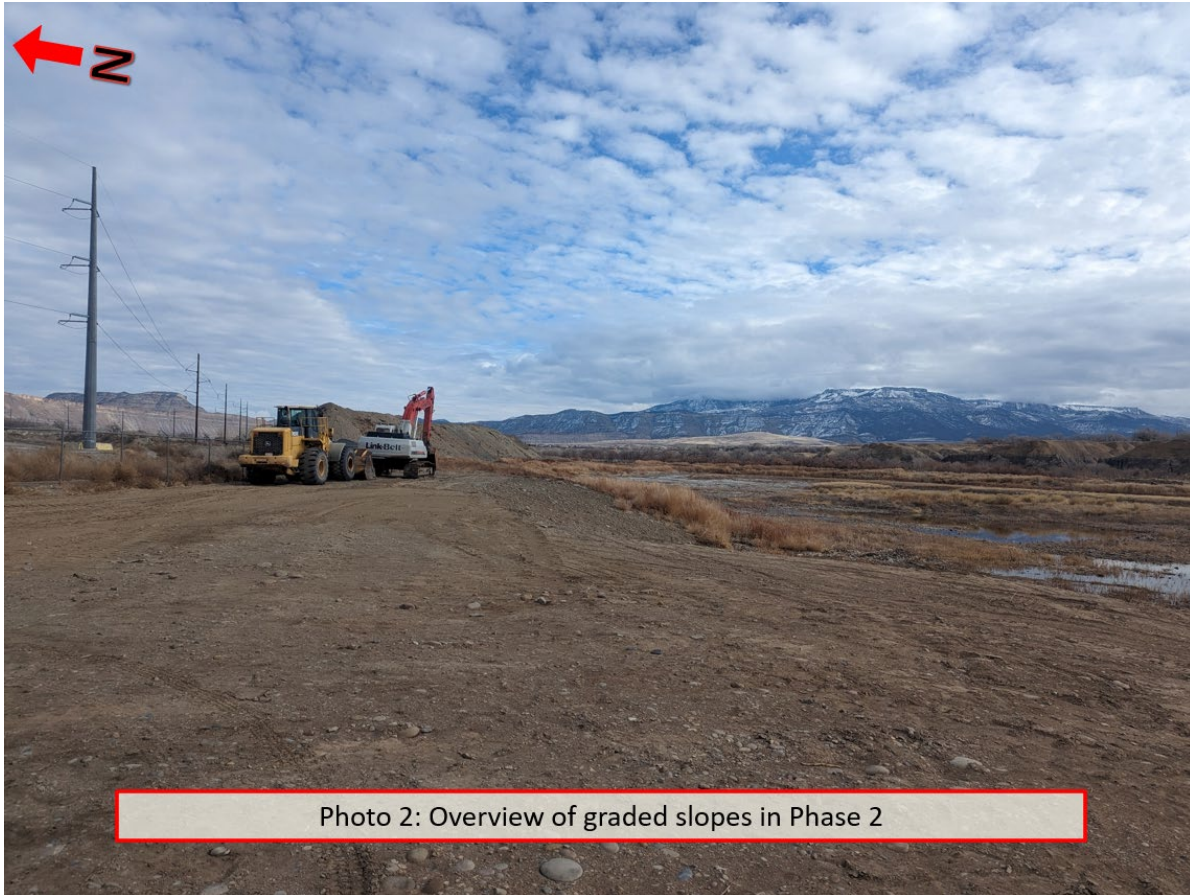
All mining has concluded at this site and only final grading as it relates to achieving reclamation remains. Phase 2 pond slope banks are nearly all at a 3H: 1V or less (Photo Two). A small knob area near the pit entrance remains at a 2H: 1V (Photo Three), this is where the crusher was previously placed. Mr. Azcarraga indicated that the landowner requested the knob area. The slope should be dug out to reduce the slope prior to seeding.

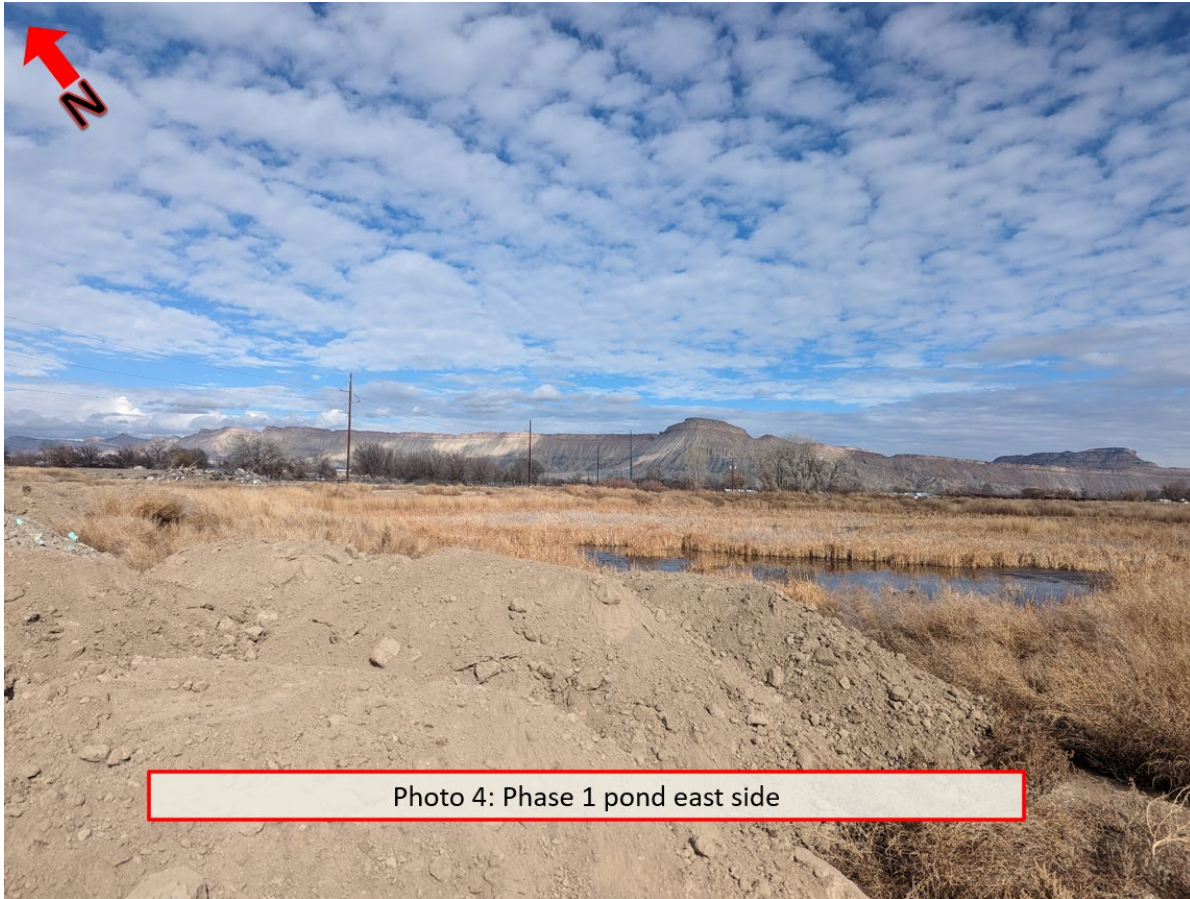
Phase 1 is also completely mined out. According to Mr. Azcarraga the east side of the pond was previously mined (Photo Four). The west side of the pond has been completely mined out and backfilled (Photo Five). Currently Clifton Sanitation (landowner) is importing inert clean out material and stockpiling it on site. The Operator is approved for import of inert fill. It was mentioned that they may want to backfill the entire east portion of the lake to aid in future land use. At a minimum these stockpiles will need to be graded out flat prior to revegetation. No highwalls or other grading besides the dump truck piles remain.

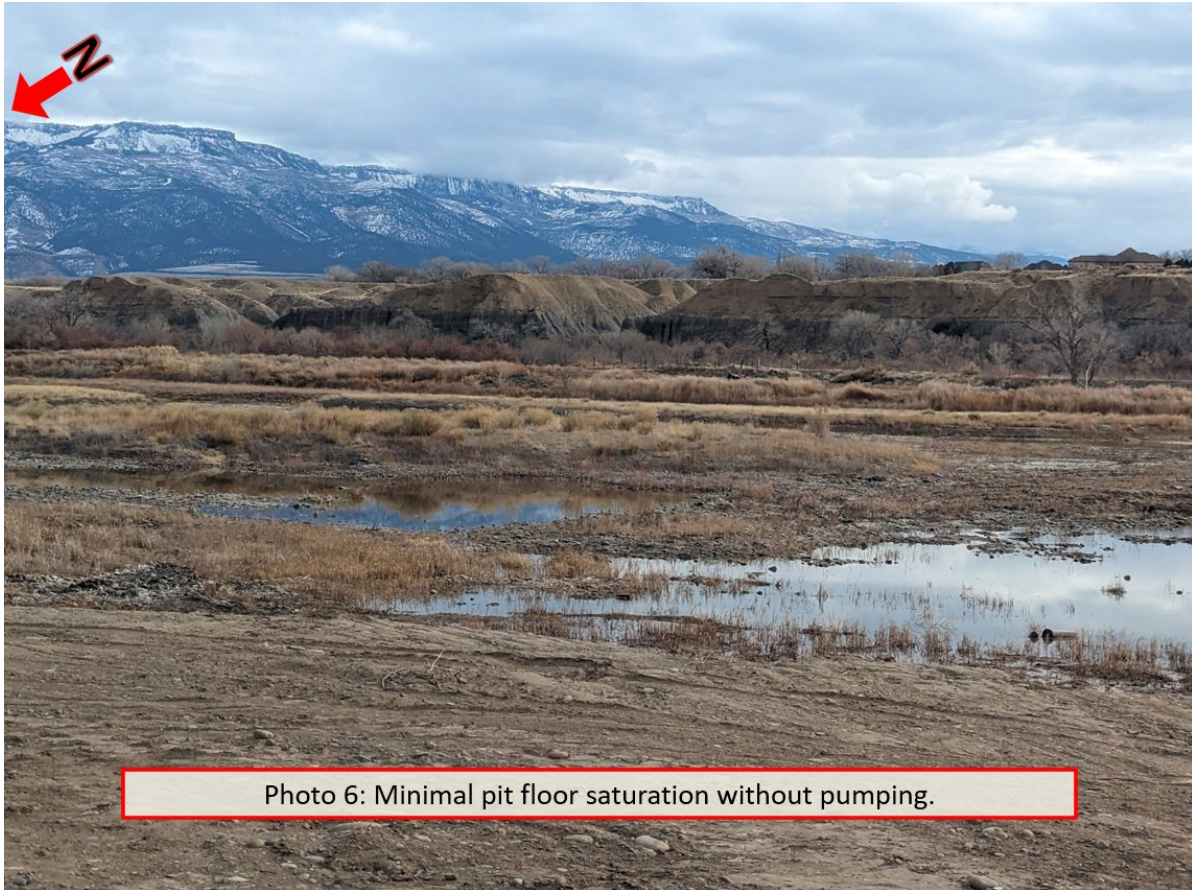
The water level in phase 2 remains low due to pumping of the adjacent mine site (Otter Creek M-2012-050) directly to the north. The pit floor is generally saturated if not completely inundated however the entire length

of the pit slopes are above the water table (Photo Six). Phase 1 east side pond is inundated, The west side has been backfilled to the original contour.

Photo 6: Minimal pit floor saturation without pumping.

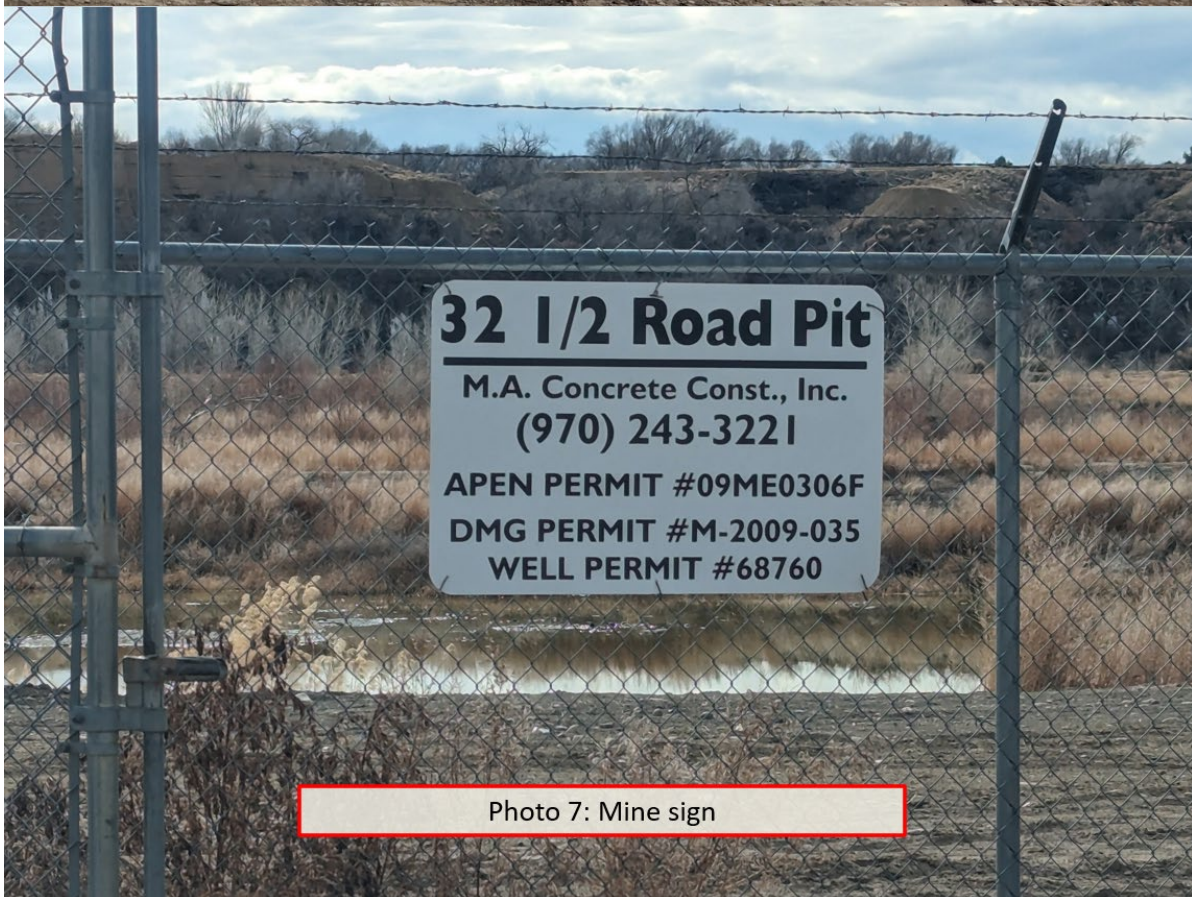
A mine sign was posted at the entrance to the mine site as required by Rule 3.1.12(1). The sign was of sufficient size (Photo Seven). The permit boundary of the affected land was clearly delineated primarily by a wire fence pursuant to Rule 3.1.12(2).

Photo 7: Mine sign
