MINERALS PROGRAM INSPECTION REPORT

MINE NAME: Hale Pit aka Earl's Pit	MINE/PROSPECTING ID#: M-1981-121	MINERAL: Sand and gravel	COUNTY: El Paso
INSPECTION TYPE: Monitoring	WEATHER: Clear	INSP. DATE: May 22, 2023	INSP. TIME: 08:45
OPERATOR: Atticus Land, LLC	OPERATOR REPRESENTATIVE: Jake Decoto	TYPE OF OPERATION: 110c - Construction Limited Impact	
REASON FOR INSPECTION: Normal I&E Program	BOND CALCULATION TYPE:	BOND AMOUNT: \$4,301.00	
DATE OF COMPLAINT: NA	POST INSP. CONTACTS: None	JOINT INSP. AGENCY: None	
INSPECTOR(S): Timothy Cazier, P.E.	INSPECTOR'S SIGNATURE:

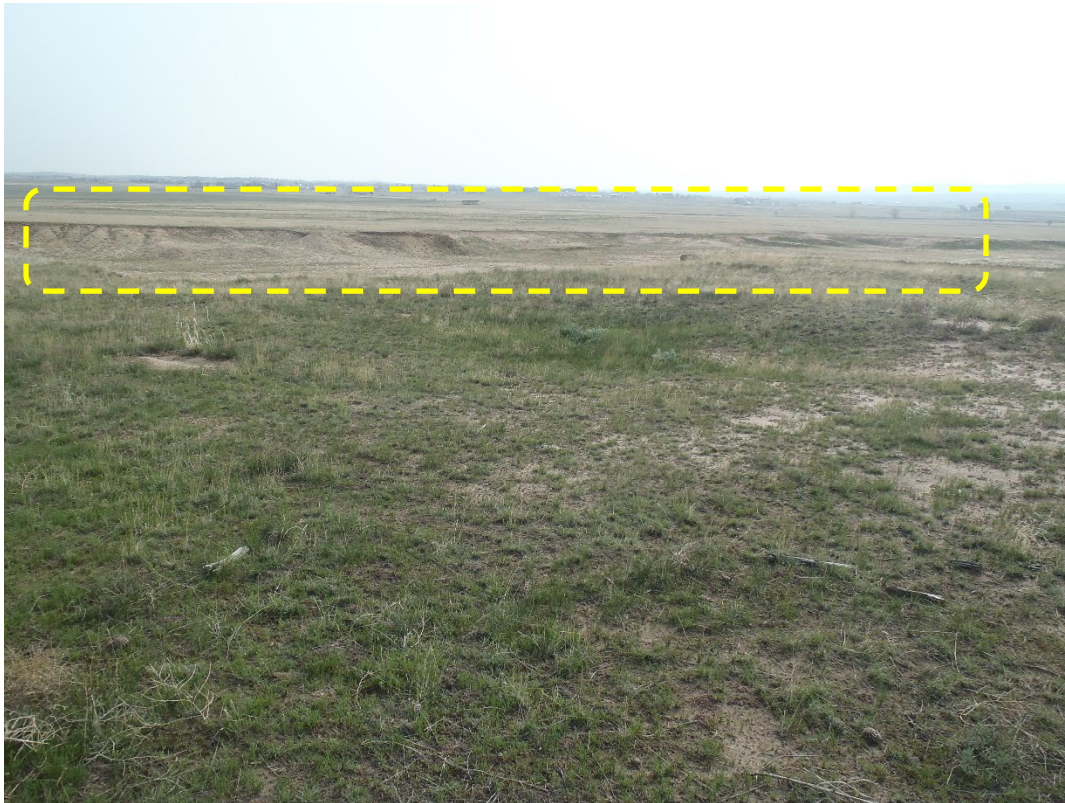
Backfilling and Grading: All required backfilling and grading appeared to be completed (see **Photo 1**).

Photo 1. Regraded highwalls (looking NE from SW corner).

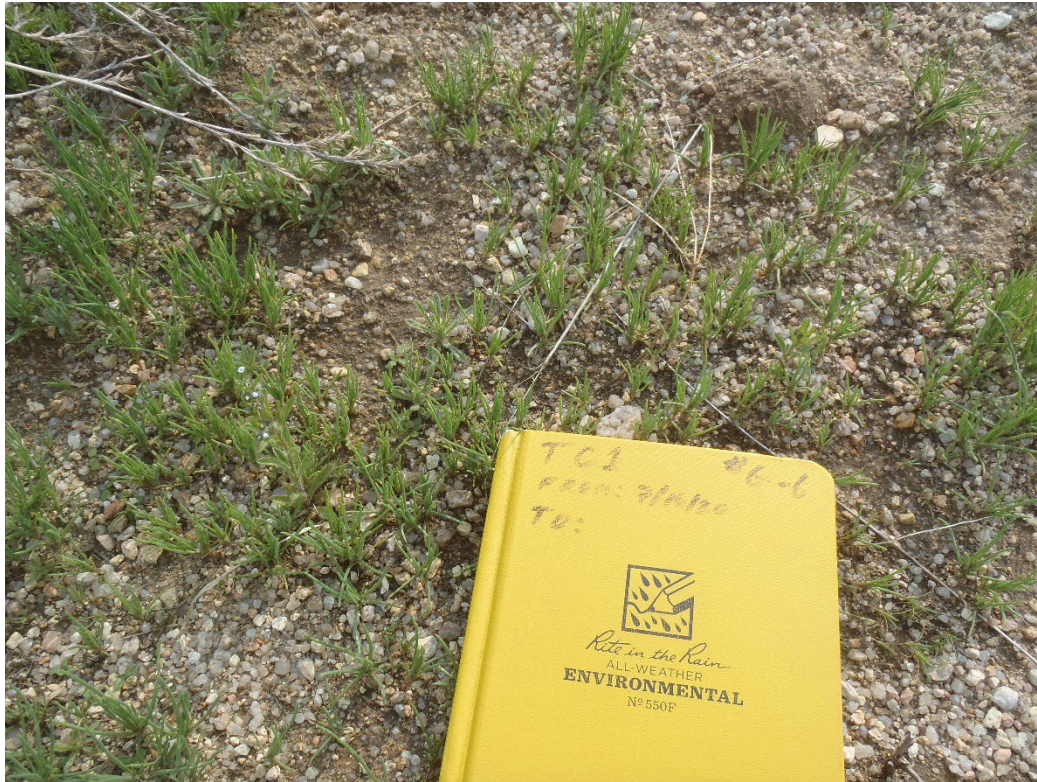
Revegetation: Vegetation was observed to be emerging (see **Photo 2**). The DRMS typically prefers to see at least two growing seasons before determining if revegetation is adequately established for a permit release. A small amount of Cheatgrass (a.k.a. Downy Brome) was observed. This is a noxious weed List C species, so it was not cited as a problem. However, the Operator should implement a weed control program to reduce the spread of cheatgrass on site.

Photo 2. Typical emerging vegetation.

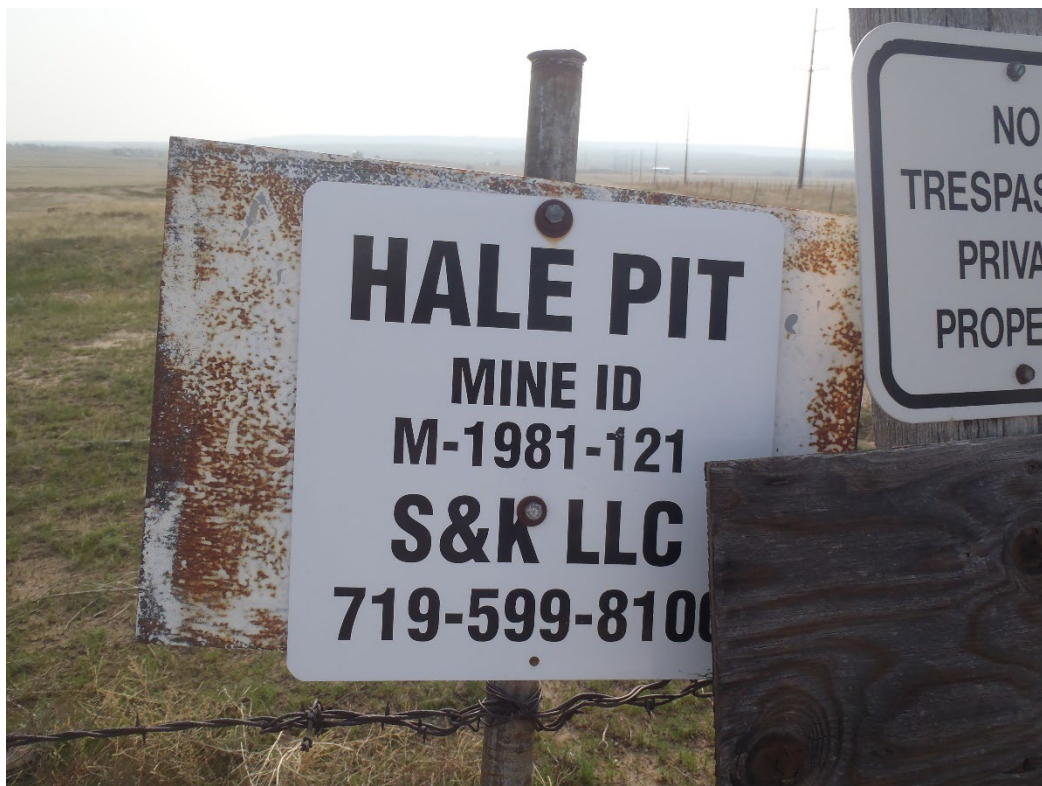
Signs and Markers: The permit sign was properly posted (see **Photo 3**).

Photo 3. Permit sign (at entrance).
