**MINERALS PROGRAM INSPECTION REPORT**  
**PHONE: (303) 866-3567**

<b>MINE NAME:</b> Mamm Creek Sand & Gravel	<b>MINE/PROSPECTING ID#:</b> M-2000-113	<b>MINERAL:</b> Sand and gravel	<b>COUNTY:</b> Garfield
<b>INSPECTION TYPE:</b> Monitoring	<b>WEATHER:</b> Clear	<b>INSP. DATE:</b> November 9, 2023	<b>INSP. TIME:</b> 09:55
<b>OPERATOR:</b> Oldcastle SW Group, Inc. dba United Compas County	<b>OPERATOR REPRESENTATIVE:</b> Jason Burkey, Tyra Bartuska	<b>TYPE OF OPERATION:</b> 112c - Construction Regular Operation	
<b>REASON FOR INSPECTION:</b> Normal I&E Program	<b>BOND CALCULATION TYPE:</b> Complete	<b>BOND AMOUNT:</b> \$188,616.00	
<b>DATE OF COMPLAINT:</b> NA	<b>POST INSP. CONTACTS:</b> None	<b>JOINT INSP. AGENCY:</b> None	
<b>INSPECTOR(S):</b> Clayton Wein	<b>INSPECTOR'S SIGNATURE:</b>

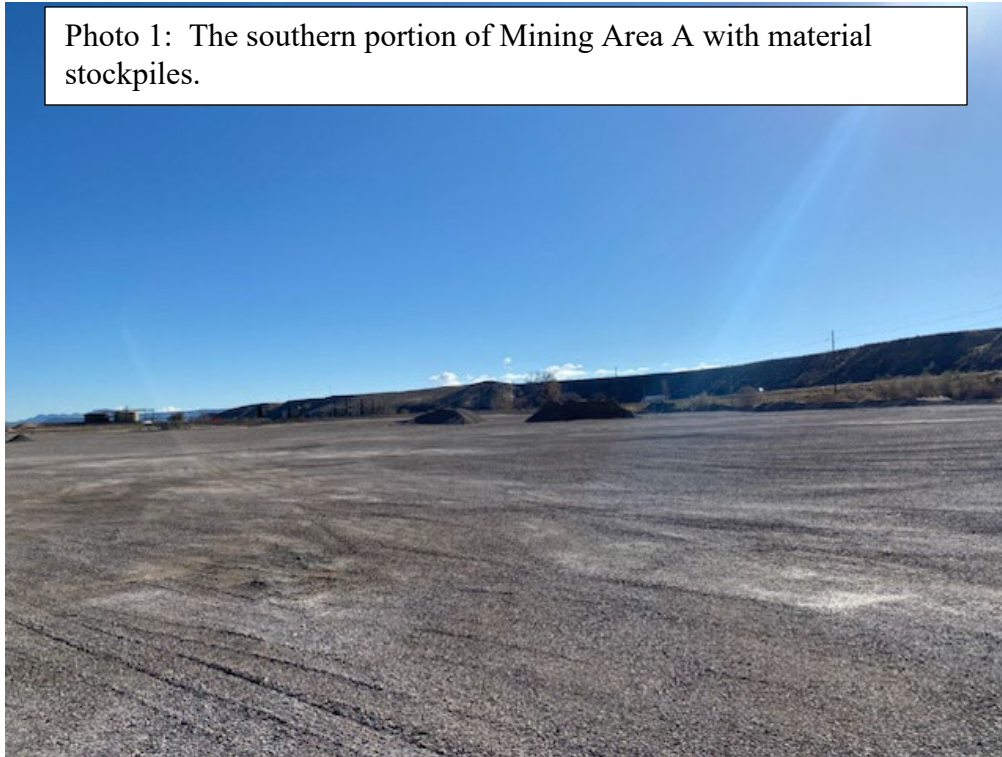
Mining activity has not recently occurred at the site. Instead the operator has mostly been using it to stockpile materials, storage and sales in mining area A (Photos 1 and 2). No activity was occurring during the inspection. Small piles of material were observed stockpiled on the pad. The pad was stable with no erosional concerns. All fuels stored on-site were located within secondary containment. No spills were observed.

Photo 1: The southern portion of Mining Area A with material stockpiles.

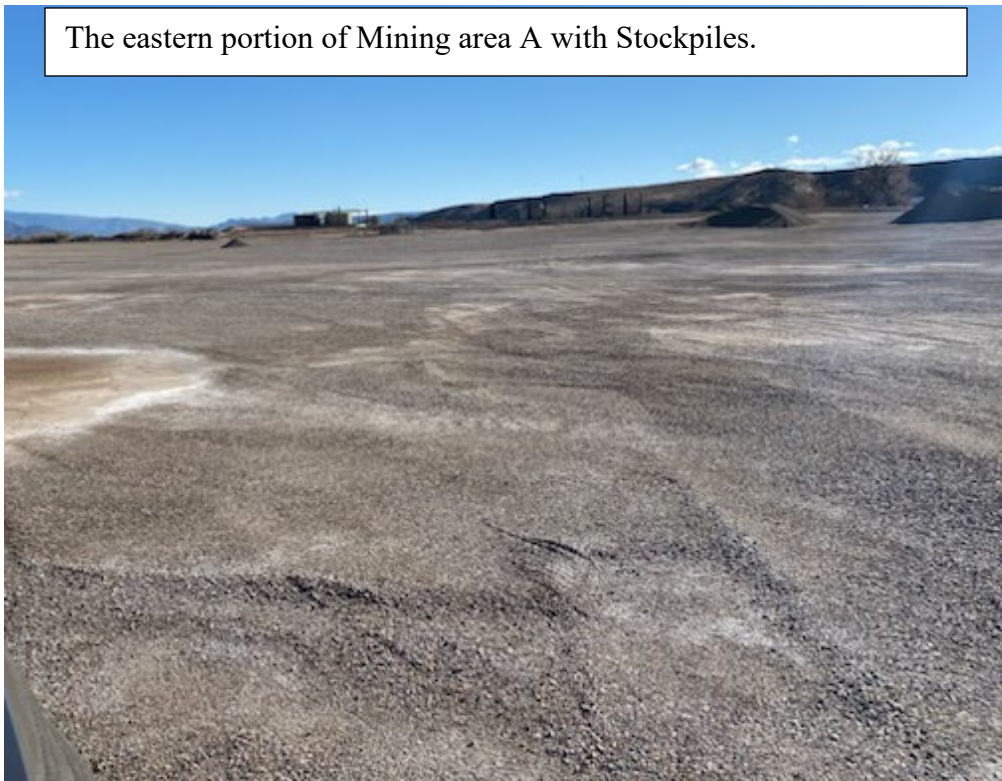
The eastern portion of Mining area A with Stockpiles.

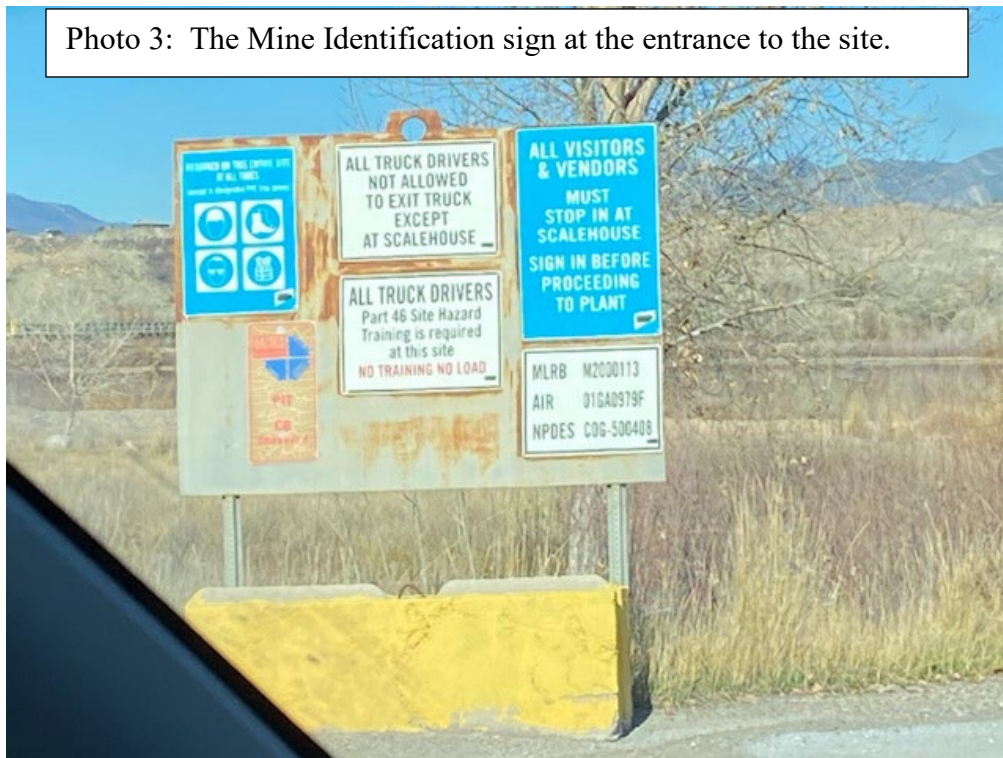
The mine identification sign was posted at the entrance to the site as required by Rule 3.1.12 (Photo 3). The mine affected boundary was marked by posts.

Photo 3: The Mine Identification sign at the entrance to the site.
