To: Jerald Schnabel  
Castle Aggregate

File: December 2023 Monitoring Summary      Date: January 31, 2024

**Reference:      December 2023 Geotechnical Monitoring Summary Pikeview Quarry**

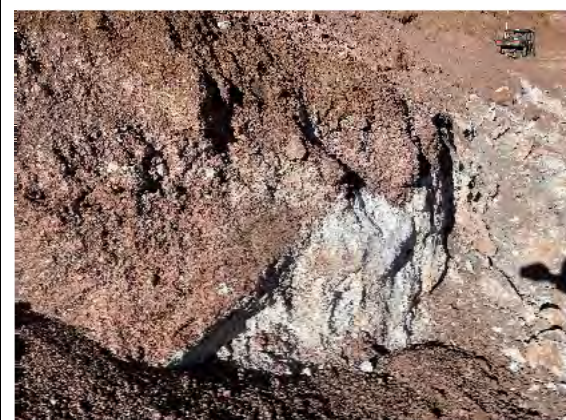
3. Highwalls being planned for blasting.

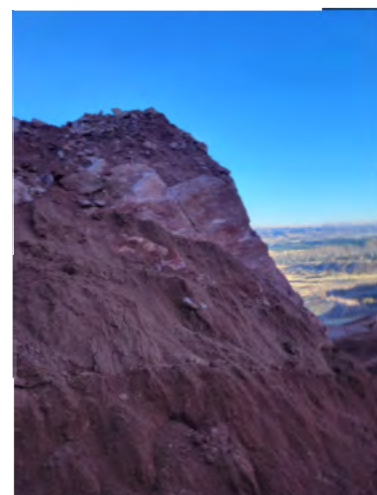
- The fault between the granite and sedimentary rocks has been partially exposed. It is generally located farther east than originally thought; and the larger amount of granitic material reduces the driving force on the reclamation buttress and remaining sedimentary material. Castle Aggregate and Stantec are evaluating the fault location and the excavation quantities required in the upper, west portions of the quarry. Also, competent granitic rock has been encountered in multiple areas of the Upper Borrow Area, and these areas may require blasting, or they may be left as natural outcrops. If any design changes are required, Castle Aggregate will submit a Technical Revision.

6. Mapping the fault location.

- Evaluate the fault and competent rock locations and identify design revisions (if applicable). This evaluation will be used to determine if a Technical Revision is required.
- Replace batteries to reduce or eliminate system outages.
- Continue placing compacted fill in the buttress area.
- Continue processing riprap.
- Continue placing topsoil where grading has been completed.
- Continue geotechnical monitoring.
- Continue to remove and replace prisms on an as-needed basis.

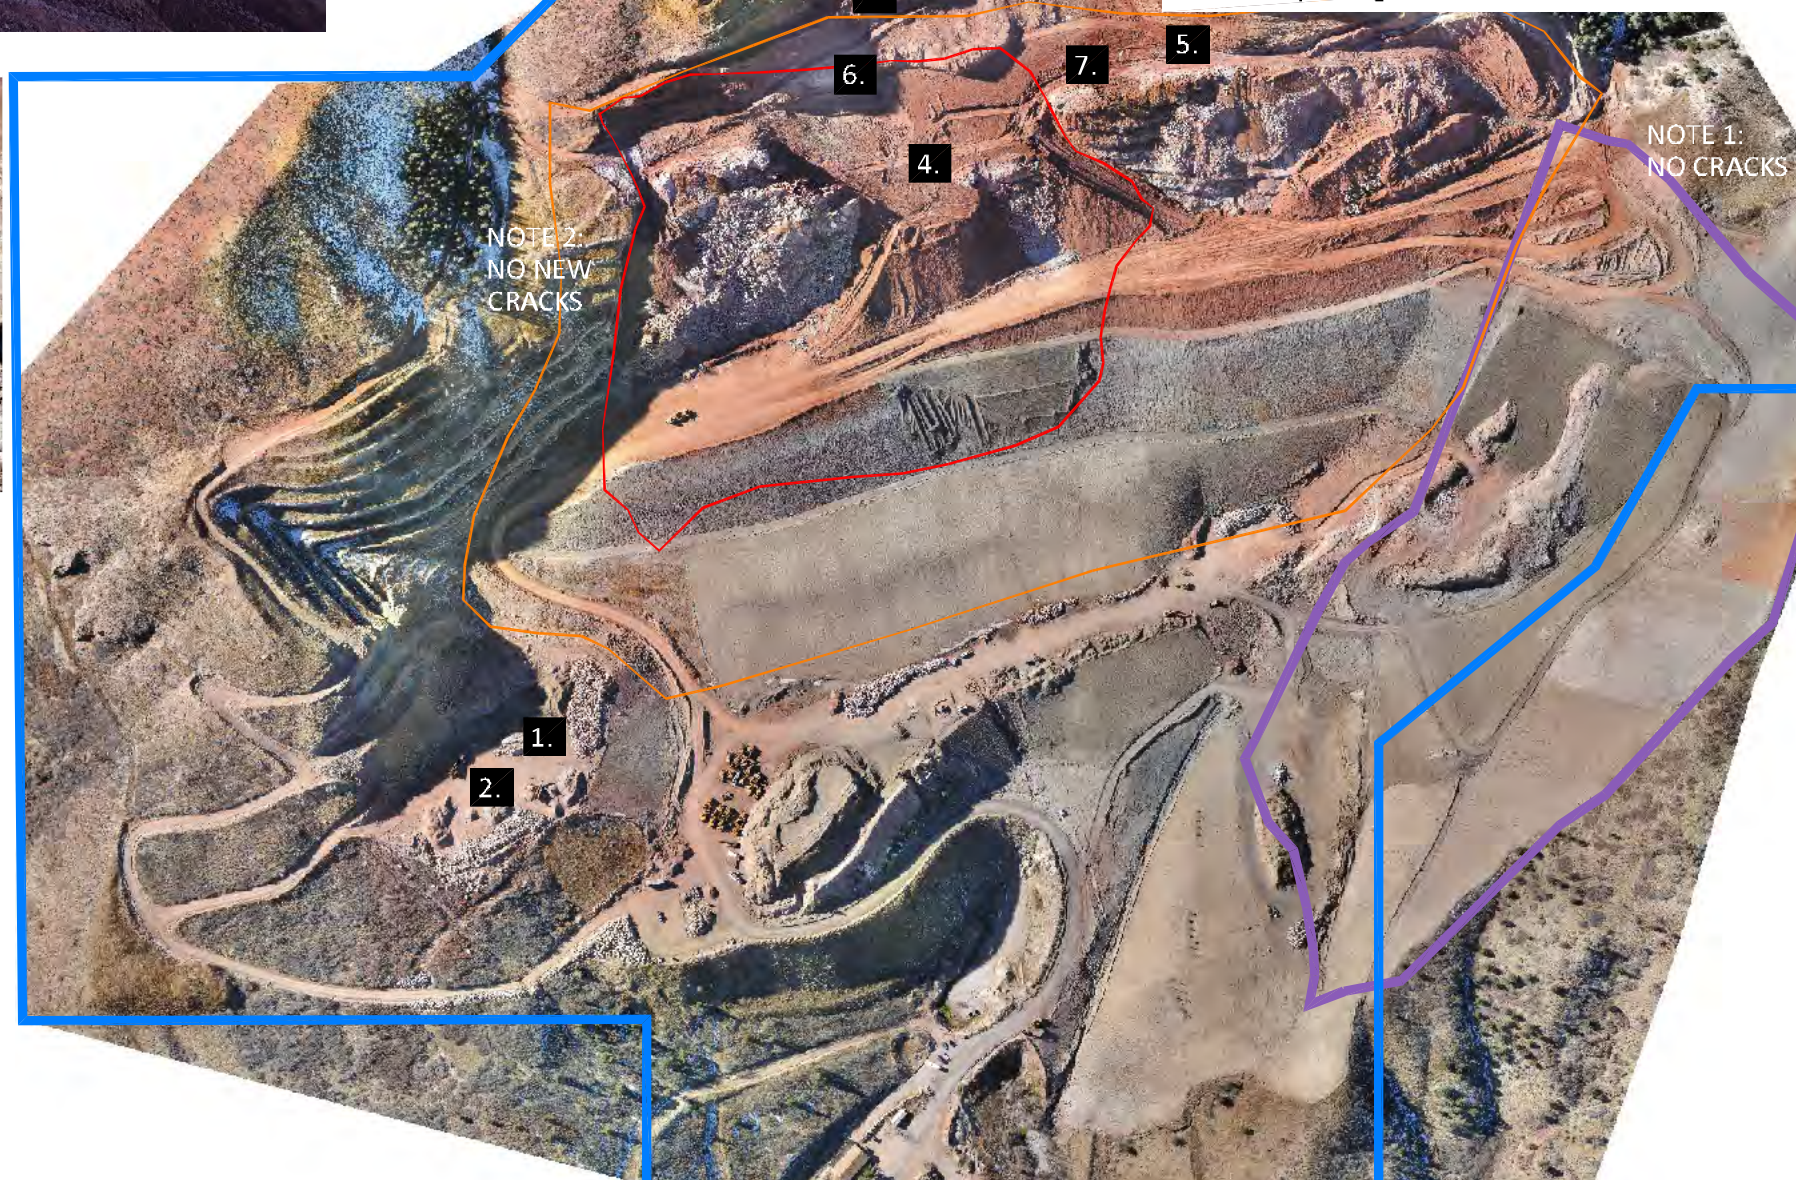
7. Typical Upper Borrow Area material.  
Mixture of soil and rock.

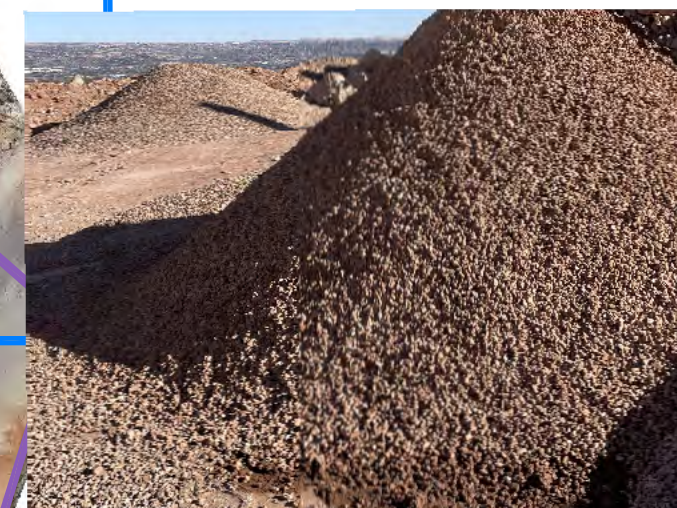
2. Screened gravel stockpile.

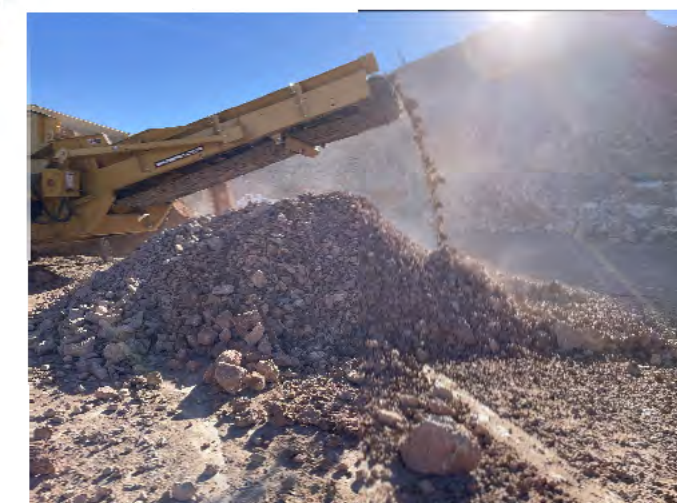
1. Screening riprap.

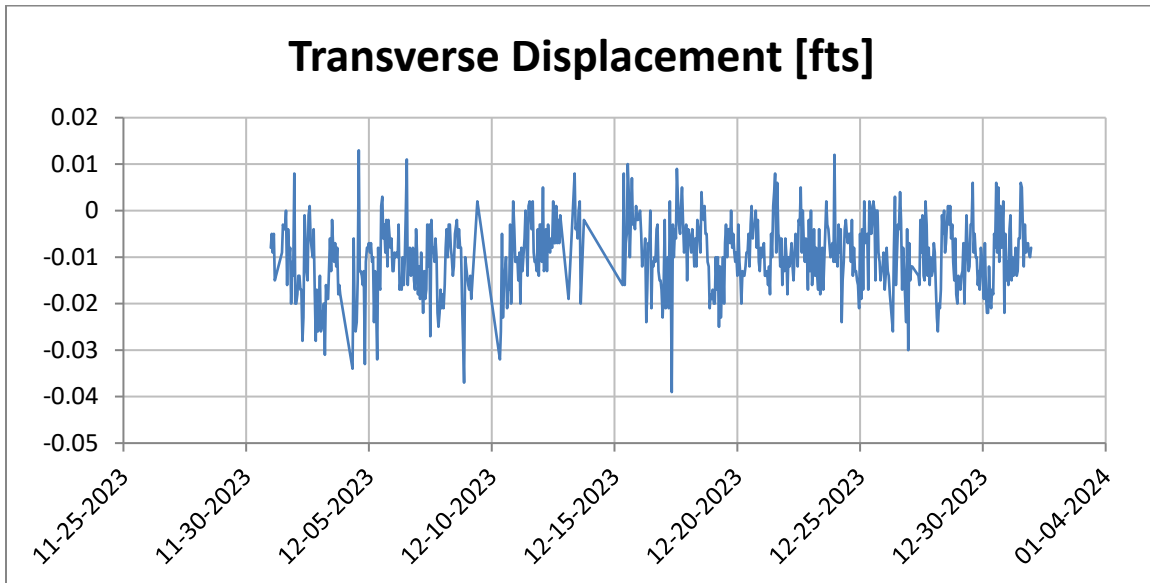
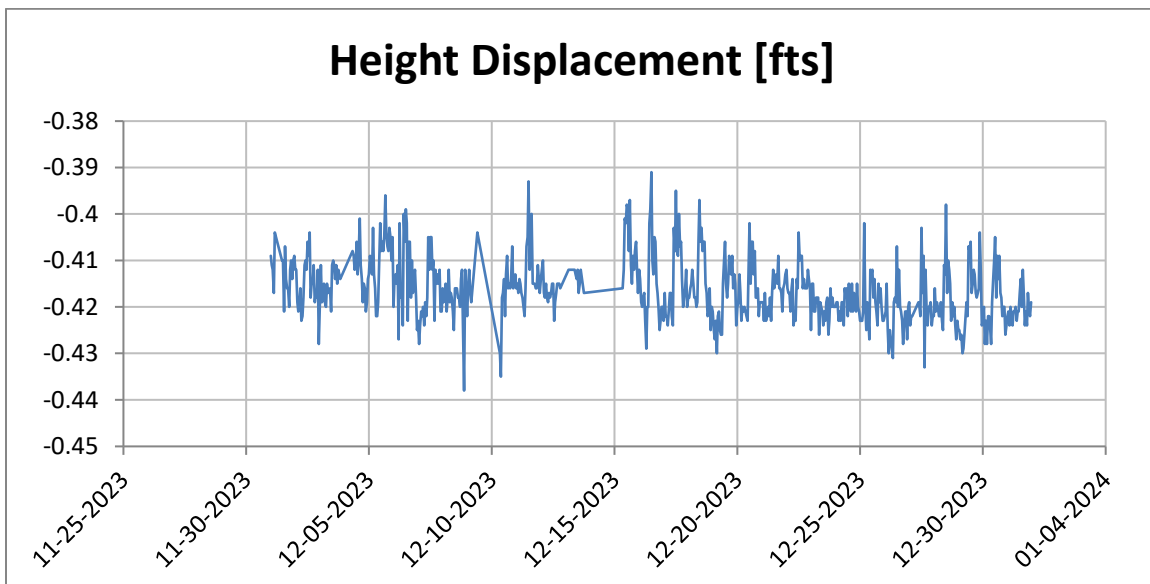
## Prism BR1

| Prism ID | Cumulative Transverse Displacement (ft) | Cumulative Height Displacement (ft) | Monthly Delta (ft) | Cumulative Delta (ft) | Notes / Recommendations |
|---|---|---|---|---|---|
| BR1 | -0.008 | -0.419 | 0.0121 | 0.7827 | Slope creep movements |

The data show stable conditions with no movements at 17 of 19 prisms with recorded displacements limited to data scatter and not actual movements. Prisms BR1 and BR3 are located above the landslide, and these prisms recorded slope creep movements at slow velocity. This settlement was likely related to loose fill or landslide material consolidating under its own weight. These prisms were placed in areas where slope creep movements are likely to occur; therefore, movements being recorded is expected. Plots of the transverse and height displacements for each prism are included in Appendix B.

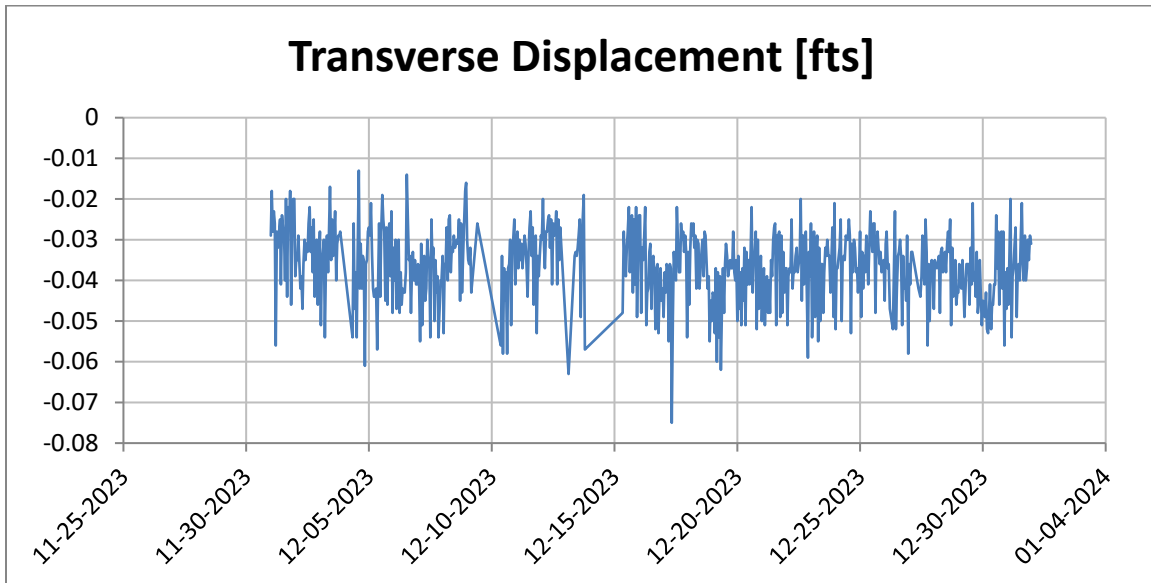
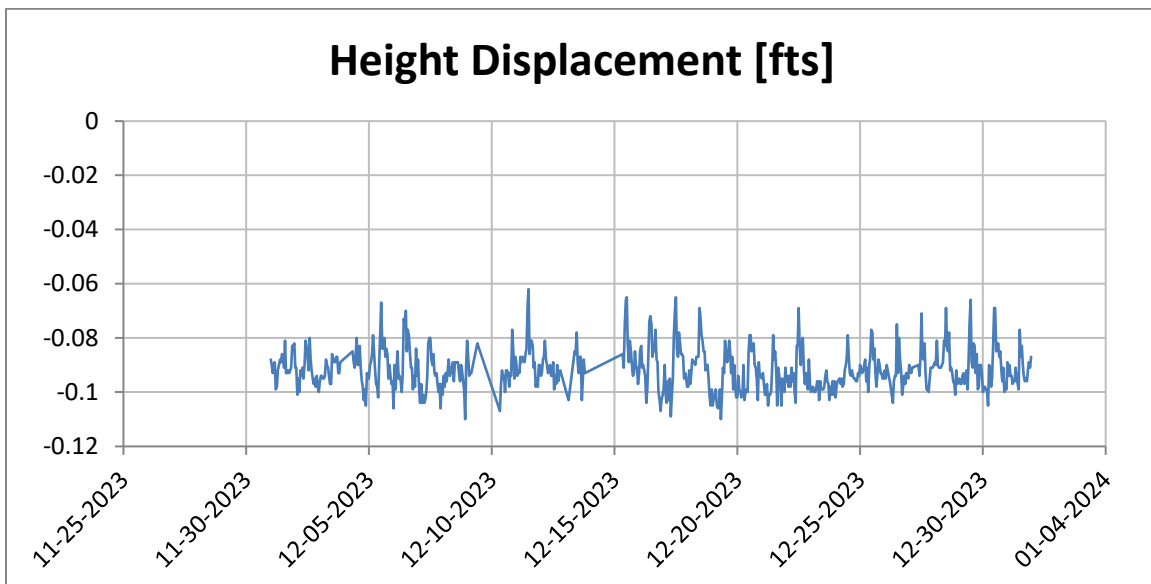
## Prism BR3

| Prism ID | Cumulative Transverse Displacement (ft) | Cumulative Height Displacement (ft) | Monthly Delta (ft) | Cumulative Delta (ft) | Notes / Recommendations |
|---|---|---|---|---|---|
| BR3 | -0.031 | -0.087 | 0.0004 | 0.0933 | Slope creep movements |

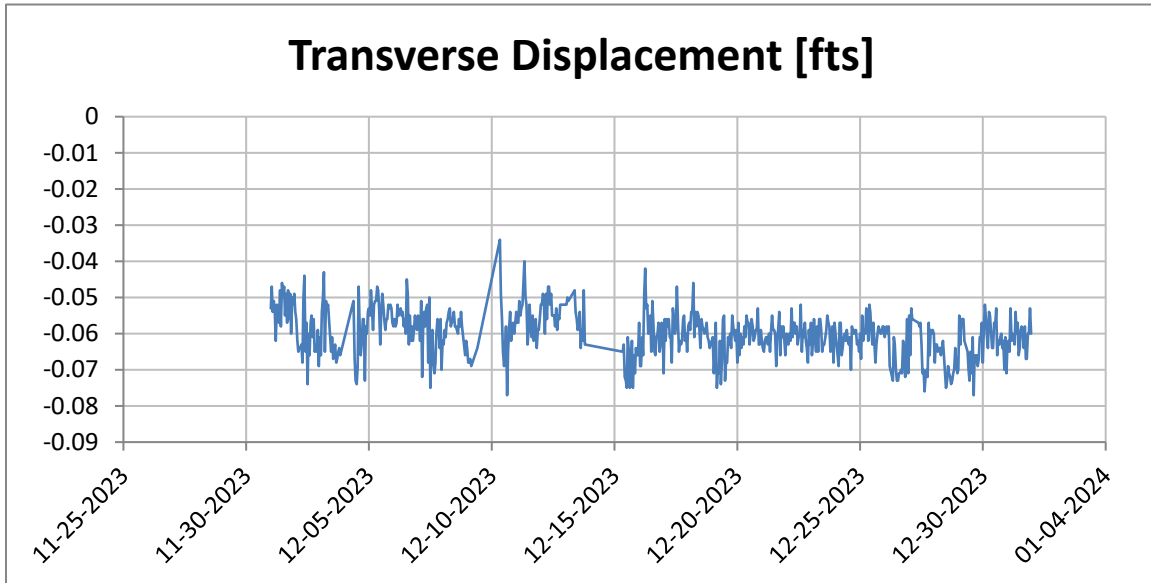
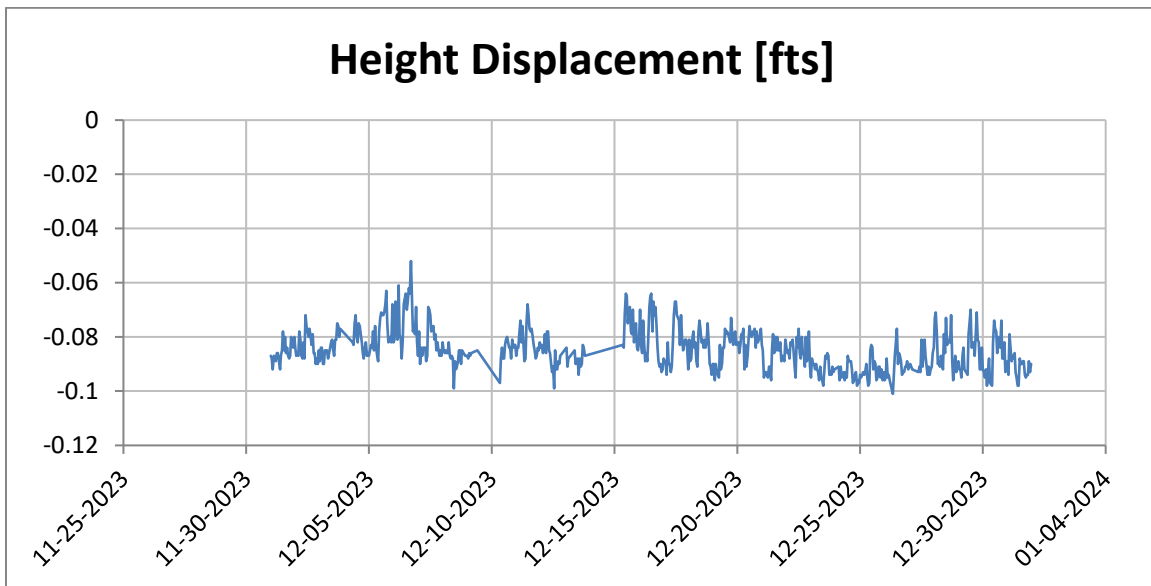
## Prism B7300-0

| Date(s) | Alert | Cause/Actions taken | Resolved |
|---|---|---|---|
| 28-Dec | B7300-0 not found | Frost on prism. No work being performed at time of alert. | 28-Dec |

| Prism ID | Cumulative Transverse Displacement (ft) | Cumulative Height Displacement (ft) | Monthly Delta (ft) | Cumulative Delta (ft) | Notes / Recommendations |
|---|---|---|---|---|---|
| B7300-0 | -0.060 | -0.090 | 0.0070 | 0.1112 | |
