## C-1981-035 King Jan 2024 Partial Inspection Report

**C-1981-035 Jan 2024 Partial Inspection Report.pdf**

<b>Permit Number:</b> C-1981-035 <b>Mine Name:</b> King Coal Mine <b>Operator:</b> GCC Energy, LLC <b>Operator Address:</b> Mr Jordan McCourt 6473 County Road 120 Hesperus, CO 81326	<b>County:</b> La Plata <b>Operation Type:</b> Underground <b>Permit Status:</b> Active <b>Ownership:</b> Private
	<b>Operator Representative Present:</b>  Michael Dickson
<b>Operator Representative Signature: (Field Issuance Only)</b>

<b>Inspection Start Date:</b> January 23, 2024 <b>Inspection Start Time:</b> 14:24 <b>Inspection End Date:</b> January 23, 2024 <b>Inspection End Time:</b> 15:50	<b>Inspection Type:</b> Coal Partial Inspection <b>Inspection Reason:</b> Normal I&E Program <b>Weather:</b> Clear
<b>Joint Inspection Agency:</b>  None	<b>Joint Inspection Contacts:</b>
<b>Post Inspection Agency:</b>  None	<b>Post Inspection Contacts:</b>
<b>Inspector(s):</b>  Lucas West	<b>Inspector's Signature:</b>

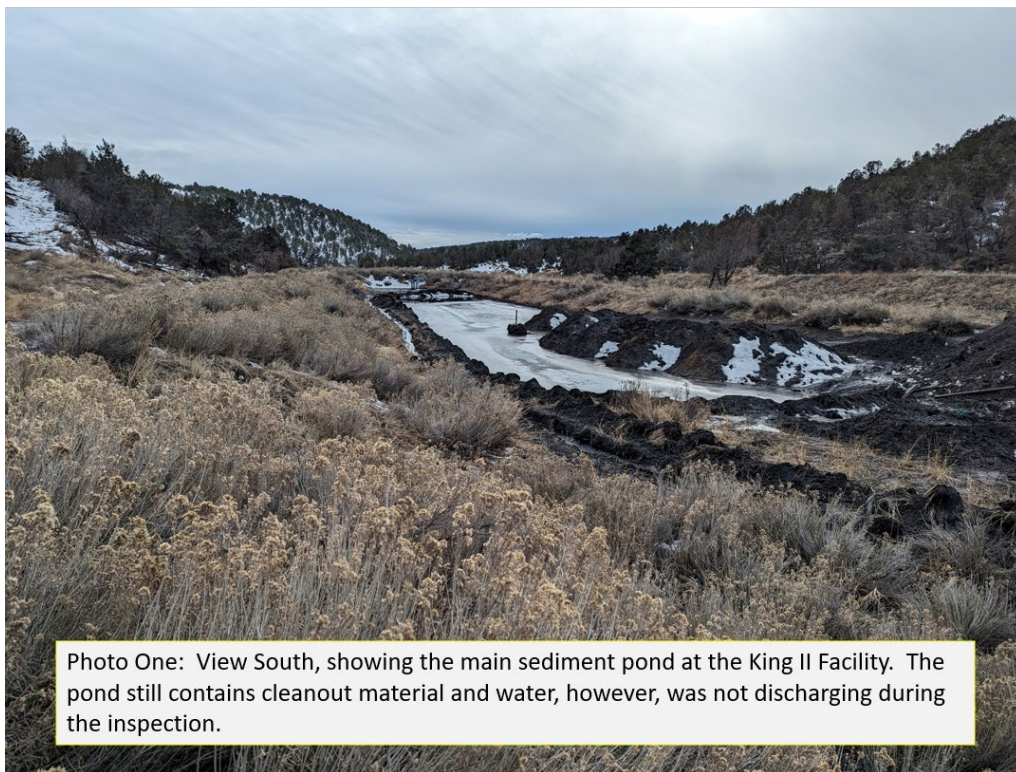
At the King II Facility the main focus of the inspection was the internal drainage structures and the main sediment pond to monitor snowmelt and sediment conveyance. The main sediment pond is in good condition and contains standing water as seen in Photo One. The banks of the pond appear stable and no evidence of discharge, or recent discharge was noted. Photo Two shows the main inlet culvert leading into the pond. The culvert was free from obstruction and flowing freely, delivering active snowmelt to the pond. Various other points in the extensive network of internal drainage structures were observed, all to be unobstructed and free flowing. Examples of the other internal structures can be seen in Photos Three and Four. All structures, and the pond appear to be functioning as designed and handling the snowmelt well.

Photo One: View South, showing the main sediment pond at the King II Facility. The pond still contains cleanout material and water, however, was not discharging during the inspection.

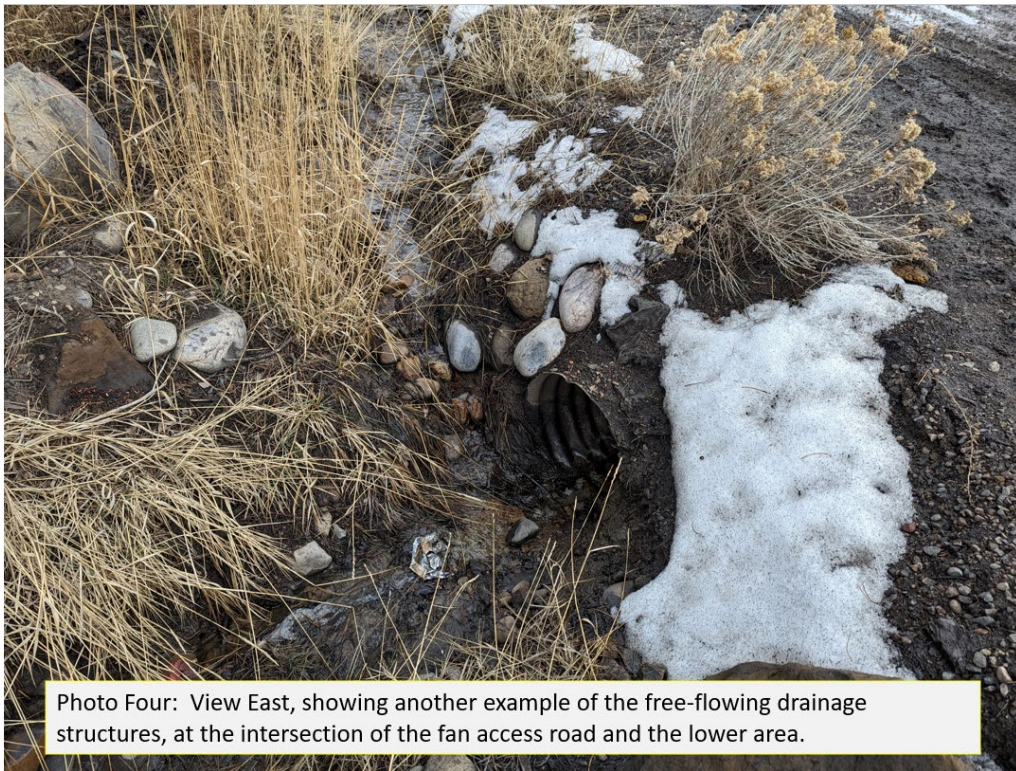
Photo Four: View East, showing another example of the free-flowing drainage structures, at the intersection of the fan access road and the lower area.

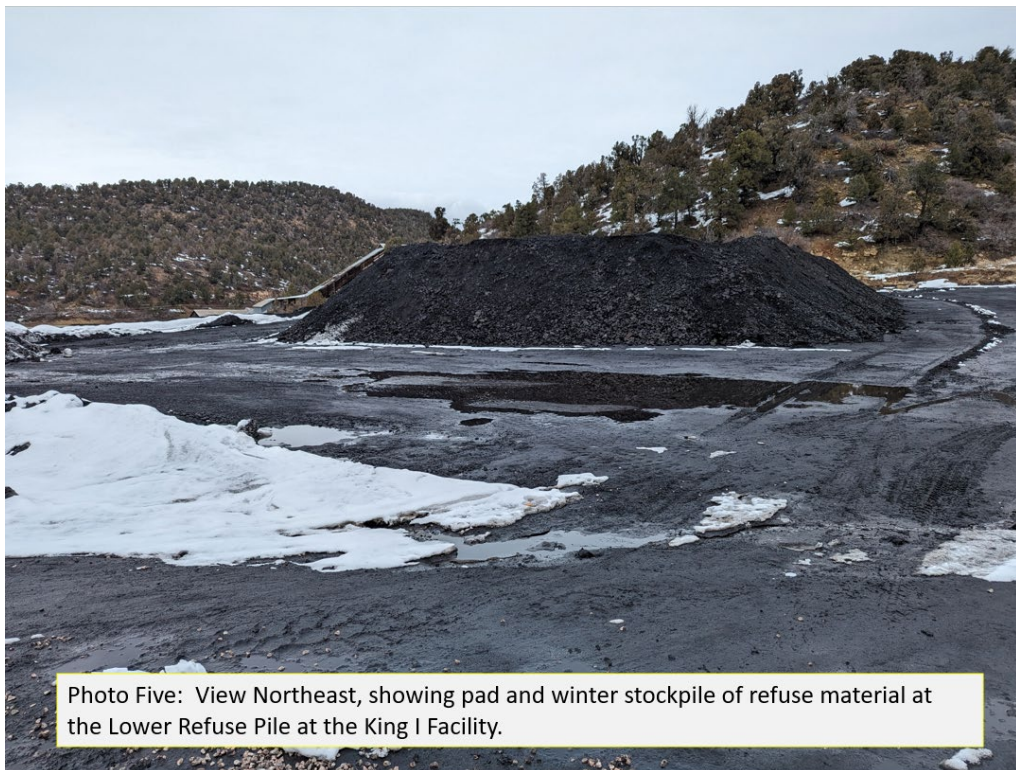
At the King I facility, the main focus was to observe the condition of the recently repaired Lower Refuse Pile, its drainage structures, and the stockpile of waste material that is being stored there for the winter. The pad of the LRP is in good condition and well compacted. The stockpile of waste material is in good condition and

appeared stable at the time of the inspection. The out slopes of the stockpile show no signs of settling or slumping. The pad area, as well as the stockpile can be seen in Photos Five and Six. The repaired area, in the northeastern portion of the pile, was observed to be in excellent condition. The compaction on the pad appears to be holding well, and the out slopes show no signs of settling or slumping. The out slope leading to Reach 13 appears stable and Reach 13 remains clear and unobstructed. This repaired area can be seen in Photos Seven and Eight.

Photo Five: View Northeast, showing pad and winter stockpile of refuse material at the Lower Refuse Pile at the King I Facility.

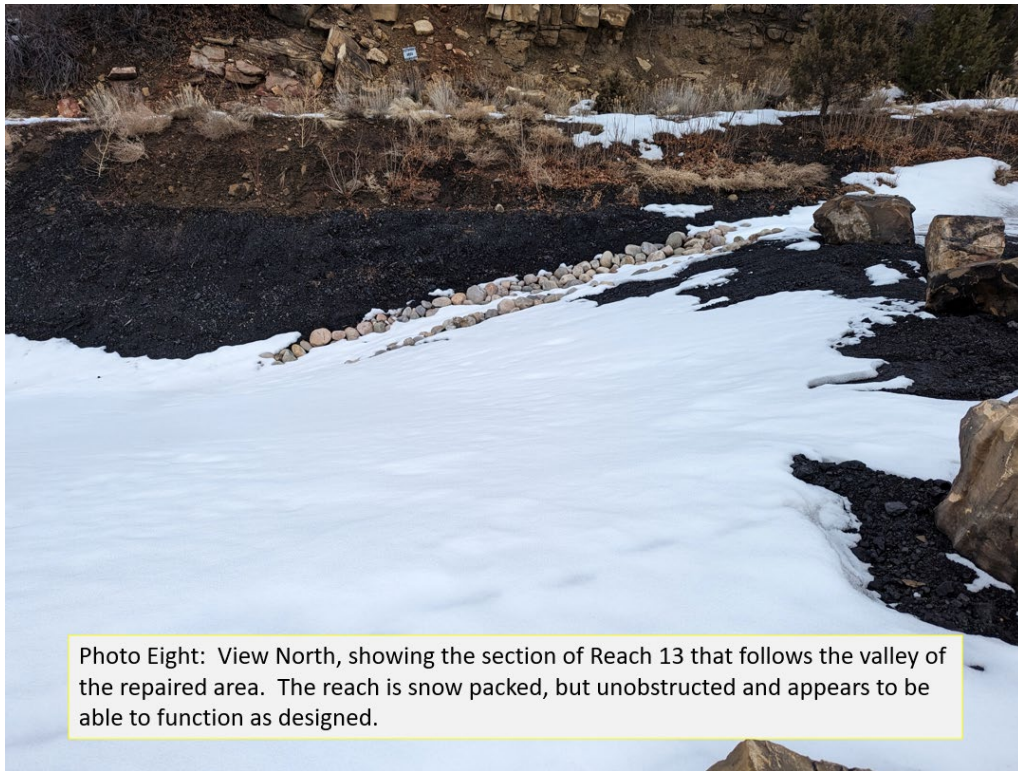
Photo Eight: View North, showing the section of Reach 13 that follows the valley of the repaired area. The reach is snow packed, but unobstructed and appears to be able to function as designed.
