## C1983059, Terror Creek Loadout, January Inspection Report

**PERMIT INFORMATION**

**INSPECTION INFORMATION**

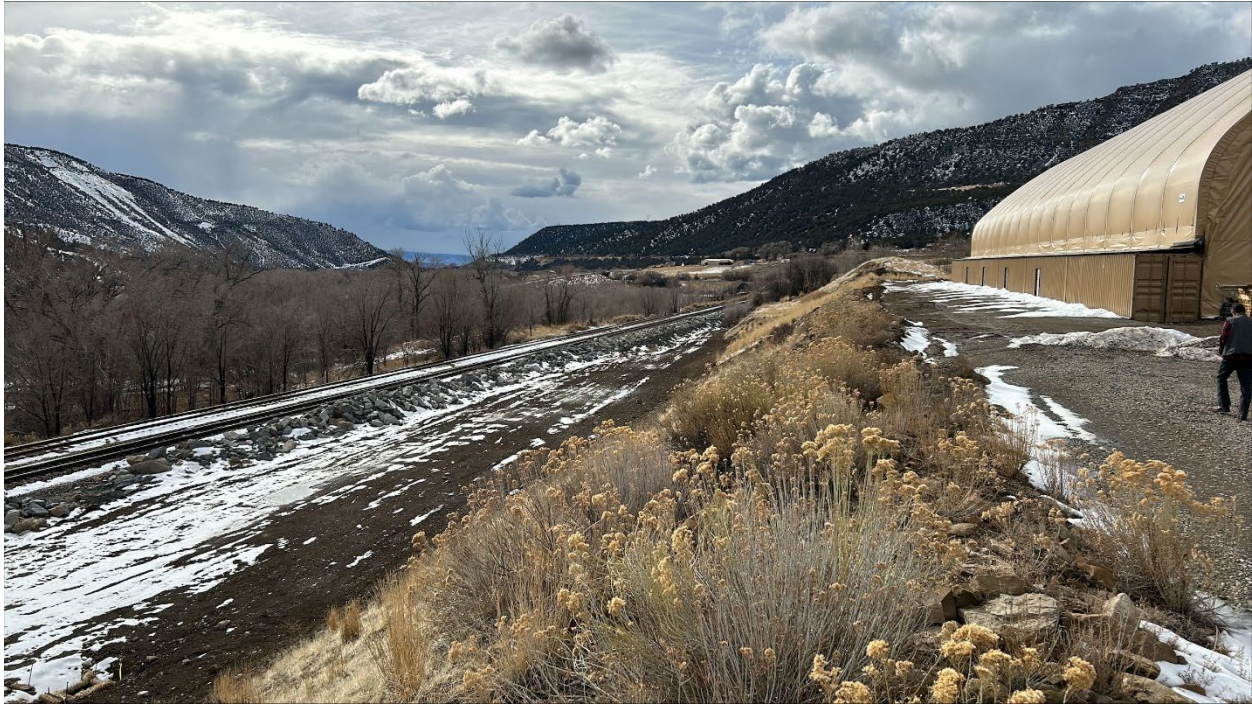
*Figure 1: Southern edge of lower pad and embankment*

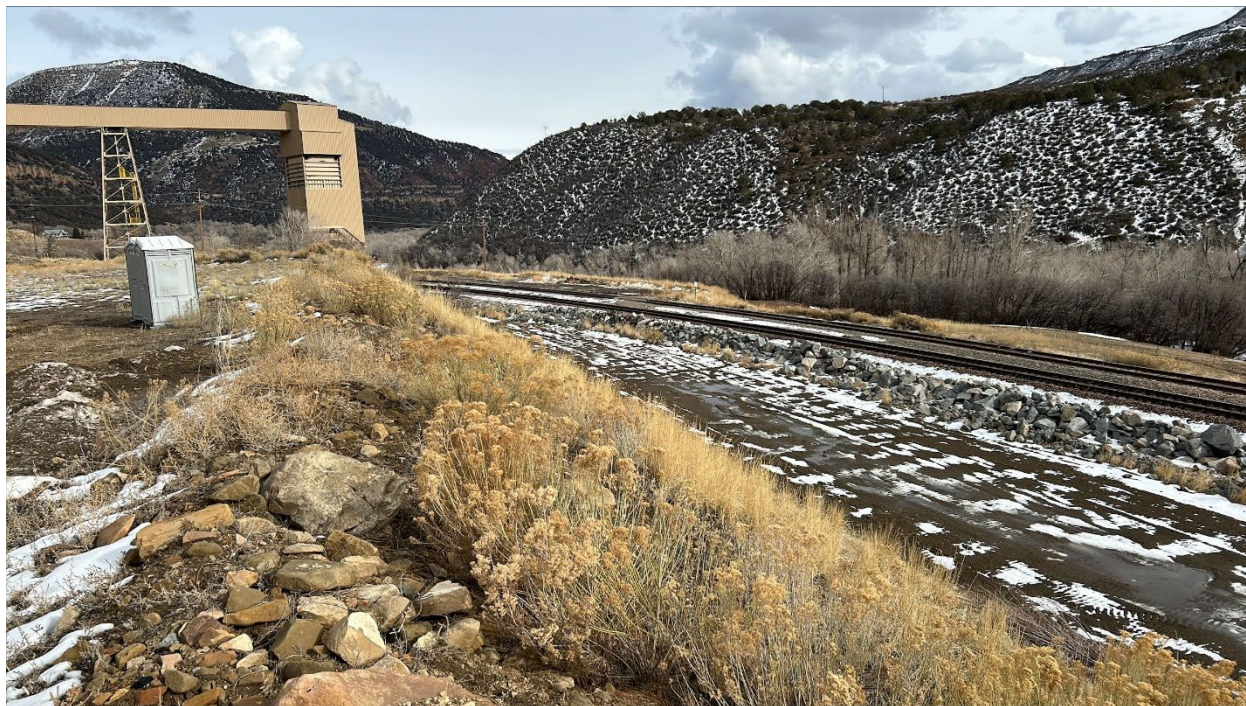
*Figure 2: Portaloo on the lower pad*

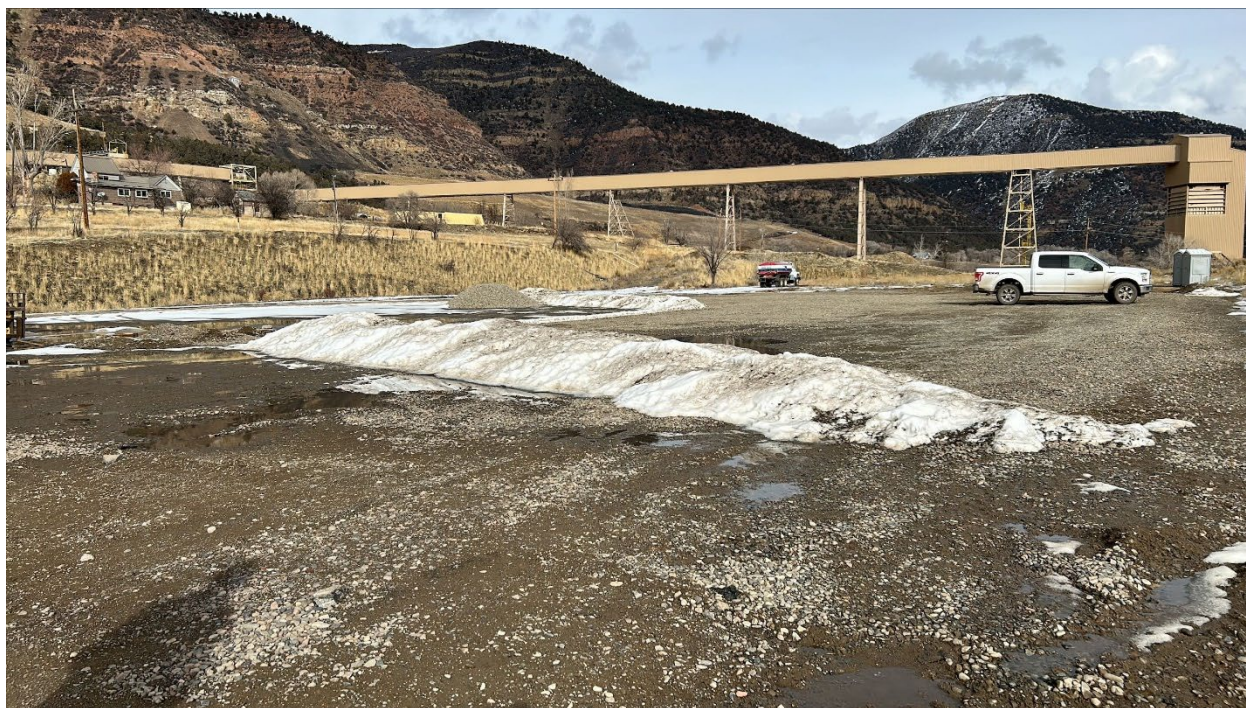
The western end of the lower pad was firm and well drained but the eastern was not draining as well. The pad was muddy and there were puddles of standing water on the pad whilst the sediment pond to the east was dry.

*Figure 3: Graveled area at western end of lower pad draining well*

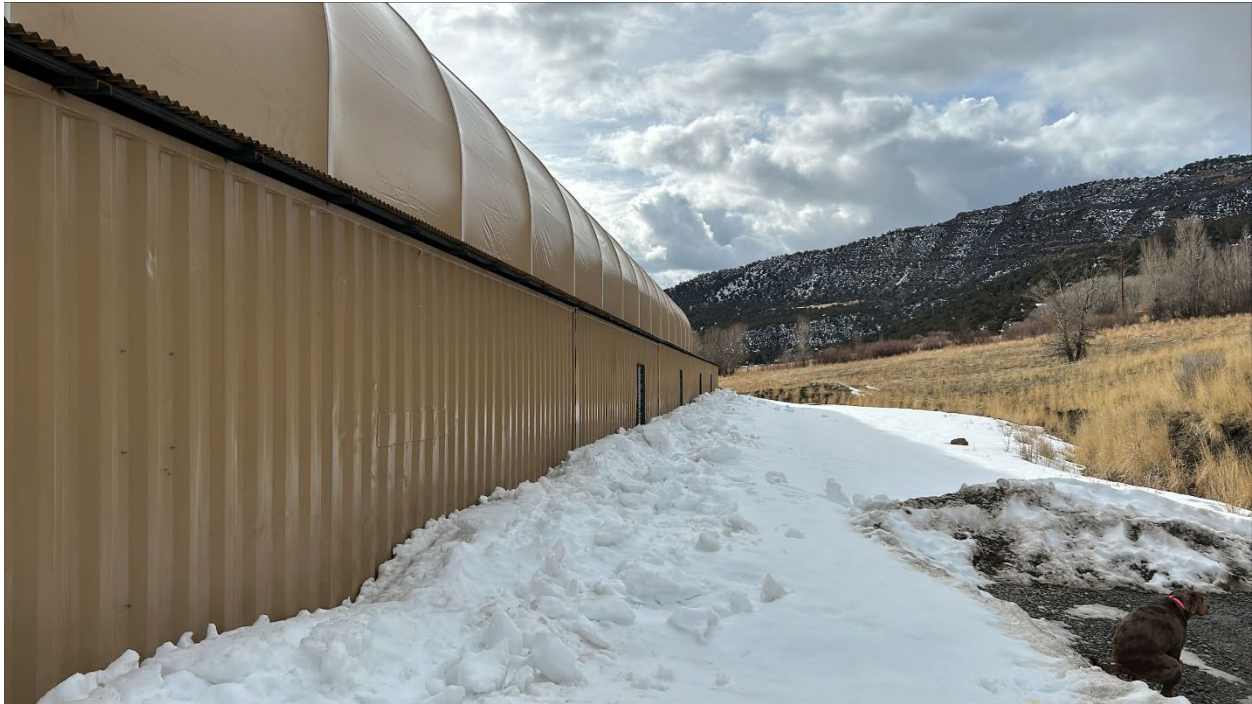
The temporary building on the pad was secure. The roof had successfully shed snow, with no damage to the structure.

*Figure 4: Snow shed from roof on north side of temporary building*

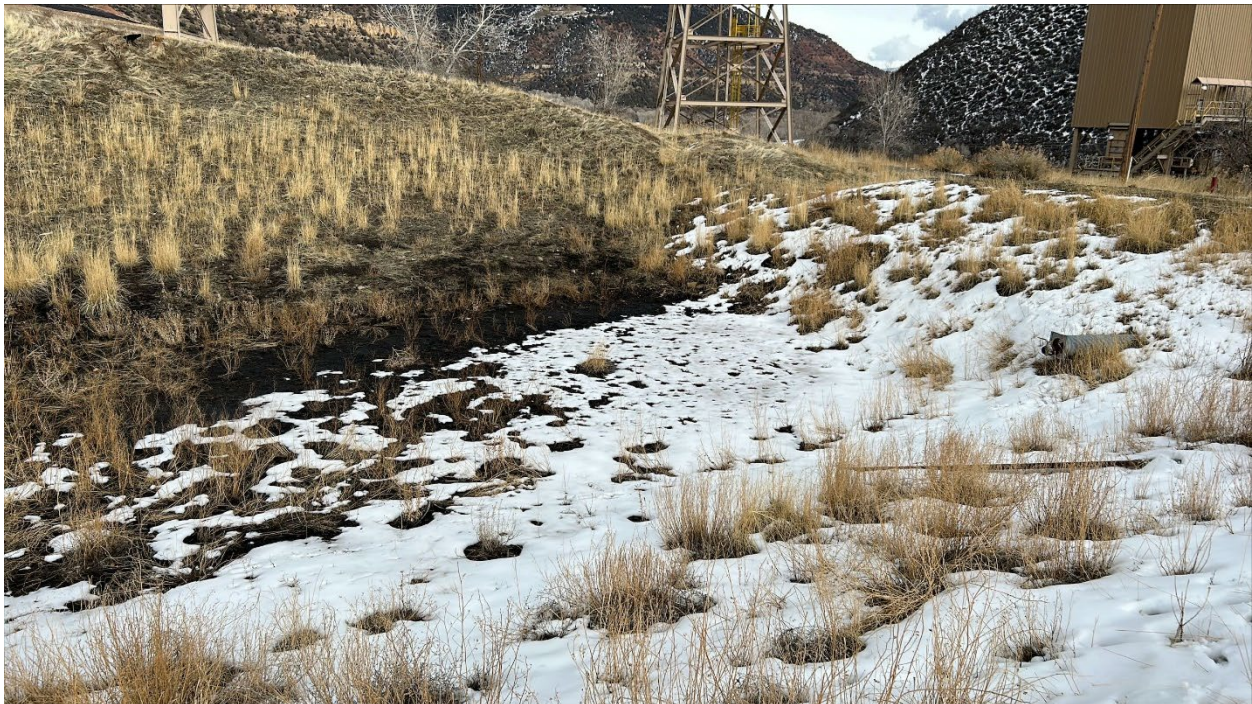
*Figure 5: Sediment pond*
