MINERALS PROGRAM INSPECTION REPORT
PHONE: (303) 866-3567

MINE NAME: Keeling Pit	MINE/PROSPECTING ID#: M-1991-081	MINERAL: Sand and gravel	COUNTY: Huerfano
INSPECTION TYPE: Monitoring	WEATHER: Cloudy	INSP. DATE: January 11, 2024	INSP. TIME: 10:00
OPERATOR: Sam Keeling	OPERATOR REPRESENTATIVE: Sam Keeling	TYPE OF OPERATION: 110c - Construction Limited Impact	
REASON FOR INSPECTION: Normal I&E Program	BOND CALCULATION TYPE: Complete Bond	BOND AMOUNT: \$14,737.42	
DATE OF COMPLAINT: NA	POST INSP. CONTACTS: None	JOINT INSP. AGENCY: None	
INSPECTOR(S): Amber Gibson	INSPECTOR'S SIGNATURE:

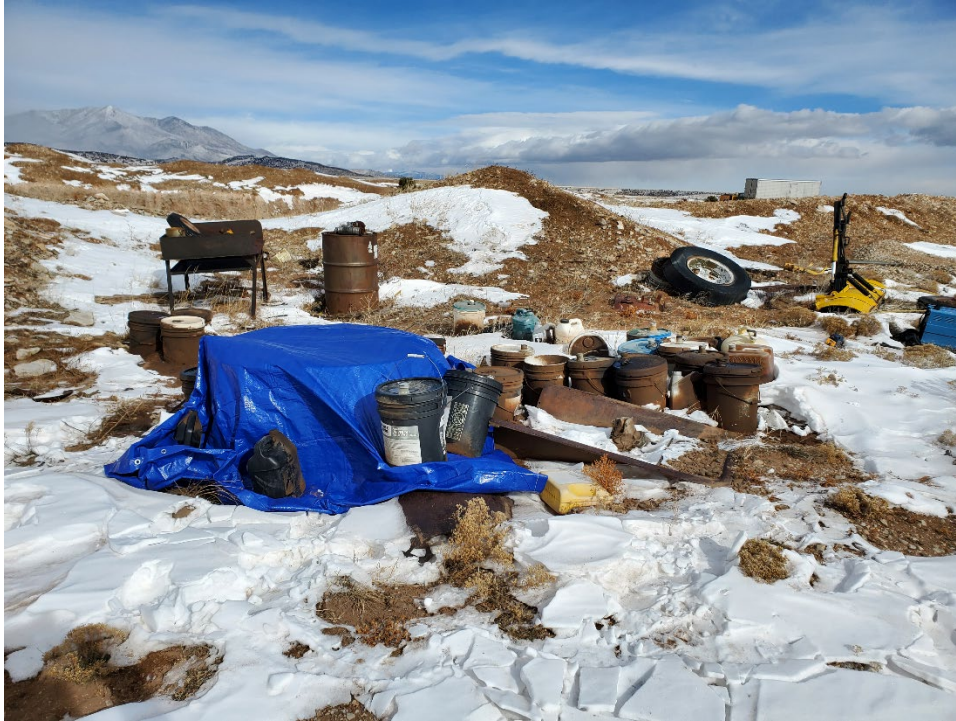
PROBLEM: Improper storage and containment of fuels and/or other hazardous materials was present on site.

During the 2024 inspection, a stock tank was observed near the pit, but an abundance of motor oil containers were placed around it (Photo 1). When asked about this, the Operator stated that they had been putting the oil containers in the stock tank. However, the Operator allows some people to bring their leftover motor oil to him. The Operator stated that they received more than they were able to use, or store in the tank, and that is why there are additional containers outside of the secondary containment. The Division informed the Operator that the additional containers need to be placed in secondary containment or removed from the site. This has been **cited above as a problem**. The Operator shall provide the Division with photo evidence that the motor oil containers have been placed within an appropriate secondary containment structure, or have been removed from the site, by the corrective action date.

Photo 1: The stock tank for the oil is located under the blue tarp. The buckets surrounding the tarp also contain oil.

CORRECTIVE ACTIONS: All storage tanks, petroleum and any hazardous materials on site for any period of time shall have appropriate secondary containment. The site will also have to comply with all applicable SPCC requirements. Please supply photo documentation that any fuel or hazardous materials containers are stored properly - including applicable secondary containment structures by the corrective action date. Note that secondary containment structures shall consist of an impermeable containment which could contain all contents of the tanks and various containers (when full) plus 10% of the total capacity. The Operator may also provide photo documentation that all containers have been removed from the site on or before the corrective action date.

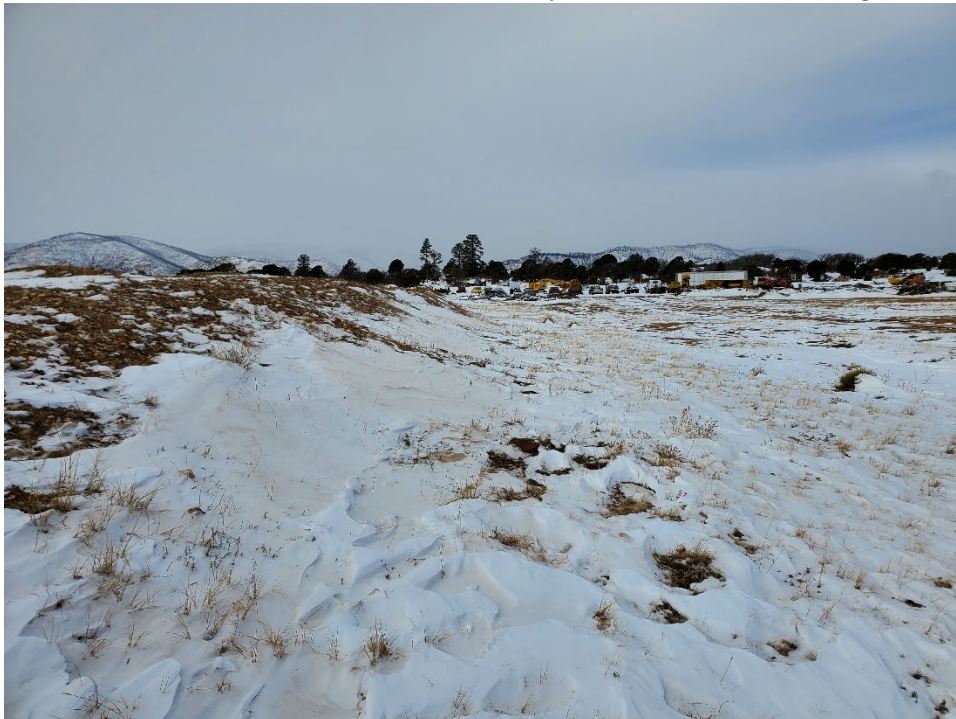
Photo 2: Looking west along the northern disturbance boundary. The disturbance consists of a berm of overburden material.

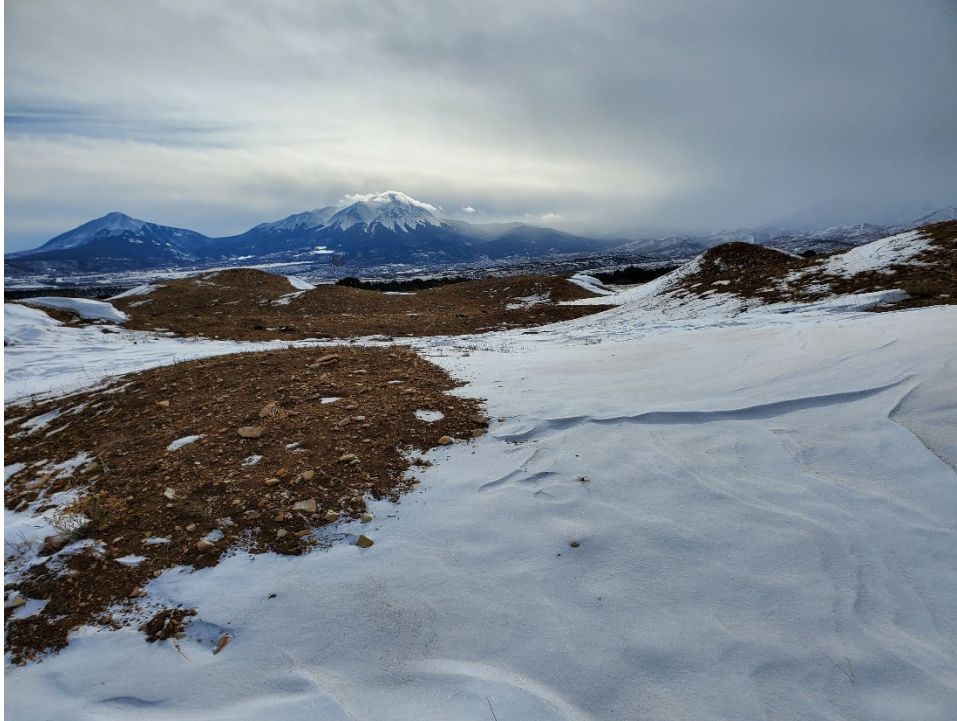
Photo 3: Looking south-east from the northern disturbance boundary to the additional overburden stored around the pit perimeter.

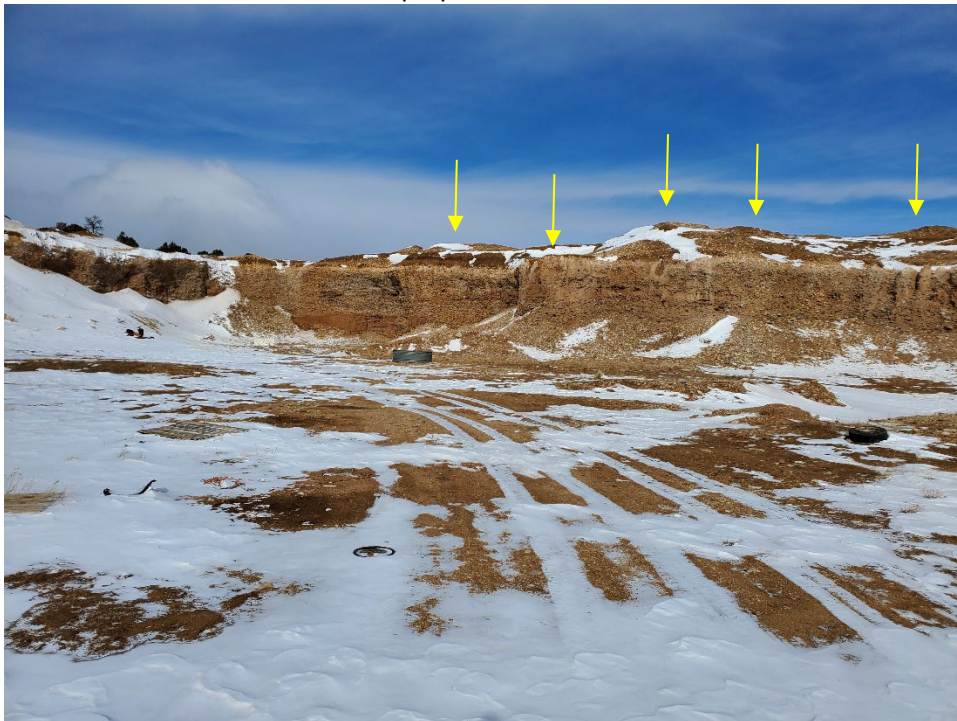
PROBLEM: Trash and refuse was noticed on the site. This is a problem at this time for failure to dispose of refuse in a manner that controls unsightliness or deleterious effects of such refuse pursuant to C.R.S. 34-32.5-116(4)(e).

Trash and debris were observed within the pit (Photo 4). The Operator stated that a lot of the trash had blown into the pit, but some pieces (like the refrigerator in Photo 12) were placed there for target practice. Trash and refuse must be disposed in a manner that controls unsightliness or deleterious effects of such refuse pursuant to C.R.S. 34-32.5-116(4)(e). Thus, this has been **cited as a problem above**. The Operator must remove the trash/refuse/debris from the pit and provide the Division with photo evidence that this has been complied with by the corrective action date.

Photo 4: Looking at the north-west corner of the pit. Arrows indicate where overburden is stored above the highwalls.

CORRECTIVE ACTIONS: The Operator shall submit a written notice to the Division with photo documentation, that the trash has been removed from the site by the corrective action date.

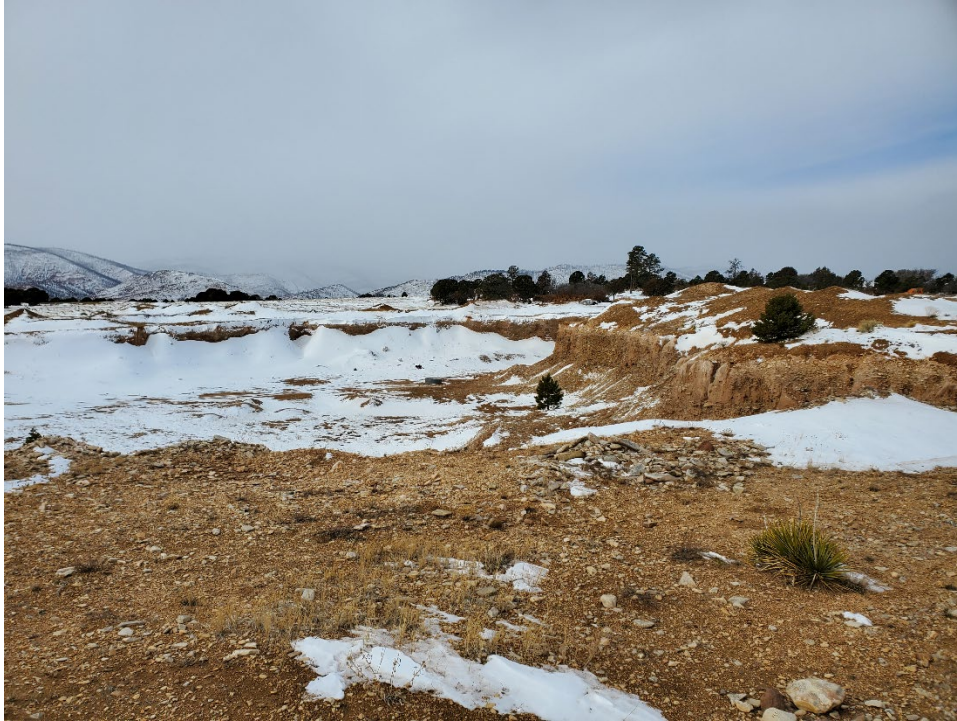
Photo 5: Looking north-west across the open pit.

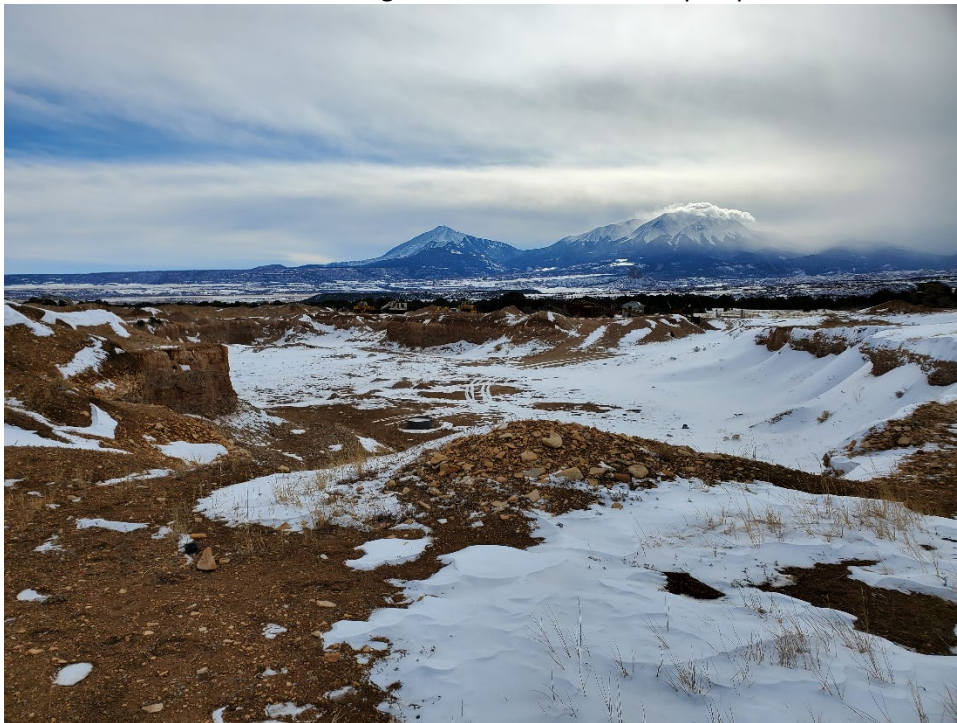
Photo 6: Looking south-east across the open pit.

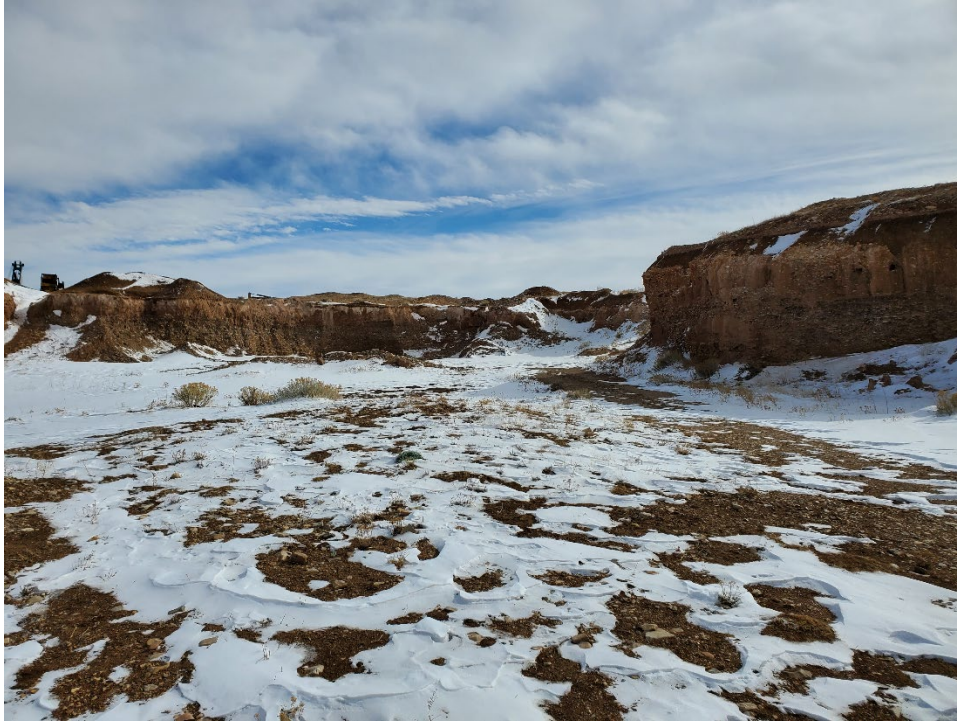
Photo 7: Looking east from within the pit at more highwalls with overburden stored above.

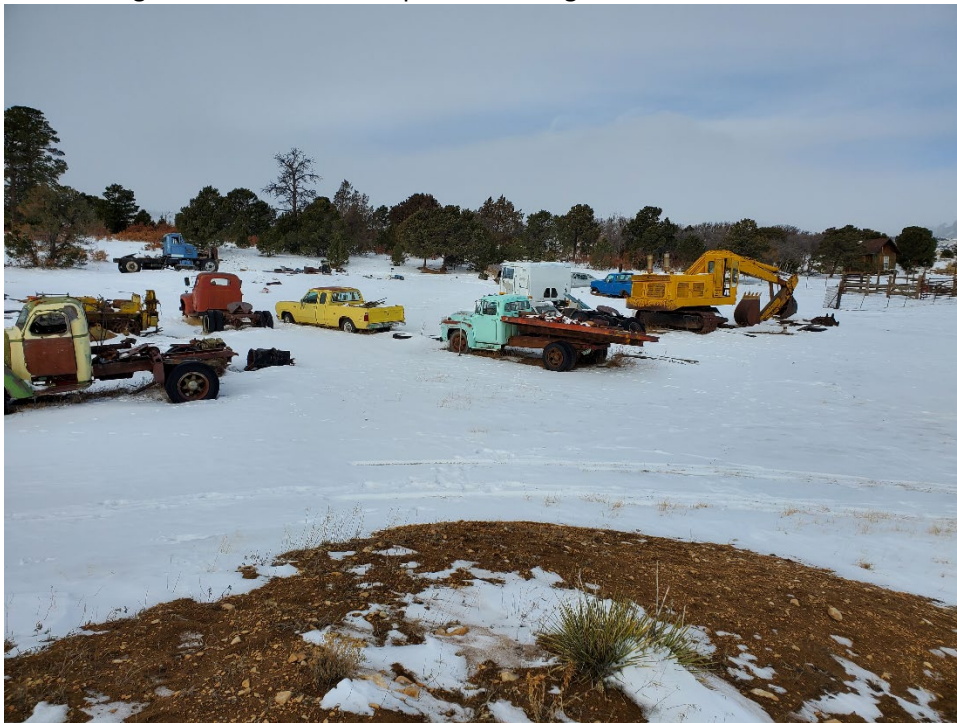
A variety of mining equipment and vehicles are stored in and around the permit boundary (Photos 8-11), many of which have been there prior to the permitted operation. A few product stockpiles are also located throughout the site. When mining is active, crushing and screening is conducted on-site.

Photo 8: Old vehicles and equipment stored outside of the permit boundary.

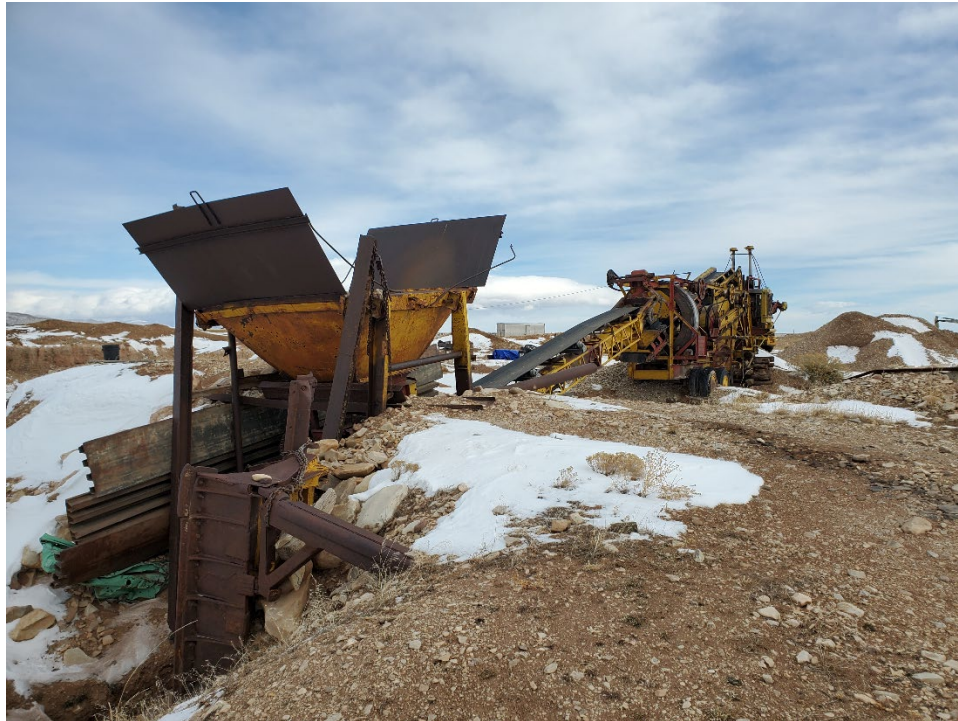
Photo 9: Equipment located within the permit boundary.

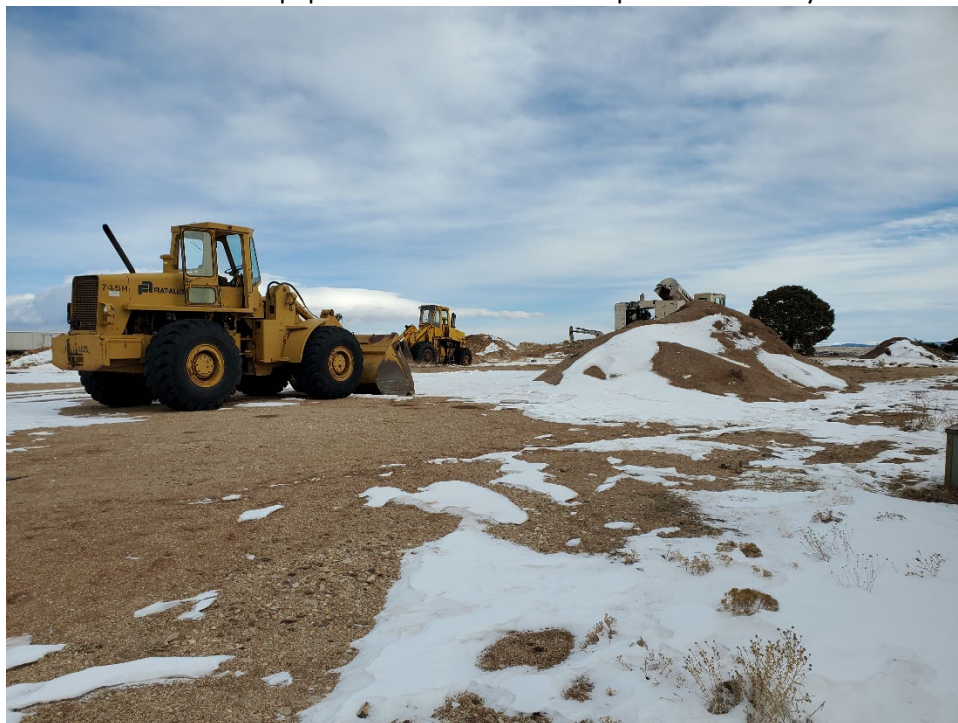
Photo 10: Looking north at equipment and product stockpiles located within the permit boundary.

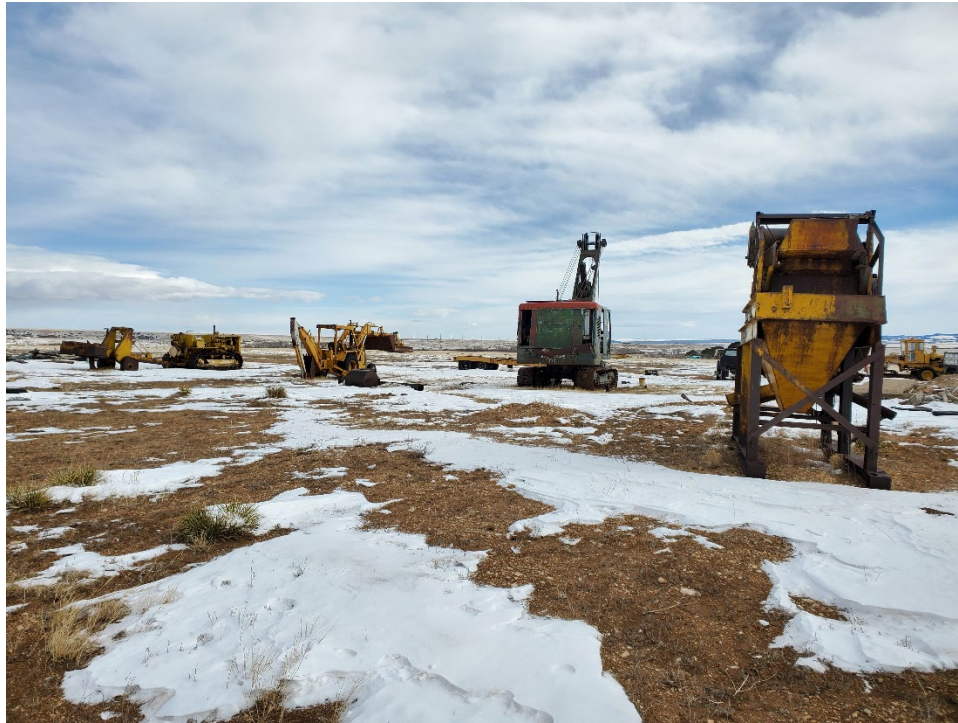
Photo 11: Looking east at more vehicles and equipment located in and outside of the permit boundary.

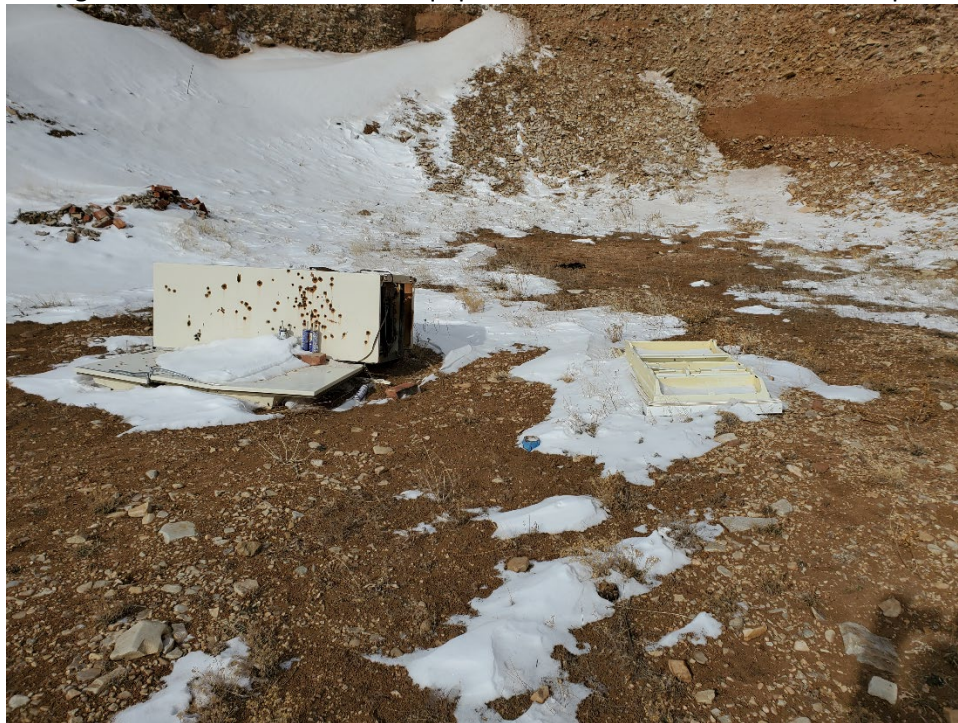
Photo 12: Refrigerator located within the pit that had been used for target practice.

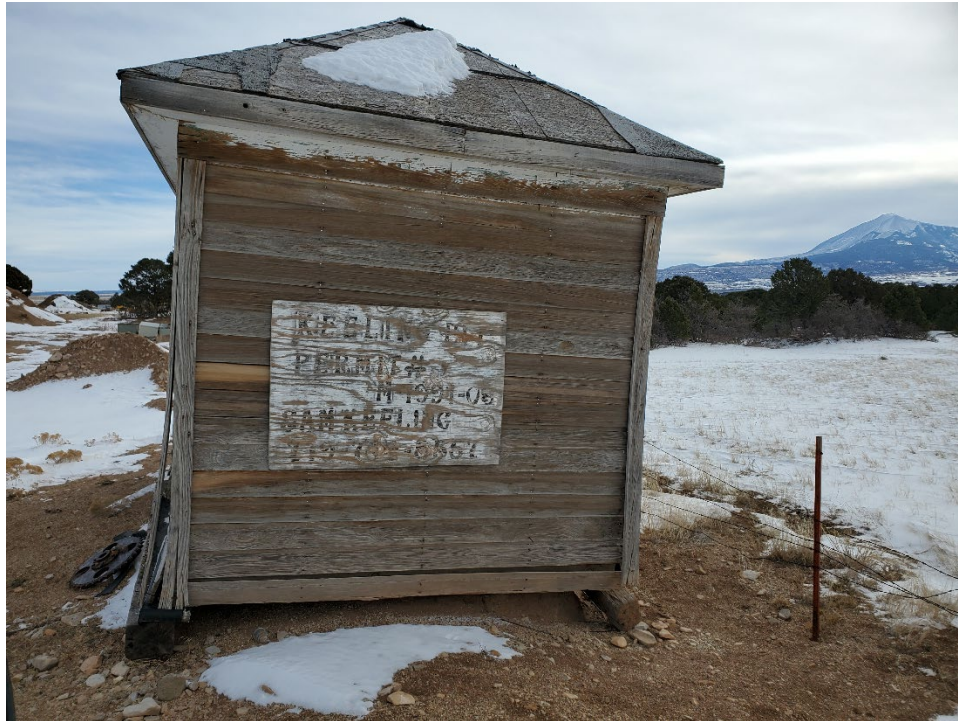
PROBLEM: The mine identification sign was posted at the entrance of the mine site, but has become illegible. This is a problem for failure to post a mine identification sign that meets the requirement of Section 3.1.12(1) of the Rule. The Operator shall, at the entrance of the mine site post a sign, which shall be clearly visible from the access road, with a minimum size equaling one hundred and eighty-seven (187) square inches, such as eleven (11) inches in height and seventeen (17) inches in width, with appropriate font size, with the following: the name of the Operator, a statement that a reclamation permit for the operation has been issued by the Colorado Mined Land Reclamation Board; and the permit number.

A sign was located at the entrance to the site. However, the sign is faded, which the Operator states is due to the sign being exposed to sand erosion from easterly blowing winds (Photo 13). This has been **cited as a problem above**. The Operator shall repair or replace the sign in accordance with Rule 3.1.12(1) and provide the Division with photo evidence that this has been done by the corrective action date.

Photo 13: Faded mine sign posted at the entrance to the site. Stockpiled material located behind the structure.

CORRECTIVE ACTIONS: The Operator shall, at the entrance of the mine site, post a sign which shall be clearly visible from the access road with the following: the name of the Operator, a statement that a reclamation permit for the operation has been issued by the Colorado Mined Land Reclamation Board; and the permit number. The Operator shall submit photo documentation that a proper sign has been posted by the corrective action date.

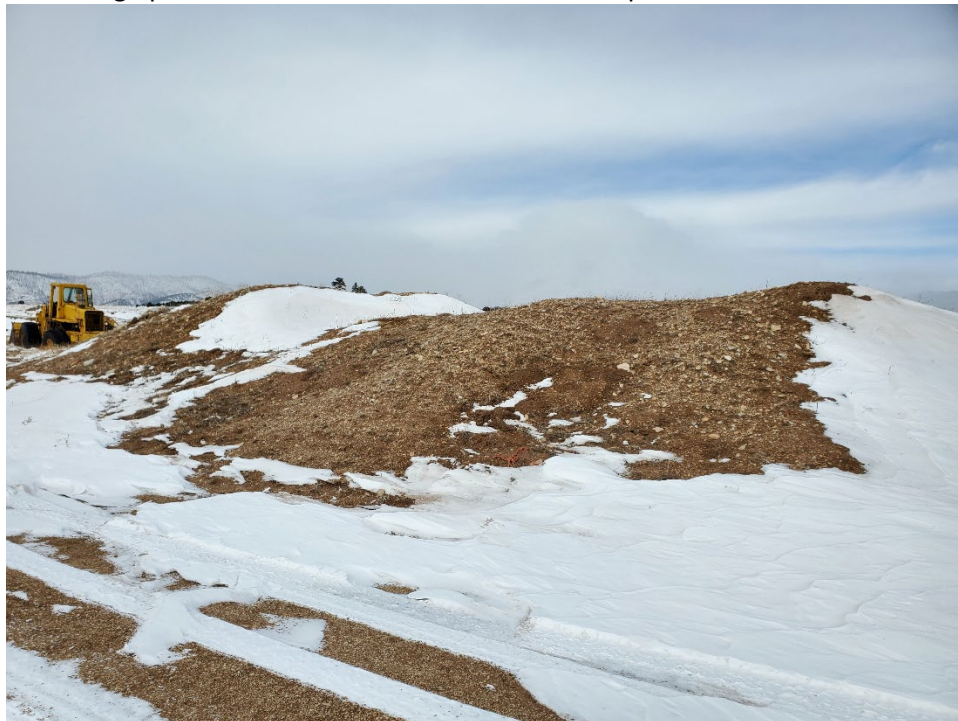
PROBLEM: The topsoil stockpiles do not have established vegetation on them and are therefore susceptible to erosion. Rule 3.1.9(1) states if topsoil is not replaced into the backfill area within a time short enough to avoid deterioration of the topsoil, vegetative cover or other means shall be employed so that the topsoil is protected from erosion.

the Operator was asked which stock piles were topsoil piles. The Operator indicated that the piles located in the south-east portion of the disturbed area were the primary topsoil piles (Photos 14 & 15). The piles are located in an area where disturbance from active mining would be minimized per Rule 3.1.9(3). However, the piles are not stabilized with a vegetative cover per Rule 3.1.9(1). This has been **cited as a problem above**. The Operator shall seed the topsoil piles and provide evidence to the Division that this has been complied with by the corrective action date.

Photo 14: Looking north-east at the topsoil pile.

CORRECTIVE ACTIONS: The Operator shall seed the stockpiles with the seed mix that was submitted as part of the approved Reclamation Plan. If no seed mix has been provided, the operator shall submit a seed mix for approval as a technical revision to the permit along with the appropriate \$216 revision fee to the Division by the corrective action date. The Operator shall demonstrate compliance by submitting seed tags, a bill of sale or photographs of seeding activities. The Operator may also request a follow up inspection.

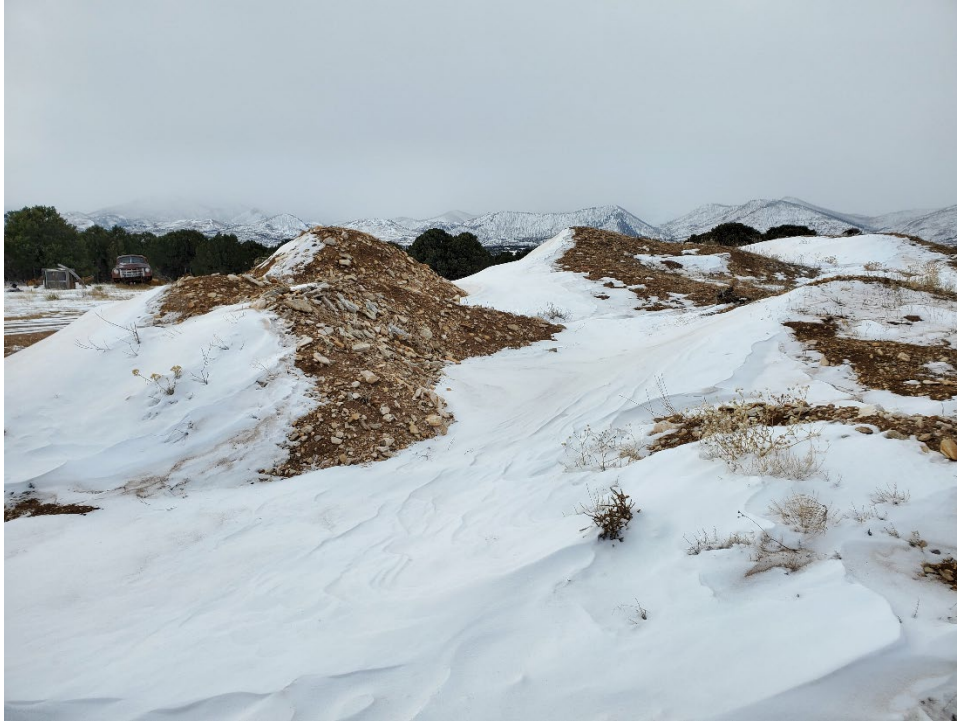
Photo 15: Looking south at the topsoil pile and an overburden pile.

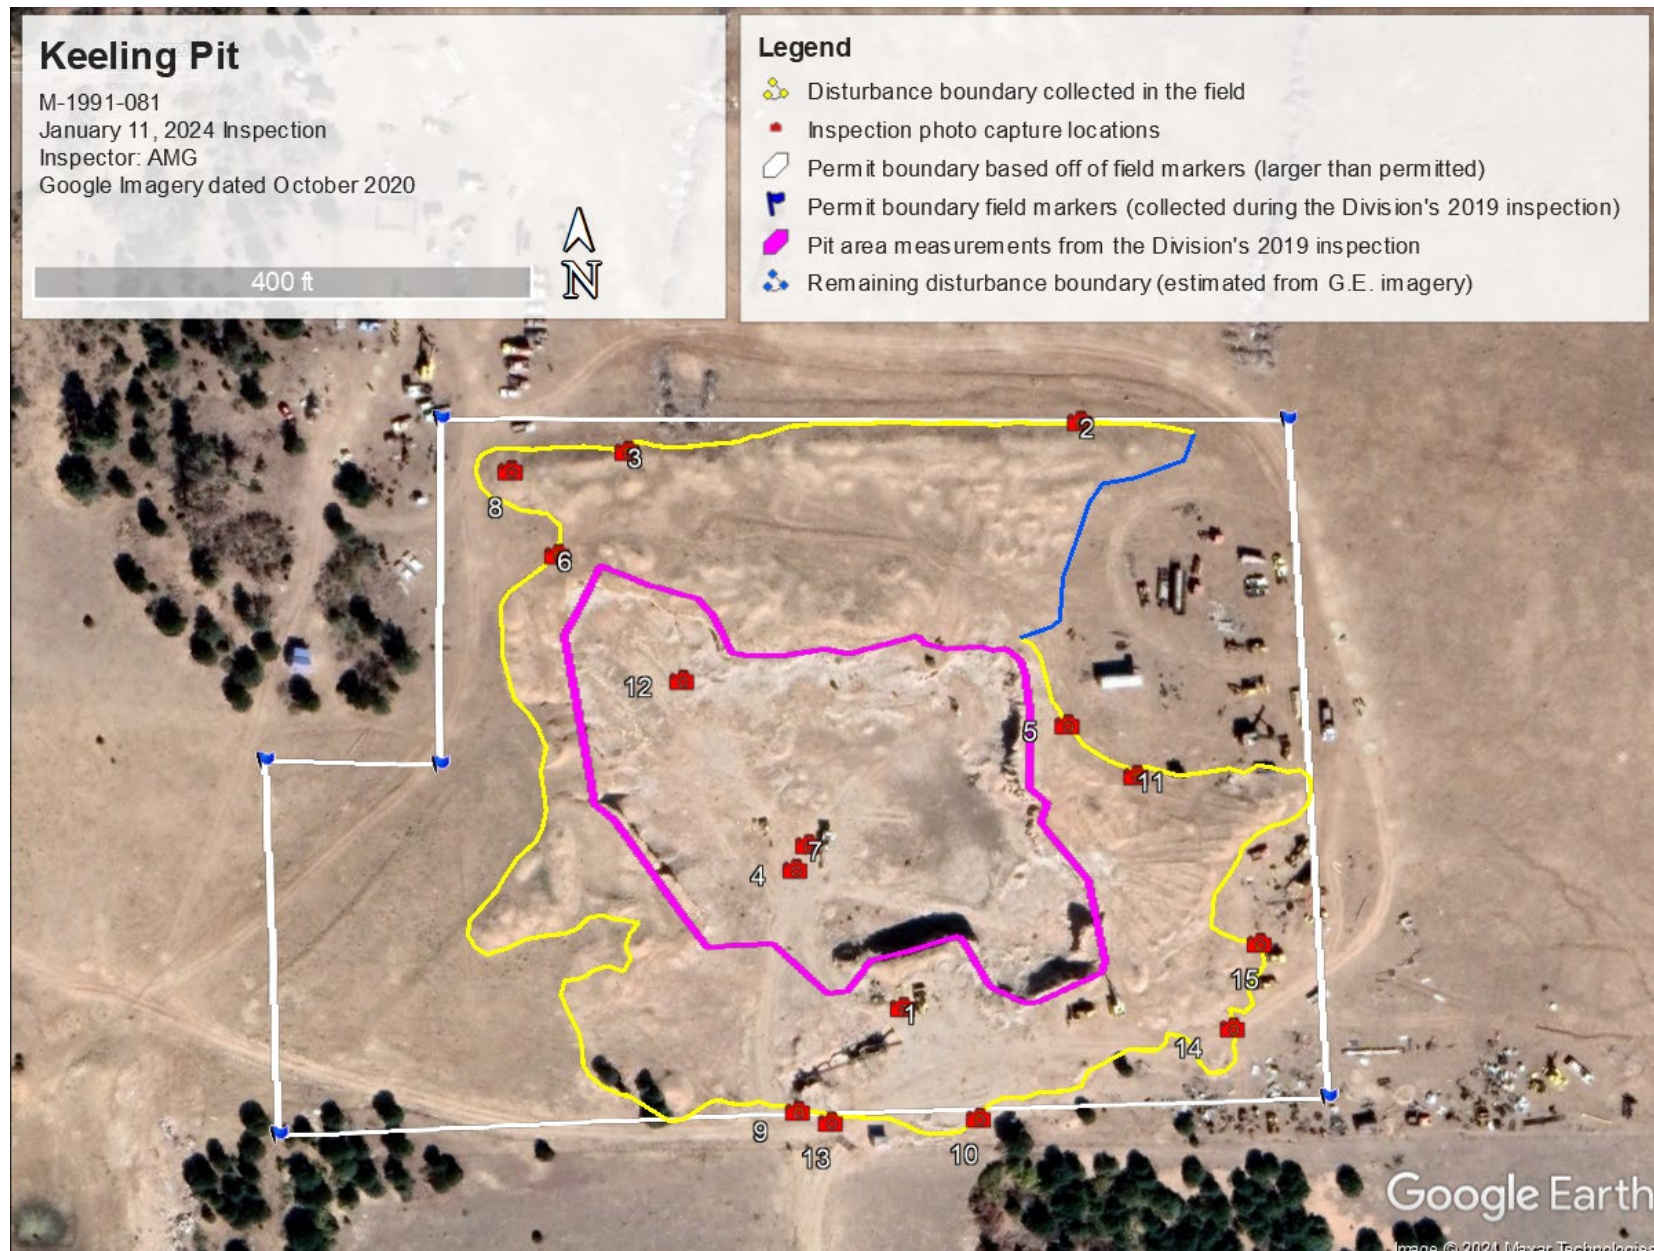
Excavation occurs in west and northerly directions. The Division walked around the disturbance on-site to determine the extent of the disturbance boundary by using the Esri Field Maps application. The yellow line on Map 1 indicates where the Division walked, and the blue line indicates an approximation of additional disturbance (gathered from aerial imagery in Google Earth Pro). The total disturbed area encompasses approximately 6.5 acres.

Map 1: Map generated in Google Earth to display the locations where photos were taken and where the disturbance boundary was walked during the January 11, 2024 inspection of the Keeling Pit. Google aerial imagery dated October 2020.

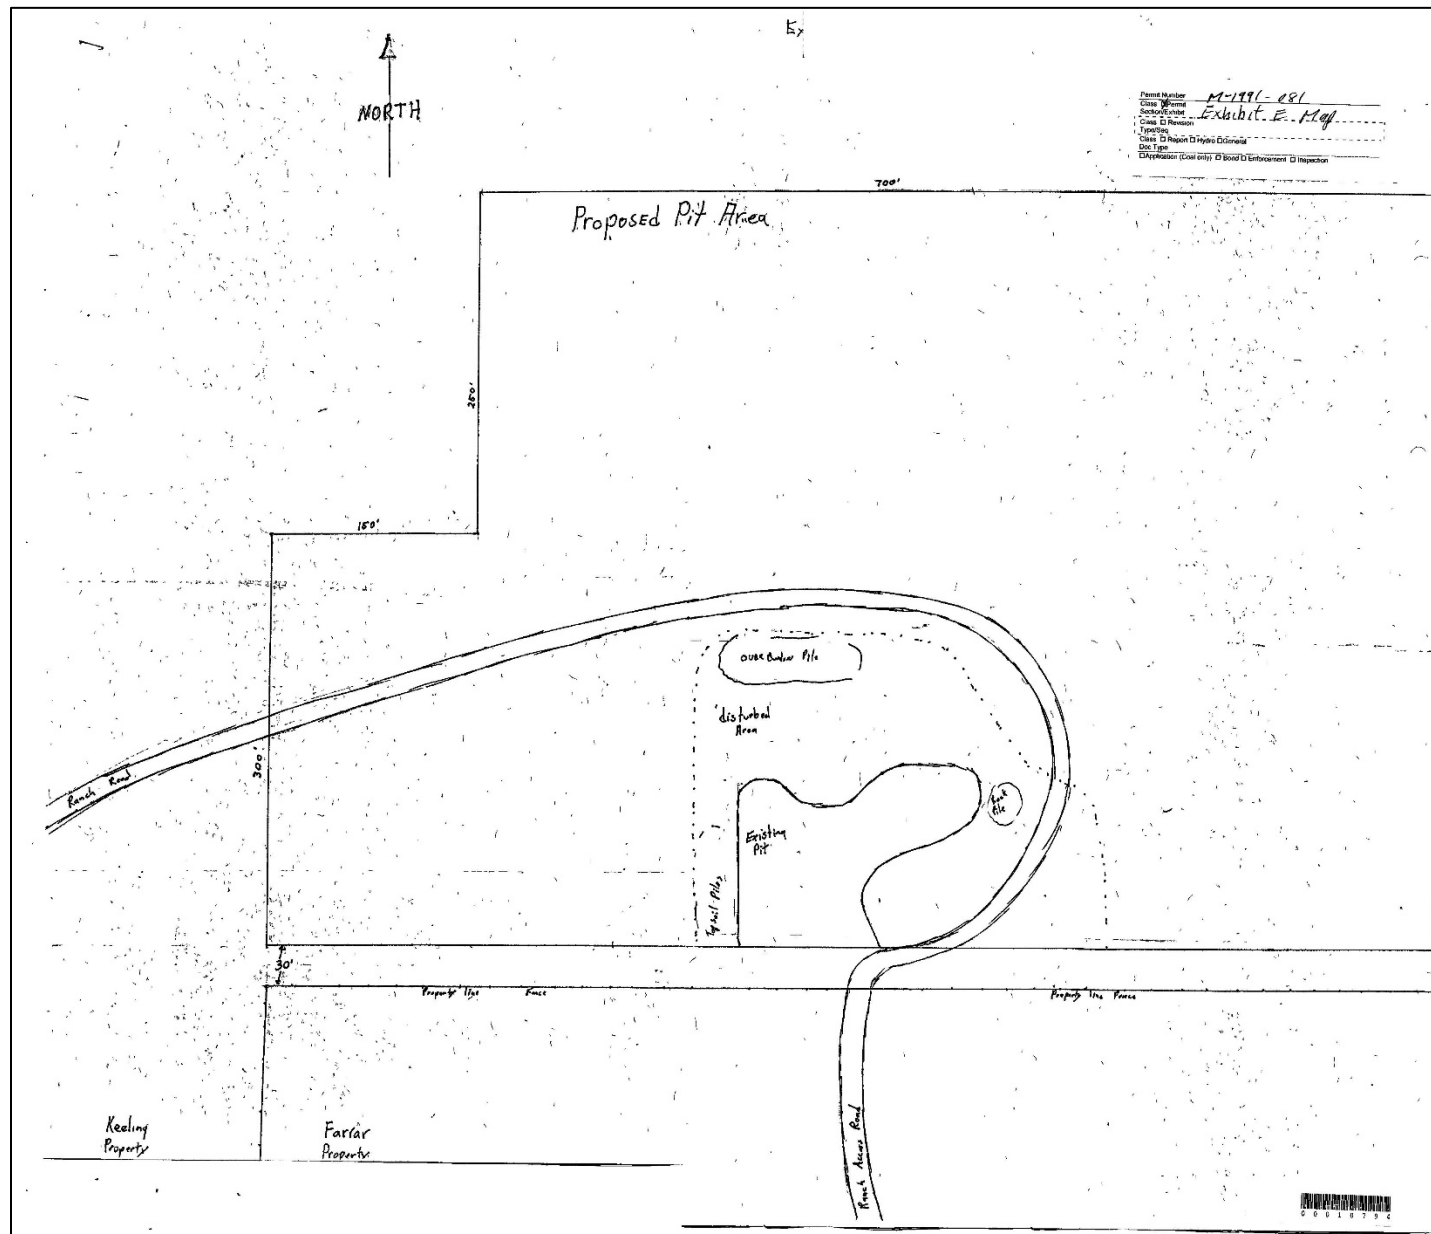
PROBLEM: The affected area boundary markers are incorrectly placed. The area encompassed by the field markers is nearly an acre larger than the approved permit area boundary. This is a problem for failure to maintain boundary markers around the affected area as required by Section 3.1.12(2) of the rule.

Most of the affected area boundary markers were observed during the inspection. The north-east marker had been placed within a tire. The tire is still in place, but the marker had fallen down. Instead of having the Operator replace the marker, the Division informed him that during a review of the permit file prior to the inspection, it was determined that the permit boundary marked in the field (collected during the Division's 2019 inspection) exceeds the approved acreage (see Maps 1 and 2). This has been **cited above as a problem**. The Operator shall replace all of the boundary markers in their approved locations per the dimensions provided on the approved mining plan map (see Map 2), or hire a surveyor to conduct a survey and replace the markers. The Operator shall provide photos and GPS coordinates of the correctly placed markers to the Division by the corrective action date.

Map 2: Copy of the approved mining plan map for the Keeling Pit. The approved distances between markers are provided on the map. The total area, calculated from the distances provided, equals 9.9 acres – consistent with the approved acreage for this operation.

CORRECTIVE ACTIONS: The Operator shall conduct a survey and replace the boundary markers in the correct location(s). The Operator shall provide photo and GPS coordinates of the adjusted marker locations as proof to the Division that this has been done by the corrective action date.
