C1980007, West Elk Mine, January Inspection Report

PERMIT INFORMATION

Permit Number: C-1980-007 Mine Name: West Elk Mine Operator: Mountain Coal Company, LLC Operator Address: Ms Jessica Wilczek 5174 Highway 133 Somerset, CO 81434	County: Delta, Gunnison Operation Type: Underground Permit Status: Active Ownership: Private
	Operator Representative Present: Chase Hiatt
Operator Representative Signature: (Field Issuance Only)

Inspection Start Date: January 26, 2024 Inspection Start Time: 09:00 Inspection End Date: Inspection End Time:	Inspection Type: Coal Partial Inspection Inspection Reason: Normal I&E Program Weather: Cloudy
Joint Inspection Agency: None	Joint Inspection Contacts:
Post Inspection Agency: None	Post Inspection Contacts:
Inspector(s): Leigh Simmons	Inspector's Signature:

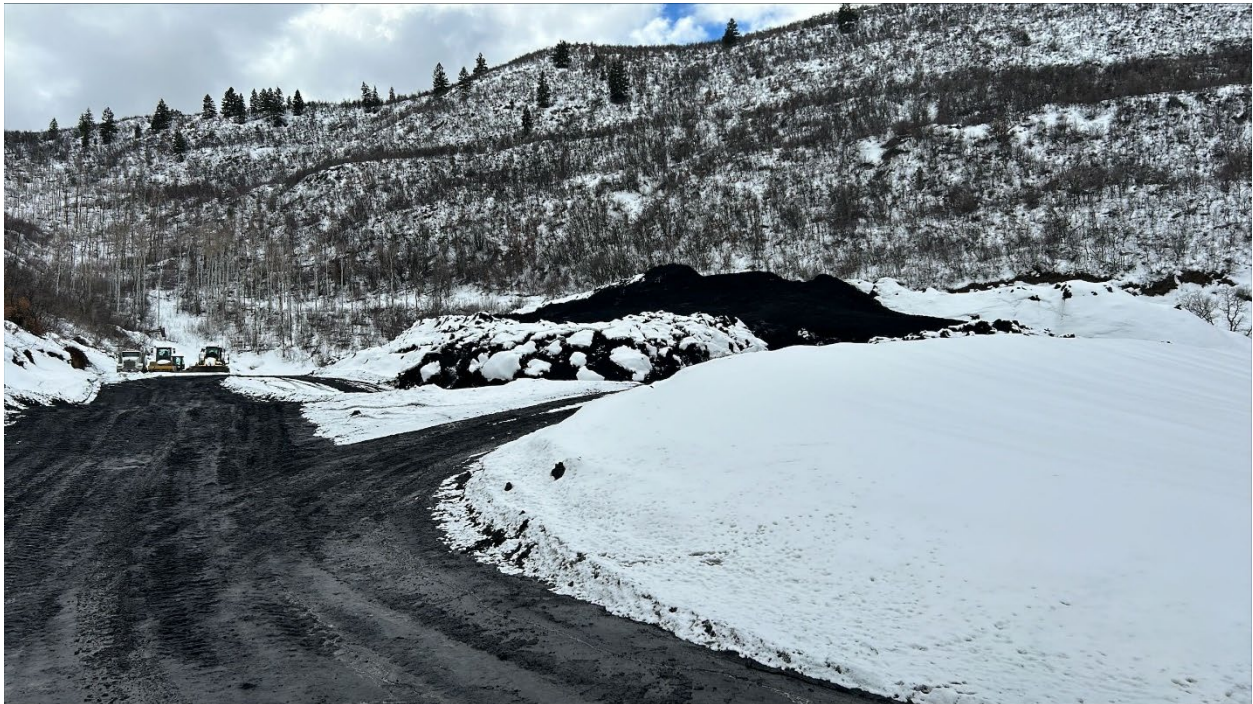
The wash plant was not in use at the time of the inspection, so no new processing waste was being generated. Transport of material from the temporary stockpile on the RPE to the RPEE had been completed. The material had been loosely piled on the western edge of the compacted surface of the RPEE, with as small a footprint as possible. No attempt was being made to compact the new material. Refuse pile contractors had

Figure 1: Loosely piled material on RPEE (1 of 3)

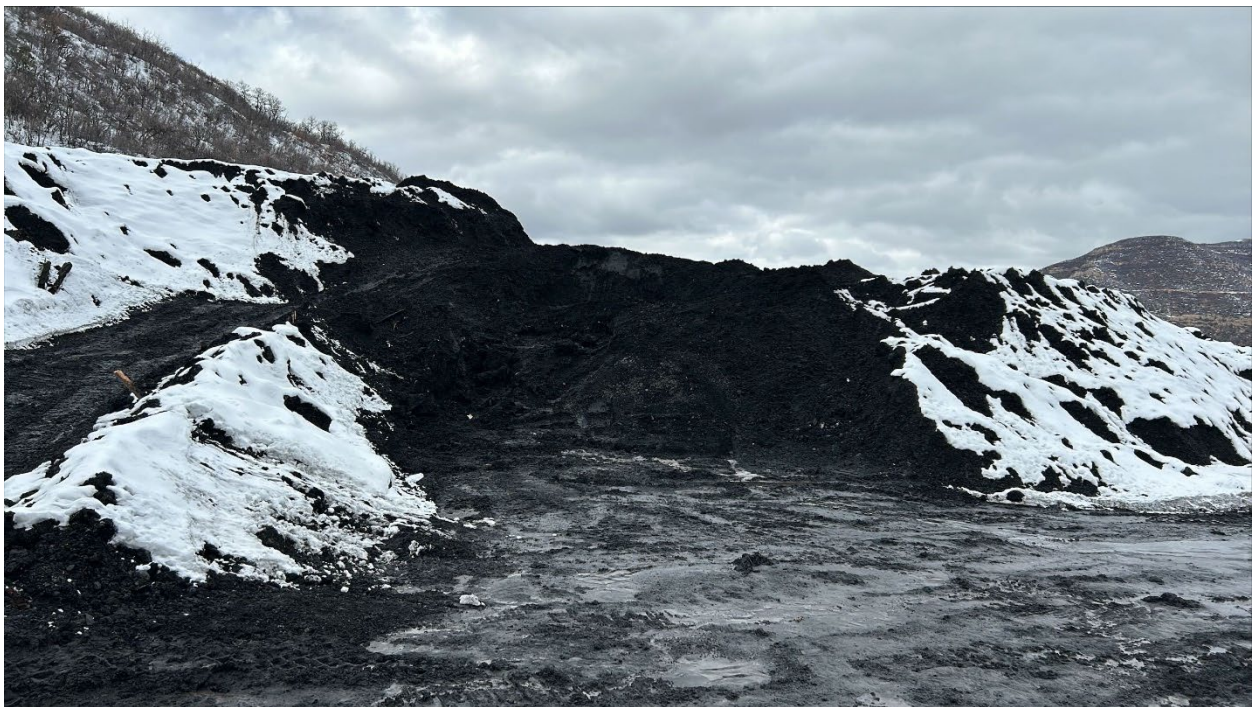
Figure 2: Loosely piled material on RPEE (2 of 3)

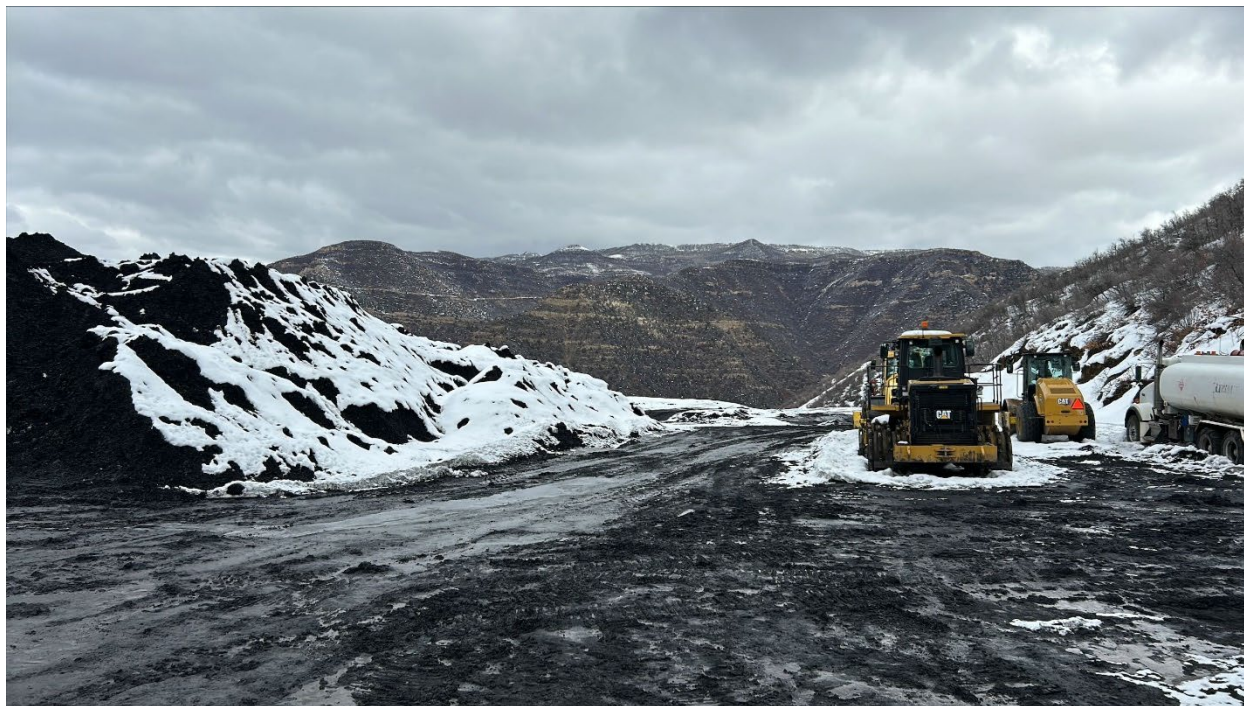
Figure 3: Loosely piled material on RPEE (3 of 3)

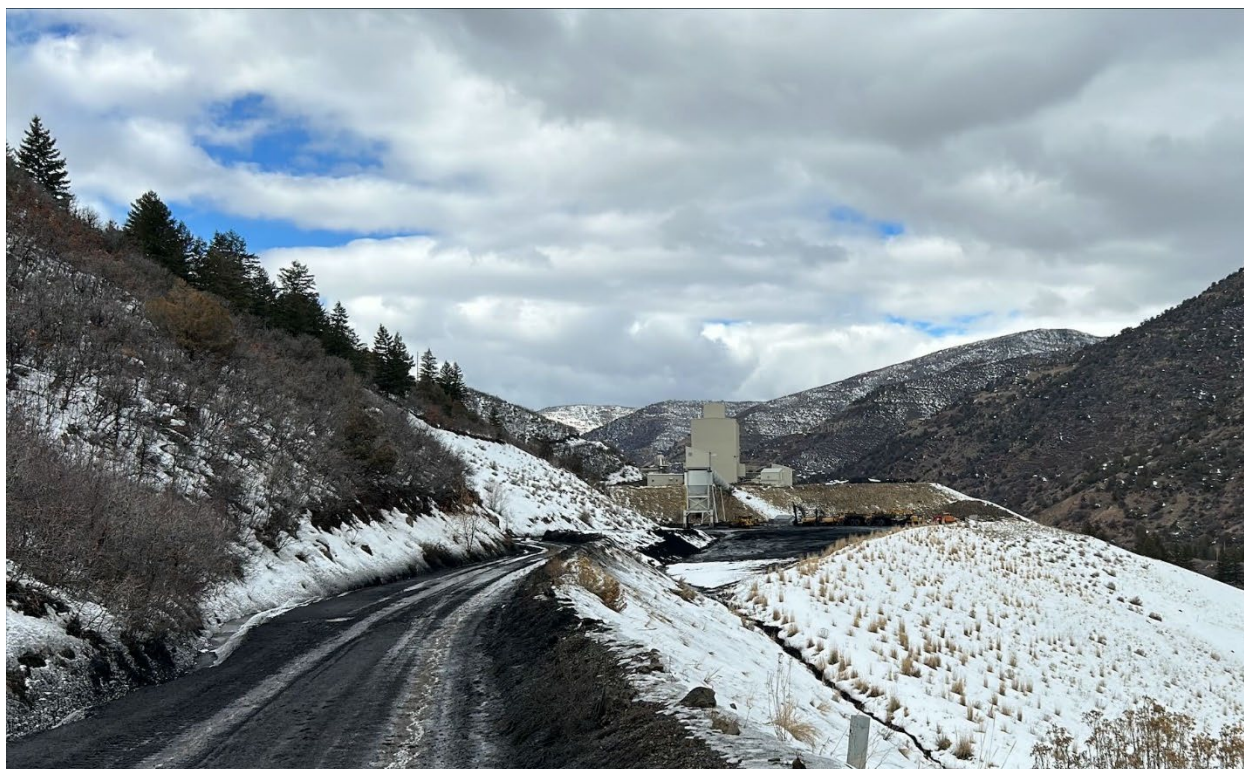
Figure 4: All material moved from temporary stockpile on RPE

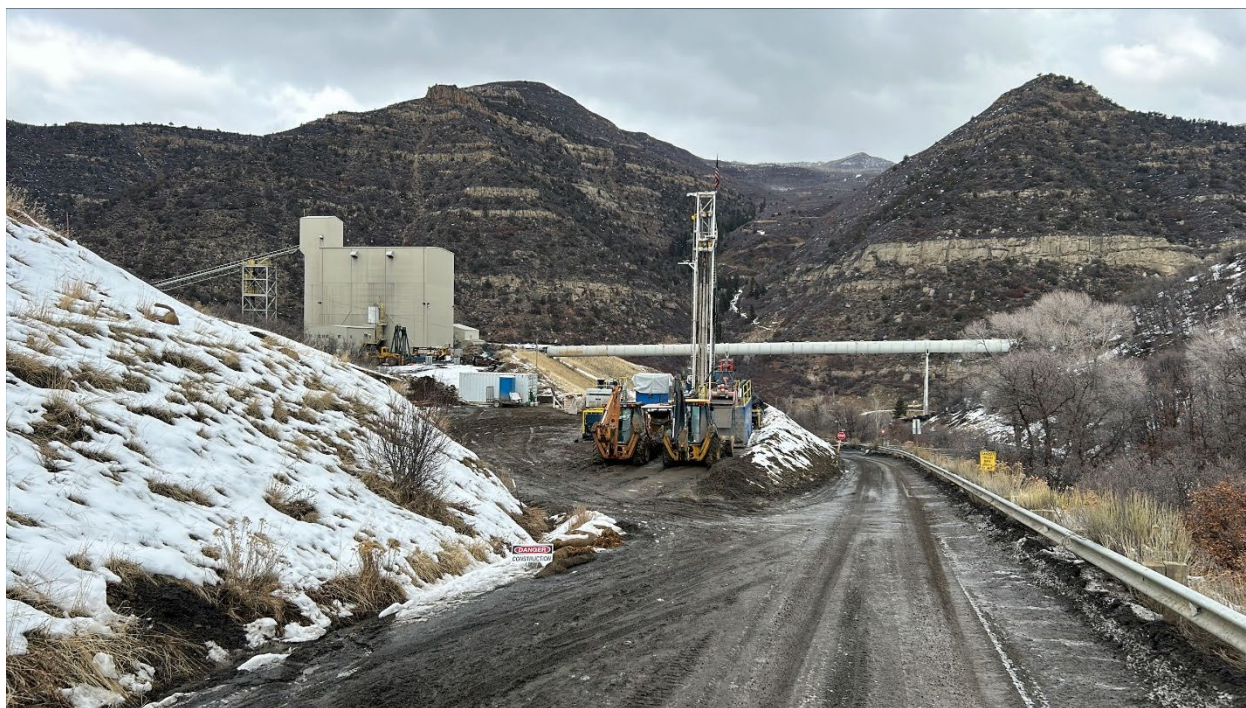
Construction of the Box Canyon North Well had resumed. The drill rig was on-site.

Figure 6: Box Canyon North Well under construction
