Glen's Pit, M-2005-075, November Inspection Report

MINERALS PROGRAM INSPECTION REPORT
PHONE: (303) 866-3567

MINE NAME: Glen's Pit	MINE/PROSPECTING ID#: M-2005-075	MINERAL: Gravel	COUNTY: Garfield
INSPECTION TYPE: Monitoring	WEATHER: Clear	INSP. DATE: November 9, 2023	INSP. TIME: 10:25
OPERATOR: Oldcastle SW Group, Inc. dba United Compas County	OPERATOR REPRESENTATIVE: Jason Burkey, Tyra Bartuska	TYPE OF OPERATION: 112c - Construction Regular Operation	
REASON FOR INSPECTION: Normal I&E Program	BOND CALCULATION TYPE: Complete	BOND AMOUNT: \$153,000.00	
DATE OF COMPLAINT: NA	POST INSP. CONTACTS: None	JOINT INSP. AGENCY: None	
INSPECTOR(S): Clayton Wein	INSPECTOR'S SIGNATURE:

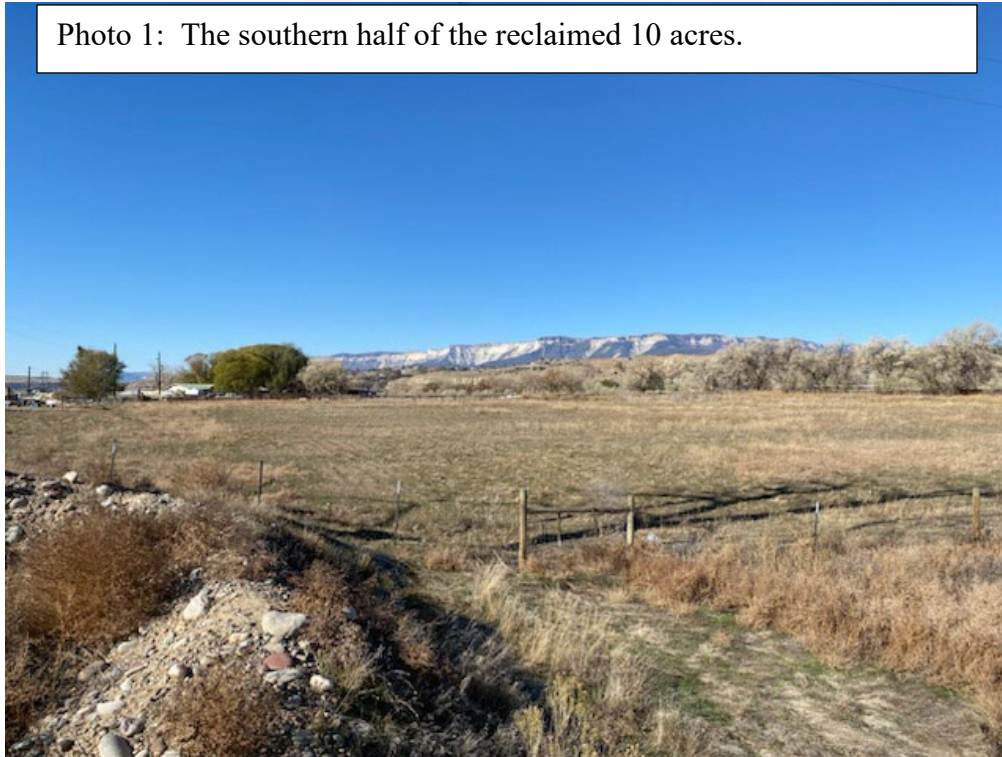
The western portion of the site, approximately 10 acres has been reclaimed. The area has been graded, topsoiled and seeded (Photos 1 and 2). The reclamation was stable with vegetative cover. The inspection was conducted in the fall, a springtime inspection to determine the success of the revegetated areas may be more beneficial for a future acreage reduction request. There were no indications of erosional features observed. The post-mining land use for the site is wildlife habitat.

Photo 1: The southern half of the reclaimed 10 acres.

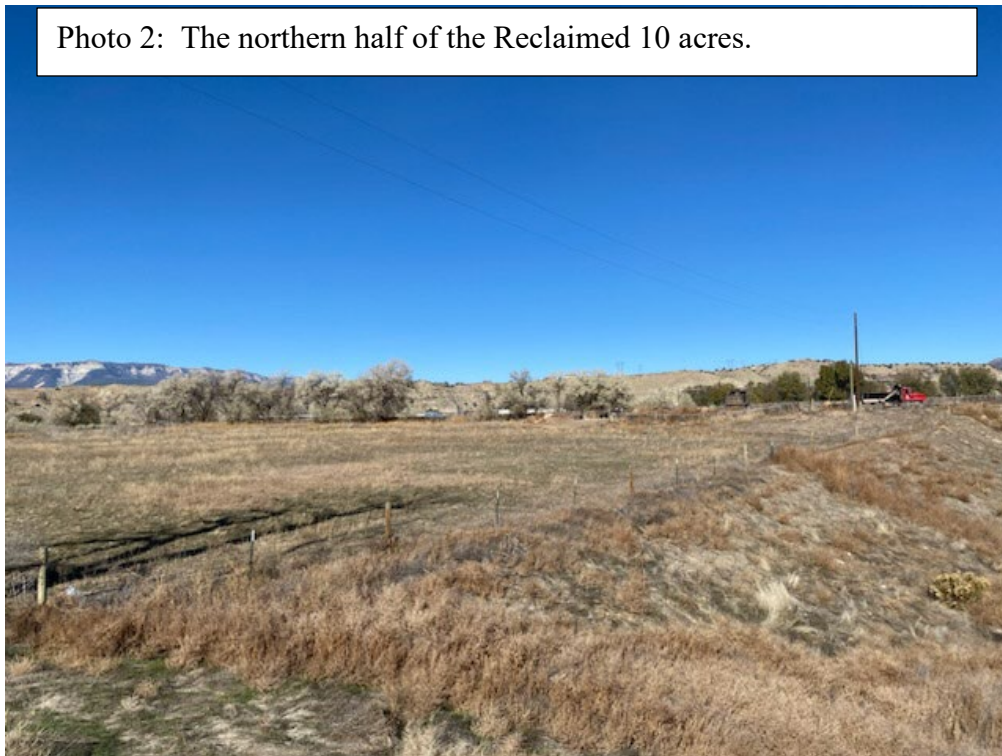
Photo 2: The northern half of the Reclaimed 10 acres.

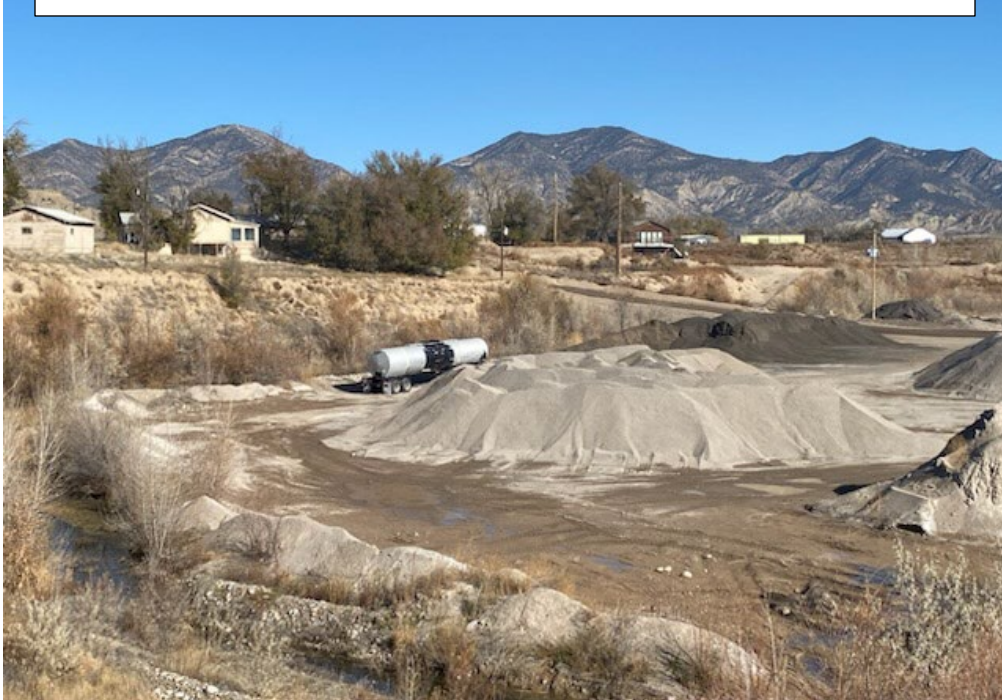
In the active portion of the site, an asphalt plant and material stockpiles were observed. Stockpiled materials were observed on the western portion of the pit (Photo 3). The piles were well maintained and stable. The asphalt plant was located in the eastern portion of the pit floor (Photo 4). Fuel stored on site was observed to be in secondary containment and no spills were observed. The walls of the pit were generally about 1H:1V and stable. There were no indications of sloughing or erosion.

Photo 3: The material stockpiles in the western portion of the pit.

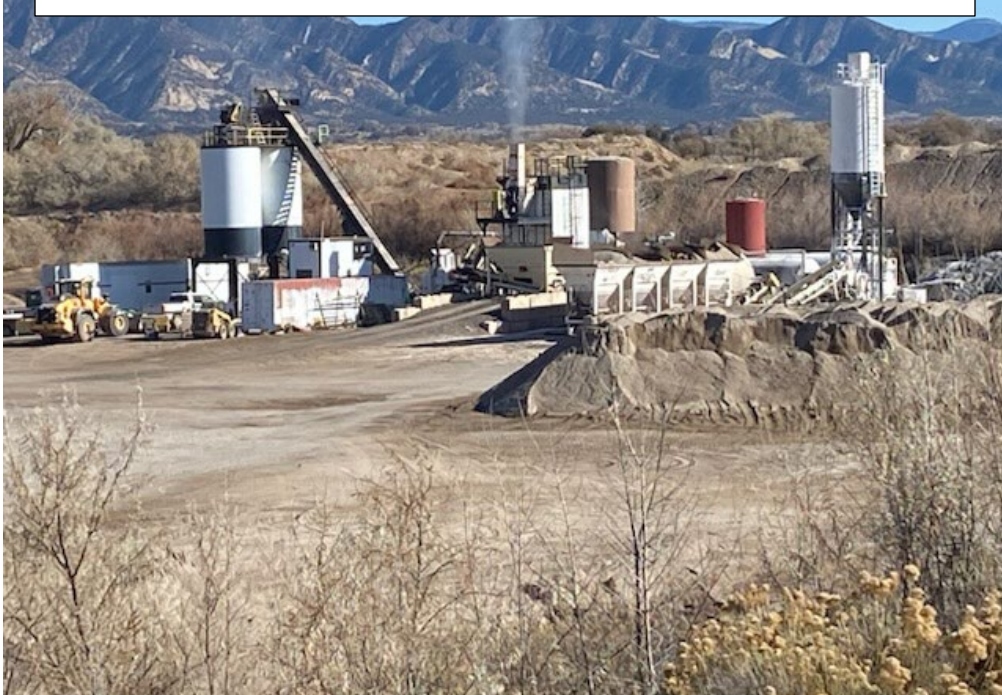
Photo 4 the asphalt plant located in the eastern portion of the pit.

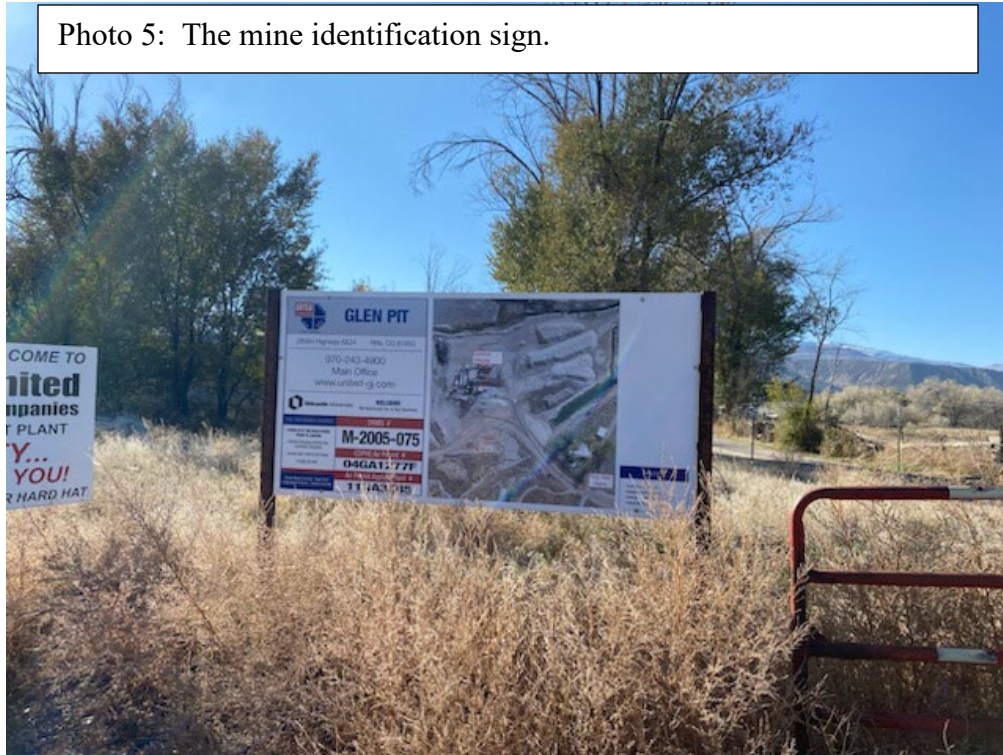
At the entrance to the site, a mine identification sign was posted (Photo 5). The sign was placed in a location that was unobstructed and easy to spot. The affected area boundary was marked with posts as required by Rule 3.1.12.

Photo 5: The mine identification sign.
