## Colowyo Mine Inspection Report

<b>Permit Number:</b> C-1981-019 <b>Mine Name:</b> Colowyo Coal Mine <b>Operator:</b> Colowyo Coal Company L.P. <b>Operator Address:</b> Mr Tony Tennyson 5731 State Highway 13 Meeker, CO 81641	<b>County:</b> Moffat, Rio Blanco <b>Operation Type:</b> Surface <b>Permit Status:</b> Active <b>Ownership:</b> Private
	<b>Operator Representative Present:</b>  Tony Tennyson and Tom Fry
<b>Operator Representative Signature: (Field Issuance Only)</b>

<b>Inspection Start Date:</b> January 25, 2024 <b>Inspection Start Time:</b> 07:30 <b>Inspection End Date:</b> January 25, 2024 <b>Inspection End Time:</b> 11:00		<b>Inspection Type:</b> Coal Partial Inspection <b>Inspection Reason:</b> Normal I&E Program <b>Weather:</b> Clear	
<b>Joint Inspection Agency:</b>  None		<b>Joint Inspection Contacts:</b>  None	
<b>Post Inspection Agency:</b>  None		<b>Post Inspection Contacts:</b>  None	
<b>Inspector(s):</b>  Zach Trujillo	<b>Inspector's Signature:</b>

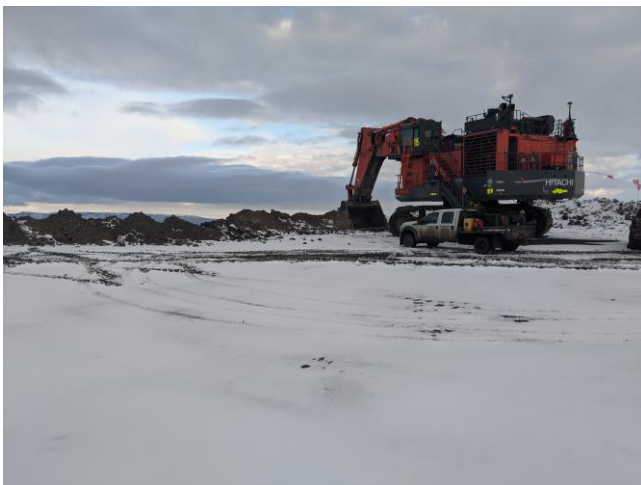
Backfill operations are currently occurring in the South Taylor Pit. The eastern end of the pit is being backfilled by truck and excavator operations from the South Taylor Temporary Spoil Pile.

Excavator on top of South Taylor Spoil Pile.

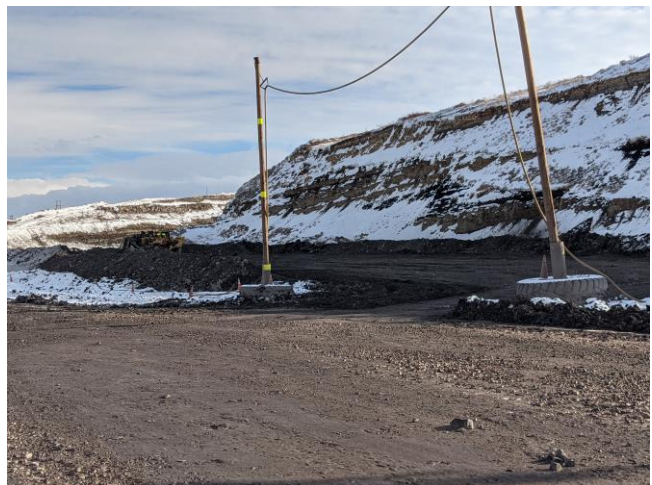
Additional fill placement was observed along the entrance of the eastern section of the Collom Pit. It appeared this spoil was to ramp up to from the current elevation of the Collom in-pit haul road to this portion of the Collom Pit. No issues were observed.

Fill placement at along entrance Collm Pit haul road.

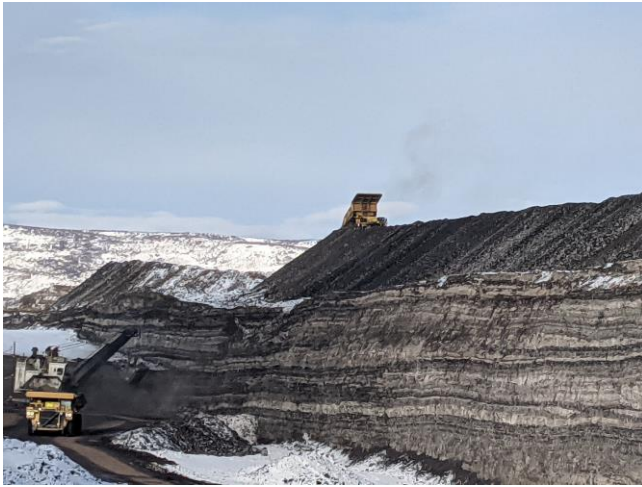
Excess spoil was being hauled by truck/shovel operations to the Collom Spoil Pile. Spoil was currently being placed just above the northwestern section of the Collom Pit highwall.

Spoil placement above Collom Pit.

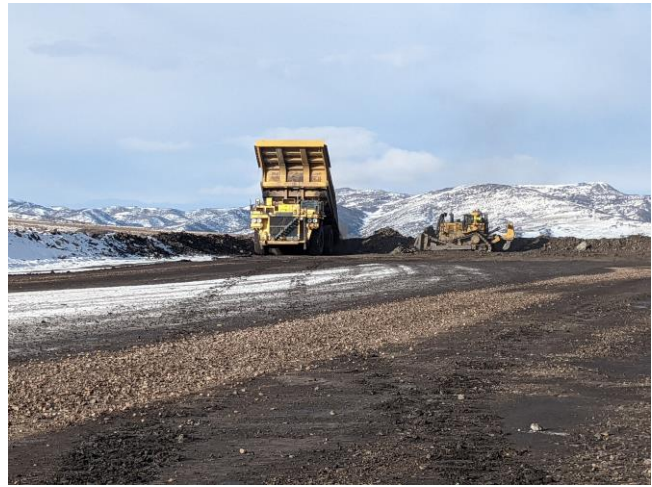
Spoil placement above Collom Pit.

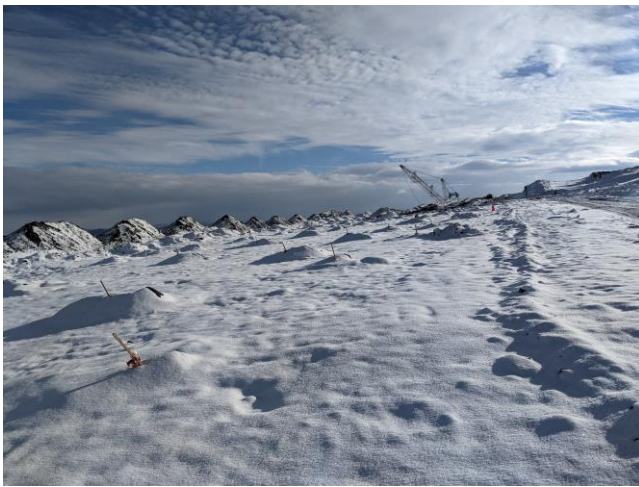
Marked blast holes were observed in overburden along the southern portion of the Collom Pit. The blast was not observed and did not occur during the inspection.

Blast holes at Collom Pit.

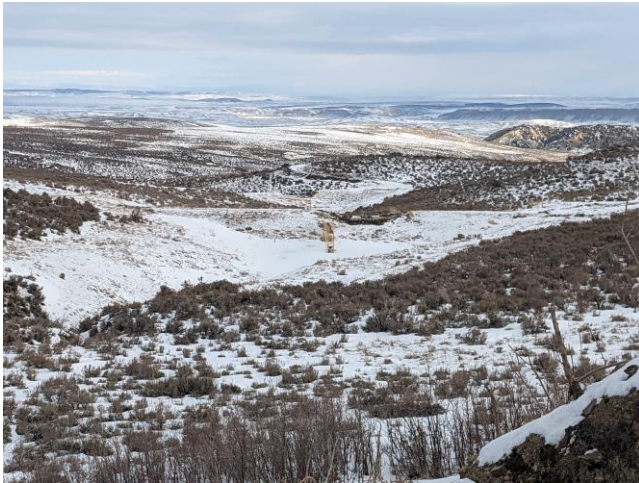
Section 36 and Middle Pond were inspected from above along the Collom Haul Road. Both ponds held water however it was unclear to what amount. Both ponds were stable with no issues observed.

Section 36 Pond.

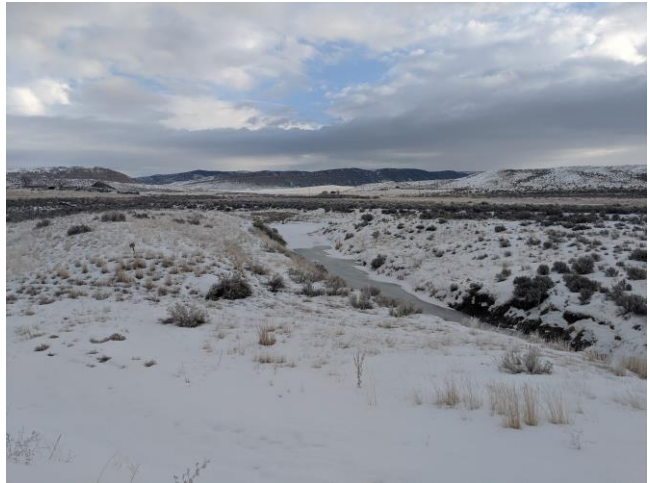
Ponds associated with the Gossard Loadout were inspected. This included the Stoker Siding, Gossard and Rail Loop. Each pond held water during the inspection. The Rail Loop and Gossard Pond are designed for full containment and do not discharge. Discharge could not be observed at the Stoker Siding Pond from the vantage point of the picture. Each pond was stable with no issues.

Stoker Siding Pond.

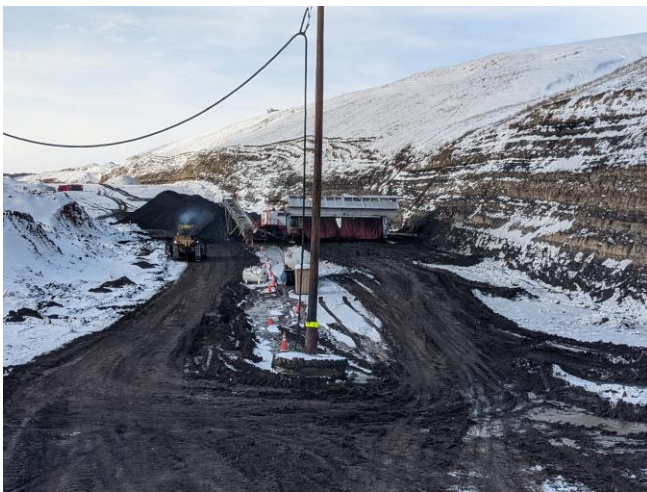
Highwall mining operations were currently in the Little Collom Gulch operating to west. Operations appear to moving to the north based on the previous Division's inspection.

Highwall mining operations in Little Collom Gulch.
