Colowyo Mine Inspection Report

Permit Number: C-1981-019 Mine Name: Colowyo Coal Mine Operator: Colowyo Coal Company L.P. Operator Address: Mr Tony Tennyson 5731 State Highway 13 Meeker, CO 81641	County: Moffat, Rio Blanco Operation Type: Surface Permit Status: Active Ownership: Private
	Operator Representative Present: Tony Tennyson and Tom Fry
Operator Representative Signature: (Field Issuance Only)

Inspection Start Date: January 25, 2024 Inspection Start Time: 07:30 Inspection End Date: January 25, 2024 Inspection End Time: 11:00		Inspection Type: Coal Partial Inspection Inspection Reason: Normal I&E Program Weather: Clear	
Joint Inspection Agency: None		Joint Inspection Contacts: None	
Post Inspection Agency: None		Post Inspection Contacts: None	
Inspector(s): Zach Trujillo	Inspector's Signature:

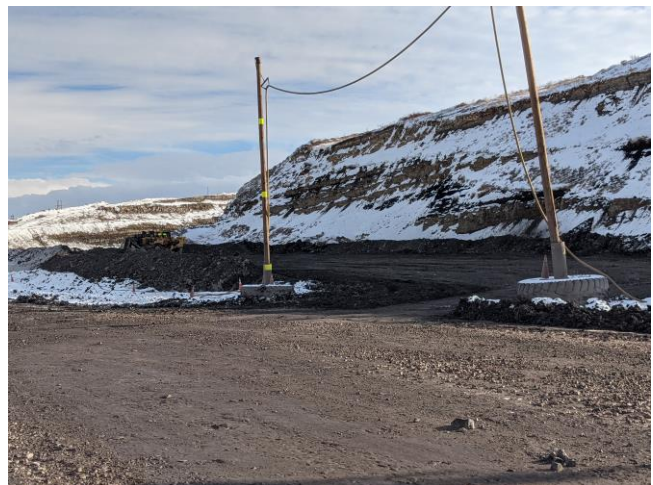
Additional fill placement was observed along the entrance of the eastern section of the Collom Pit. It appeared this spoil was to ramp up to from the current elevation of the Collom in-pit haul road to this portion of the Collom Pit. No issues were observed.

Fill placement at along entrance Collm Pit haul road.

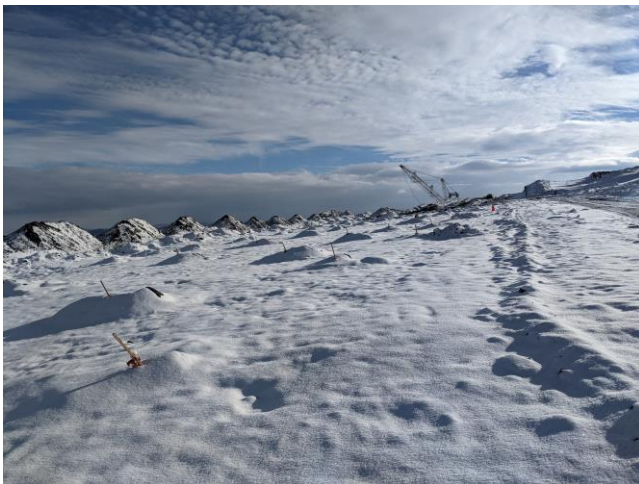
Marked blast holes were observed in overburden along the southern portion of the Collom Pit. The blast was not observed and did not occur during the inspection.

Blast holes at Collom Pit.

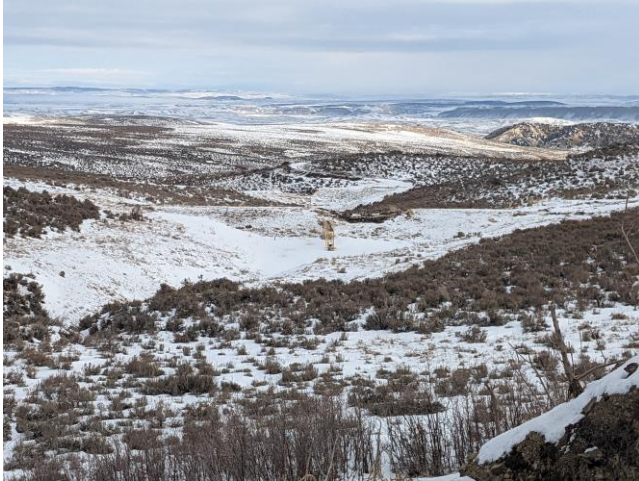
Section 36 and Middle Pond were inspected from above along the Collom Haul Road. Both ponds held water however it was unclear to what amount. Both ponds were stable with no issues observed.

Section 36 Pond.

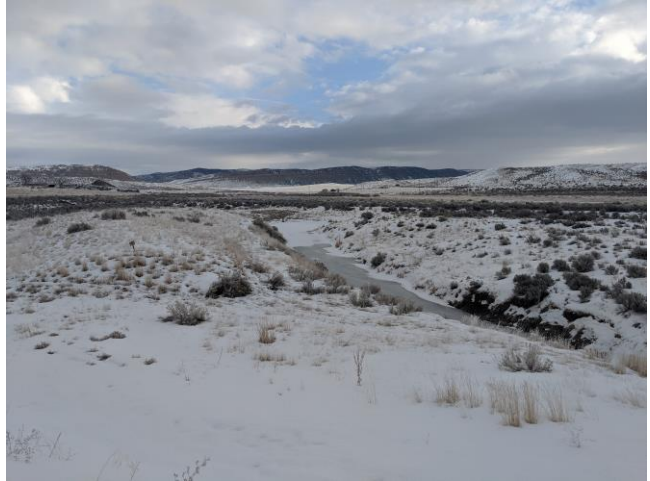
Ponds associated with the Gossard Loadout were inspected. This included the Stoker Siding, Gossard and Rail Loop. Each pond held water during the inspection. The Rail Loop and Gossard Pond are designed for full containment and do not discharge. Discharge could not be observed at the Stoker Siding Pond from the vantage point of the picture. Each pond was stable with no issues.

Stoker Siding Pond.
