MINERALS PROGRAM INSPECTION REPORT
PHONE: (303) 866-3567

MINE NAME: Nickell Gravel Pit	MINE/PROSPECTING ID#: M-1994-077	MINERAL: Gravel	COUNTY: Washington
INSPECTION TYPE: Monitoring	WEATHER: Clear	INSP. DATE: January 31, 2024	INSP. TIME: 09:00
OPERATOR: Washington County	OPERATOR REPRESENTATIVE: Steve Williams	TYPE OF OPERATION: 112c - Construction Regular Operation	
REASON FOR INSPECTION: Normal I&E Program	BOND CALCULATION TYPE: None	BOND AMOUNT: \$0.00	
DATE OF COMPLAINT: NA	POST INSP. CONTACTS: None	JOINT INSP. AGENCY: None	
INSPECTOR(S): Brock Bowles	INSPECTOR'S SIGNATURE:

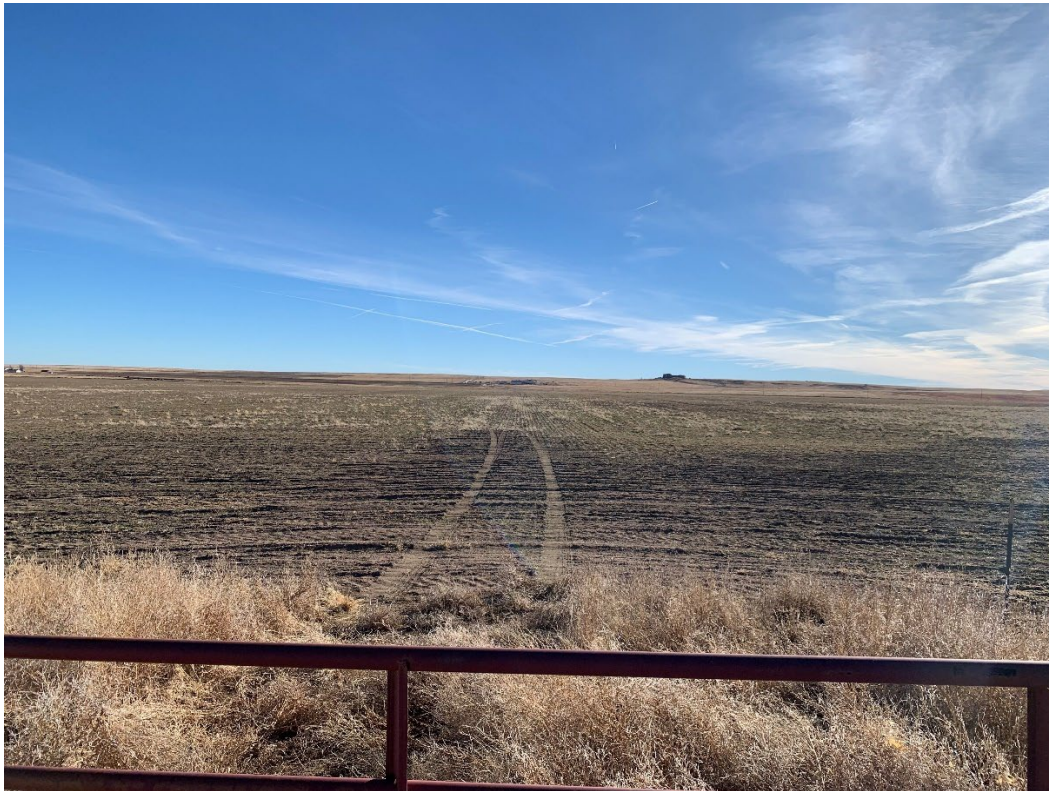
The pit access road from Hwy 71 has been reclaimed (photo 1). The gravel has been removed and the area has been graded to blend in with the surrounding agricultural field. Topsoil has been replaced and winter wheat was recently planted and is beginning to sprout.

Photo 1 – Reclaimed access road, the road went straight across the agricultural field for 2,000’.

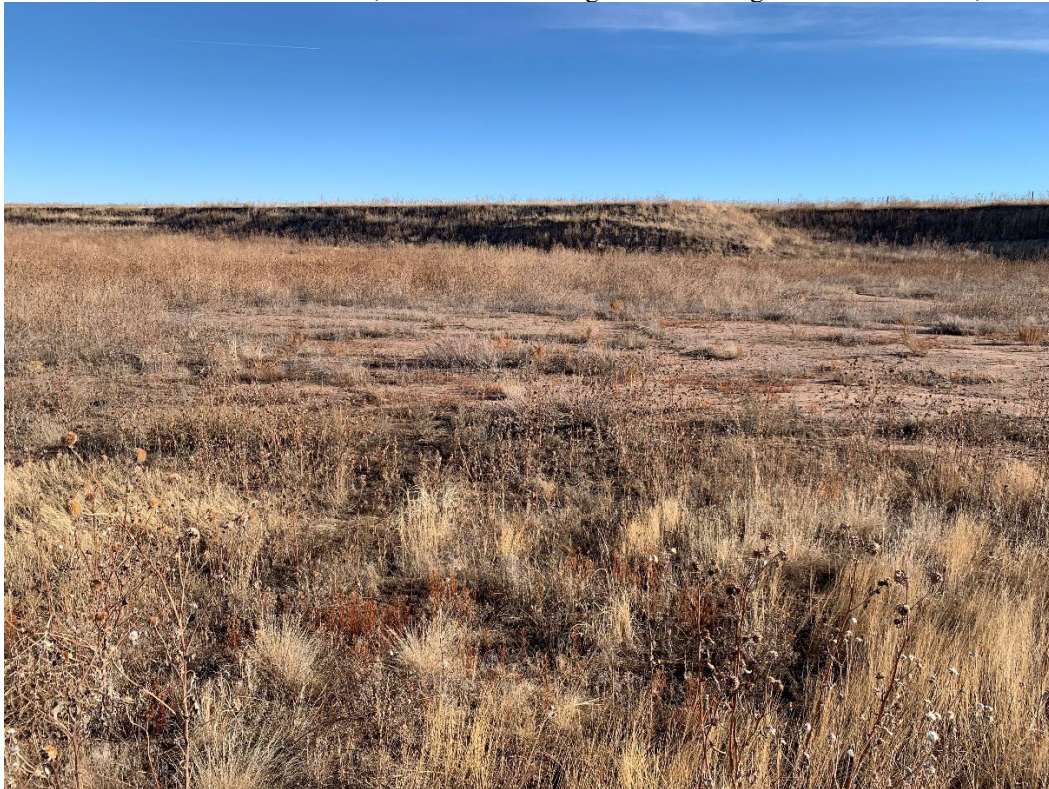
The mining operations were located on the west bank and in the channel of Vega Creek, an ephemeral stream. The east side of Vega Creek is a natural cut bank that was not disturbed by mining (photo 2). This cut bank feature is documented in previous inspection reports.

The bottom of Vega Creek did not have topsoil and was comprised of gravel. There were some grasses and a lot of sunflower stalks in the creek bottom. The channel bottom was mostly flat with a few small water flow channels. The creek was dry at the time of the inspection.

Photo 2 – Vega Creek bottom with natural cut bank on east side.

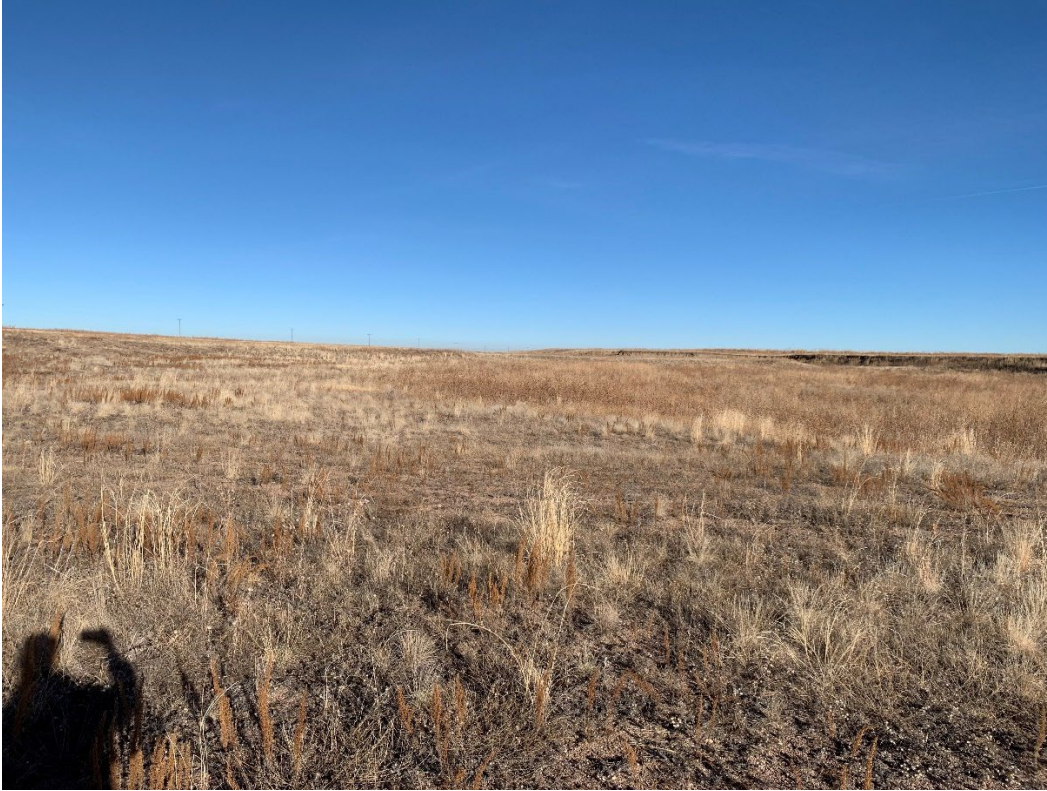
The west side of Vega Creek is where the access road, loading area and stockpiles were located. These areas have been backfilled/graded, topsoiled, and seeded (photos 3 - 5). The slopes are graded to 3h:1v or less. There is a bench about 8 acres in size and roughly 2'-5' feet higher than the creek bottom but is still within the creek channel. The bench is graded flat and sloped towards the creek. The bench area is well vegetated with upland grass species and forbs. The vegetation density and composition is consistent with the surrounding undisturbed areas. No noxious weeds were noted. No erosion features were seen on the bench area or on the side slopes.

Photo 3 – West side of Vega Creek, facing north, former location of loading area and stockpiles.

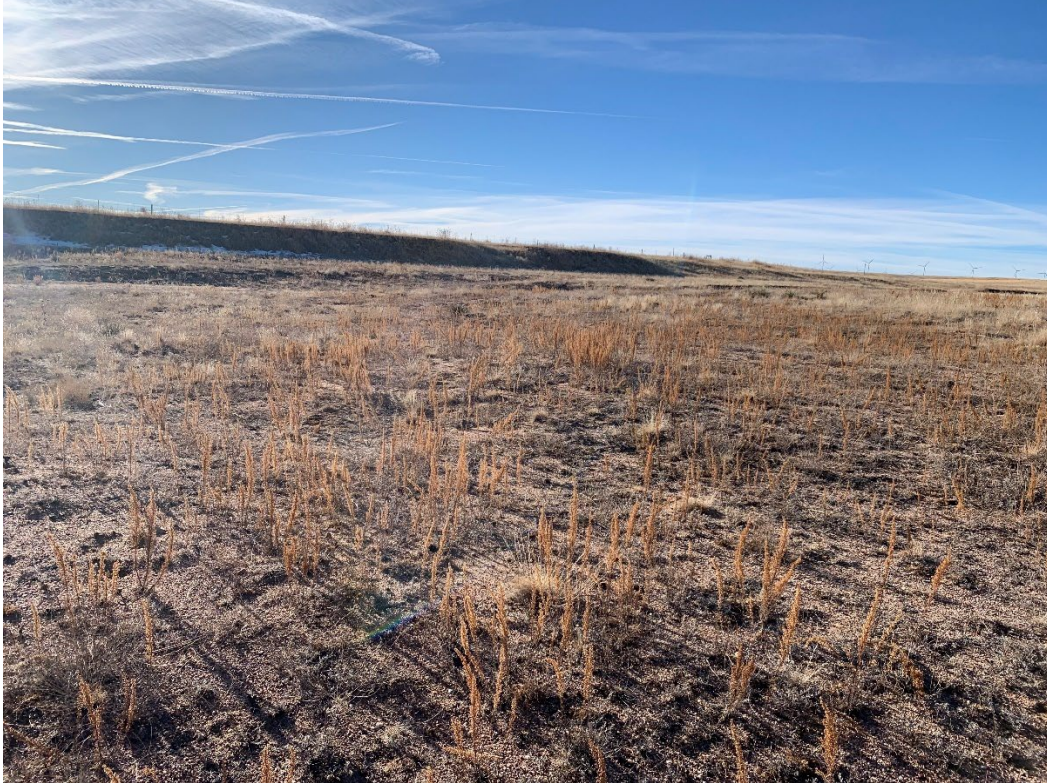
Photo 4 – Southern part of mined area where Vega Creek enters the permit area, photo facing southeast.

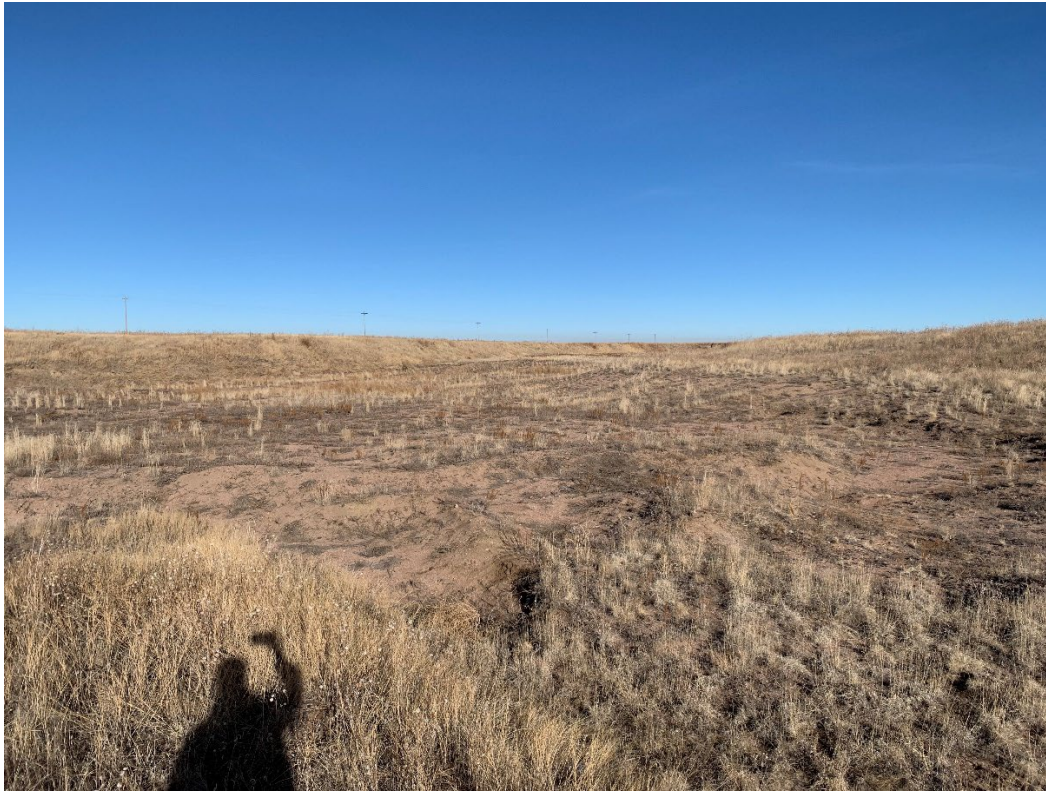
Photo 5 - Northern section of Vega Creek.

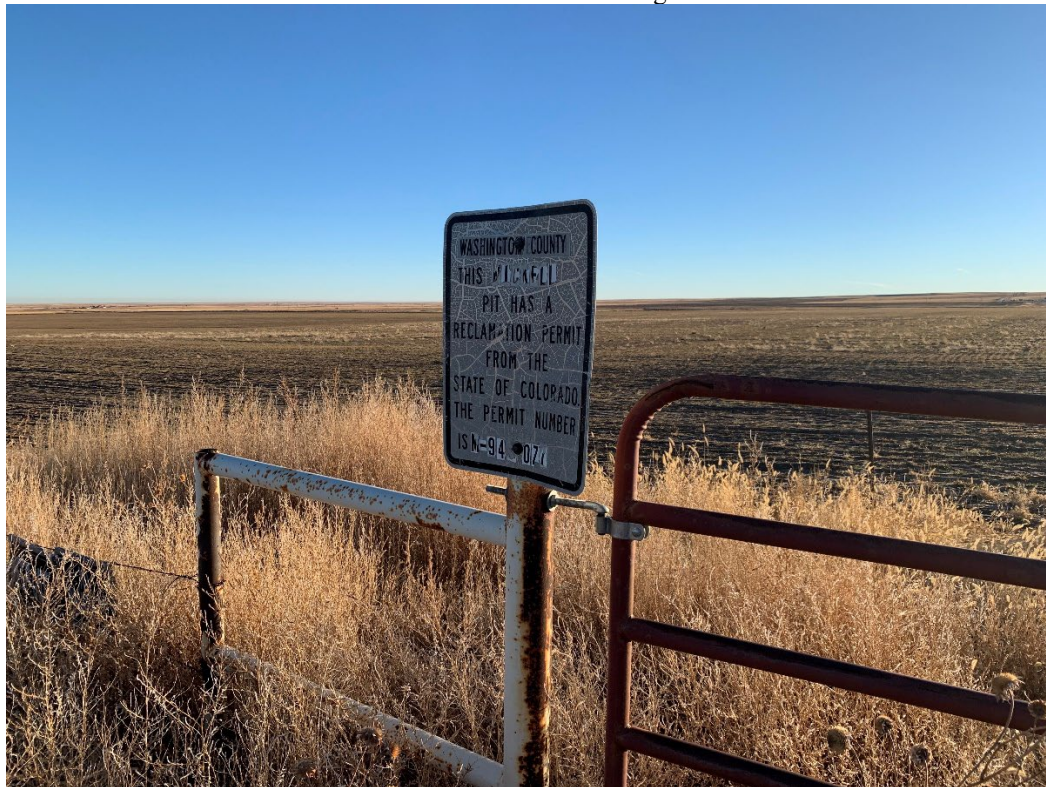
The permit sign was posted at the site entrance off Highway 71 (photo 6). The entry gate was closed upon arrival.

Photo 6 – Mine entrance sign facing Hwy 71
