MINERALS PROGRAM INSPECTION REPORT
PHONE: (303) 866-3567

MINE NAME: Laybourn Pit	MINE/PROSPECTING ID#: M-2016-074	MINERAL: Clay (general), gravel	COUNTY: Washington
INSPECTION TYPE: Monitoring	WEATHER: Clear	INSP. DATE: January 31, 2024	INSP. TIME: 10:00
OPERATOR: Washington County	OPERATOR REPRESENTATIVE: Steve Williams	TYPE OF OPERATION: 110c - Construction Limited Impact	
REASON FOR INSPECTION: Normal I&E Program	BOND CALCULATION TYPE: None	BOND AMOUNT: \$0.00	
DATE OF COMPLAINT: NA	POST INSP. CONTACTS: None	JOINT INSP. AGENCY: None	
INSPECTOR(S): Brock Bowles	INSPECTOR'S SIGNATURE:

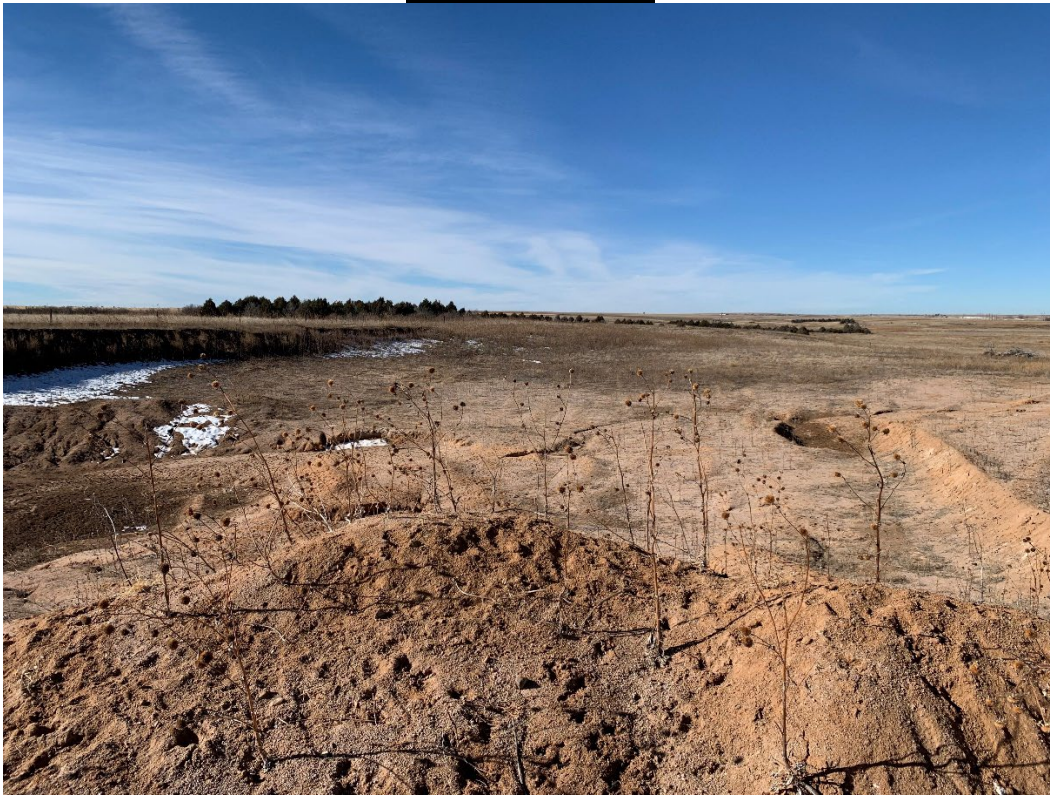
The main pit area is in the middle of the permit area. Gravel is pushed out of the pit on the eastern side where it is stockpiled and loaded onto trucks. The pit area is open to the west which allows for water drainage (photo 1). A small stockpile of gravel was stacked east of the pit area.

The highwall on the south side of the pit was about 10 feet high. The approved height is 15 feet. The highwall was sloughing in some areas and is getting close to the southern permit boundary fence line. The operator needs to monitor this section of the highwall to ensure it doesn't migrate to close to the permit boundary.

Photo 1 – Western side of pit area. Highwall close to fence line on left side.

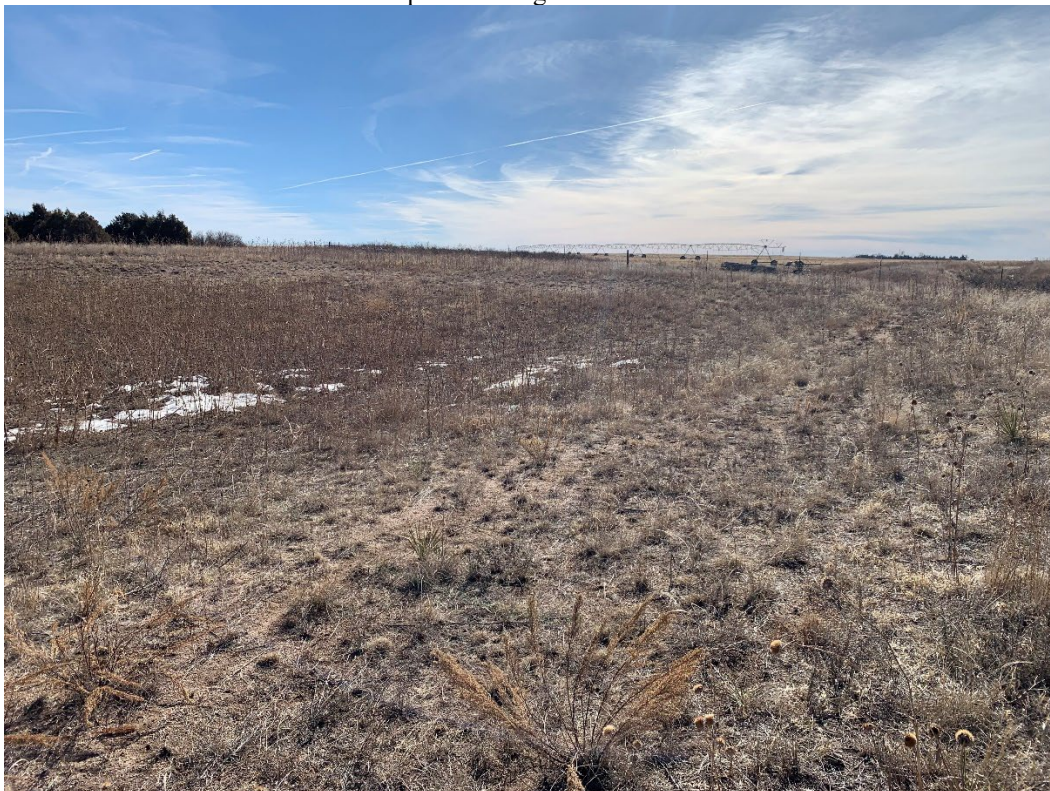
The southwestern corner of the permit area has been backfilled and graded to 3h:1v slopes (photo 2). The vegetation in this area is recovering very well although Mr. Williams said it has not been seeded yet.

Photo 2 – Southwest corner of permit area, facing south.

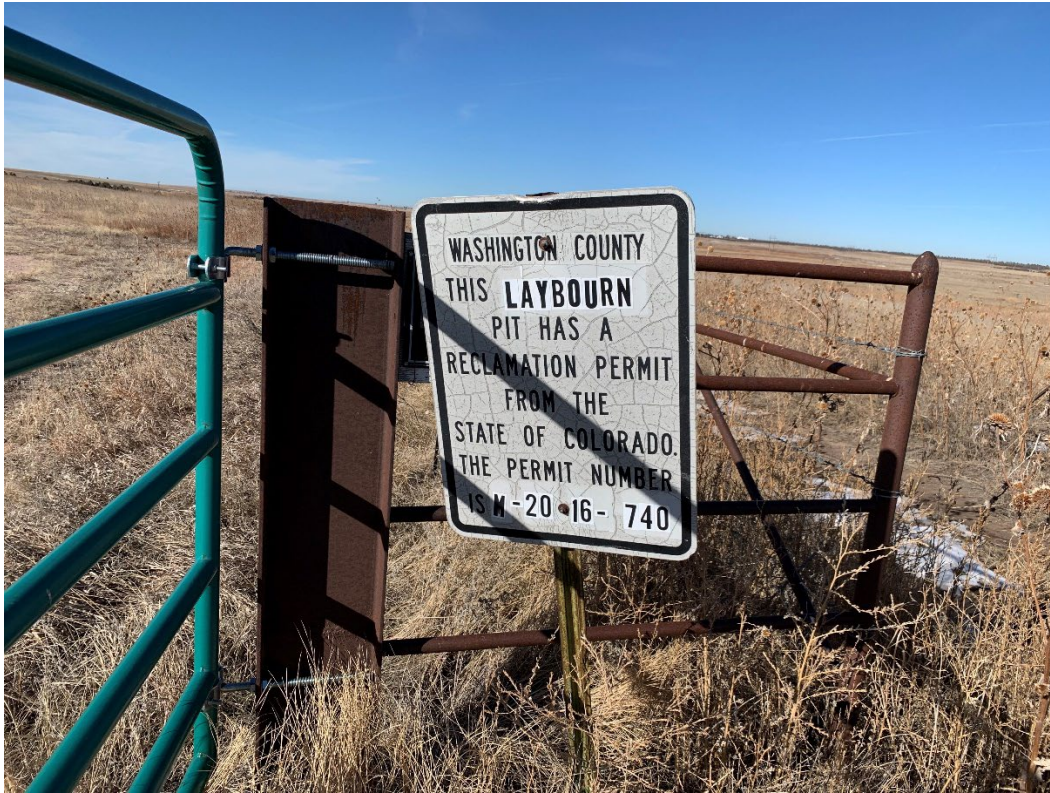
The mine entrance sign was in place at the entrance gate (photo 3). The gate was closed upon arrival. The permit boundary was clearly delineated by a fence on all sides which was in good repair.

Photo 3 – Mine entrance sign facing east access road.

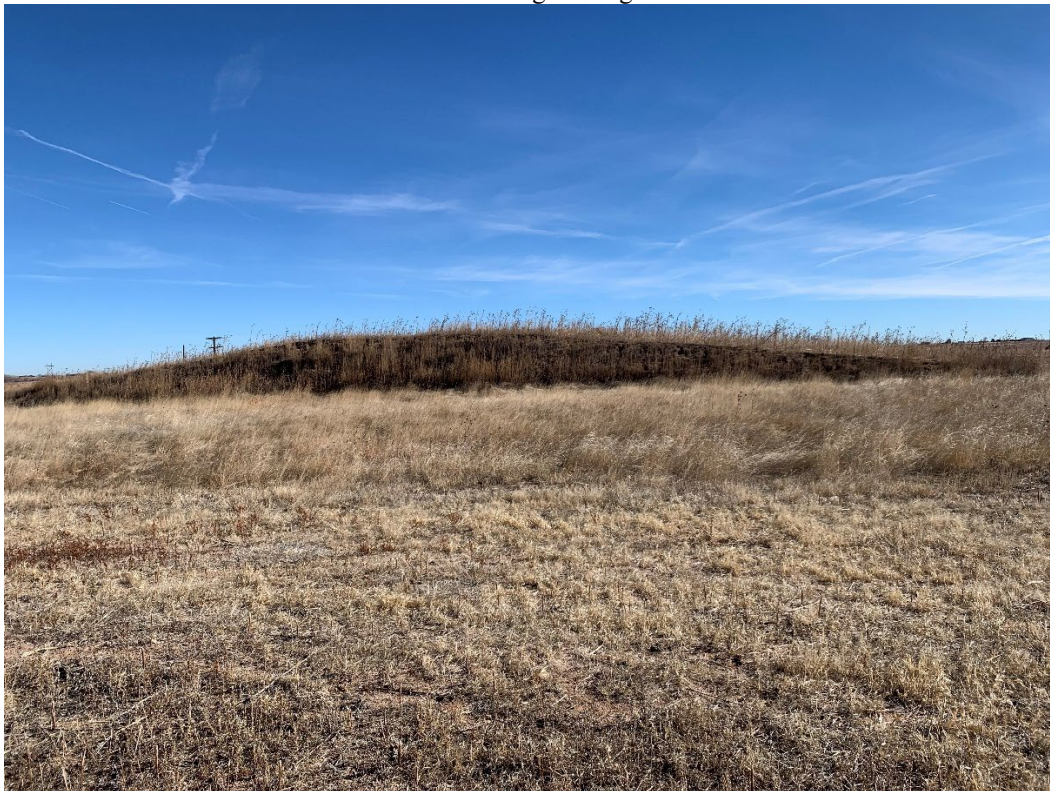
The topsoil stockpile is located along the eastern fence line and was well vegetated (photo 4). An additional overburden stockpile is located on the eastern side of the southern fence line. The overburden pile was also well vegetated and stable.

Photo 4 -Topsoil stockpile along eastern permit boundary.
