NewFields		CLIENT CRIPPLE CREEK & VICTOR GOLD MINING COMPANY	
PROJECT		VLF3 PHASE 3 STAGE A.2	
TITLE LEAK DETECTION TRENCH 1 AS-BUILT PLAN AND PROFILE		FILENAME 0106.060.064F	
		FIGURE NO. 5	REVISION 2

CLIENT CRIPPLE CREEK & VICTOR GOLD MINING COMPANY	
PROJECT		VLF3 PHASE 3 STAGE A.2	
TITLE	LEAK DETECTION TRENCH 2 AS-BUILT PLAN AND PROFILE (1 OF 2)		FILENAME
			0106.060.064F
			FIGURE NO. 6A
			REVISION 0

NewFields		CLIENT CRIPPLE CREEK & VICTOR GOLD MINING COMPANY	
PROJECT		VLF3 PHASE 3 STAGE A.2	
TITLE	LEAK DETECTION TRENCH 2		FILENAME
	AS-BUILT PLAN AND PROFILE (2 OF 2)		0106.060.064F
		FIGURE NO.	REVISION
		6B	0

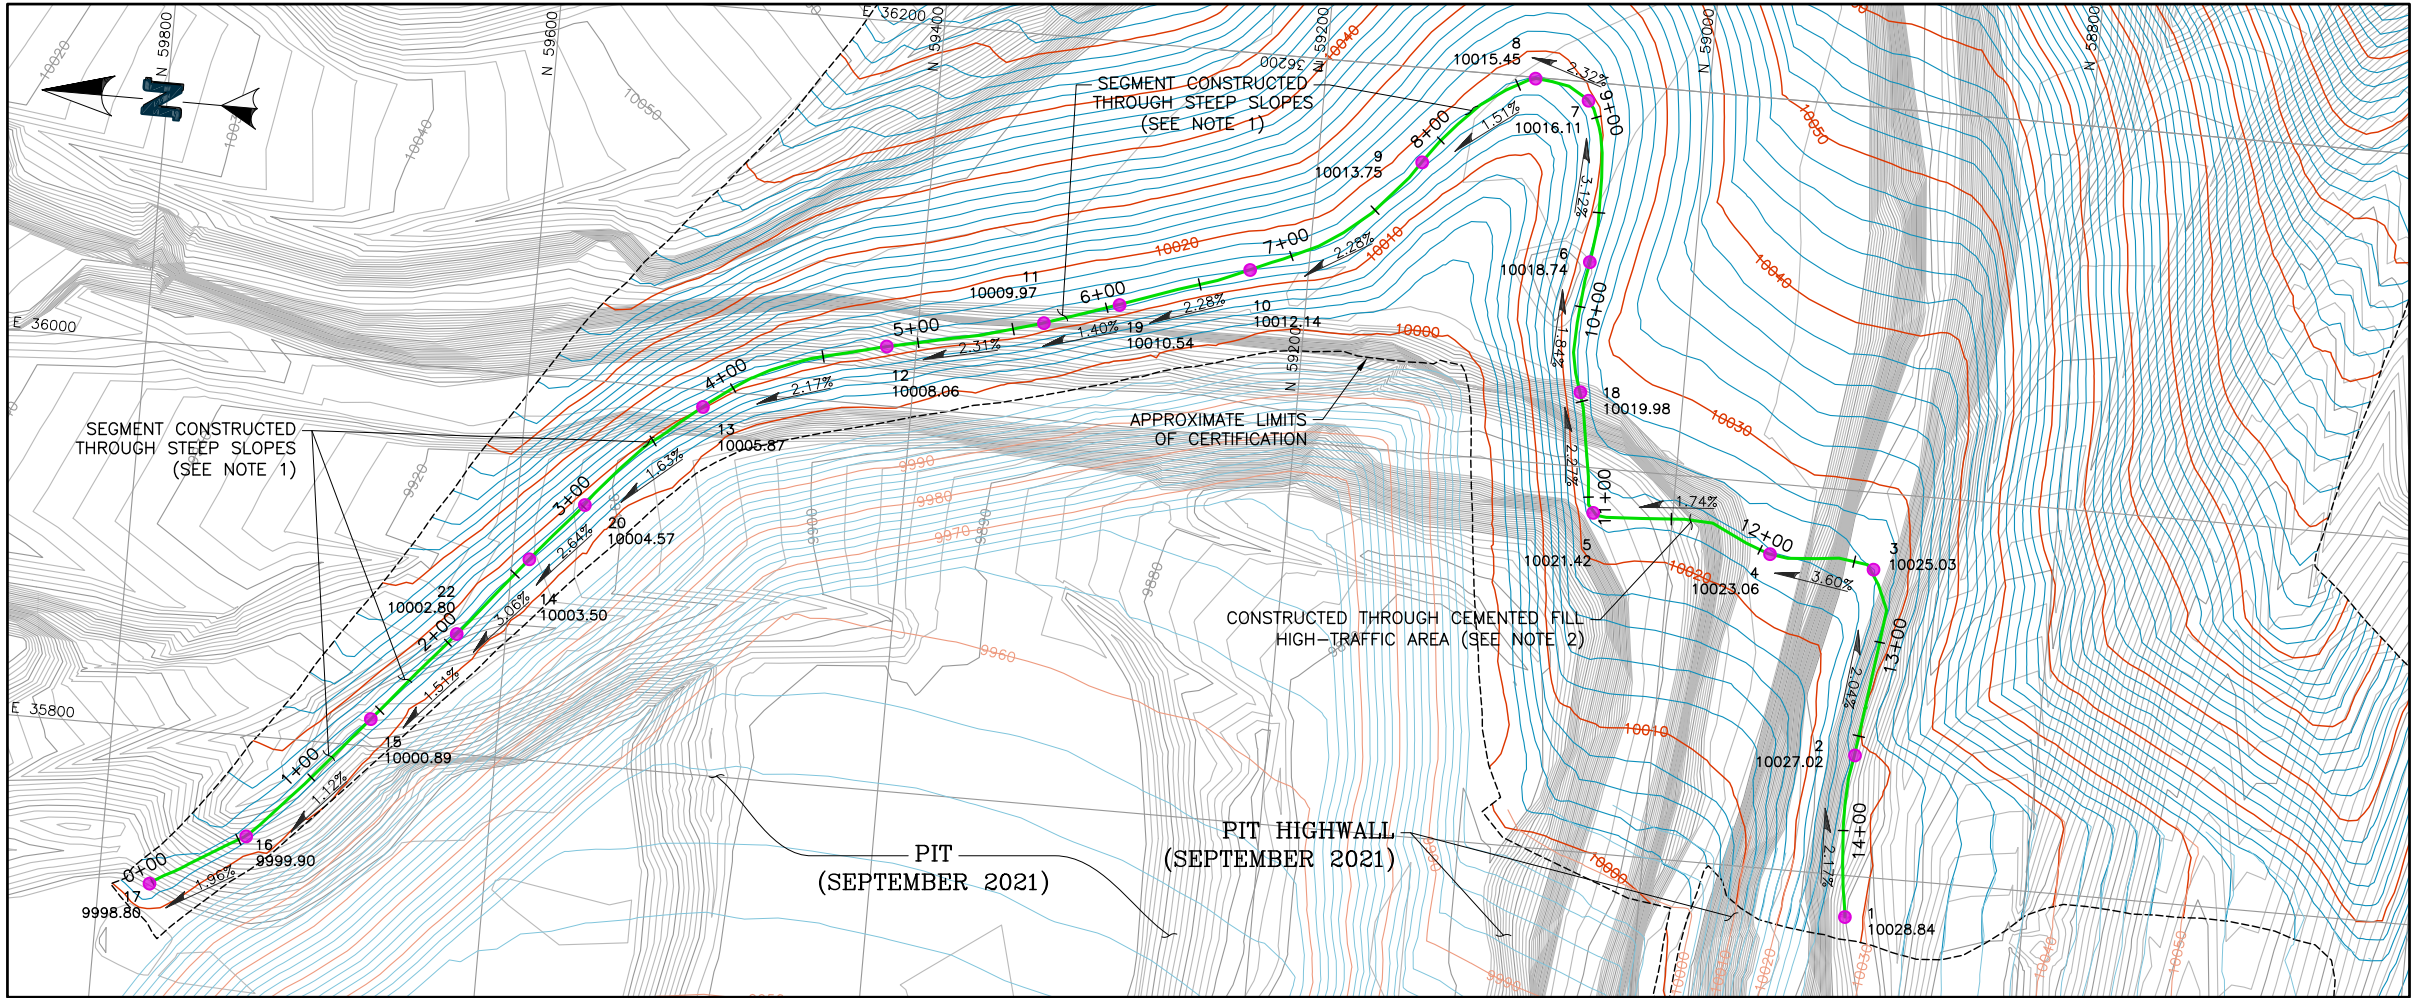
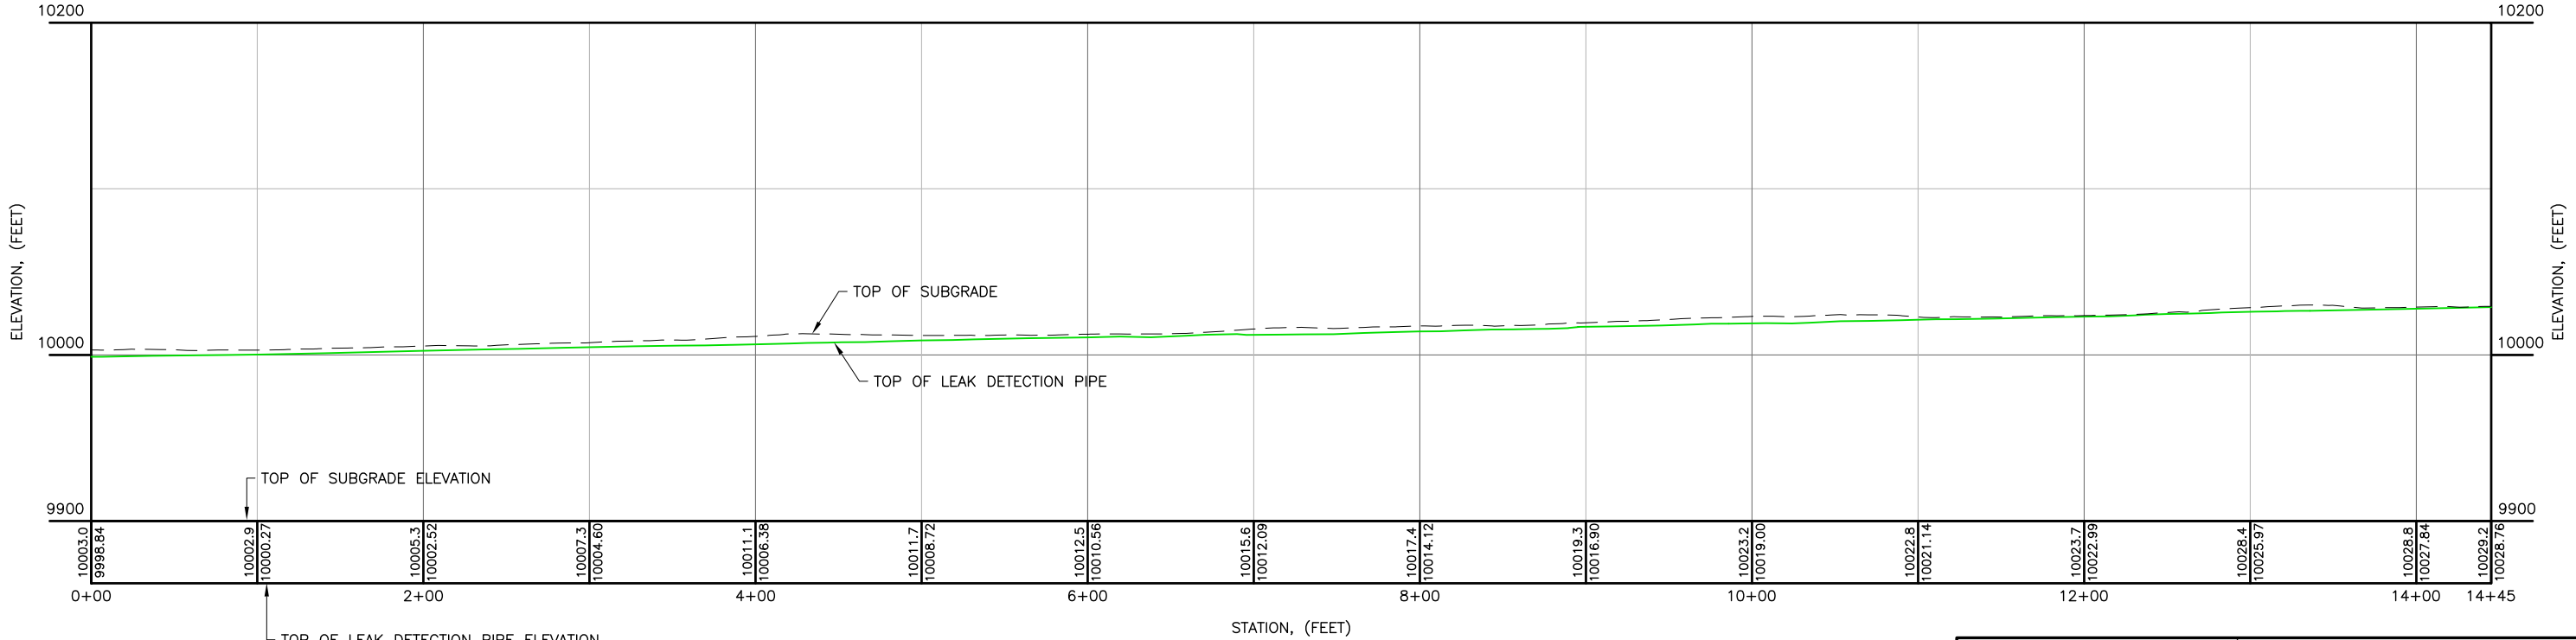
- SEGMENT CONSTRUCTED THROUGH STEEP SLOPES MAKING CONSTRUCTION AT EXACT SLOPE PROHIBITIVELY DIFFICULT.
- SEGMENT CONSTRUCTED THROUGH HIGH TRAFFIC AREA (AUGUST 2021 – JUNE 2023) WITH CEMENTED FILL. GIVEN THE LEVEL OF COMPACTION THIS AREA RECEIVED AS A RESULT OF THIS TRAFFIC, SETTLEMENT IS UNLIKELY.
- OVERALL SLOPE OF LOWER LEAK DETECTION TRENCH IS 2.10%.

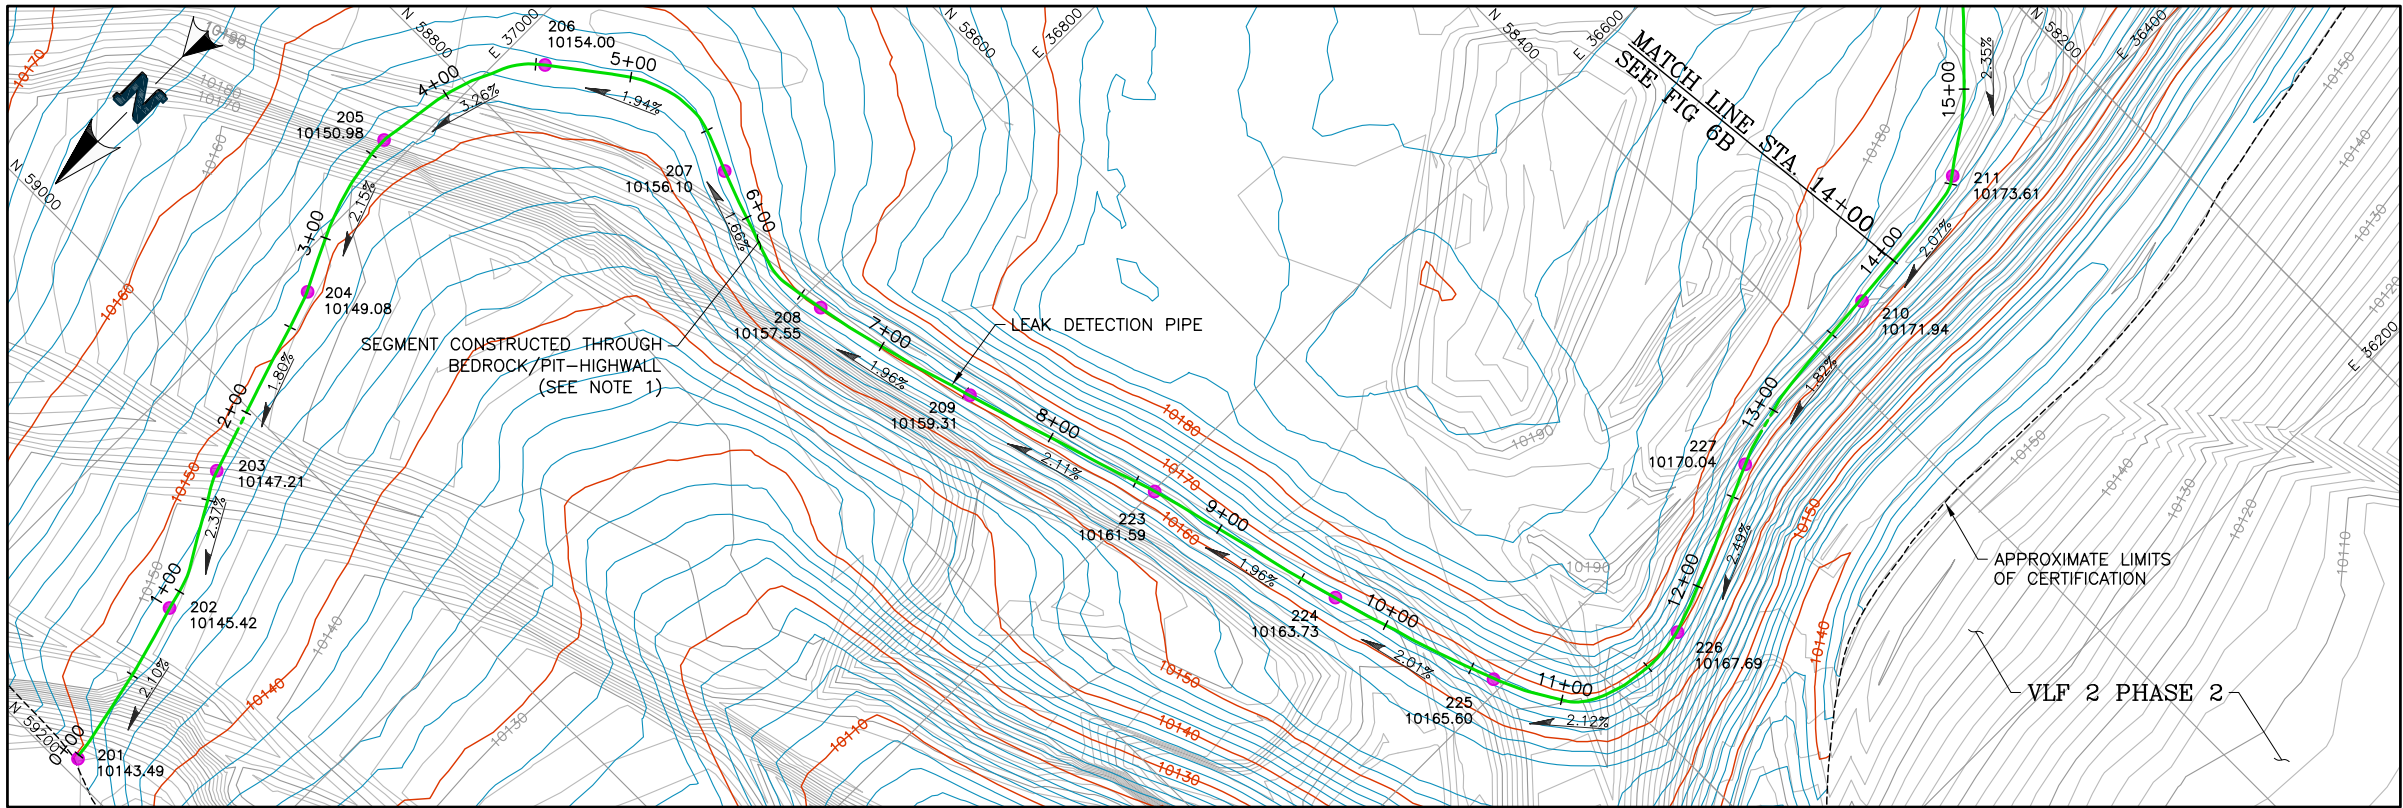
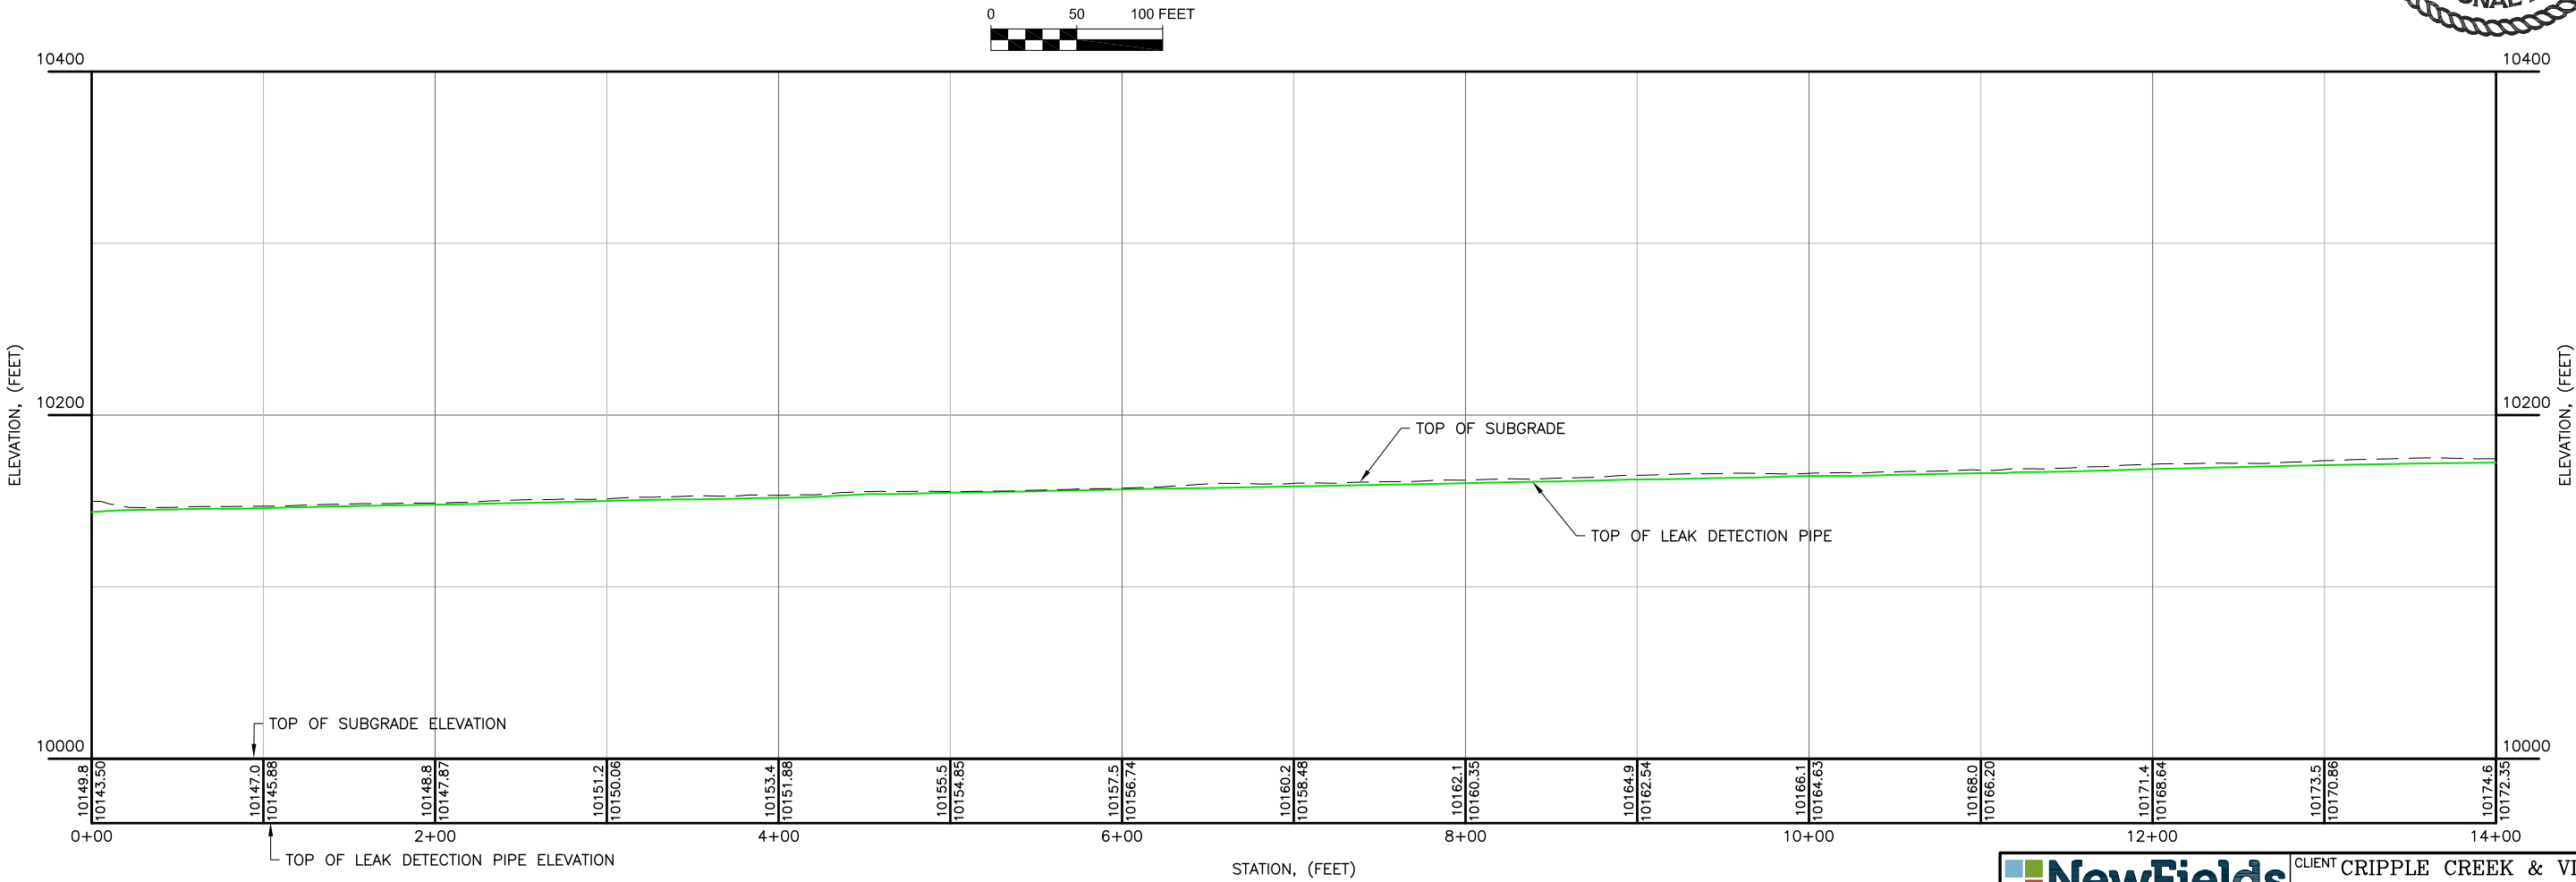
- NOTES:**
- SEGMENT CONSTRUCTED THROUGH BEDROCK/PIT-HIGHWALL. METHODS NECESSARY FOR FURTHER EXCAVATION, SUCH AS BLASTING, WOULD BE LESS PRECISE AND ULTIMATELY DETRIMENTAL TO THE PROJECT. SETTLEMENT IN THESE AREAS IS UNLIKELY.
 - SEGMENT CONSTRUCTED THROUGH IN-SITU FILL PLACED BEFORE 2012. SETTLEMENT IN THESE AREAS IS UNLIKELY.
 - OVERALL SLOPE OF UPPER LEAK DETECTION TRENCH IS 2.06%.

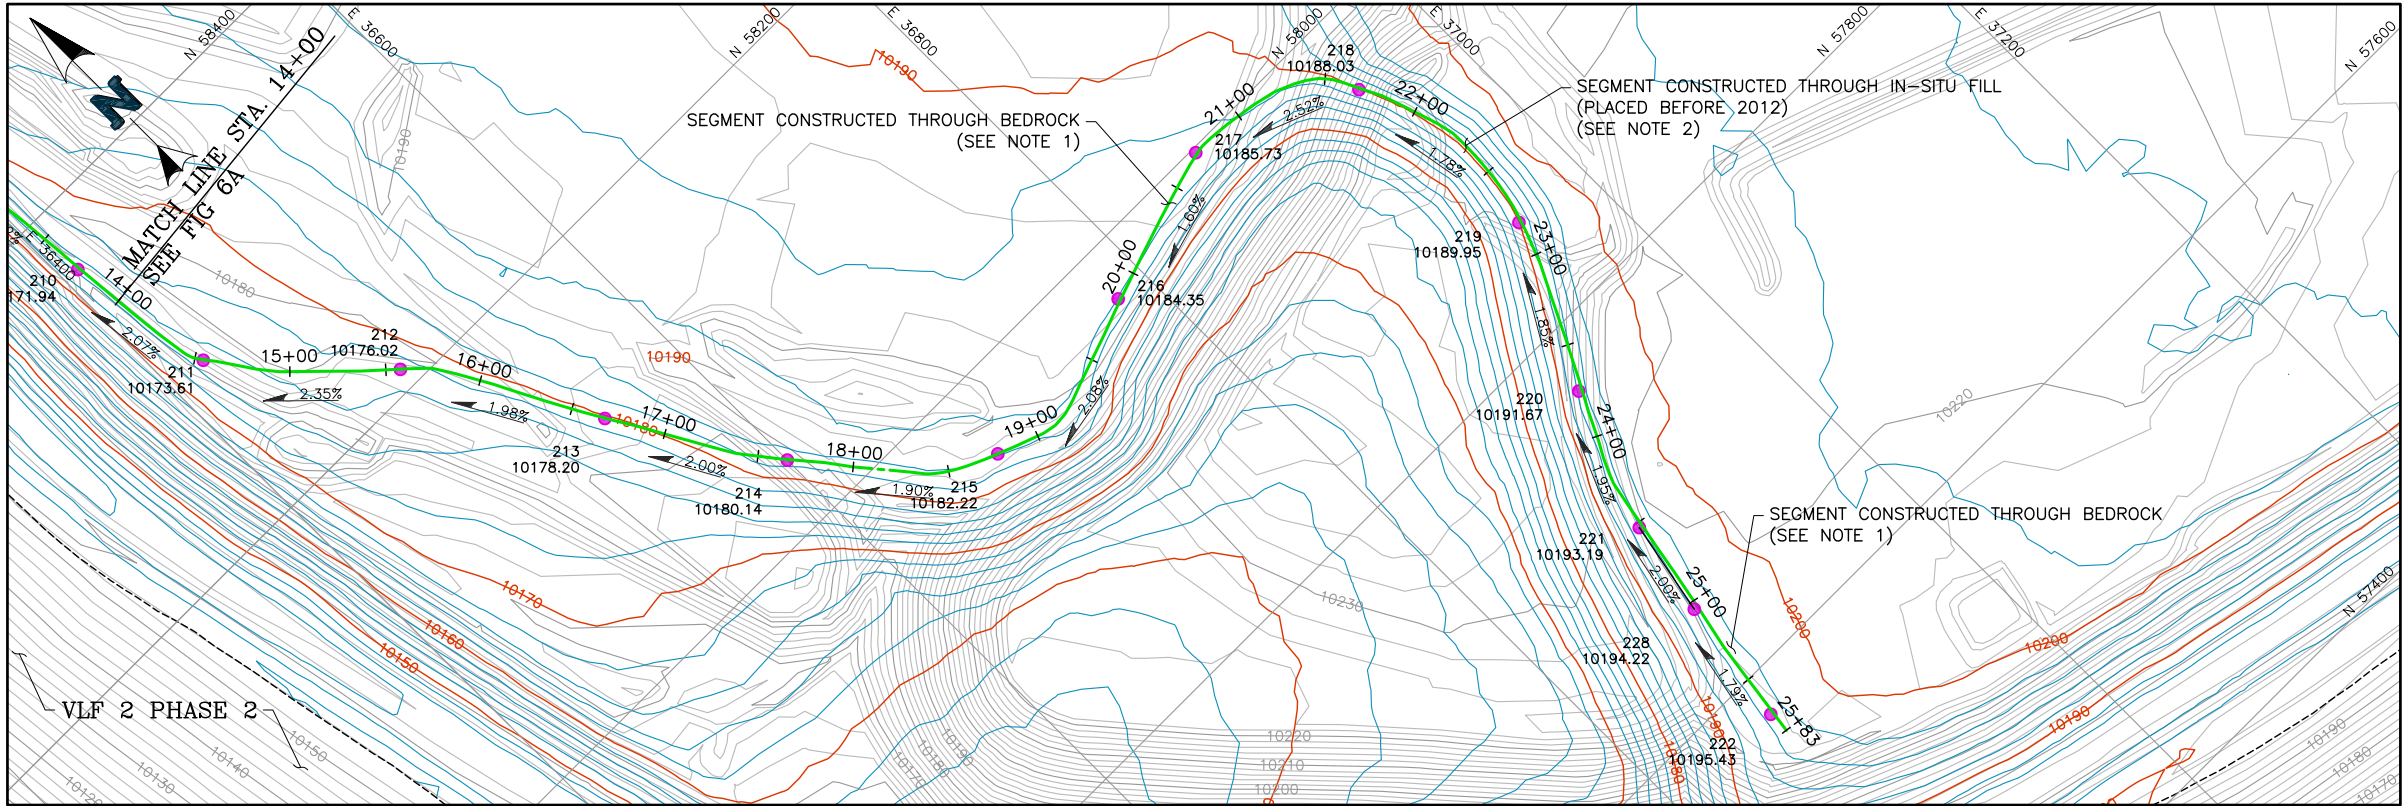
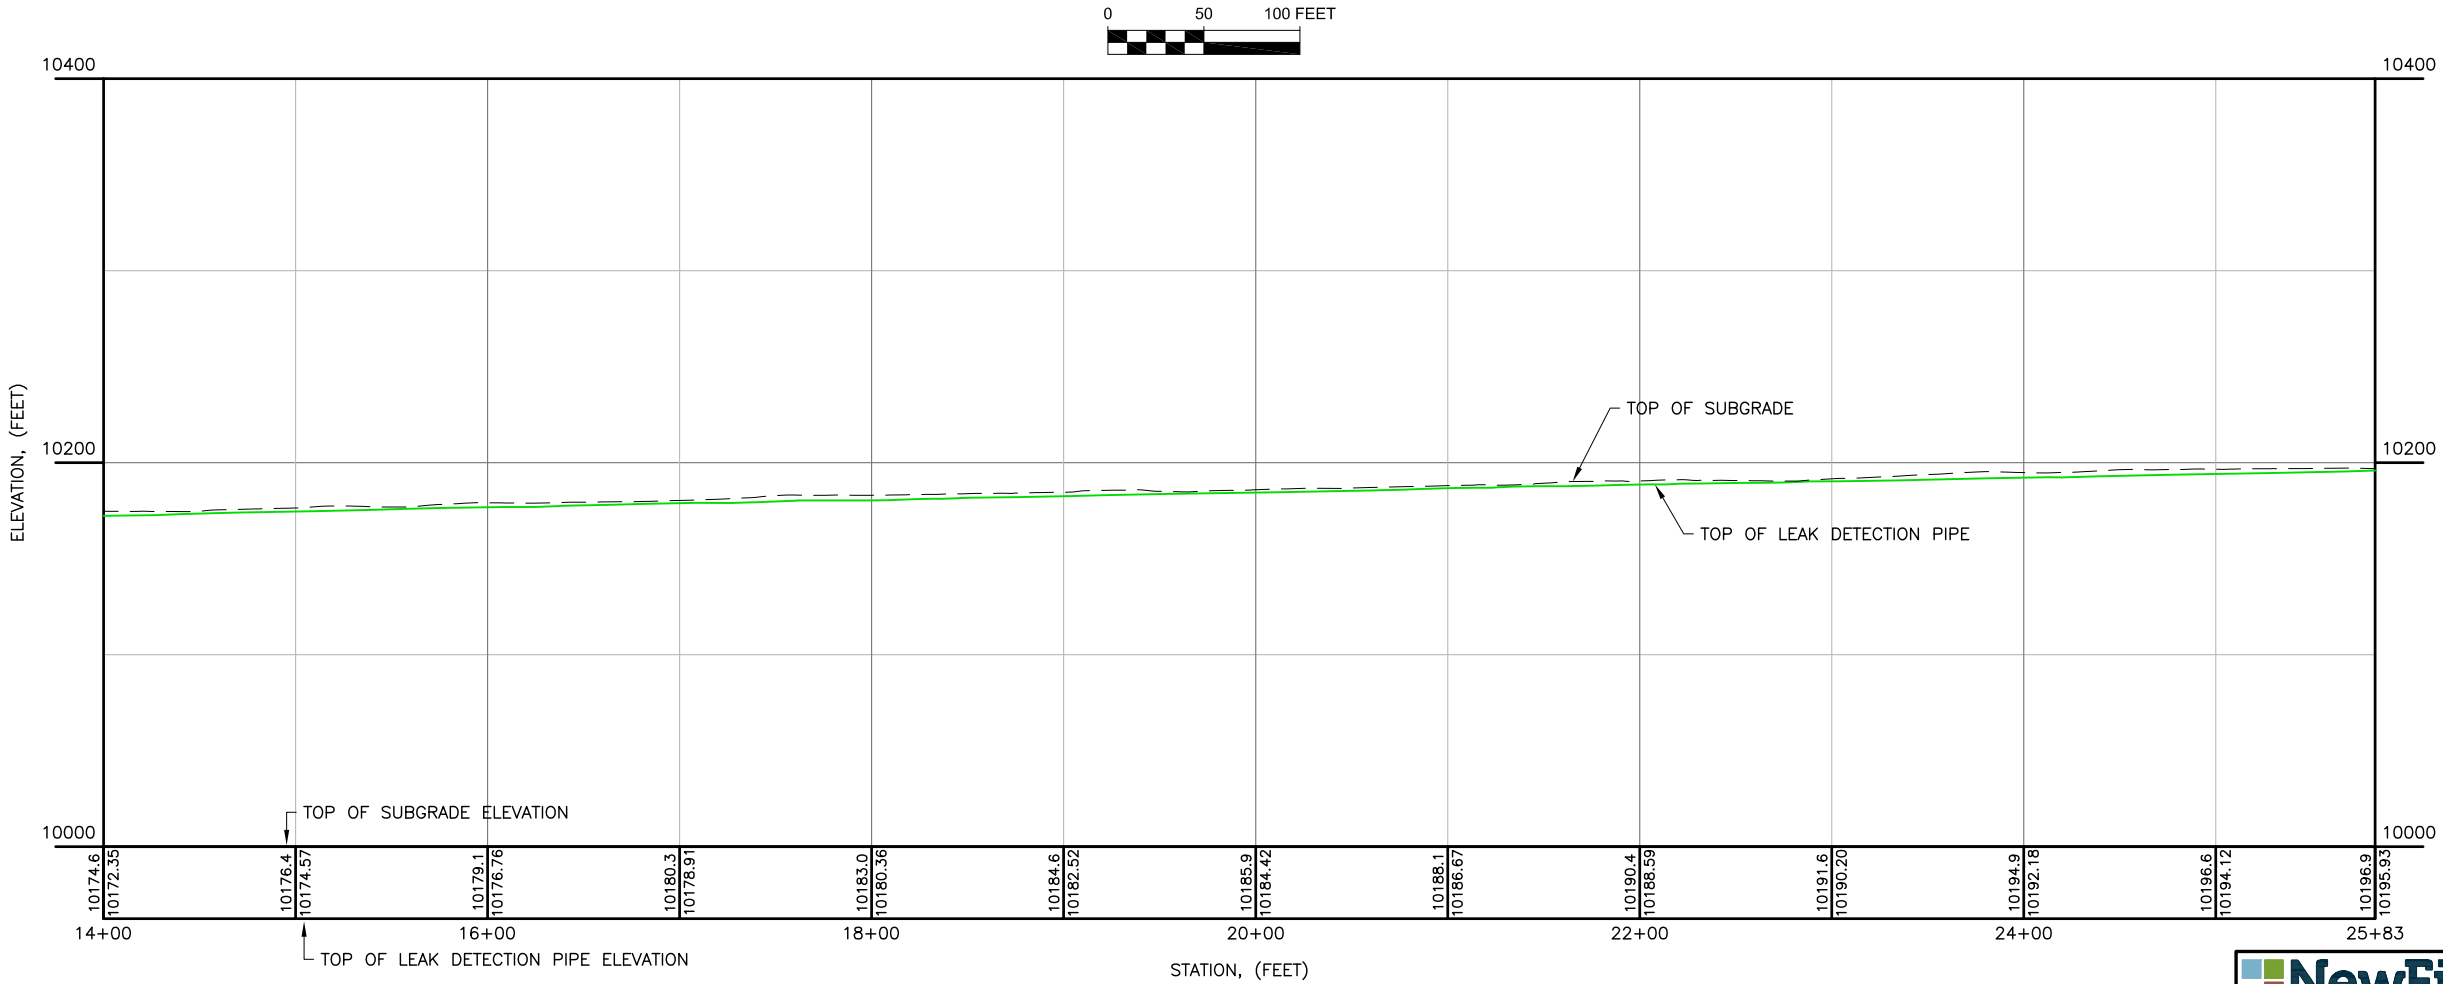
- NOTES:**
- SEGMENT CONSTRUCTED THROUGH BEDROCK/PIT-HIGHWALL. METHODS NECESSARY FOR FURTHER EXCAVATION, SUCH AS BLASTING, WOULD BE LESS PRECISE AND ULTIMATELY DETRIMENTAL TO THE PROJECT. SETTLEMENT IN THESE AREAS IS UNLIKELY.
 - SEGMENT CONSTRUCTED THROUGH IN-SITU FILL PLACED BEFORE 2012. SETTLEMENT IN THESE AREAS IS UNLIKELY.
 - OVERALL SLOPE OF UPPER LEAK DETECTION TRENCH IS 2.06%.
