**MINERALS PROGRAM INSPECTION REPORT**  
**PHONE: (303) 866-3567**

<b>MINE NAME:</b> Cole Gravel Pit	<b>MINE/PROSPECTING ID#:</b> M-2004-020	<b>MINERAL:</b> Sand and gravel	<b>COUNTY:</b> Mesa
<b>INSPECTION TYPE:</b> Monitoring	<b>WEATHER:</b> Clear	<b>INSP. DATE:</b> January 24, 2024	<b>INSP. TIME:</b> 13:15
<b>OPERATOR:</b> M.A. Concrete Construction, Inc.	<b>OPERATOR REPRESENTATIVE:</b> Andy Azacarraga	<b>TYPE OF OPERATION:</b> 112c - Construction Regular Operation	
<b>REASON FOR INSPECTION:</b> Normal I&E Program	<b>BOND CALCULATION TYPE:</b> Complete Bond	<b>BOND AMOUNT:</b> \$399,860.00	
<b>DATE OF COMPLAINT:</b> NA	<b>POST INSP. CONTACTS:</b> DRMS	<b>JOINT INSP. AGENCY:</b> None	
<b>INSPECTOR(S):</b> Amy Yeldell	<b>INSPECTOR'S SIGNATURE:</b>

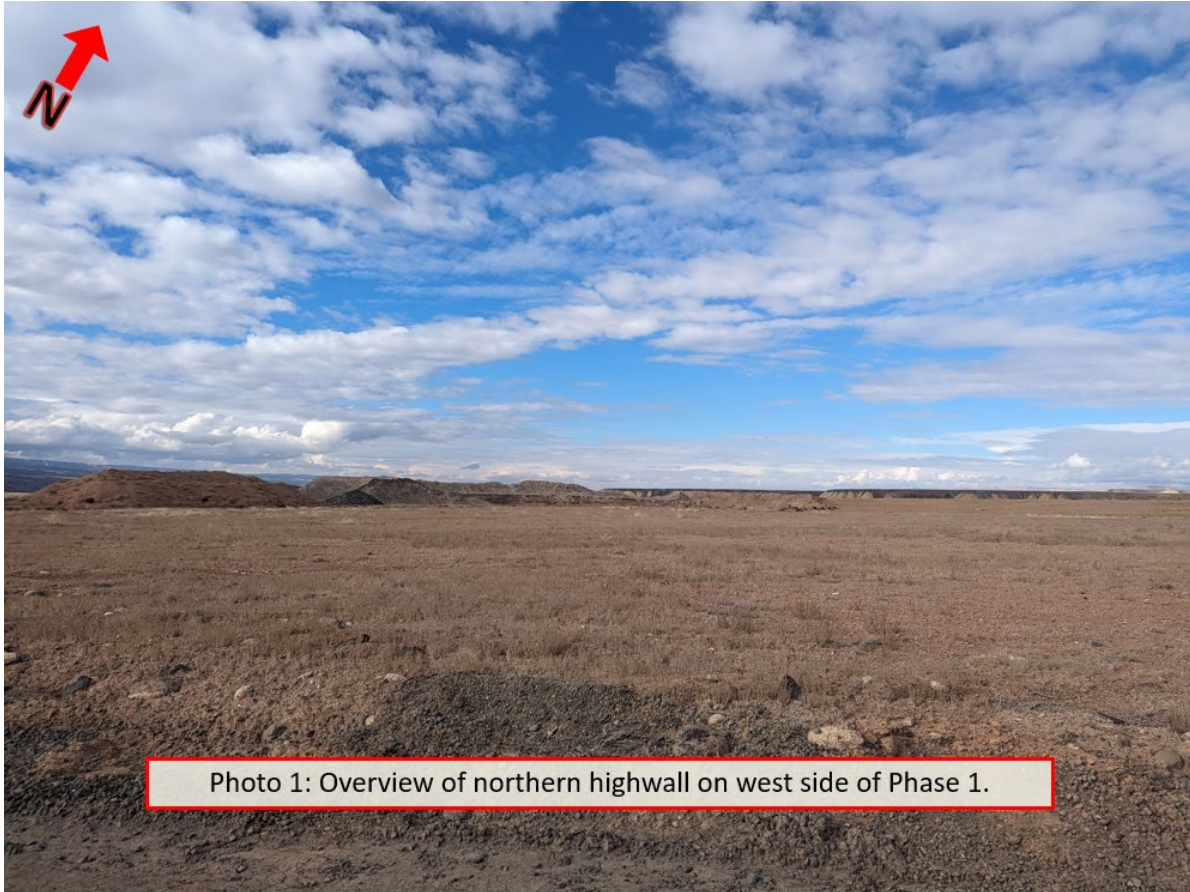
There is a small highwall remaining along the west side of phase 1 (Photo One). This material is primarily reject fines or sand that will be used for grading at the end. The highwall is estimated to be approximately 10 feet high and stretches along most of the east side of phase 1, approx. 1000LF. As well as the highwall that runs nearly the entire length of the affected lands from east to west (Photo Two and Three). This highwall is the divider of phases 1 and 2 from the southern Phases 3-6. Its approximately 2000 LF at 10-15 feet high. There is also an active highwall in Phase 2 that is moving from east to west. This highwall is estimated to be approximately 10-15'H and 900 LF in total. All of these highwalls vary from near vertical to a 1H: 1V slope and can be cut/fill.

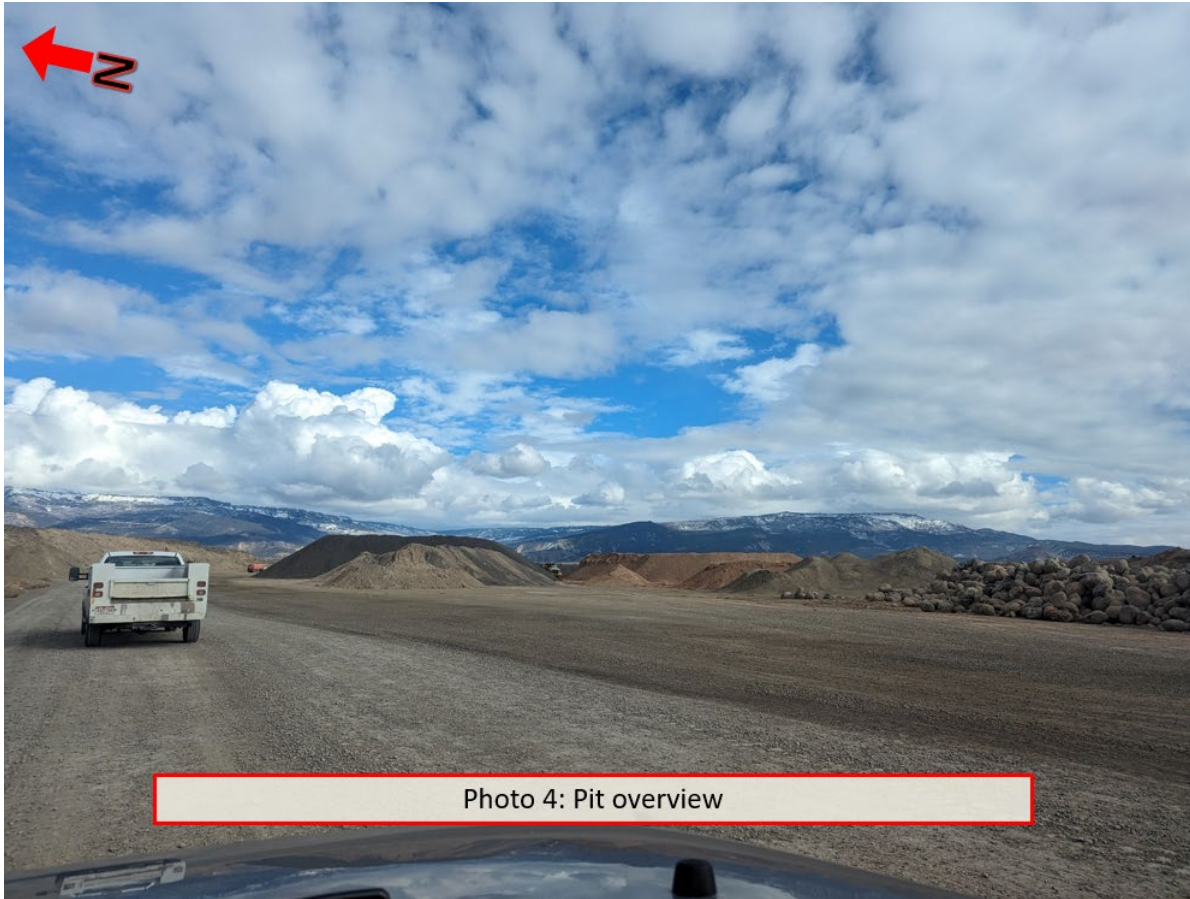
The site was active at the time of the inspection. It is estimated that approximately 100 acres have been affected to date. There are several large stockpiles of processed material stored on the pit floor, primarily within phase 2 (Photos 4-6). Mr. Azacarraga stated that they recently demobilized the crusher. No processing equipment remains on site. A loader, two excavators, a haul truck and a water truck remain on site.

Photo 4: Pit overview

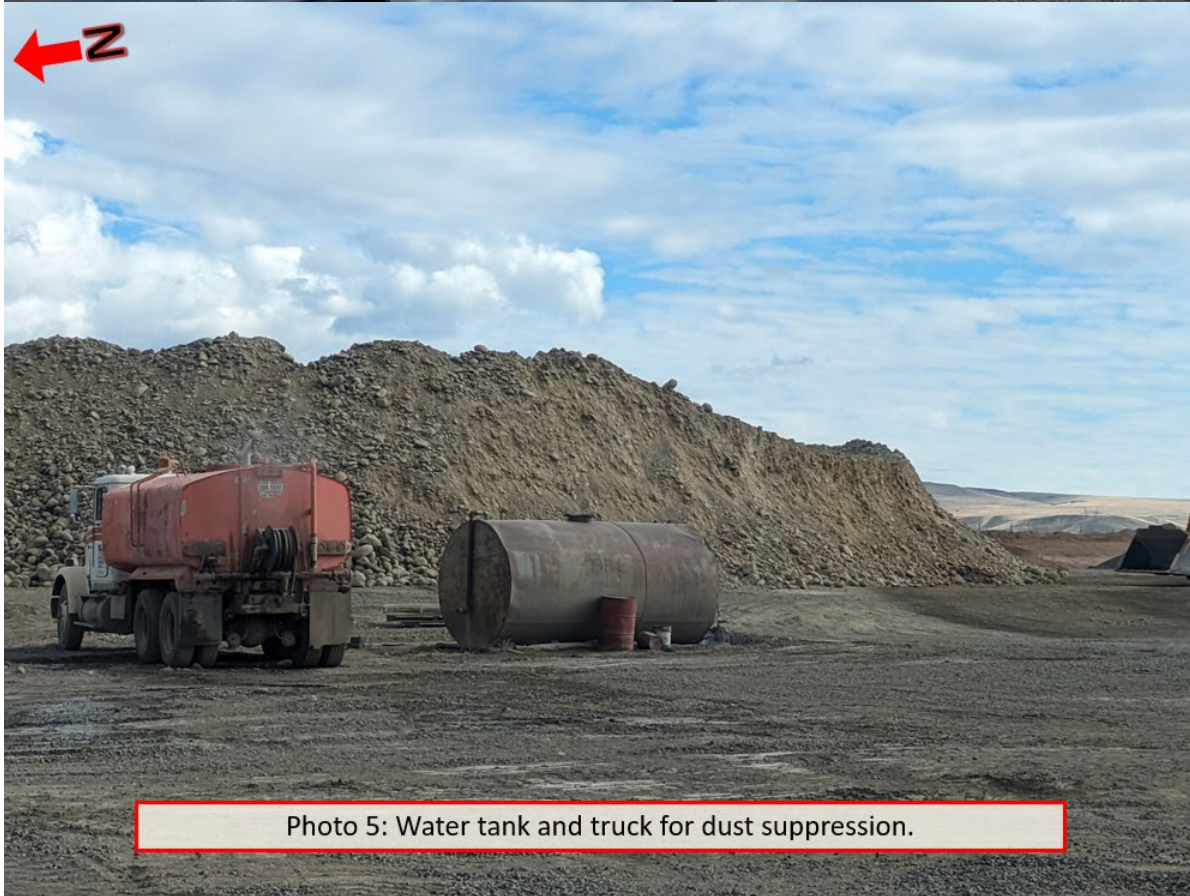
Photo 5: Water tank and truck for dust suppression.

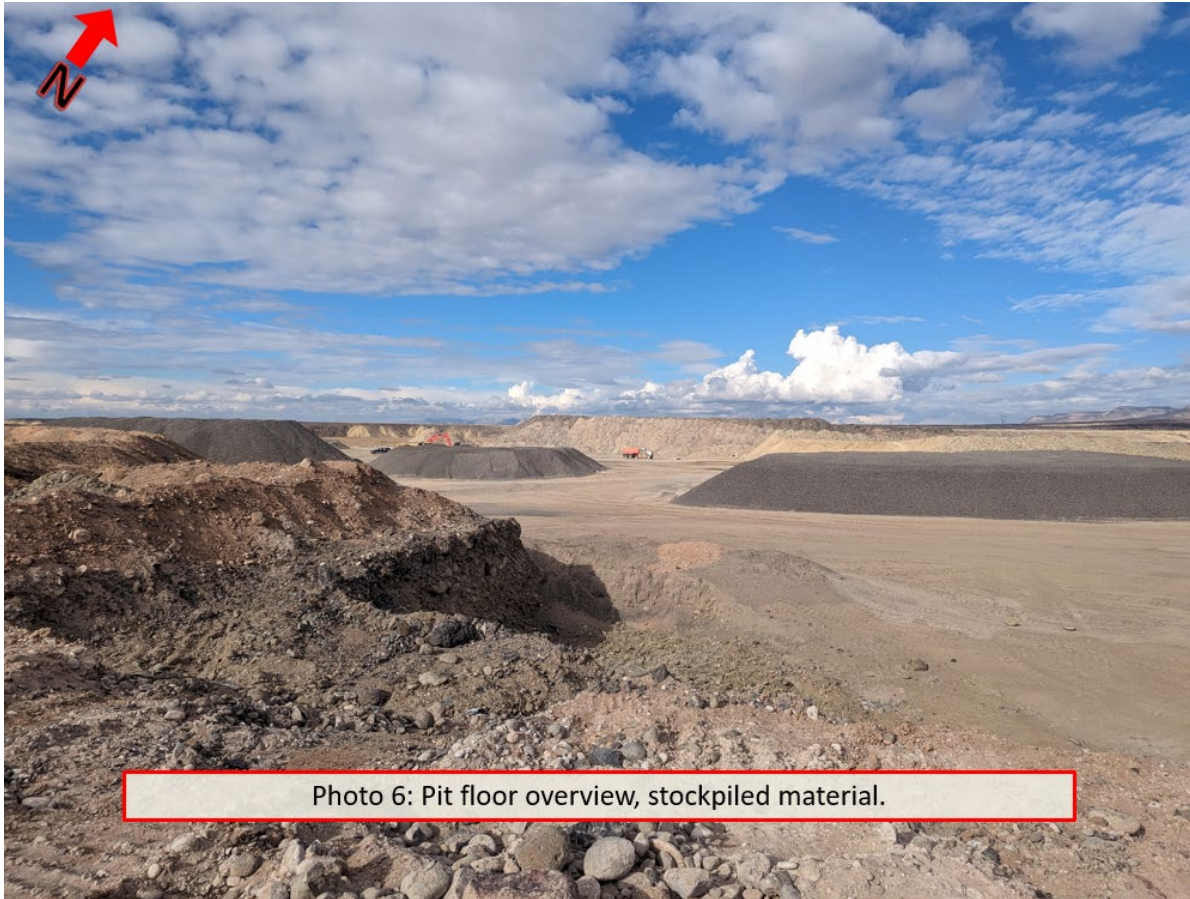
Photo 6: Pit floor overview, stockpiled material.

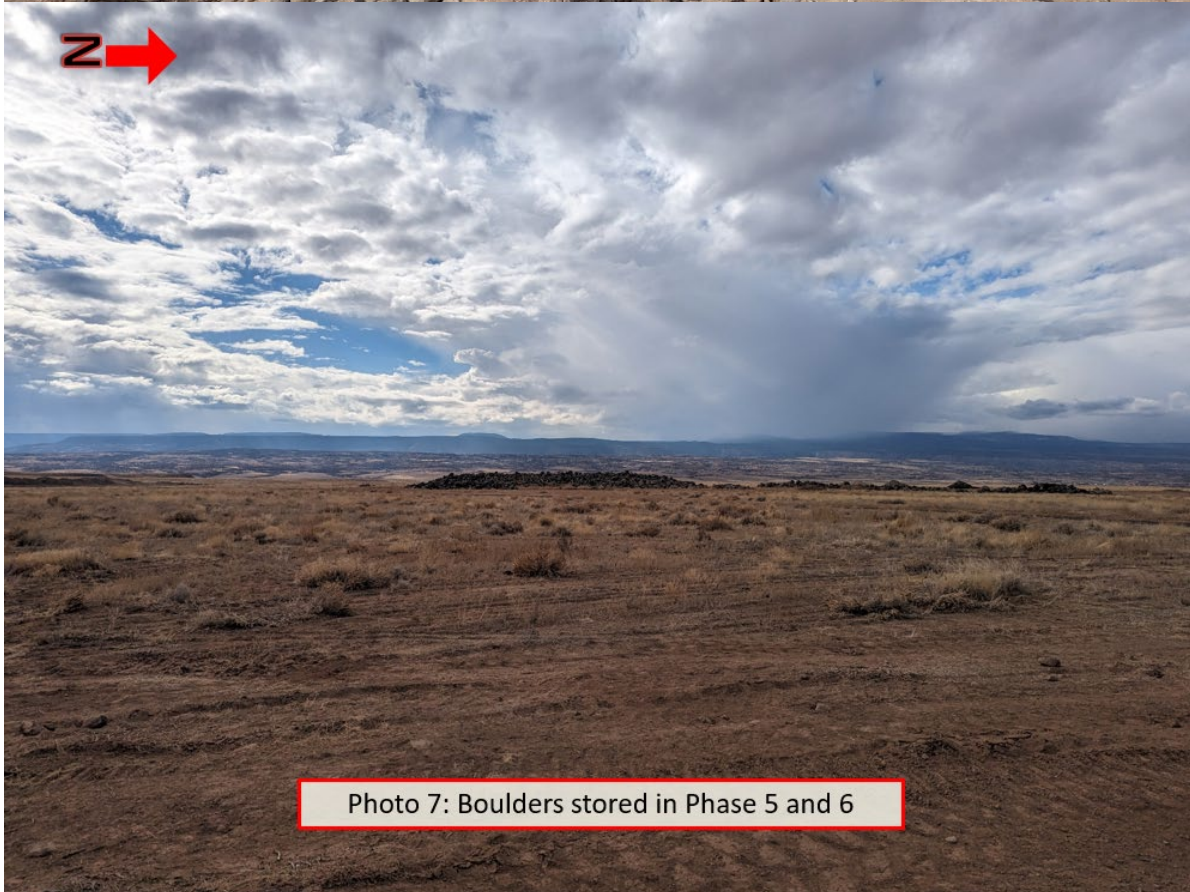
Misc. boulders are stockpiled in Phase 5 and 6 on the un-mined land (Photo Seven).

Photo 7: Boulders stored in Phase 5 and 6

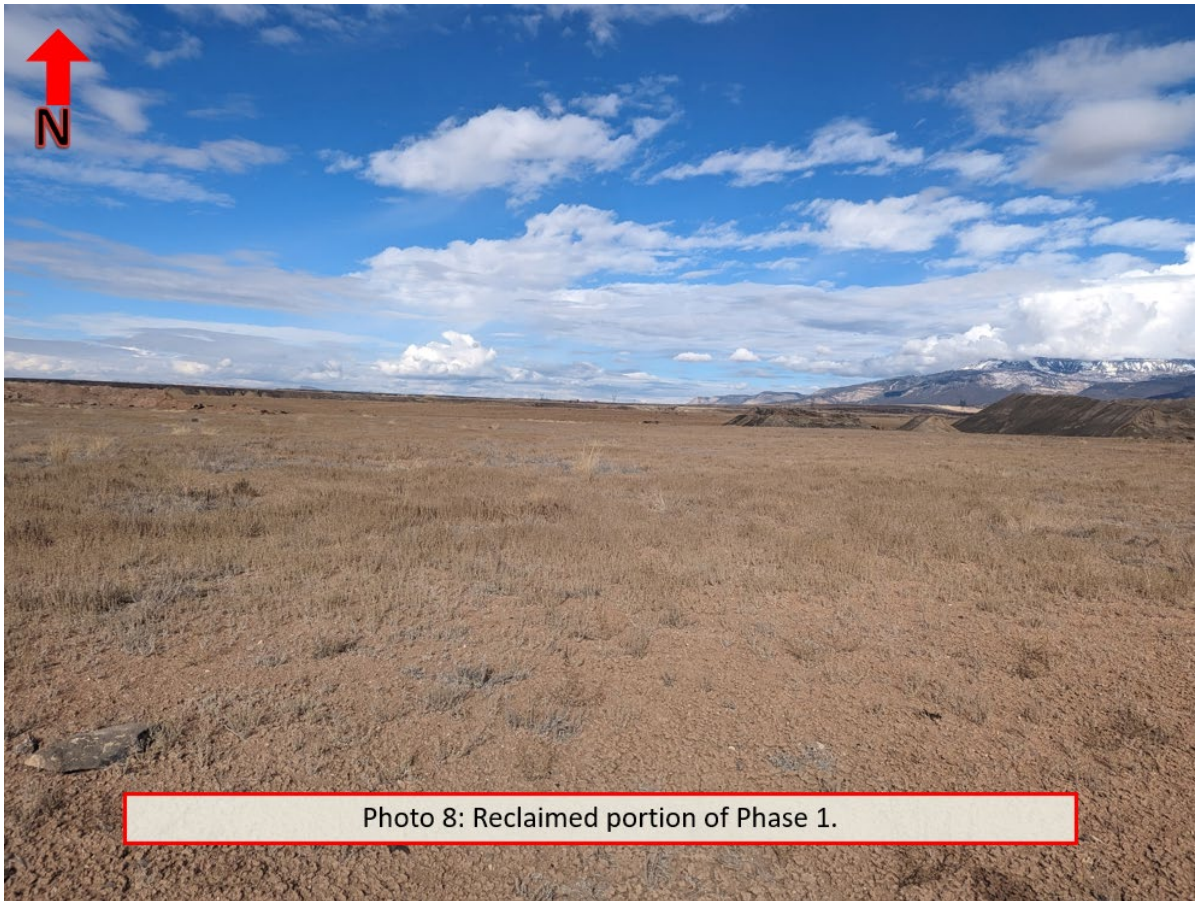
A fair amount of time was spent discussing the reclamation plan and the several failed revegetation efforts. Approximately 8 acres has been seeded to date with almost no visible success (Photo Eight). In general, the reclamation plan is adequate however the site given its arid nature, establishment of vegetation (especially desirable) is difficult. The surrounding areas on the mesa are extremely sparse. Crested wheatgrass and saltbrush were the only desirable species observed. And they occurred at fairly low densities. The hillside areas have slightly more cover and a wider variety of species.

Photo 8: Reclaimed portion of Phase 1.

The Operator may consider harvesting saltbrush seeds for adjacent lands to use for reclamation for reclamation on site. The operator may consider doing a soil test to ensure that a nutrient deficiency isn't exacerbating an already challenging environment. Application of mulching post seeding may help with moisture retention. The Operator is also encouraged to reach out to the NRCS for additional guidance/suggestions.

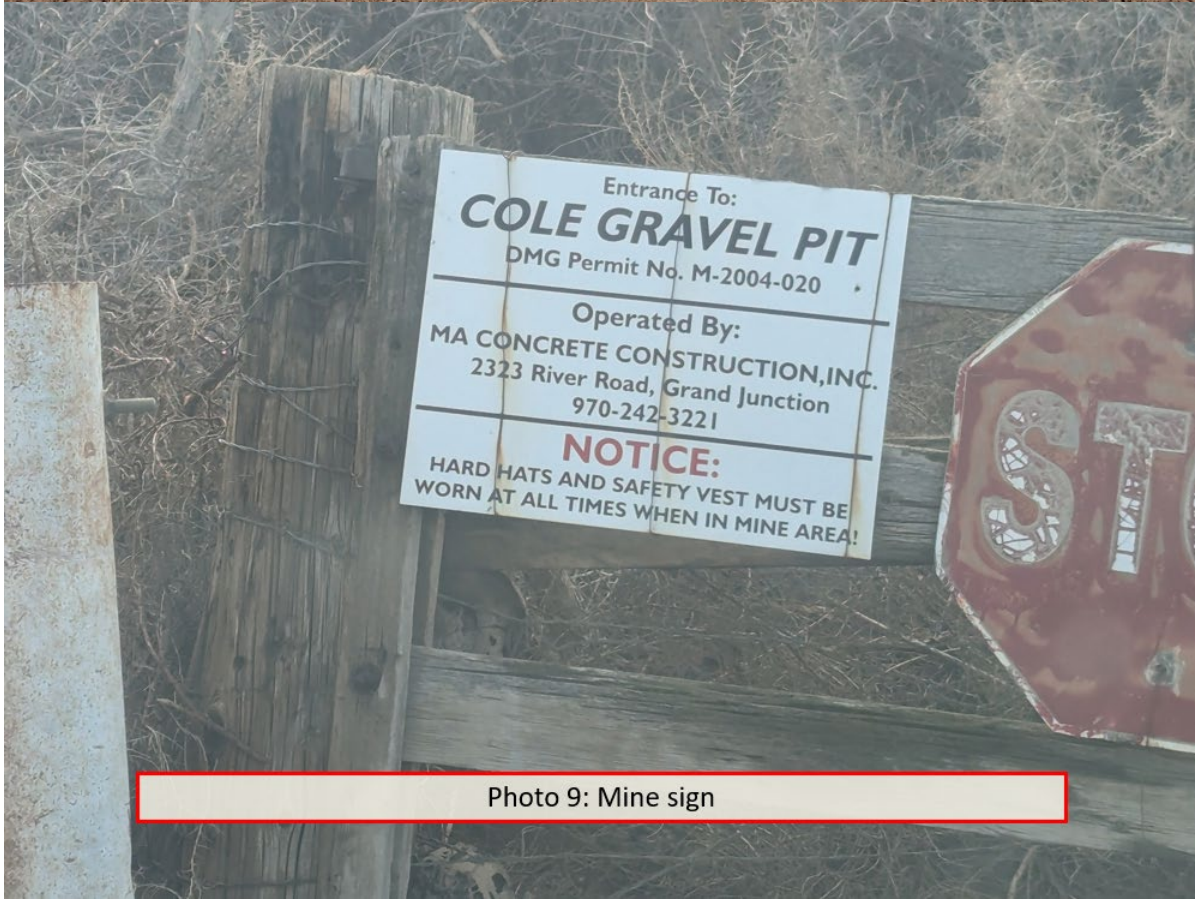
A mine sign was posted at the entrance to the mine site as required by Rule 3.1.12(1). The sign was of sufficient size (Photo Nine). The permit boundary of the affected land was clearly delineated primarily by a wire fence pursuant to Rule 3.1.12(2).

Photo 9: Mine sign

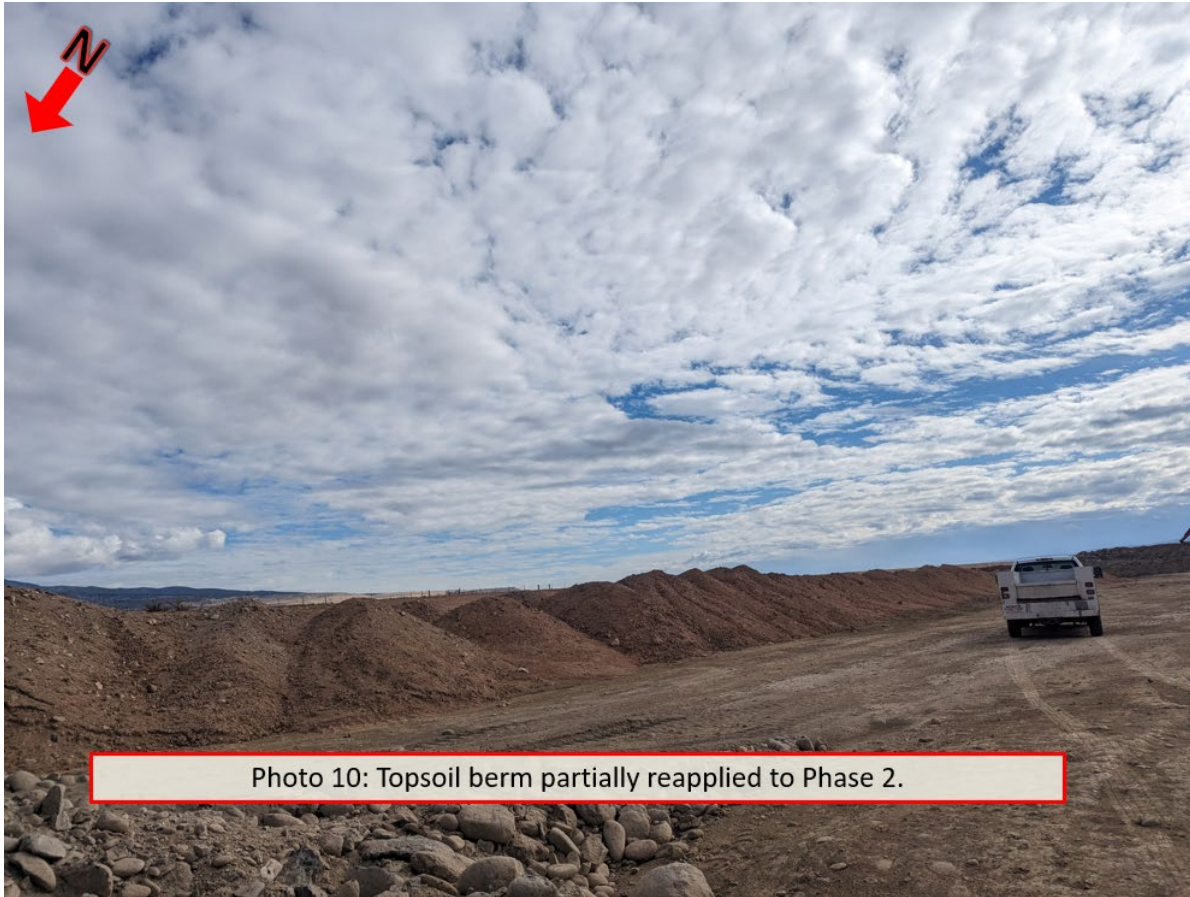
There are two main topsoil stockpiles. One pile is located on the west side of phase 1, this material will be used at the of final reclamation on phase 6. The other stockpile is located within phase 2 and 3 and will/is being reapplied to graded portions not in use for material stockpiling (Photos 10 - 11). The northeast perimeter portions that are not the pit floor (stockpiling areas) of Phases 1 and 2 have had topsoil applied. The Division estimates that approximately 24 acres of topsoil has been applied.

Photo 10: Topsoil berm partially reapplied to Phase 2.

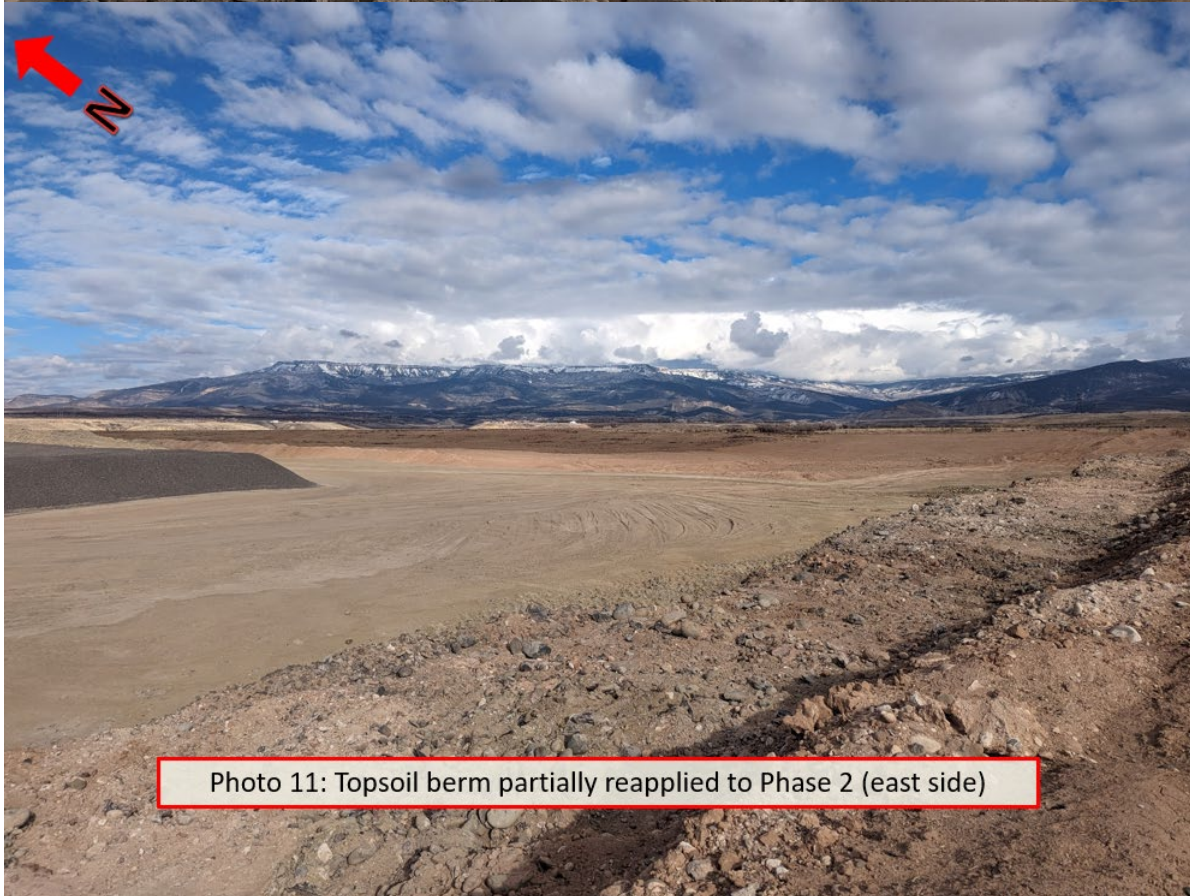
Photo 11: Topsoil berm partially reapplied to Phase 2 (east side)
