MINERALS PROGRAM INSPECTION REPORT
PHONE: (303) 866-3567

MINE NAME: Cecil 11-34-49	MINE/PROSPECTING ID#: M-1983-001	MINERAL: Sand and gravel	COUNTY: Washington
INSPECTION TYPE: Monitoring	WEATHER: Clear	INSP. DATE: January 31, 2024	INSP. TIME: 11:15
OPERATOR: Washington County	OPERATOR REPRESENTATIVE: Steve Williams	TYPE OF OPERATION: 110c - Construction Limited Impact	
REASON FOR INSPECTION: Normal I&E Program	BOND CALCULATION TYPE: None	BOND AMOUNT: \$0.00	
DATE OF COMPLAINT: NA	POST INSP. CONTACTS: None	JOINT INSP. AGENCY: None	
INSPECTOR(S): Brock Bowles	INSPECTOR'S SIGNATURE:

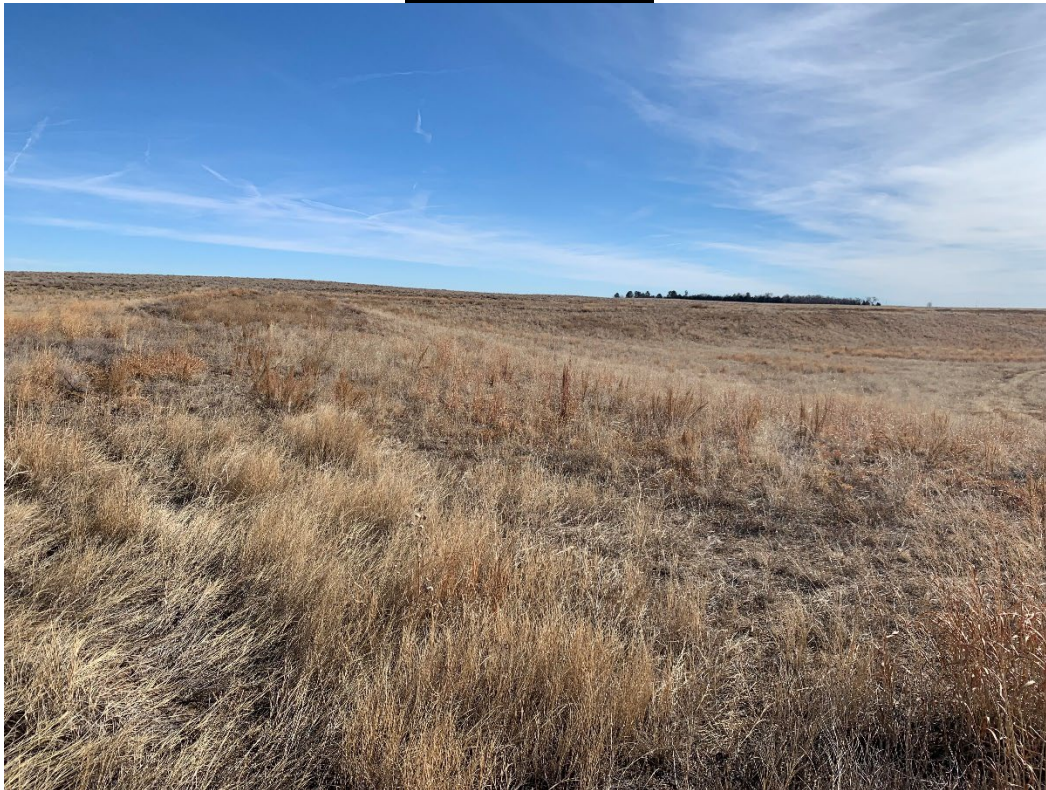
The pit walls are sloped to 3h:1v and graded to blend in with the surrounding terrain (photo 1). The topsoil has been spread across the site and all but one stockpile has been removed (photo 2). The remaining stockpile contains about 30 cubic yards of gravel. The stockpile was left at the request of the landowner for private use on the landowner's land.

Photo 1 – North part of the pit area, facing east.

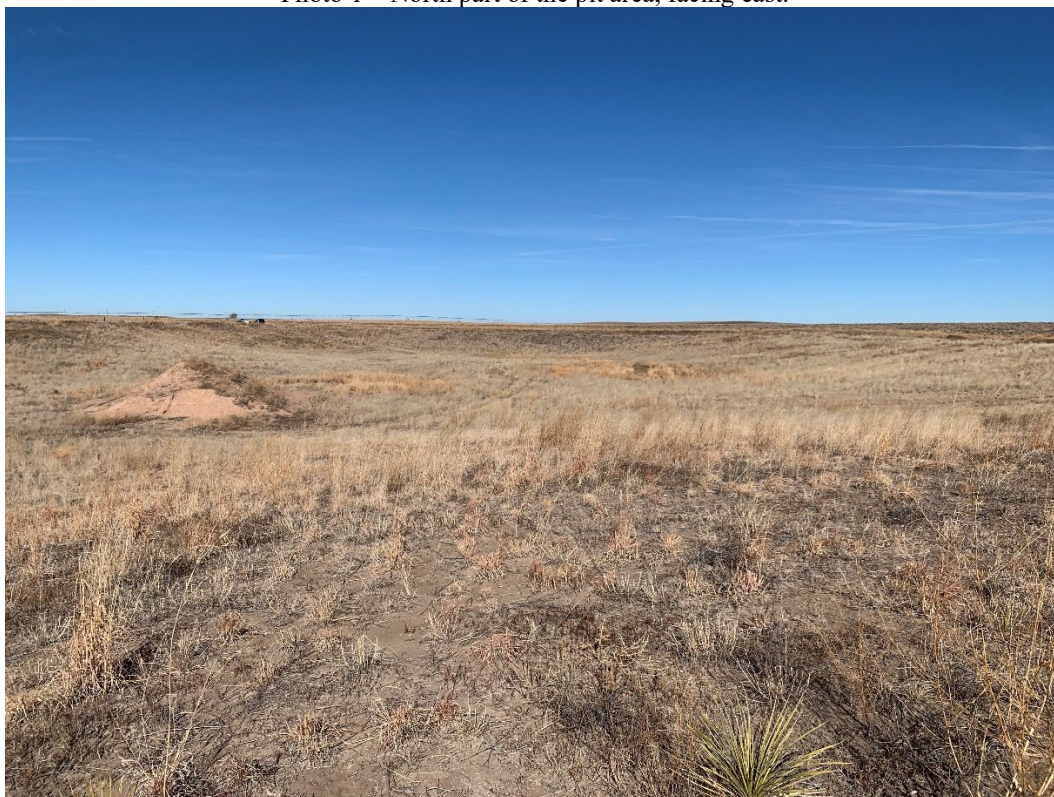
The site has also been seeded. The vegetation on the site is very well established in most of the pit area (photos 2 & 3). The vegetation consists of grasses and some forbs. No noxious weeds were noted while walking around the site.

Photo 2 – South side of pit area, facing north. Landowner gravel pile on left.

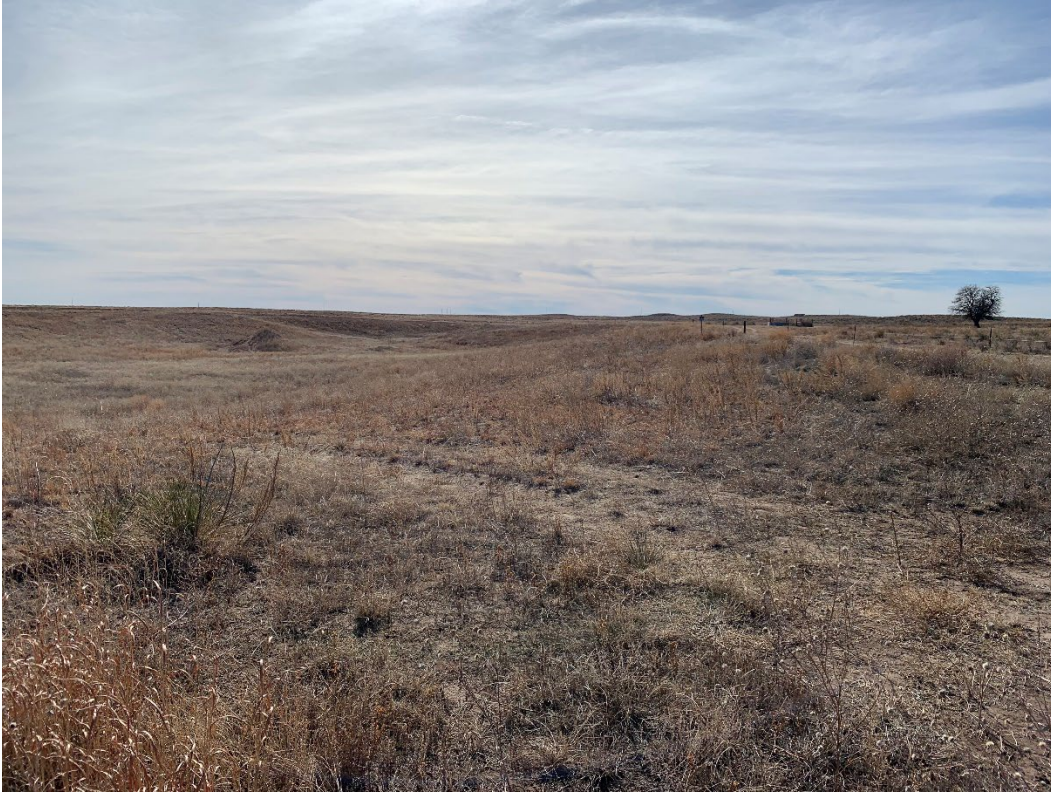
Photo 3 – North pit area, west side facing south.

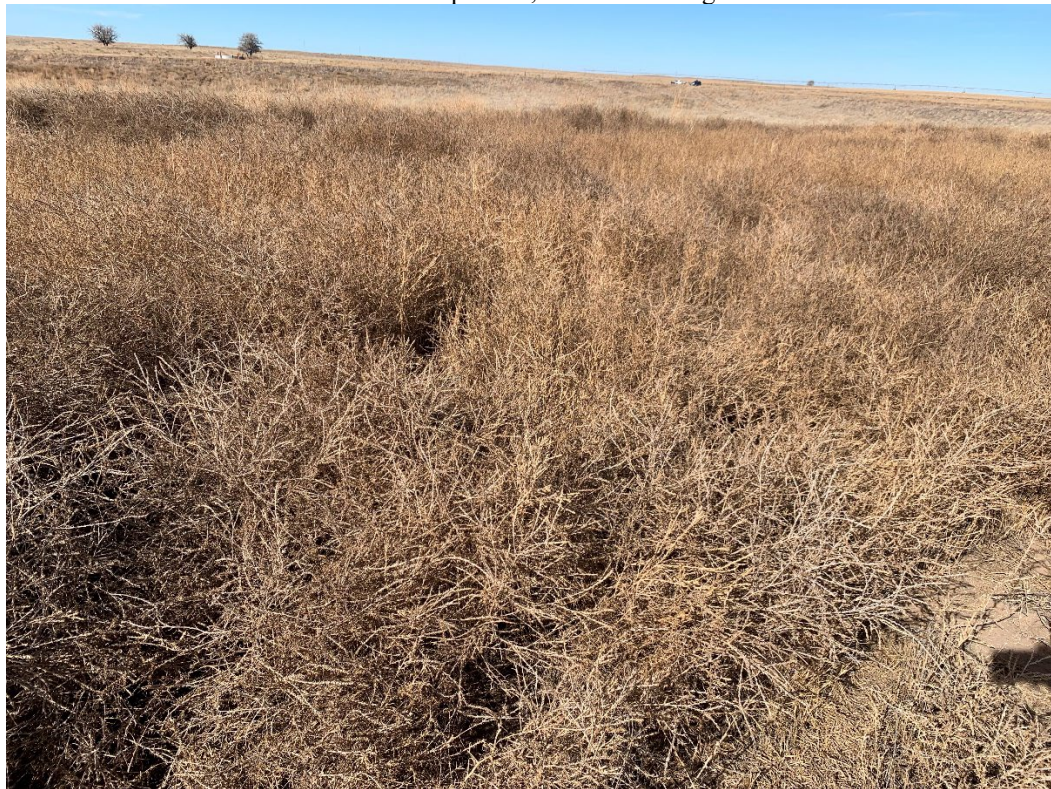
A large patch of Russian thistle was noted along the eastern fence line of the permit area (photo 4). The patch is about 0.5 acre in size. This is the location of the former topsoil stockpile. The thistle is really dense and no grass species were seen in this area. This thistle patch will have to be addressed before the site is eligible for final bond release.

Photo 4 – Russian thistle on east side of pit area.

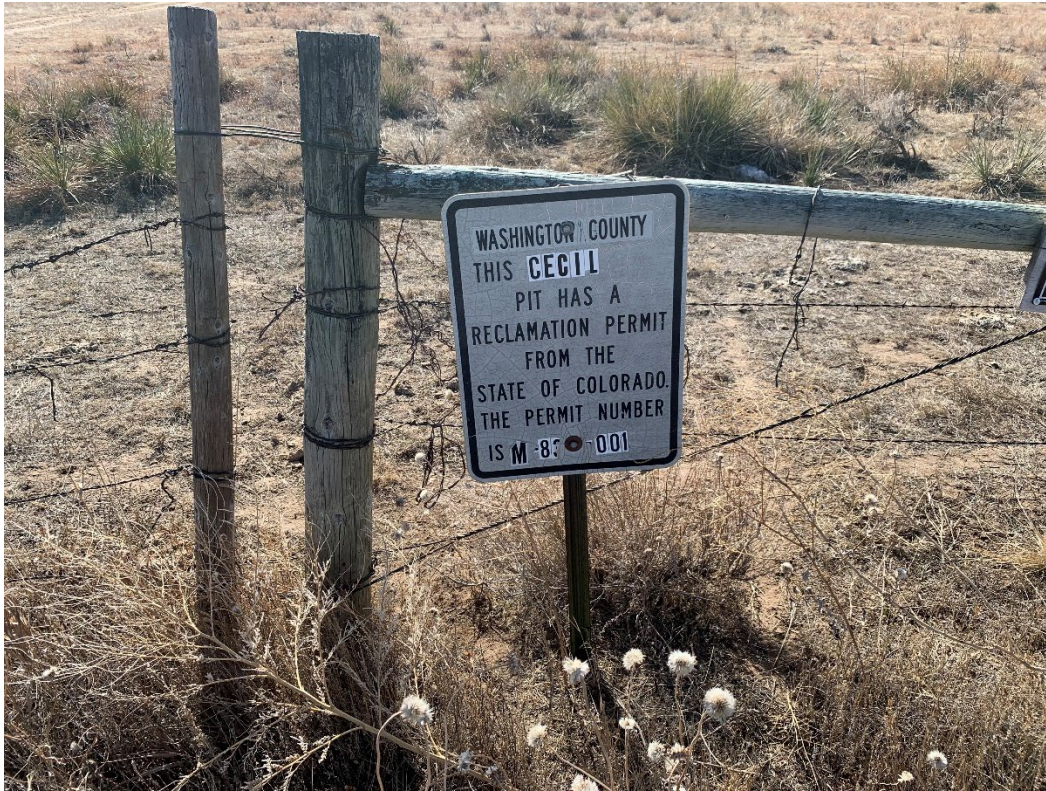
The mine entrance sign was in place at the entrance gate facing CR 11 (photo 5).

Photo 5 – Mine entrance sign facing CR 11
