**COLORADO**  
Division of Reclamation,  
Mining and Safety  
Department of Natural Resources

February 6, 2024

**Re: Third Adequacy Review, Revision No. TR-140, Cresson Project, Permit No. M-1980-244**

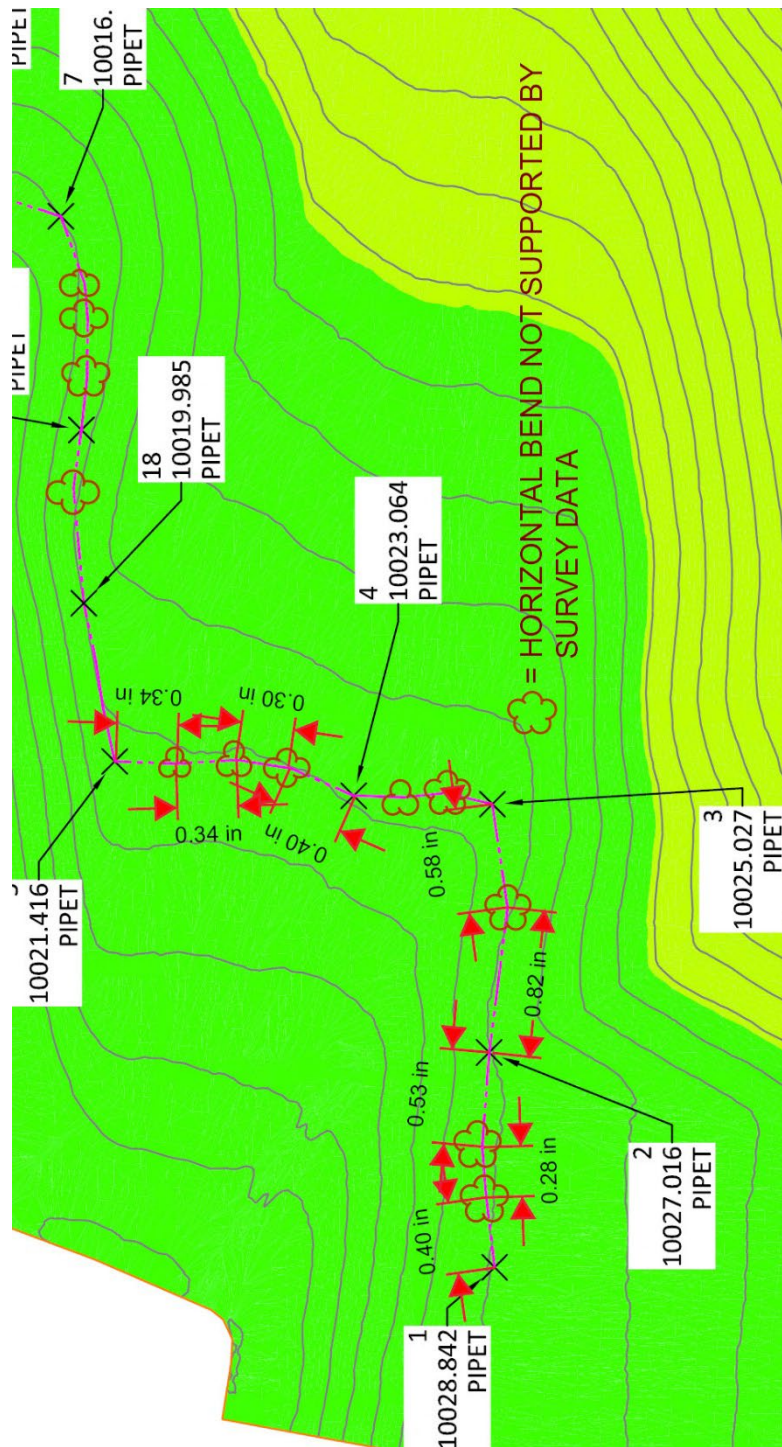
**ATTACHMENT A – EXAMPLE 1**

Please see the three examples in **Attachment A** depicting the unsupported horizontal bends presented in the Leak Detection Trench As-Built drawings. Based on the information received to date there is either additional survey data that has not been reported but supports the existence of the additional horizontal bends in the Record Drawings; or the Record Drawings do not reflect the as-constructed conditions of the

12 Horizontal Bends (cloud circles) Not Supported by Provided Survey Data  
[from SHEET 3 LEAK DETECTION TRENCH 1 AS-BUILT; Drawing scale stated as 1" = 70']

Leak Detection System (LDS) piping. Please explain the discrepancy and make the appropriate changes (either submit additional survey data and/or revise the record drawings) and resubmit to the Division.

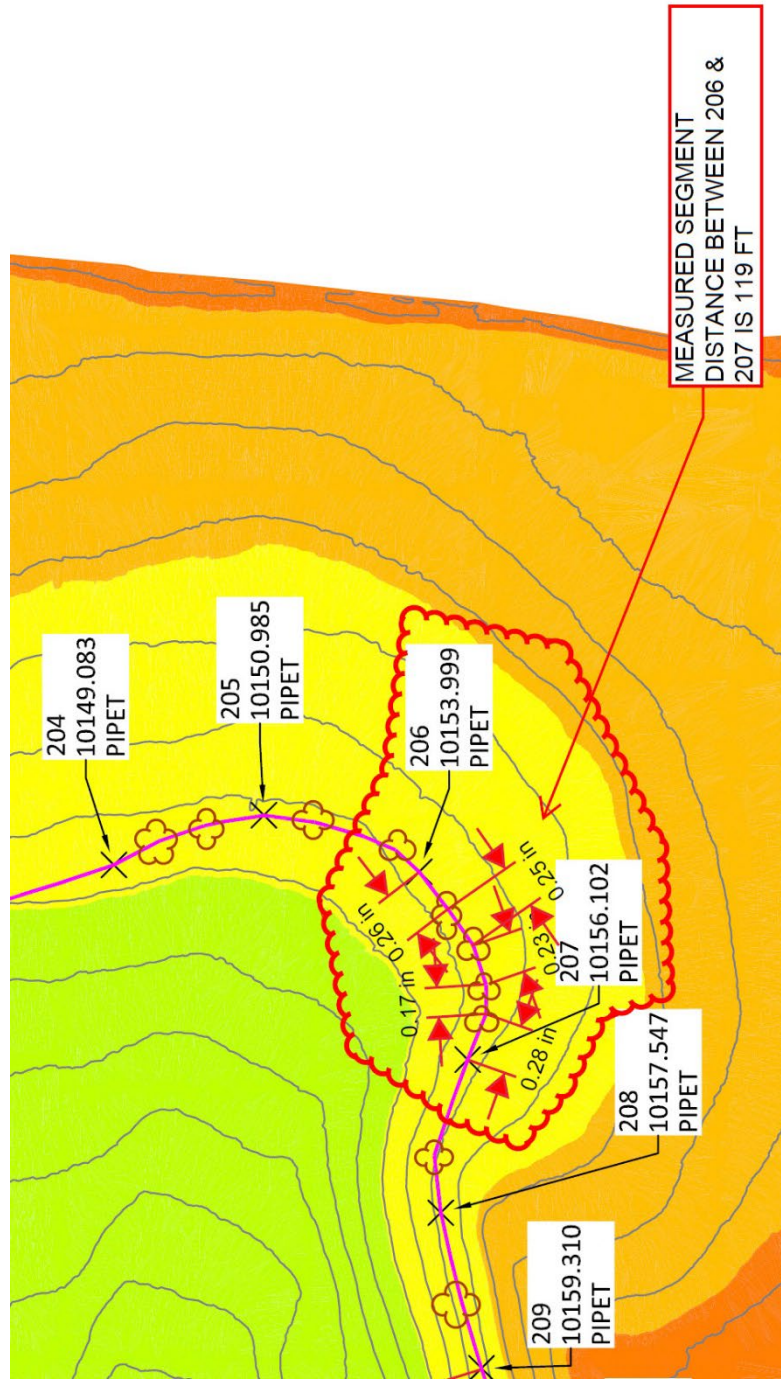
**ATTACHMENT A – EXAMPLE 2**

10 Horizontal Bends (cloud circles) Not Supported by Provided Survey Data  
[from SHEET 4 LEAK DETECTION TRENCH 2 AS-BUILT EXHIBIT; Drawing scale stated 1" = 100']

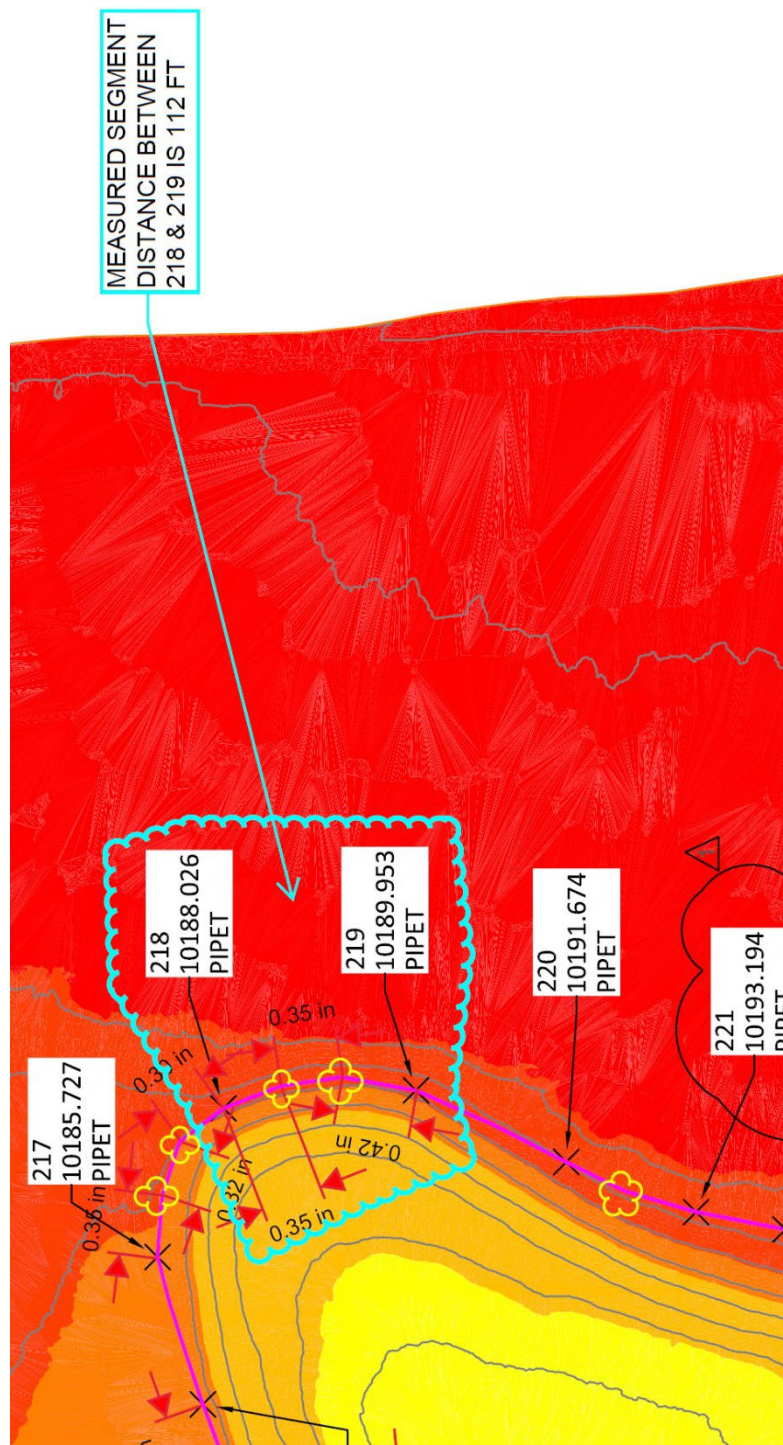
**ATTACHMENT A – EXAMPLE 3**

Five Horizontal Bends (cloud circles) Not Supported by Provided Survey Data  
[from SHEET 4 LEAK DETECTION TRENCH 2 AS-BUILT EXHIBIT; Drawing scale stated 1" = 100']
