MINERALS PROGRAM INSPECTION REPORT
PHONE: (303) 866-3567

MINE NAME: Yakutat Land Pit	MINE/PROSPECTING ID#: M-2014-008	MINERAL: Sand, gravel and clay	COUNTY: Washington
INSPECTION TYPE: Monitoring	WEATHER: Clear	INSP. DATE: January 31, 2024	INSP. TIME: 11:45
OPERATOR: Washington County	OPERATOR REPRESENTATIVE: Steve Williams	TYPE OF OPERATION: 112c - Construction Regular Operation	
REASON FOR INSPECTION: Normal I&E Program	BOND CALCULATION TYPE: None	BOND AMOUNT: \$0.00	
DATE OF COMPLAINT: NA	POST INSP. CONTACTS: None	JOINT INSP. AGENCY: None	
INSPECTOR(S): Brock Bowles	INSPECTOR'S SIGNATURE:

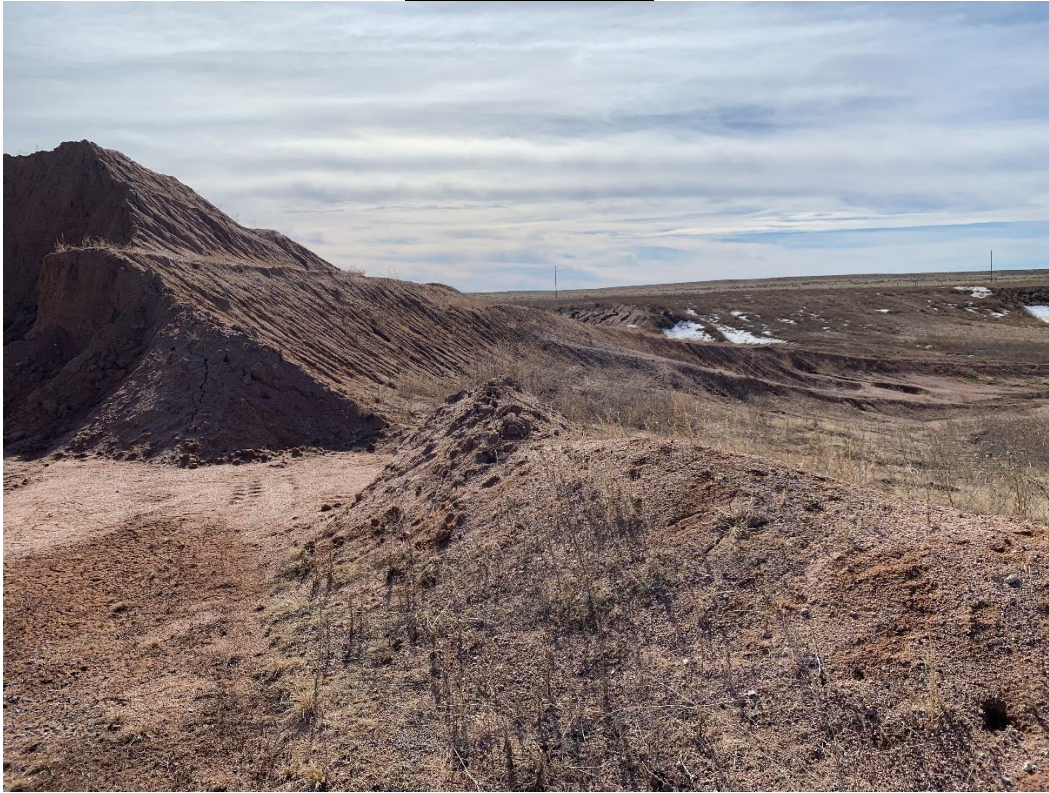
The pit is located in the eastern half of the permit area. Gravel is pushed from the middle of the pit area to either the east (photo 1) or west sides of the pit where it is stacked in large piles for loading onto trucks. The pit is approximately 15 feet deep and the approved permitted depth is 20 feet (photo 2). The slopes of the pit are approximately 3h:1v on all sides.

Photo 1 – Gravel stacked on the eastern side of the pit, photo facing south.

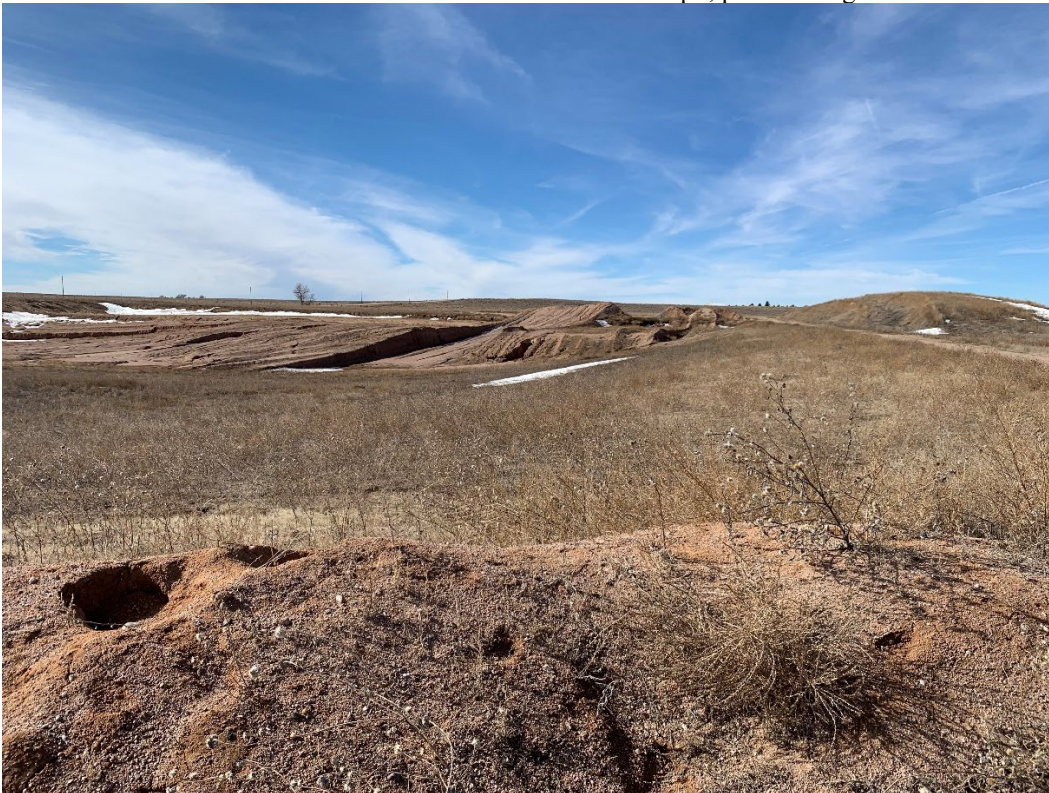
Photo 2 – Center of pit, facing west at gravel piles on west side of pit.

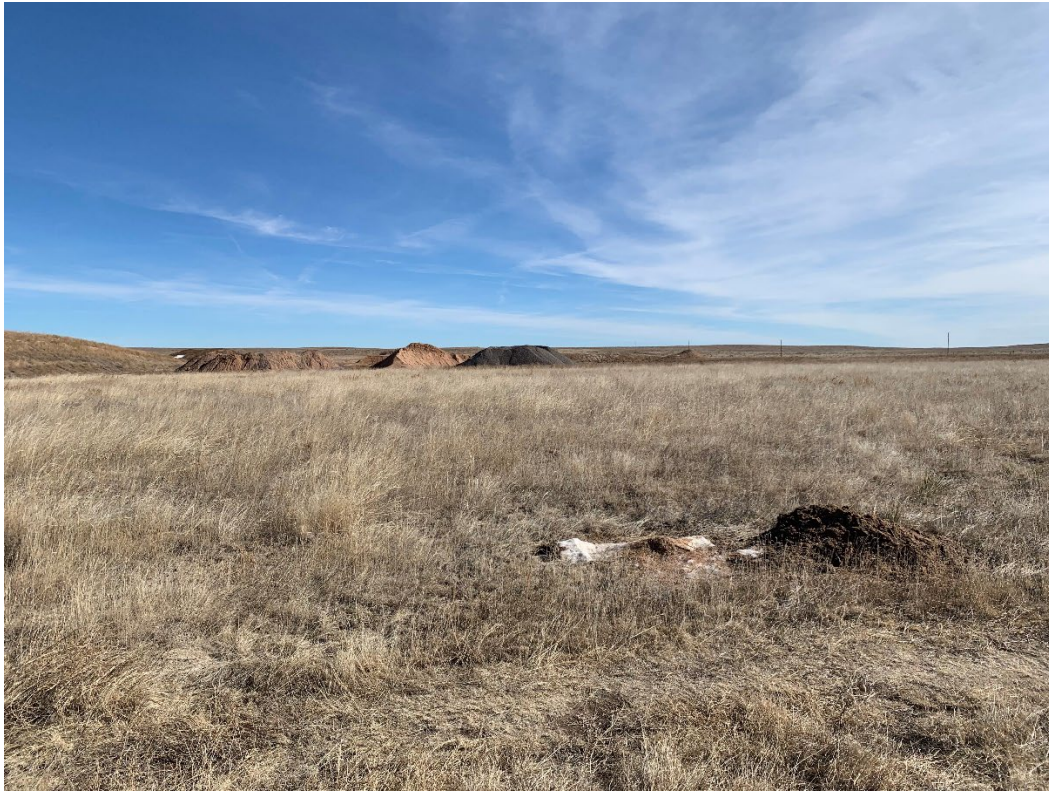
The western half of the permit area has not been disturbed yet except for the western entrance road (photo 3).

Photo 3 – Western section of permit area, facing east.

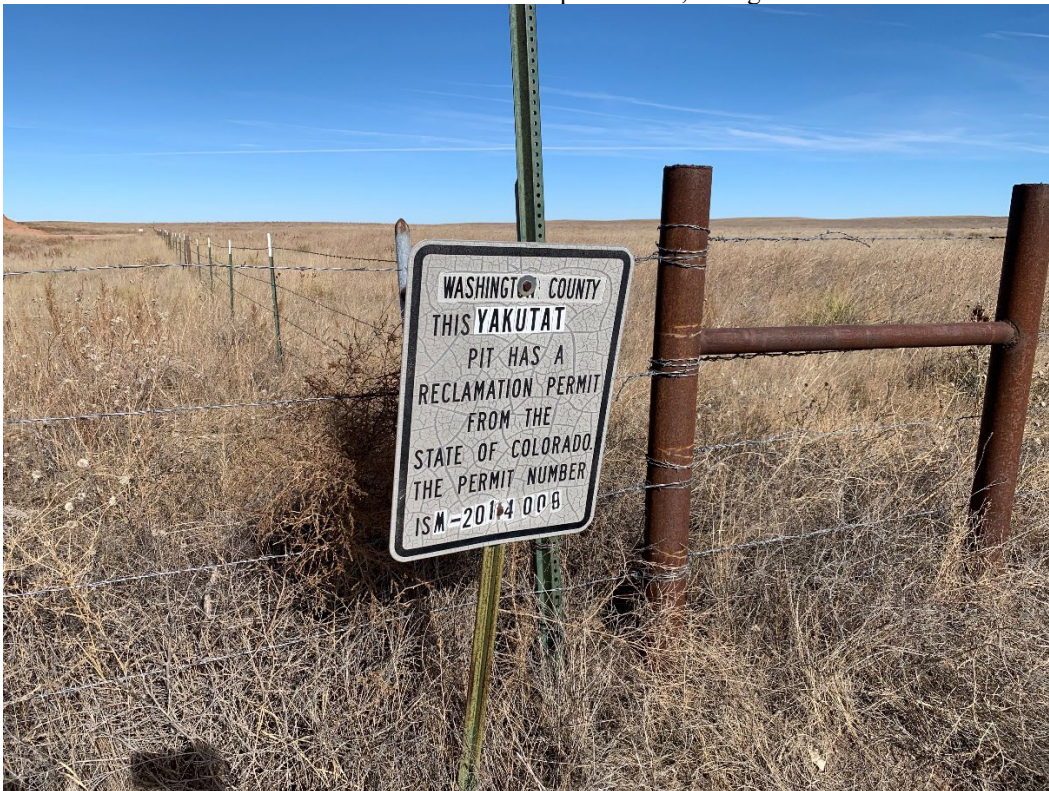
The mine entrance sign was in place at the entrance gate facing CR 11 (photo 4). The gate was closed upon arrival. The permit boundary is marked by a fence on all four sides.

Photo 4 – Mine entrance sign facing CR 11.

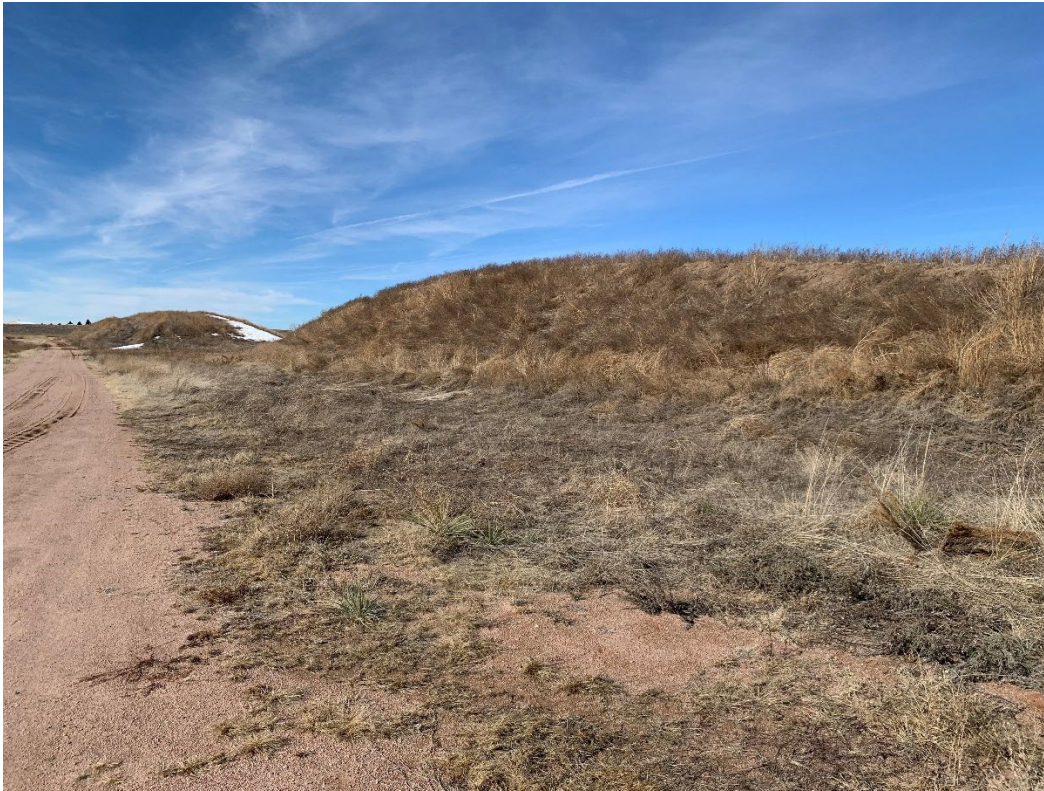
The topsoil and overburden stockpiles are situated along the northern permit boundary (photo 5). Both piles are well vegetated, and no erosion features were seen.

Photo 5 – Topsoil (foreground) and overburden stockpiles.
