Pikeview monitoring report

**Pikeview Monitoring Memo December 2023-Final (1).pdf**

PIKEVIEW QUARRY SLOPE

MONITORING

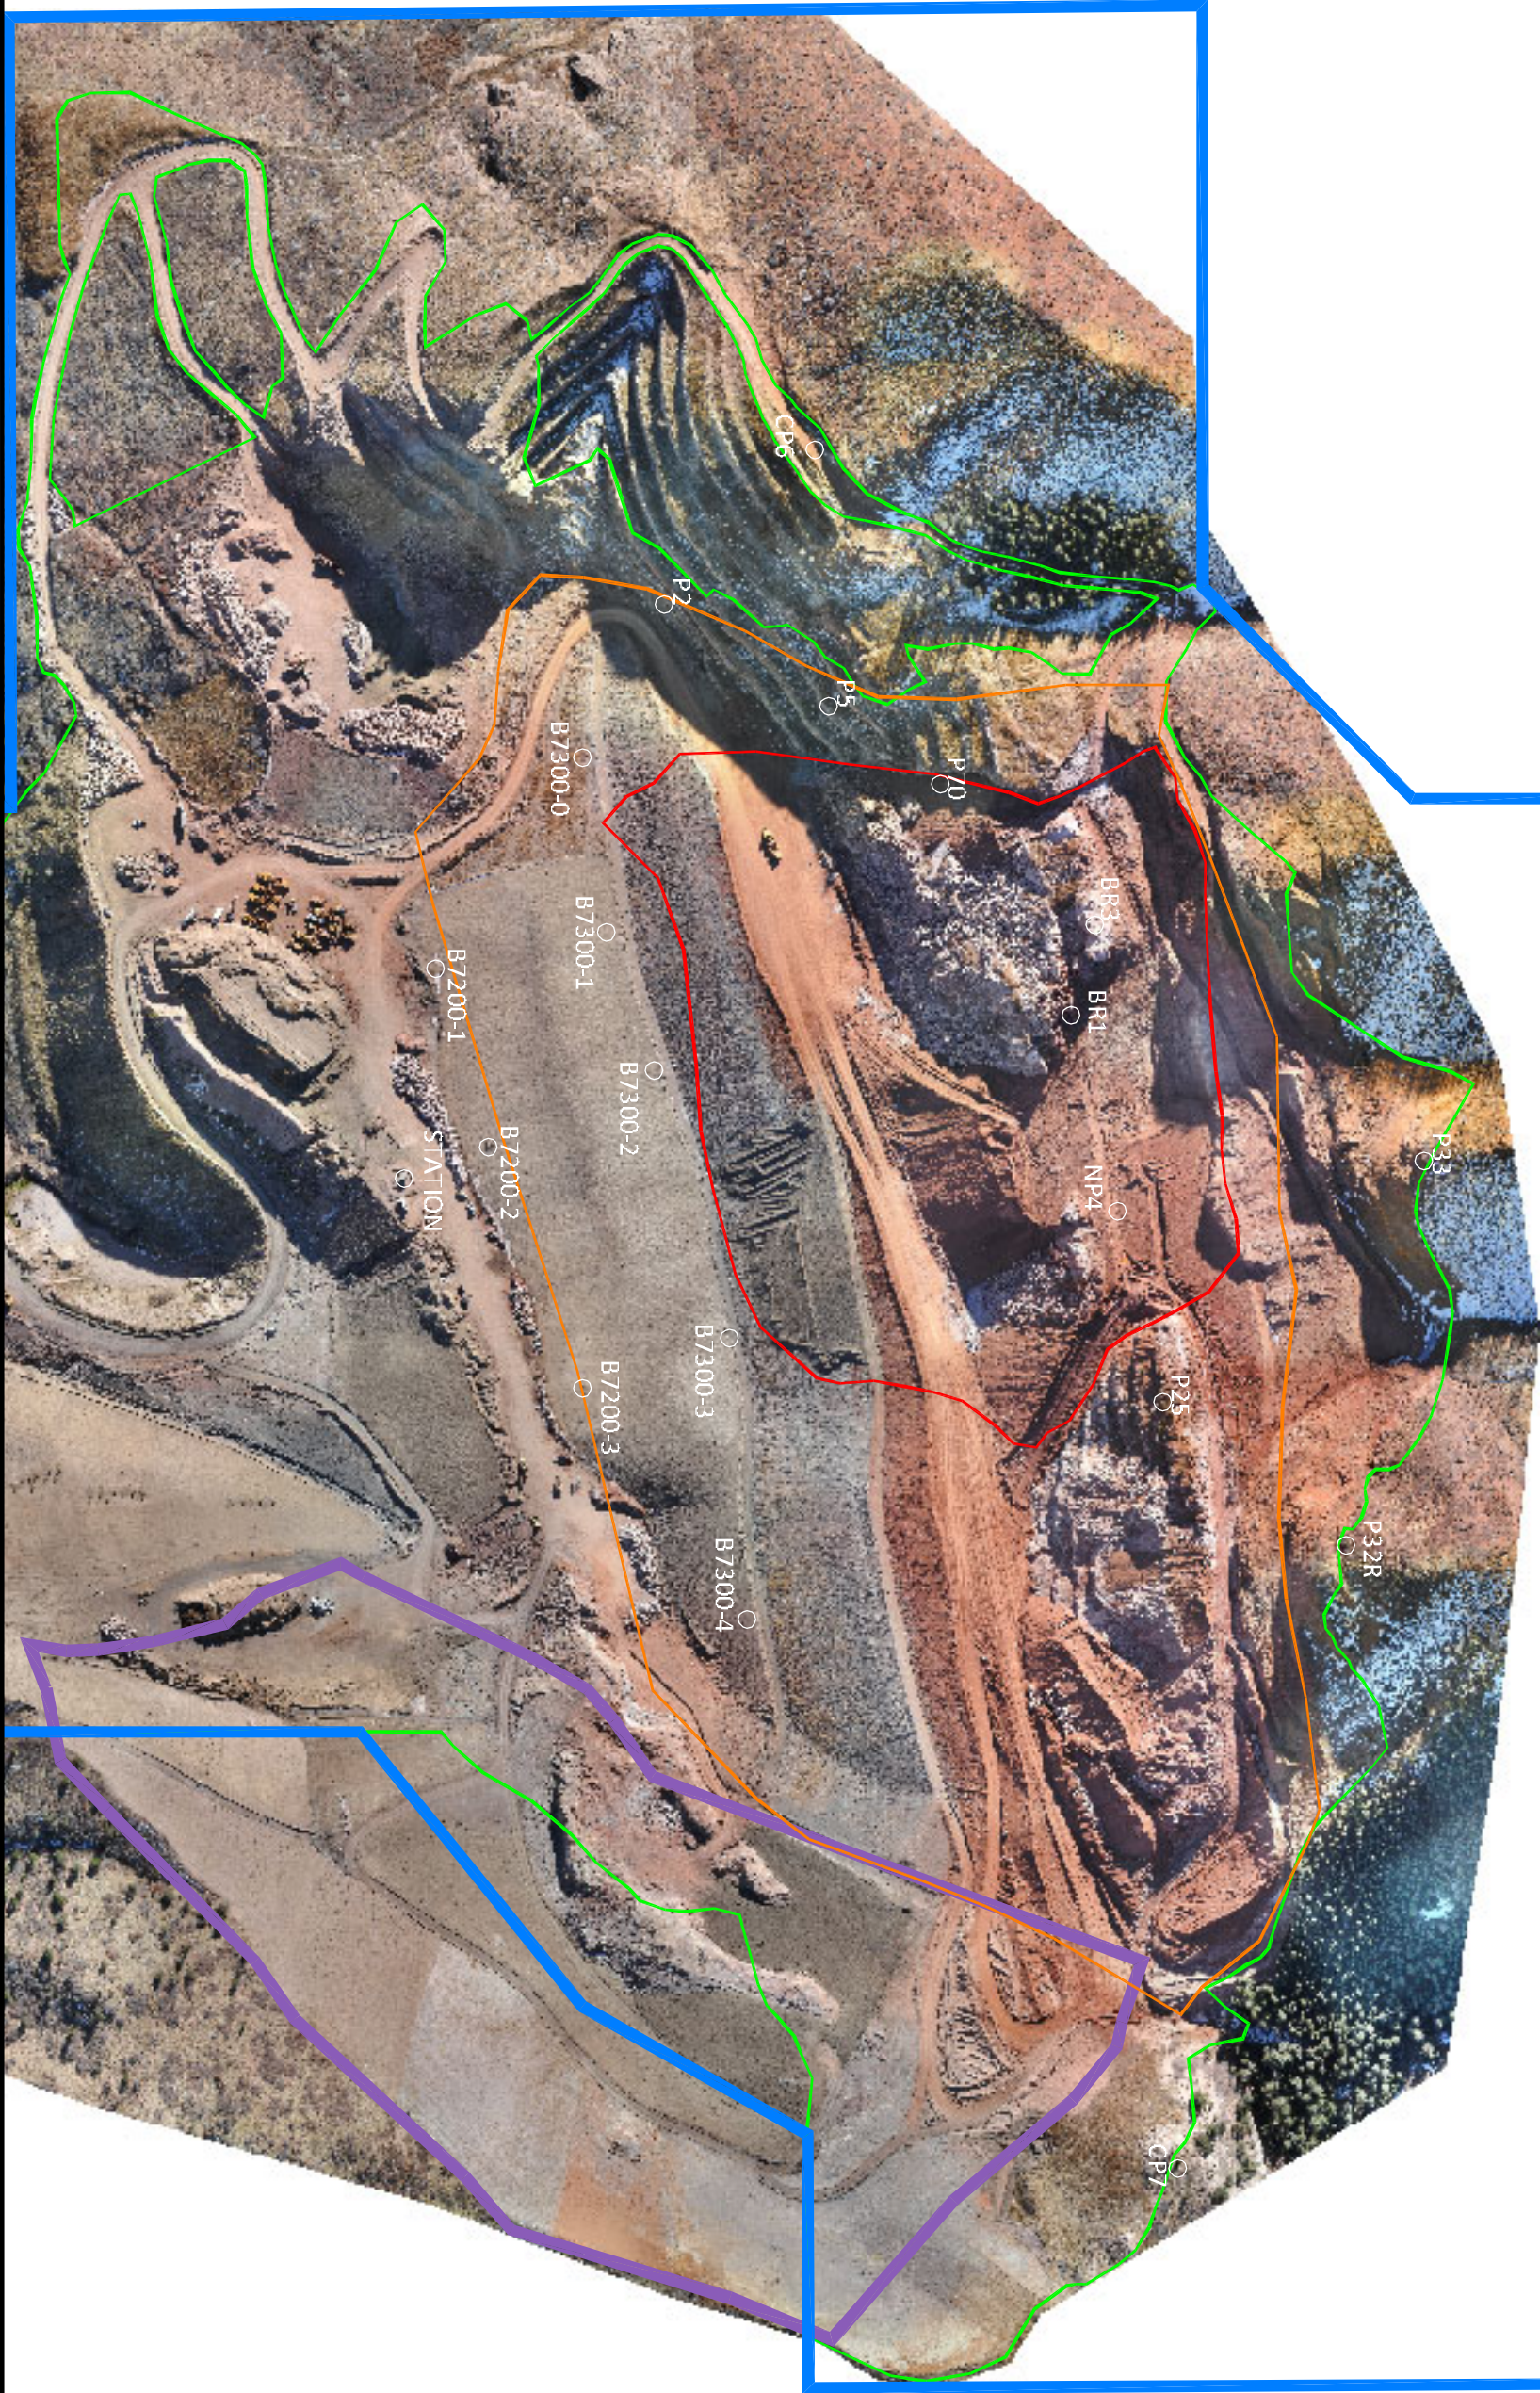
Title	
SITE MAP	
Revision	Date
#	2024.01.31
Drawn by	Figure No.
PK	1

1) The Site Map (pdf pg 8) shows 14 existing prisms. Appendix B map (pdf pg 13) shows 19 existing prisms. Is there a reason for leaving off 5 prisms on the site map? Prisms shown on Appendix B map not shown on the site map are: CP6, P33, P32R, CP7, B7300-4

Those prisms are active and were inadvertently left off the map. The attached Site Map includes all 19 active prisms.
