**MINERALS PROGRAM INSPECTION REPORT**  
**PHONE: (303) 866-3567**

<b>MINE NAME:</b> City of Rifle Material Resource Area	<b>MINE/PROSPECTING ID#:</b> M-2007-030	<b>MINERAL:</b> Sand and gravel	<b>COUNTY:</b> Garfield
<b>INSPECTION TYPE:</b> Monitoring	<b>WEATHER:</b> Clear	<b>INSP. DATE:</b> January 31, 2024	<b>INSP. TIME:</b> 08:30
<b>OPERATOR:</b> City of Rifle	<b>OPERATOR REPRESENTATIVE:</b> Colton Secary	<b>TYPE OF OPERATION:</b> 110c - Construction Limited Impact	
<b>REASON FOR INSPECTION:</b> Normal I&E Program	<b>BOND CALCULATION TYPE:</b> None	<b>BOND AMOUNT:</b> \$0.00	
<b>DATE OF COMPLAINT:</b> NA	<b>POST INSP. CONTACTS:</b> None	<b>JOINT INSP. AGENCY:</b> None	
<b>INSPECTOR(S):</b> Todd Jesse	<b>INSPECTOR'S SIGNATURE:</b>

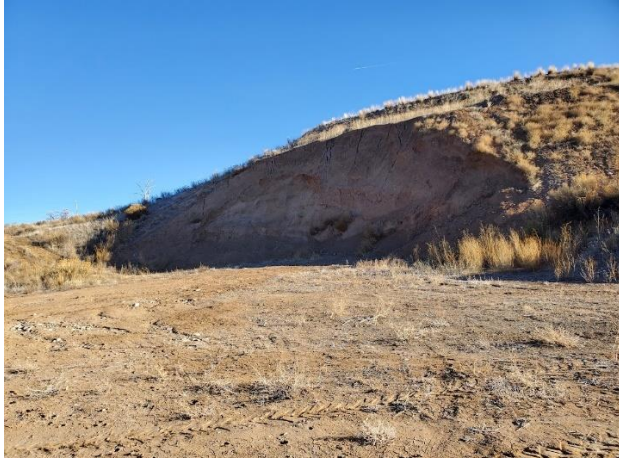
The City of Rifle is mining a river rock seam below clay overburden. The pit is located along a terrace above the Colorado River. Mining has been conducted according to the submitted plan. There is a highwall onsite that is approximately 20 feet high and 40 feet long. Away from the highwall, the slopes of the pit are stable and well vegetated - showing no signs of erosion or slumping. Multiple stockpiles of various sized materials both processed and unprocessed are located within the permit boundary. There is no evidence of impounded meteoric water or exposed groundwater within the permit boundary. A berm along the southern edge of the mining area for sediment control. Bobcat tracks were seen in mud in the mining area.

Photo 1: View to the north of highwall in the mining area.

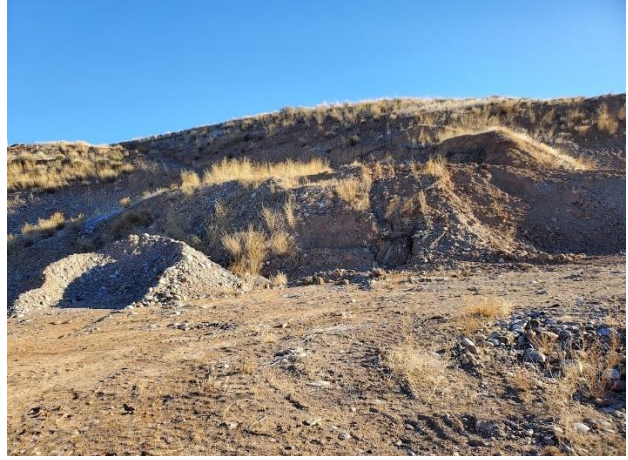
Photo 2: View to the north of stockpiles in the mining area.

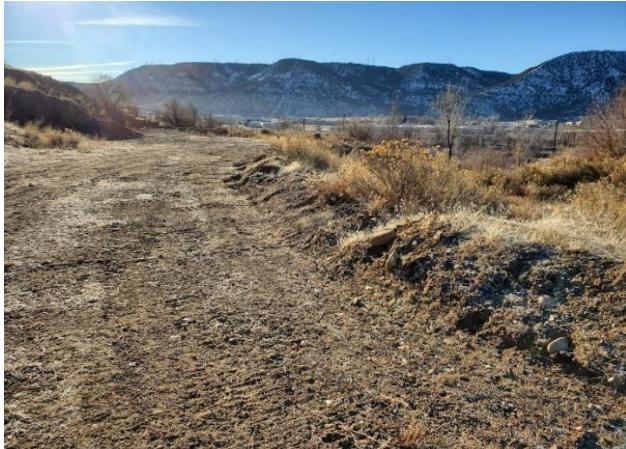
Photo 3: View to the southeast of berm to control sediment in mining area.

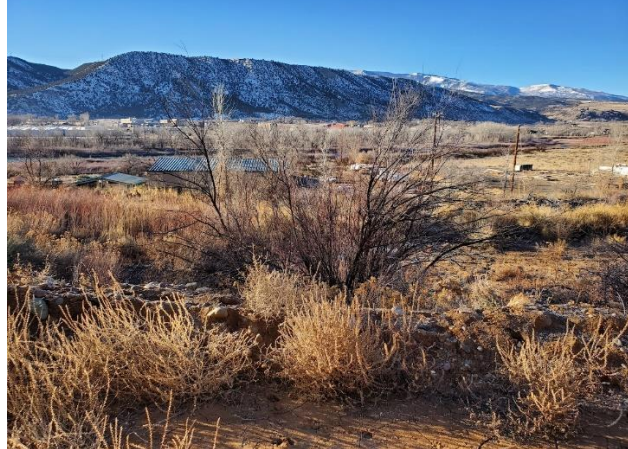
The Division noted an infestation of Salt Cedar (*Tamarix spp.*) in the southern area of the permit boundary. This species is categorized as a List B noxious weed by the State of Colorado's Department of Agriculture. The Division also noted an infestation of Downy Brome (*Bromus tectorum*). This species is categorized as a List C noxious weed by the State of Colorado's Department of Agriculture. **Per Rule 3.1.10(6) weed control shall be employed for state listed noxious weed species. Please contact the Garfield County Noxious Weed Program to develop a Weed Management Plan.**

Photo 4: View to the south of Salt Cedar within the permit boundary.

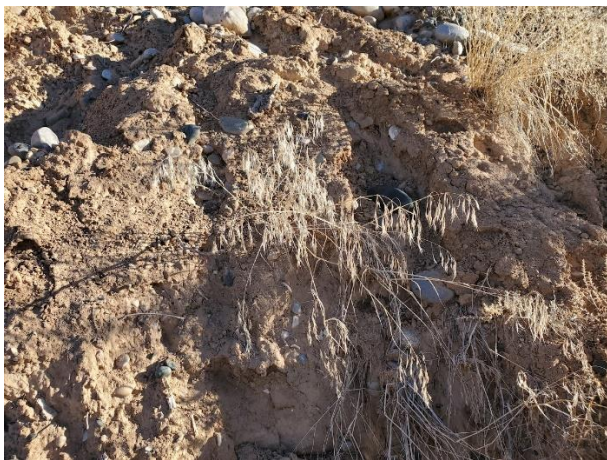
Photo 5: View to the north of Brome Grass within the permit area.

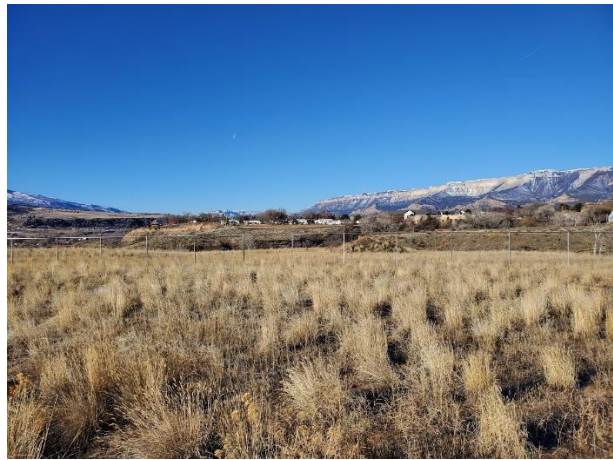
Photo 6: View to the southwest of undisturbed area to the northeast of the mining area.
