## Inspection Report, Hayden Gulch Loadout, C-1992-081

### PERMIT INFORMATION

### INSPECTION INFORMATION

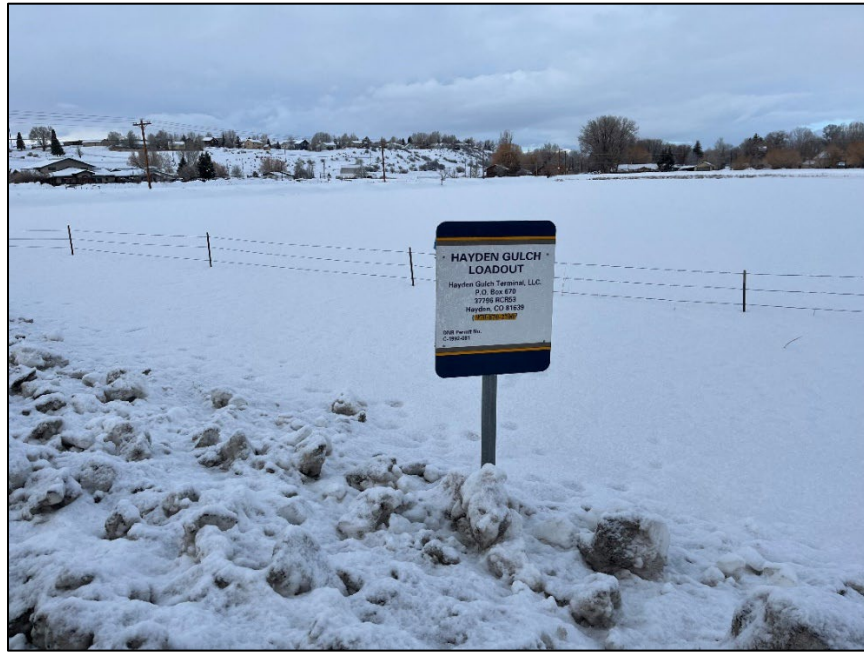
Mine identification signs were observed adjacent to the unreleased agricultural section north and south of Hwy 40 (Photo 1) and at the western end of the TAHR (Photo 2). All required information was present on the signage.

*Photo 1: Mine sign located at the corner of CR37 and Hwy 40.*

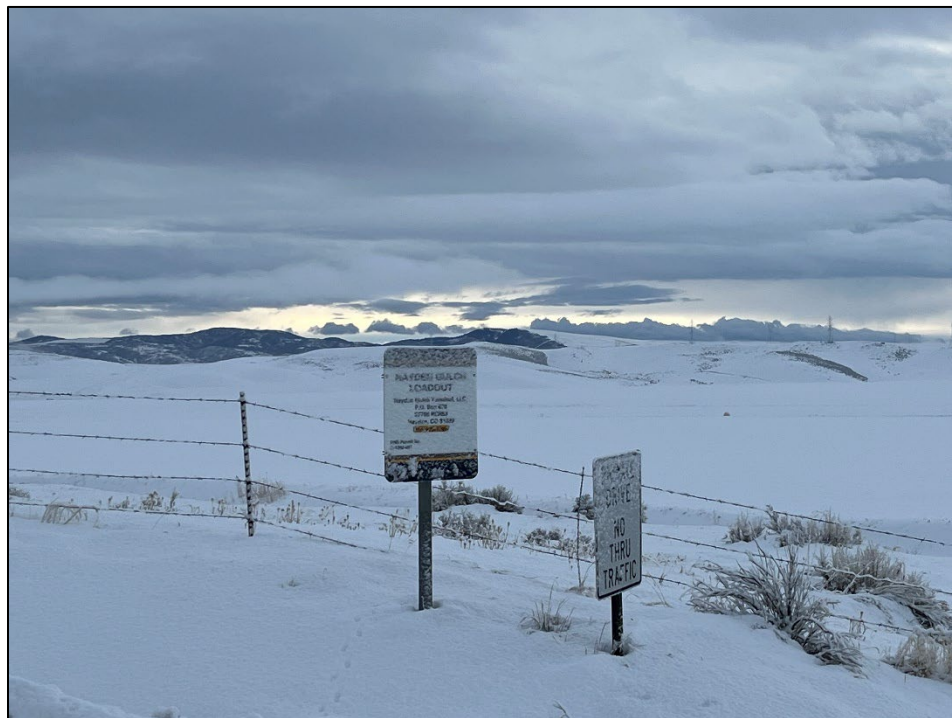
*Photo 2: Mine sign located at the intersection of the TAHR and CR 53.*

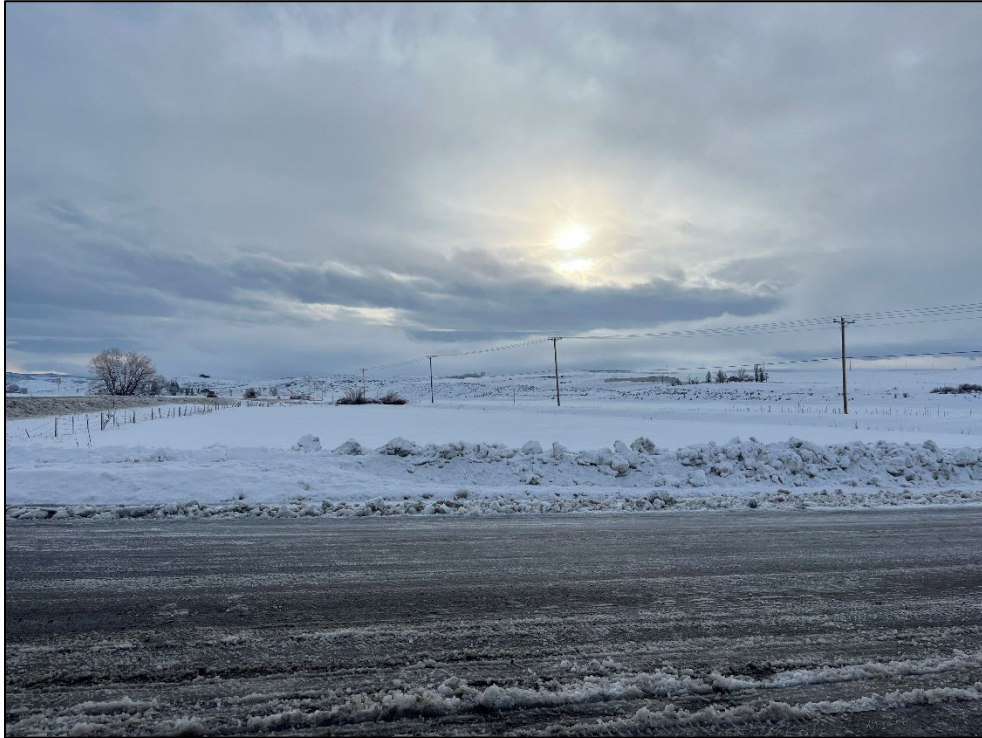
Areas not yet Phase III bond released and not included in the current SL-3 release include the area directly north and south of Hwy 40, to be reclaimed to agricultural use as hay fields. It is the only part of the previous rail loop not donated to Routt County. This area includes 6.8 acres of which 2.3 are disturbed (Photo 3).

The remaining permit area near Hwy 40 appeared vegetated under the snow (Photo 3). This area of disturbance will be fully incorporated into adjacent hay fields at the conclusion of the 10-year liability period.

*Photo 3: View east of the unreleased hayfields adjacent to Hwy 40 and CR 37.*

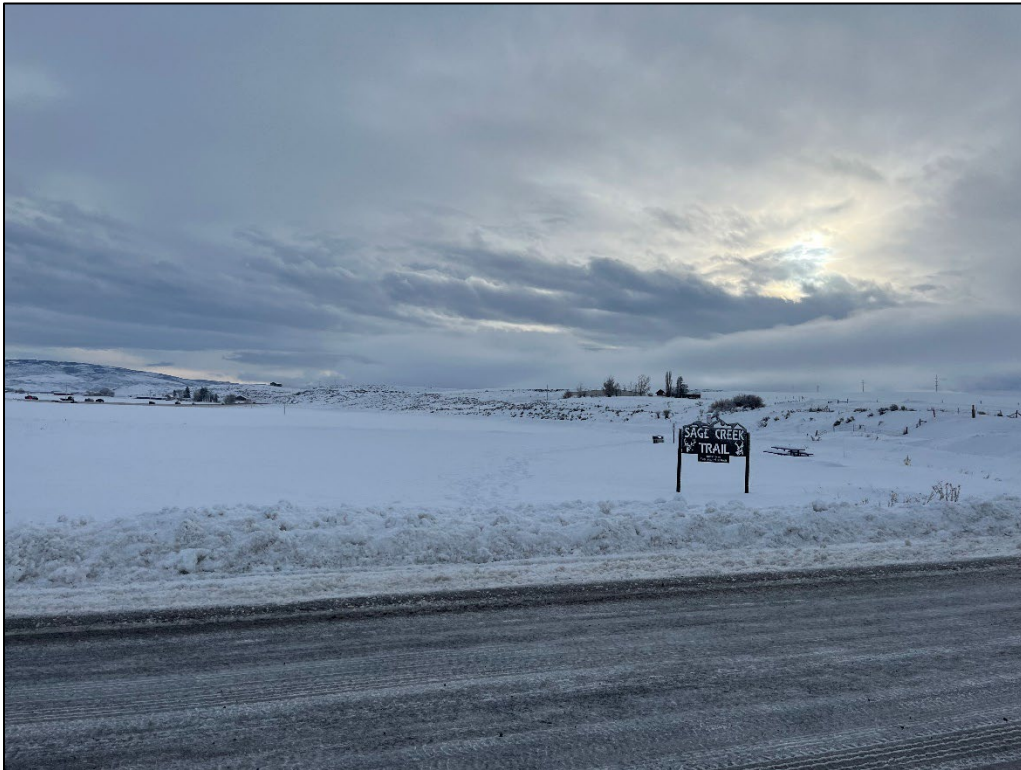
Work by the City of Hayden to replace culverts located within the previously released Tracks to Trails area (Photo 4) seems to have halted for the winter season. Two dozers and two excavators are currently being stored along the trail (Photo 5). Culverts located in this area which were not being replaced were stable and free of blockages (Photo 6).

*Photo 4: View east of the snowed in parking lot for the Sage Creek Trail which was created after handover to the City of Hayden for recreational use.*

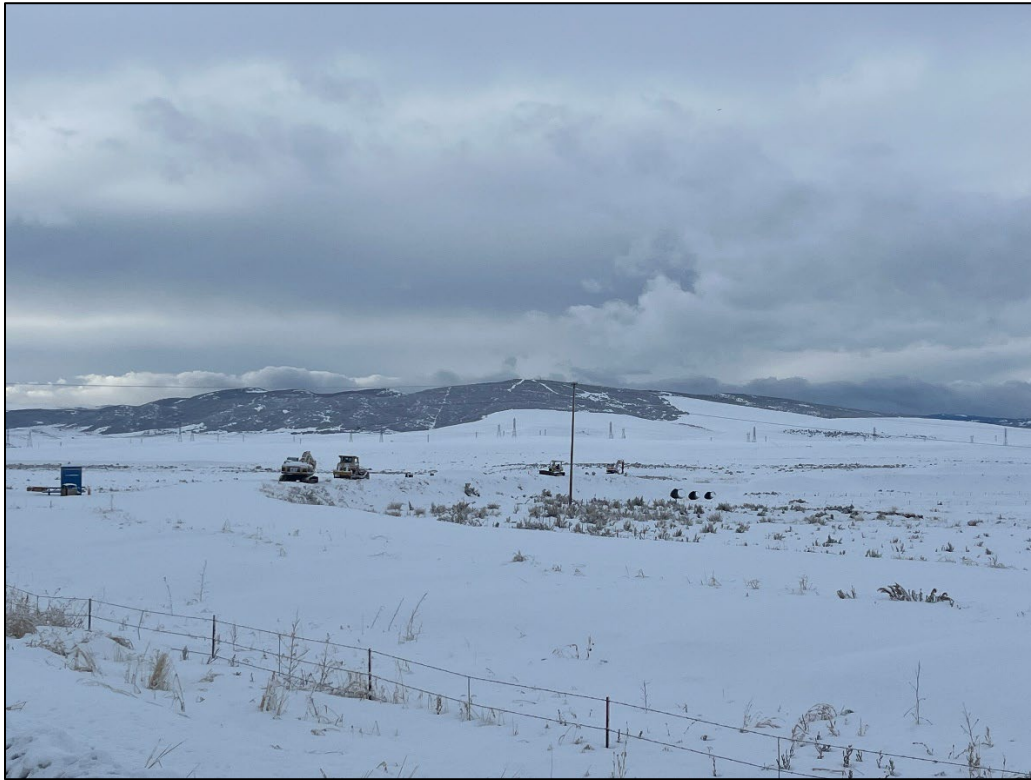
*Photo 5: The City of Hayden's work on replacing culverts has been halted for the winter season, view southwest.*

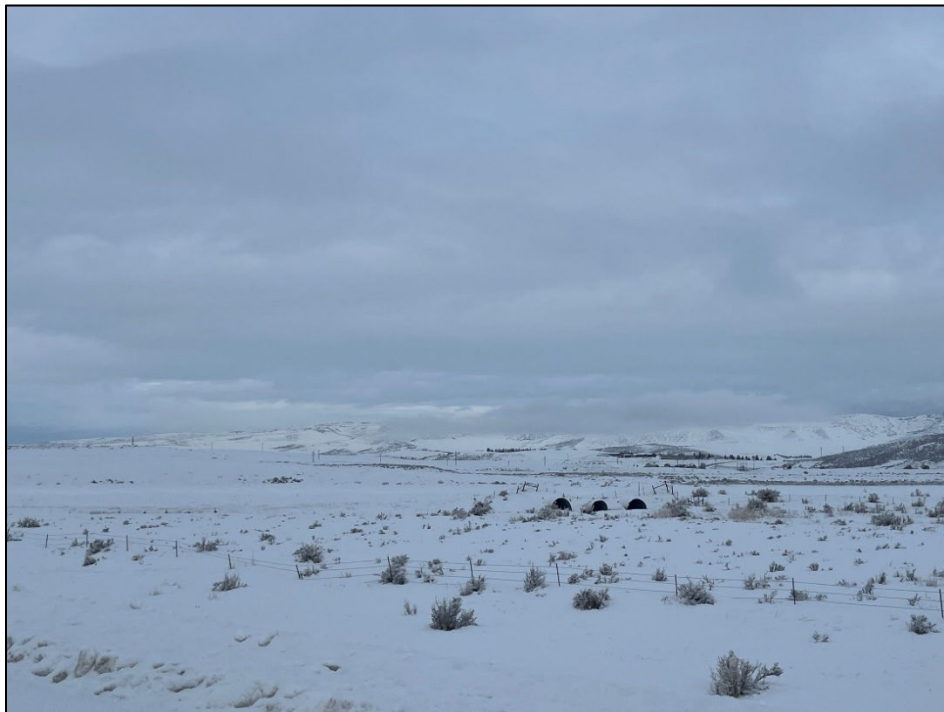
*Photo 6: Other culverts located in the released recreation area were stable and undamaged.*

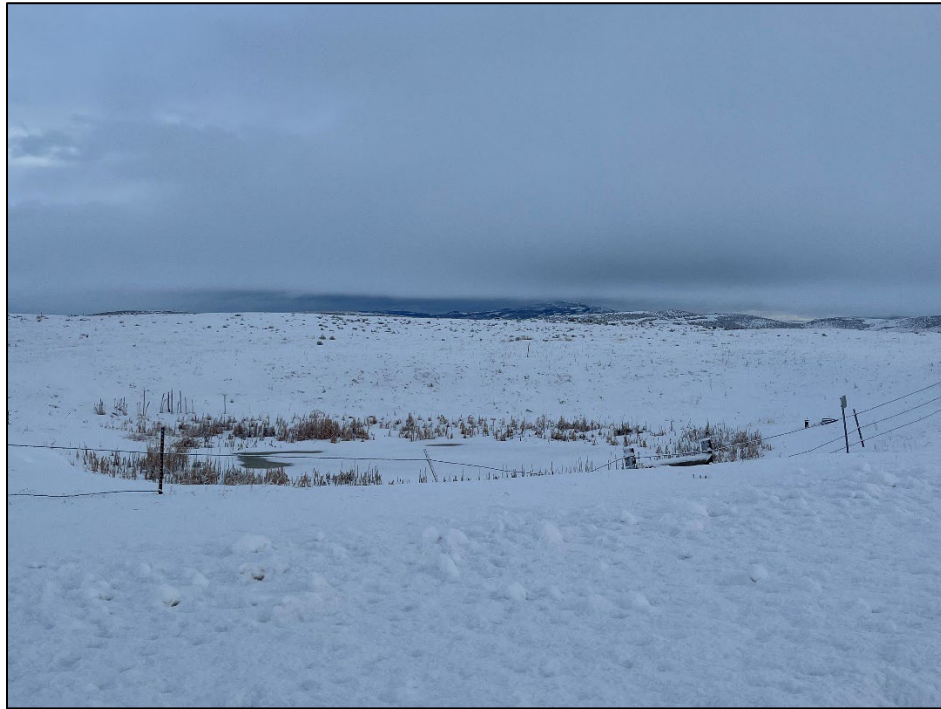
Truck Loop Pond 001 was frozen over but appeared to be stable and free of issues (Photo 7). Rail Loop Pond 002 was inaccessible due to the culvert construction happening along the Sage Creek Trail. This construction has closed off the trail entrance to the public.

*Photo 7: View north of Truck Loop Pond 001.*

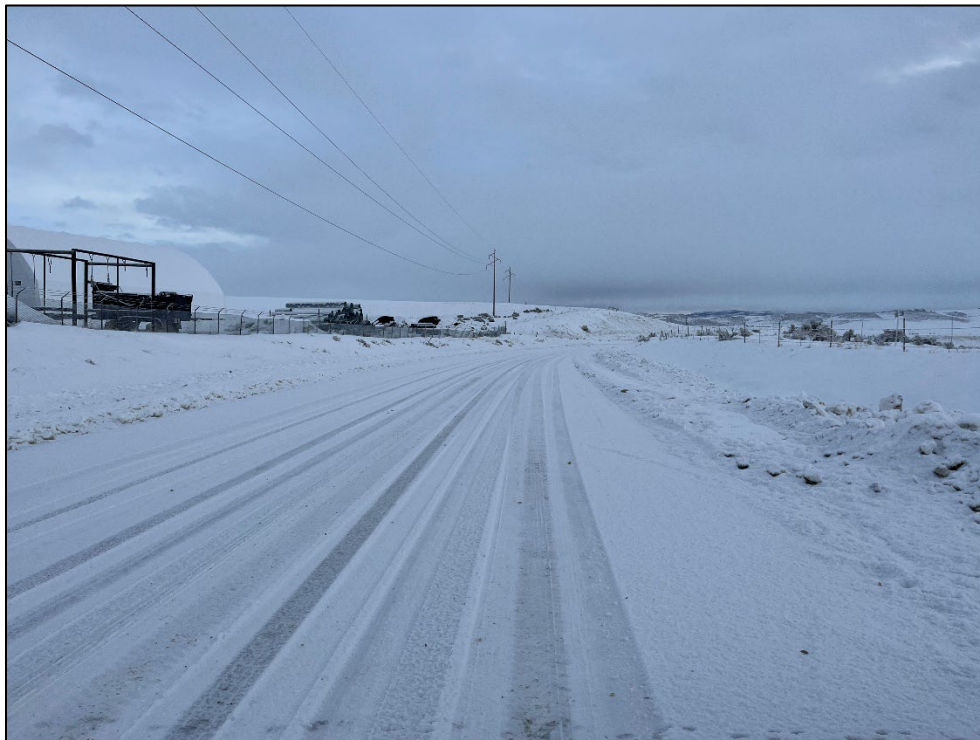
Snow received the night prior to the inspection had not yet been plowed from the Tie Across Haul Road (TAHR) but this road had been recently plowed of the heavier snowfall event which occurred a week prior to the inspection (Photo 8). The TAHR and its associated permanent topsoil pile features will be Phase III released with the approval of SL-3.

*Photo 8: View north of the TAHR adjacent to CR 53, roads had been recently plowed.*

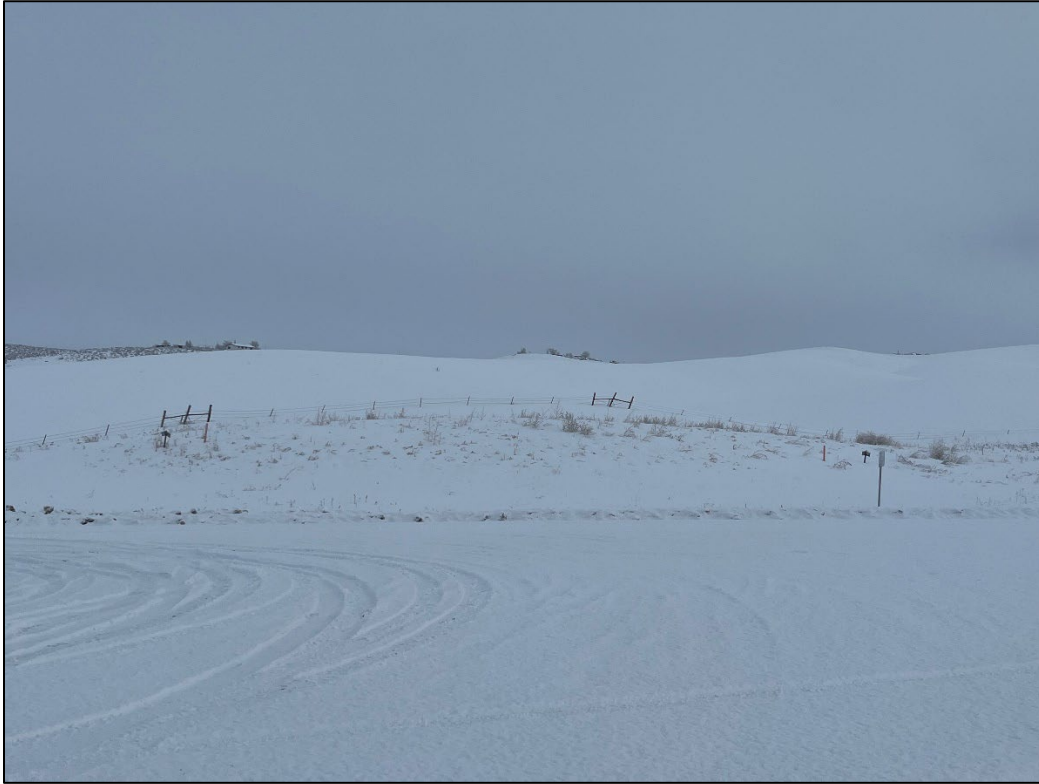
Several permanent topsoil pile features are located to the east along the currently unreleased TAHR. All piles appeared to still be vegetated underneath the snow and were marked by appropriate signage (Photo 9). These piles will be released with the approval of SL-3.

*Photo 9: Topsoil piles along the eastern half of the TAHR were stable, marked, and appeared to still be vegetated.*
