Inspection Report, Peabody Sage Creek Mine, C-2009-087

Permit Number: C-2009-087 Mine Name: Peabody Sage Creek Mine Operator: Peabody Sage Creek Mining, LLC Operator Address: Ms Mirdanda Kawcak 29515 Routt County Road 27 Oak Creek, CO 80467	County: Routt Operation Type: Underground Permit Status: Temporary Cessation Ownership: Private
	Operator Representative Present:
Operator Representative Signature: (Field Issuance Only)

Inspection Start Date: February 6, 2024 Inspection Start Time: 12:30 Inspection End Date: February 6, 2024 Inspection End Time: 13:00		Inspection Type: Coal Complete Inspection Inspection Reason: Normal I&E Program Weather: Clear / Cloudy	
Joint Inspection Agency: None		Joint Inspection Contacts:	
Post Inspection Agency: None		Post Inspection Contacts:	
Inspector(s): Hunter Ridley	Inspector's Signature:

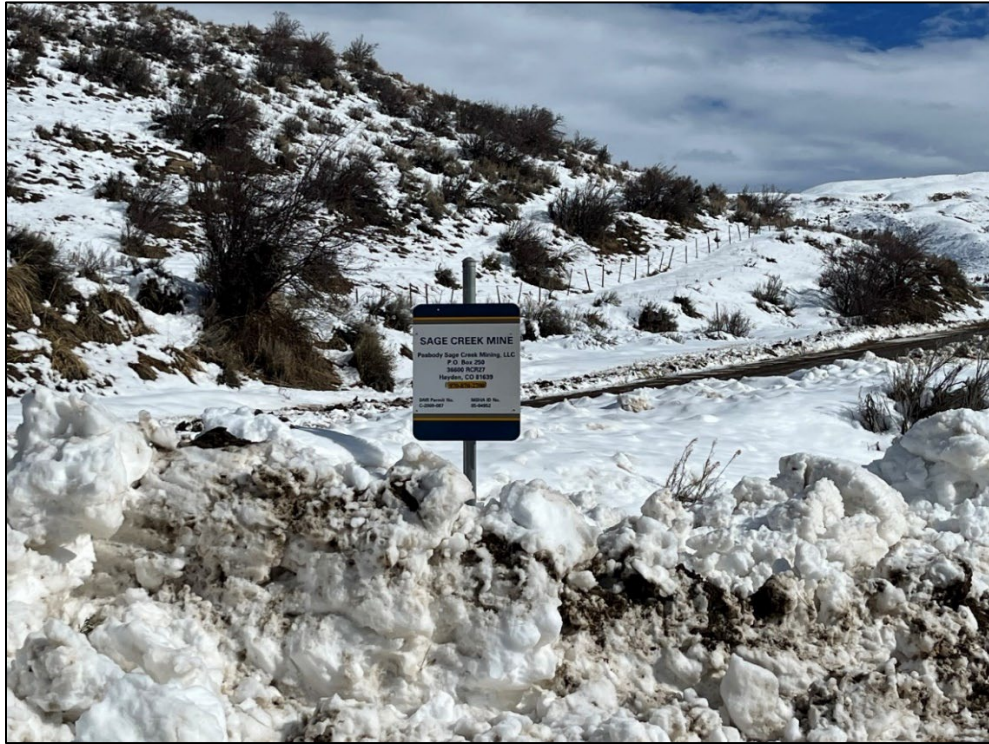
Mine identification markers were observed throughout the site (Photo 1). A scale, scale house, and office buildings are located near the site entrance.

Photo 1: Mine signage located at the intersection of the access road and CR 27A.

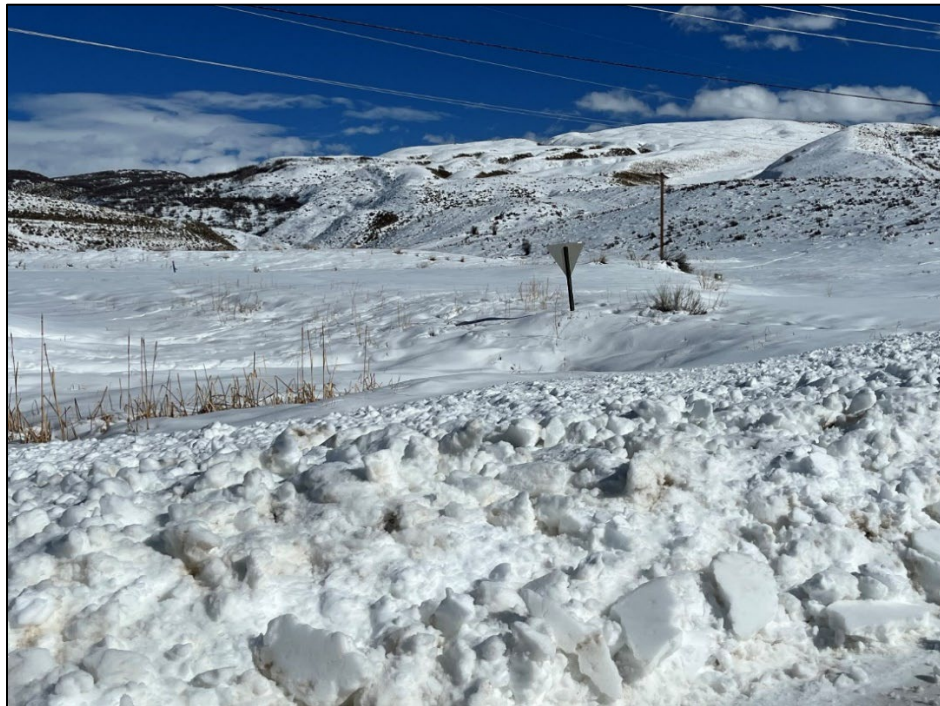
Although snow-covered, all ponds and sumps at the site were discharging slightly at the time of inspection (Photo 6). NPDES #7, located by the site’s main office buildings, was also discharging but heavily snow-covered (Photo 2). Due to snow covered conditions, it is unclear if PSCM has made the appropriate repairs to the NPDES #7 culvert as noted in the last inspection report. This will continue to be a maintenance item. **Please inform the Division when the appropriate repairs have been completed.**

Photo 2: Culvert and discharge location NPDES #7 were covered in snow and inaccessible without snow shoes.

- The ditch around the portal area needs to be cleared of cattail growth to maintain proper drainage in the area in spring/summer months.
- Additional disturbance markers are recommended.
- Culvert at NPDES #7 needs to be repaired.
- Continue to monitor the pipe below Pond 002 for leakage or blowout.

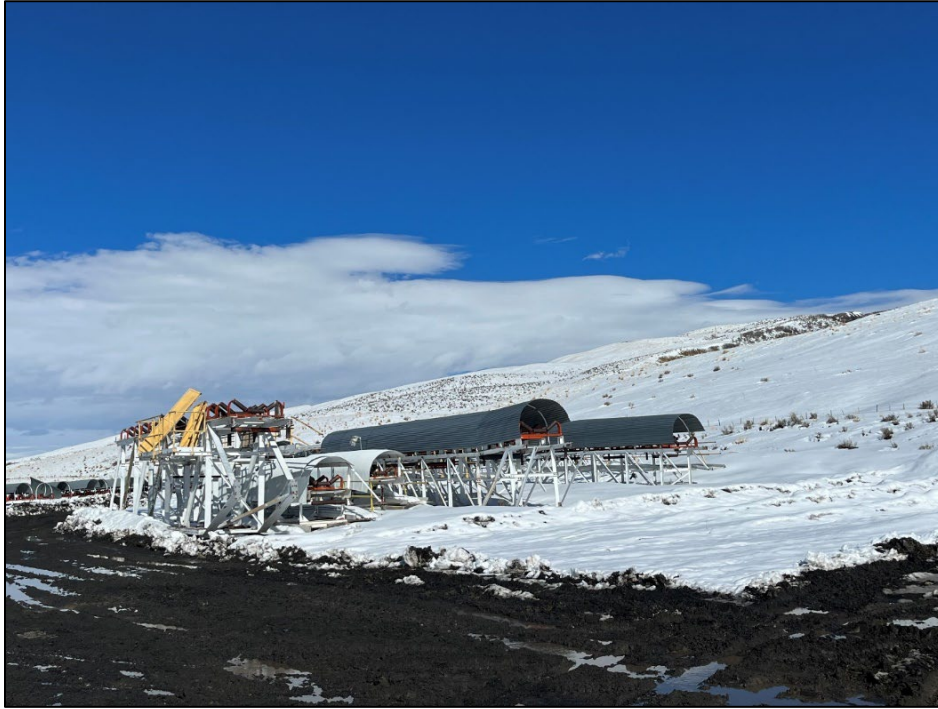
As this site is in temporary cessation, many of the on-site support facilities are unused. This includes storage buildings, a water tank located along Road B, and other unused storage areas. These areas remain organized and contained. Old conveyor equipment stored at the southeastern ‘Material/Coal Storage Area’ will be transported and used to build a temporary conveyor at the Foidel Creek Mine to replace a recently damaged conveyor tube at the Foidel Creek wash plant (Photo 3).

Photo 3: Extra conveyor equipment stored at the Peabody Sage Creek Mine will be transported to the Foidel Creek Mine and used to build a temporary conveyor for the recently damaged wash plant facility.

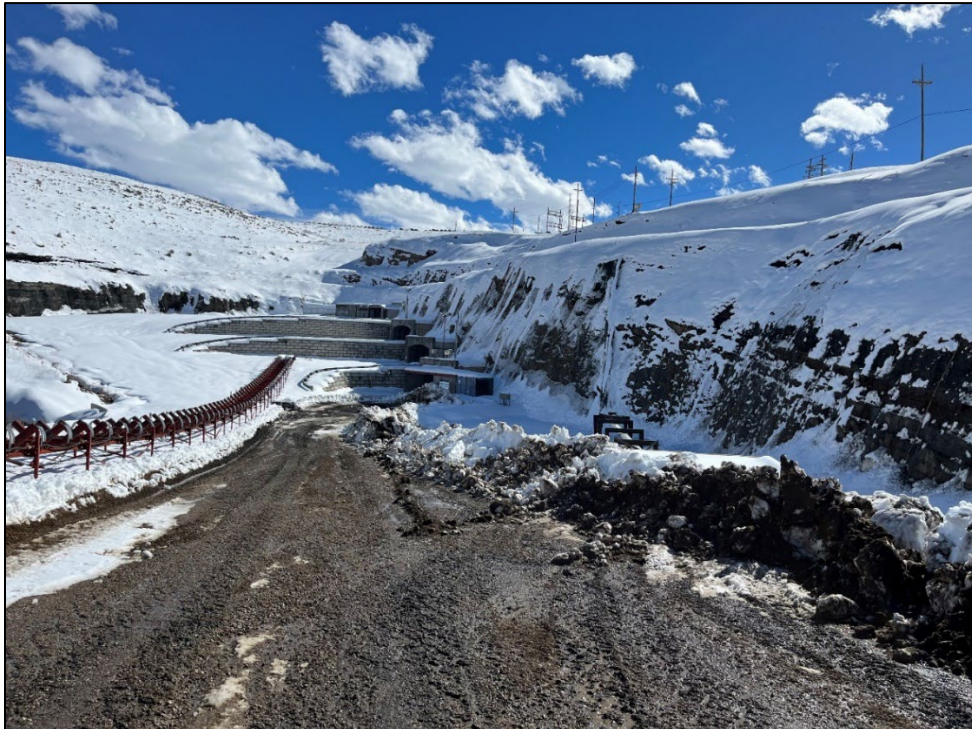
Mine water and snowmelt are still able to be pumped from the portal area should this be necessary. A float system which automatically turns on pumps when needed at the portal entry is in place (Photo 4).

Photo 4: View east of the portal entry area.

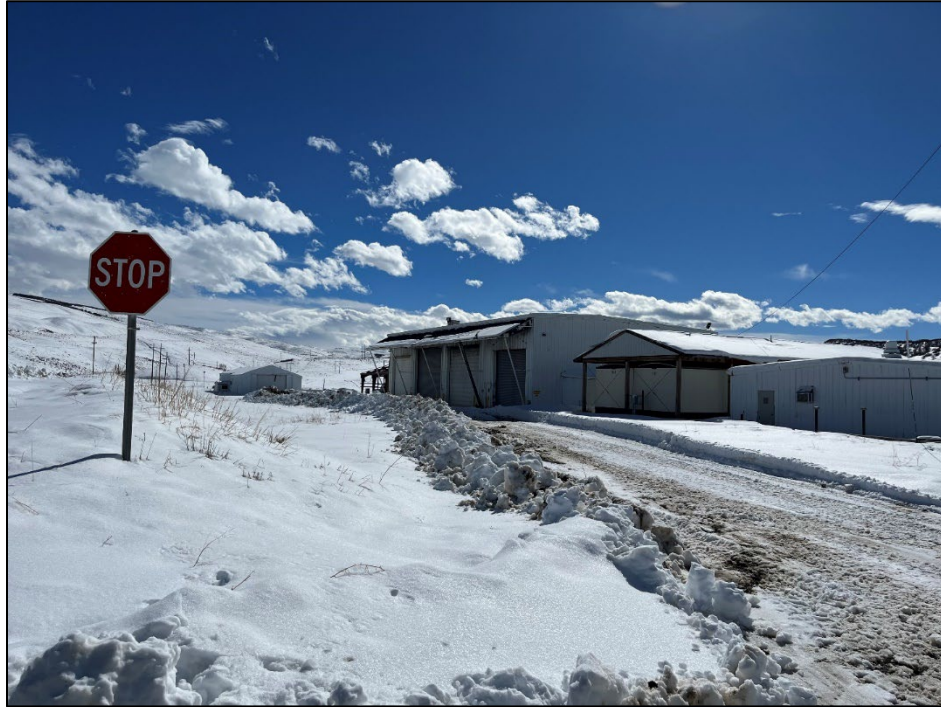
All haul roads, A through F, were well maintained and recently plowed (Photo 5). The Peabody Sage Creek Mine is not usually plowed in the winter, but equipment salvaging activities- further discussed in the next section- were planned for the coming weeks.

Photo 5: Roads were plowed to allow for access to maintenance facilities if needed.

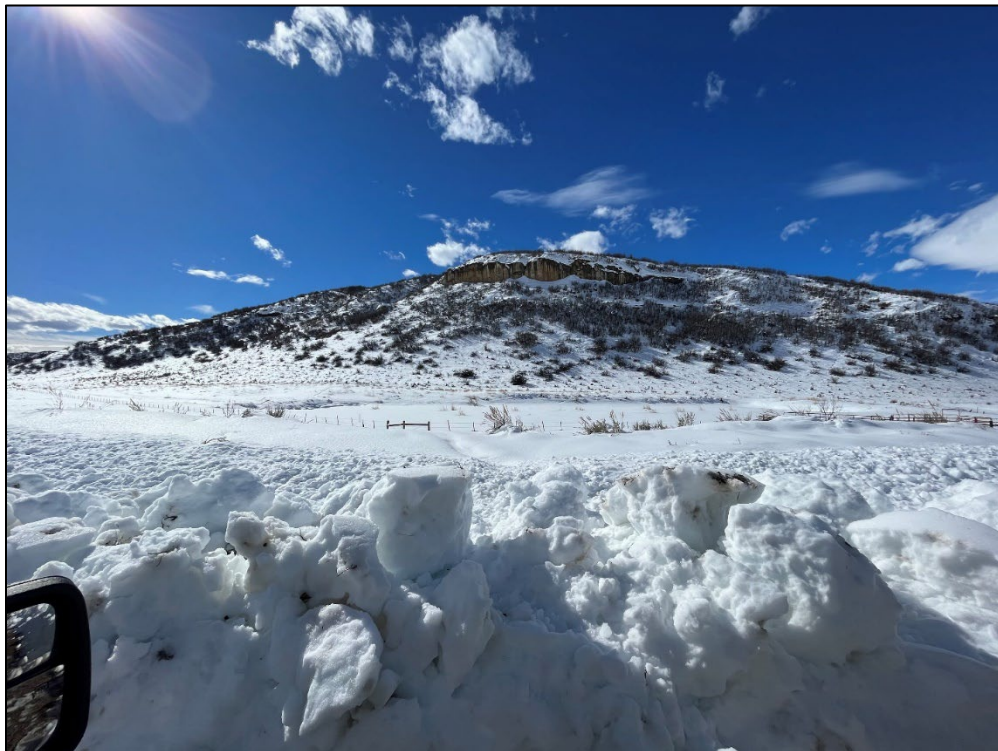
Photo 6: View west of Pond 3, pond was snow-covered but discharging at the time of inspection.
