2023 February DRMS Inspection Report

COLORADO
 Division of Reclamation,
 Mining and Safety
 Department of Natural Resources

PERMIT INFORMATION

INSPECTION INFORMATION

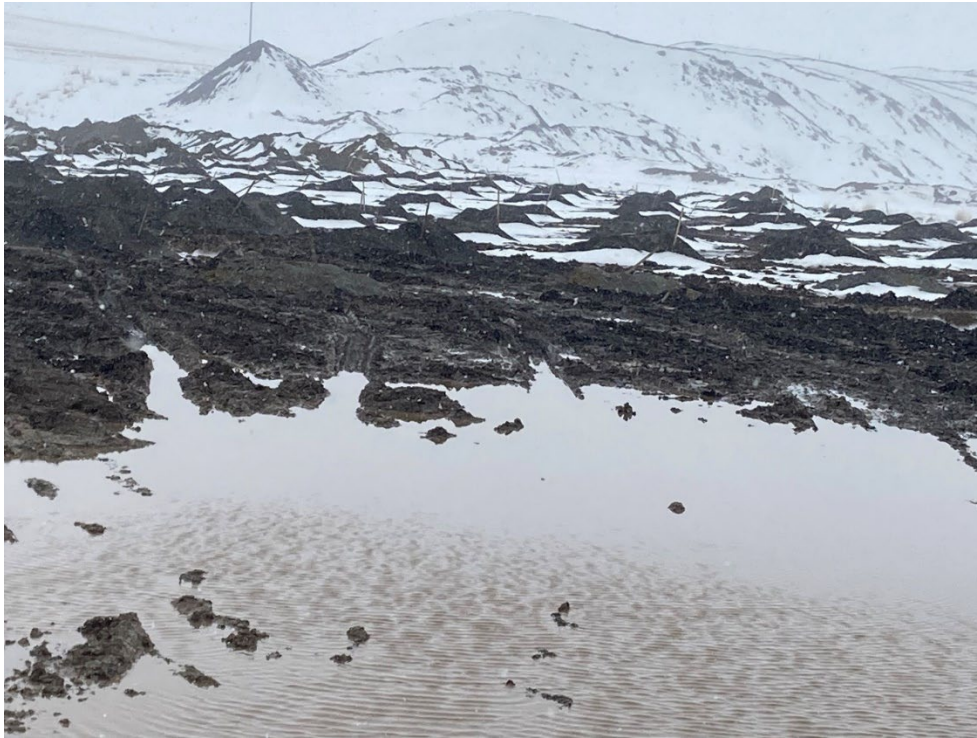
- A blast was in the process of being laid out in J Pit.

Photo 1: Blast being set up in N Pit, looking west.

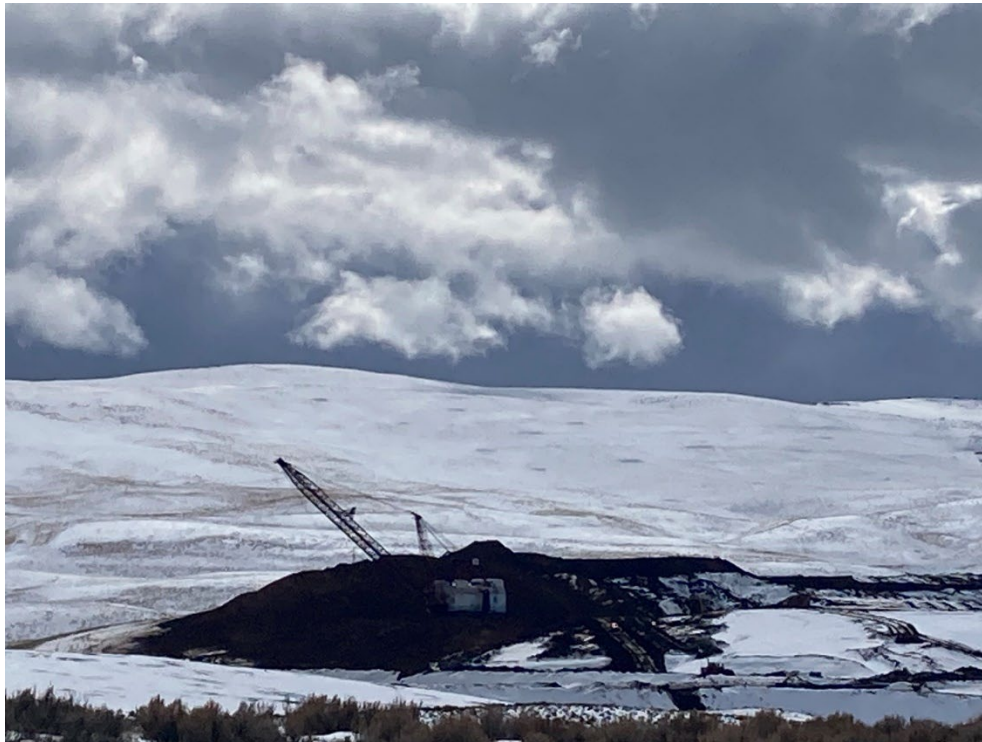
The inspection began in L Pit, where the Molly Braun drag line was working in the south end of the L Pit and The Baby Doe drag line positioned at the north end of the pit was casting spoil. The top north end of the pit was being leveled. J Pit has been opened and the Queen Ann dragline was working in the pit casting spoil.

Photo 2: N Pit, and Queen Ann dragline from a distance looking south.

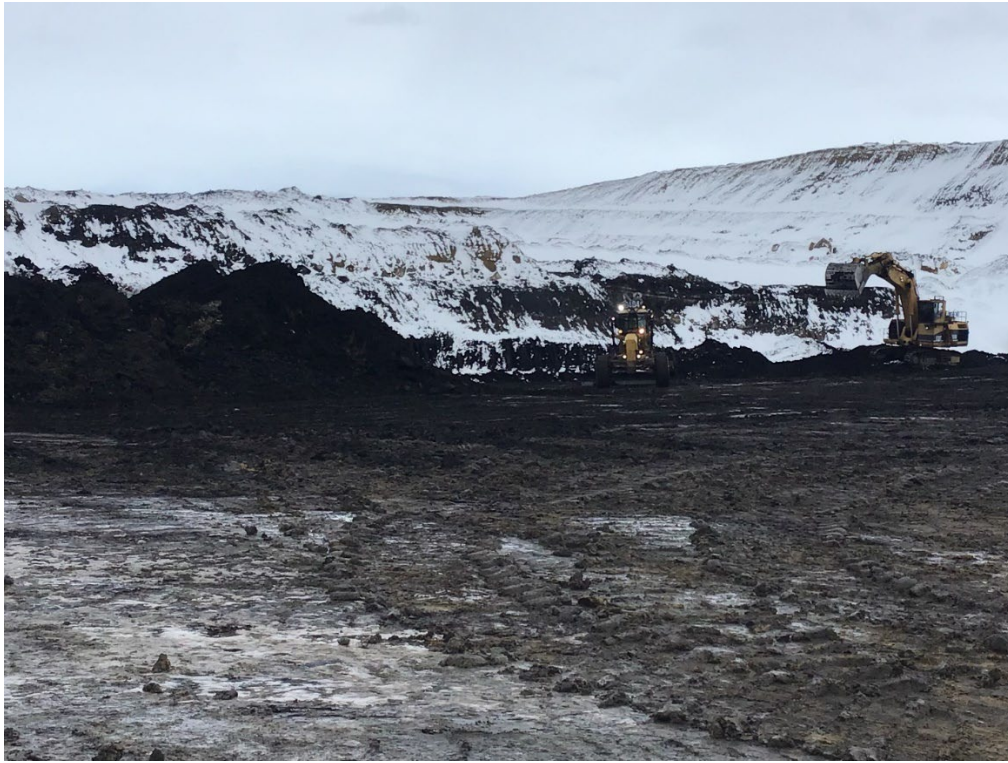
- Reclamation consists of benched overburden in L Pit awaiting grading, an ongoing activity at Trapper Mine.

Photo 3: Activities in L Pit, looking south.
