Bowie #1 inspection report

Permit Number: C-1981-038 Mine Name: Bowie No. 1 Mine Operator: Bowie Resources, LLC Operator Address: Mr. Basil R Bear P.O. Box 1488 Paonia, CO 81428	County: Delta Operation Type: Underground Permit Status: Active Ownership: Private
	Operator Representative Present: None
Operator Representative Signature: (Field Issuance Only)

Inspection Start Date: February 13, 2024 Inspection Start Time: 13:40 Inspection End Date: February 13, 2024 Inspection End Time: 14:00		Inspection Type: Aerial Inspection Inspection Reason: Normal I&E Program Weather: Clear	
Joint Inspection Agency: None		Joint Inspection Contacts: 	
Post Inspection Agency: None		Post Inspection Contacts: 	
Inspector(s): Robert Zuber, P.E. Brock Bowles	Inspector's Signature:

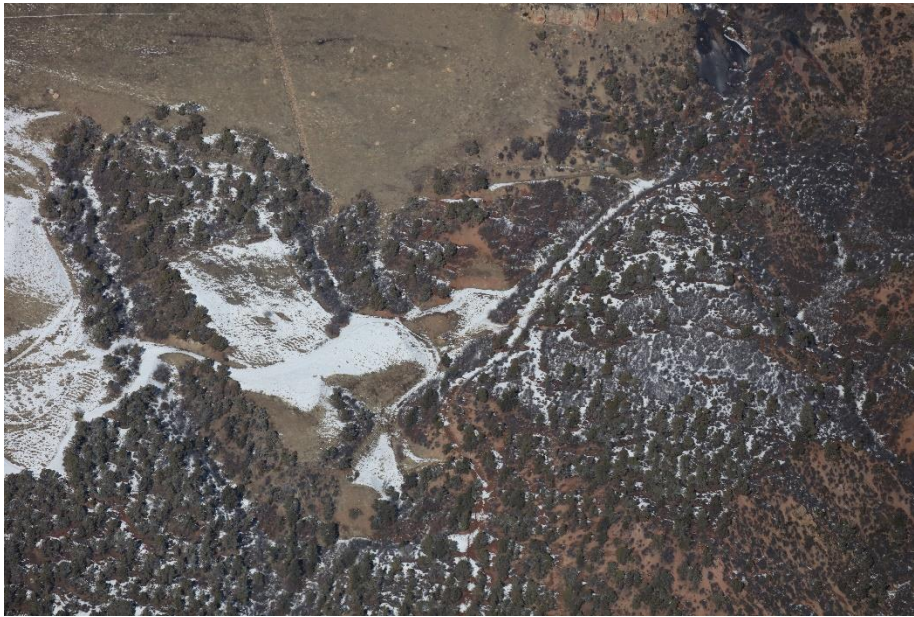
Drainage near Pond 1 and Pond 2

Reclaimed Ponds 1-4, southeast of the East Mine, were inspected. The West Mine was also inspected, including the area near the creek and the road at the north end. No erosion or other problems were identified.

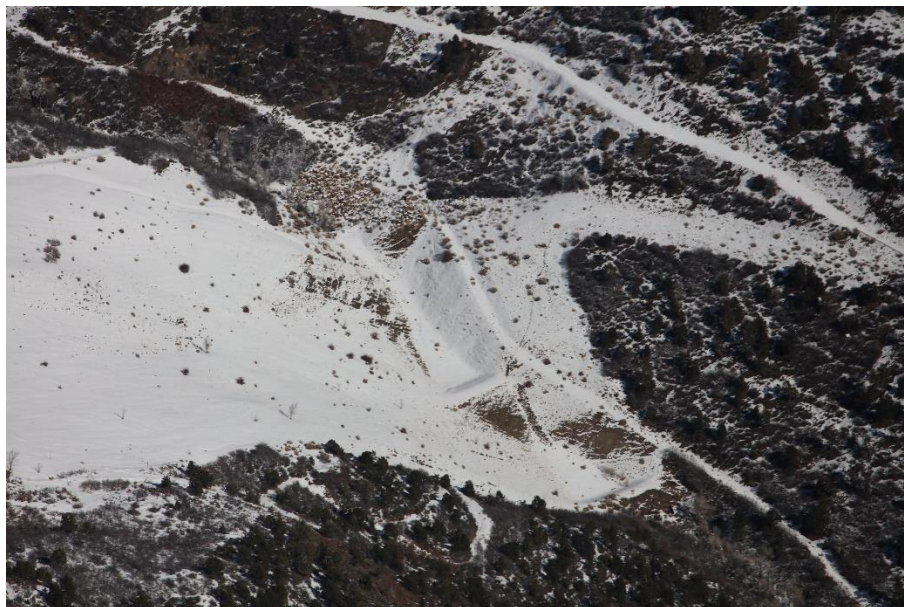
Lower portion of West Mine, including ponds

The ponds at the West Mine contained a large amount of snow. The ponds at the coal storage by the highway and the loadout were nearly dry. No erosion or other problems were seen with the embankments or other portions of these ponds.

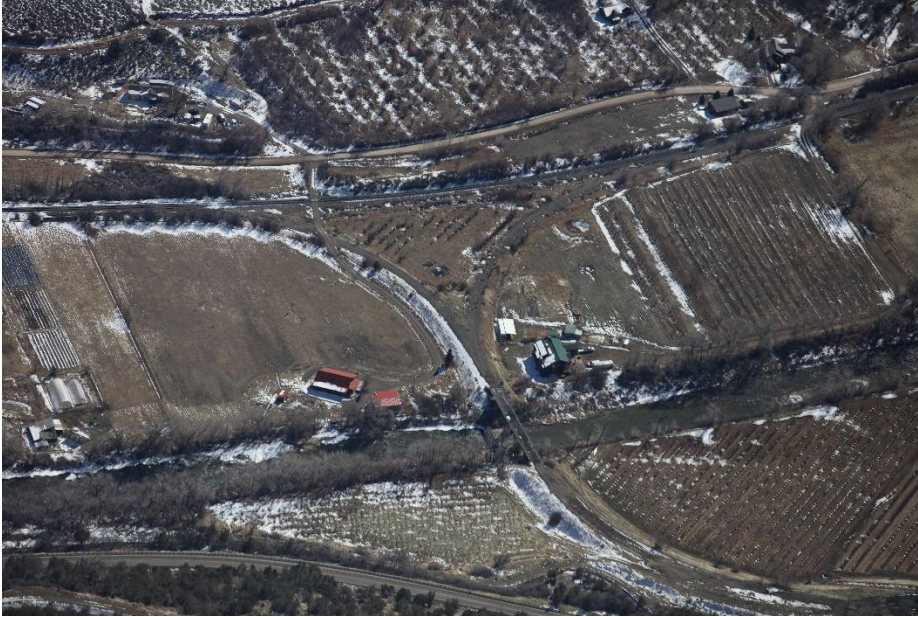
Loadout “Y” and adjacent bridge

No erosion or other problems were identified at the loadout. This includes the “Y” and adjacent bridge at the east end of the main loadout area, as well as the UPRR tracks adjacent to Grange Road and Black Bridge Road.
