MINERALS PROGRAM INSPECTION REPORT
PHONE: (303) 866-3567

MINE NAME: Wild Cat Claim	MINE/PROSPECTING ID#: M-2023-031	MINERAL: Borrow Material	COUNTY: Teller
INSPECTION TYPE: Illegal (Unpermitted Operation)	INSPECTOR(S): Elliott Russell	INSP. DATE: September 27, 2023	INSP. TIME: 09:30
OPERATOR: Michael Brown	OPERATOR REPRESENTATIVE: Michael Brown	TYPE OF OPERATION: ILL - Illegal

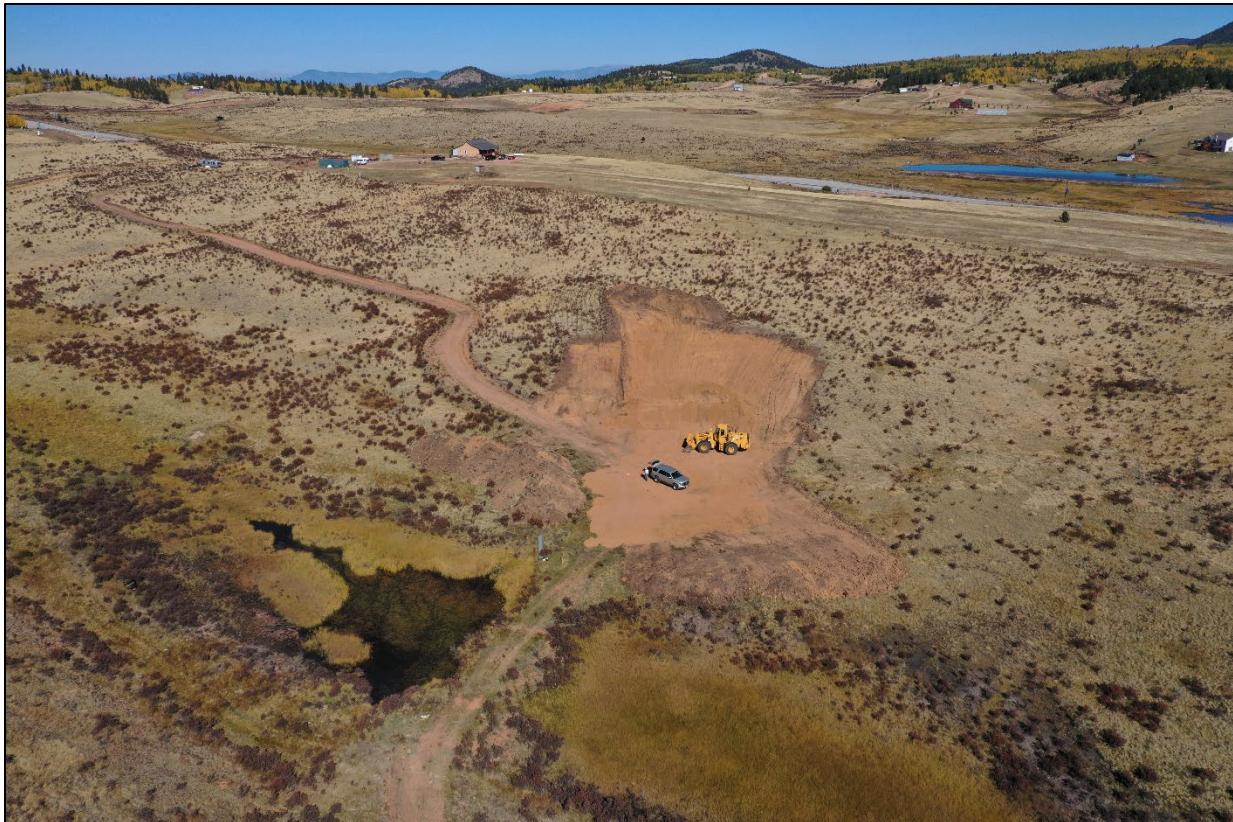
Photo 1. Overview of excavation area; looking north.

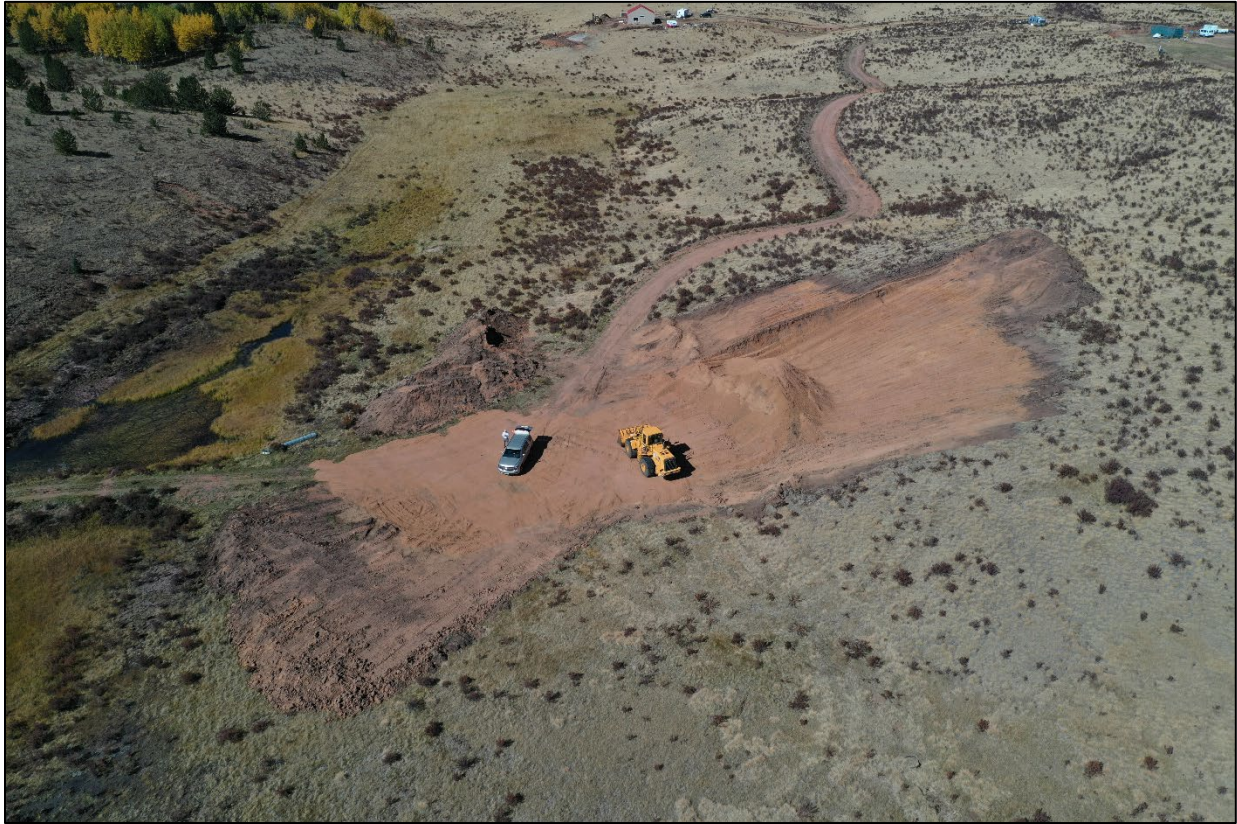
Photo 2. Overview of excavation area; looking west.

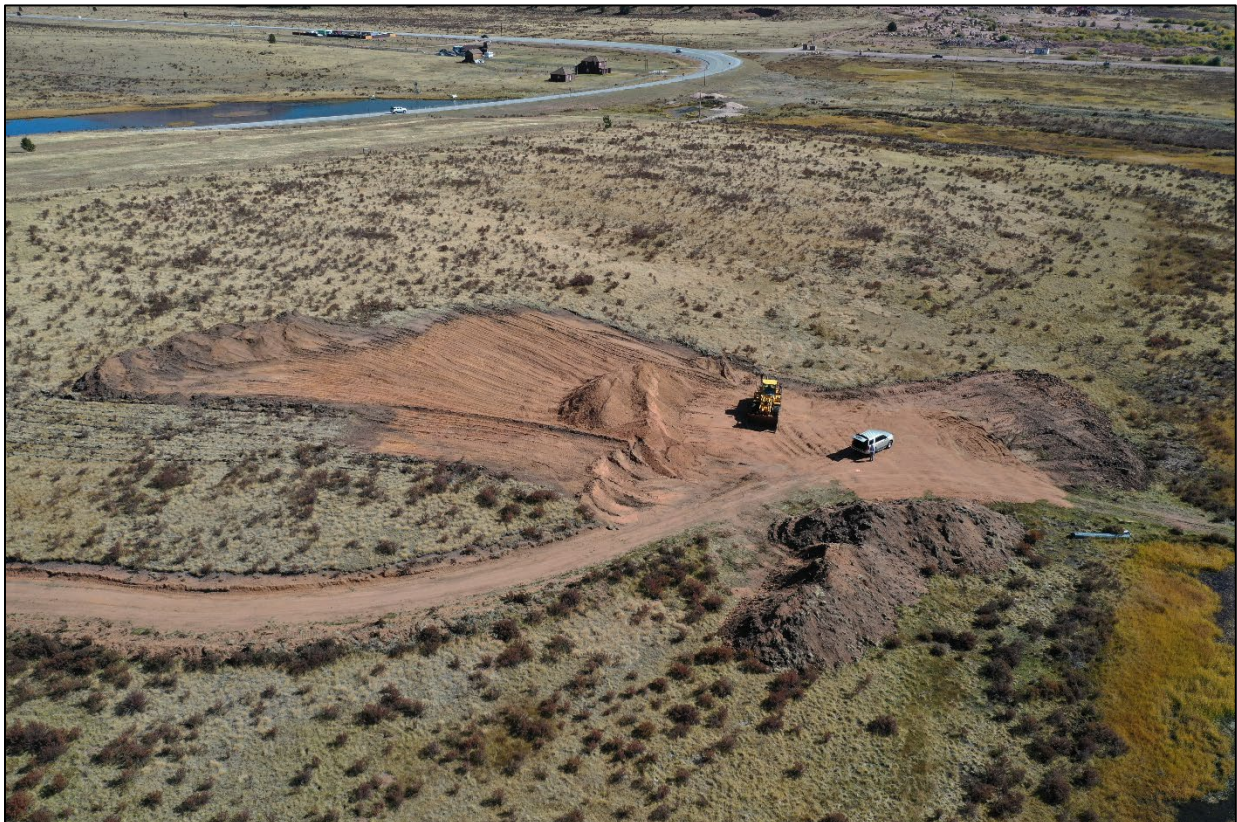
Photo 3. Overview of excavation area; looking east.

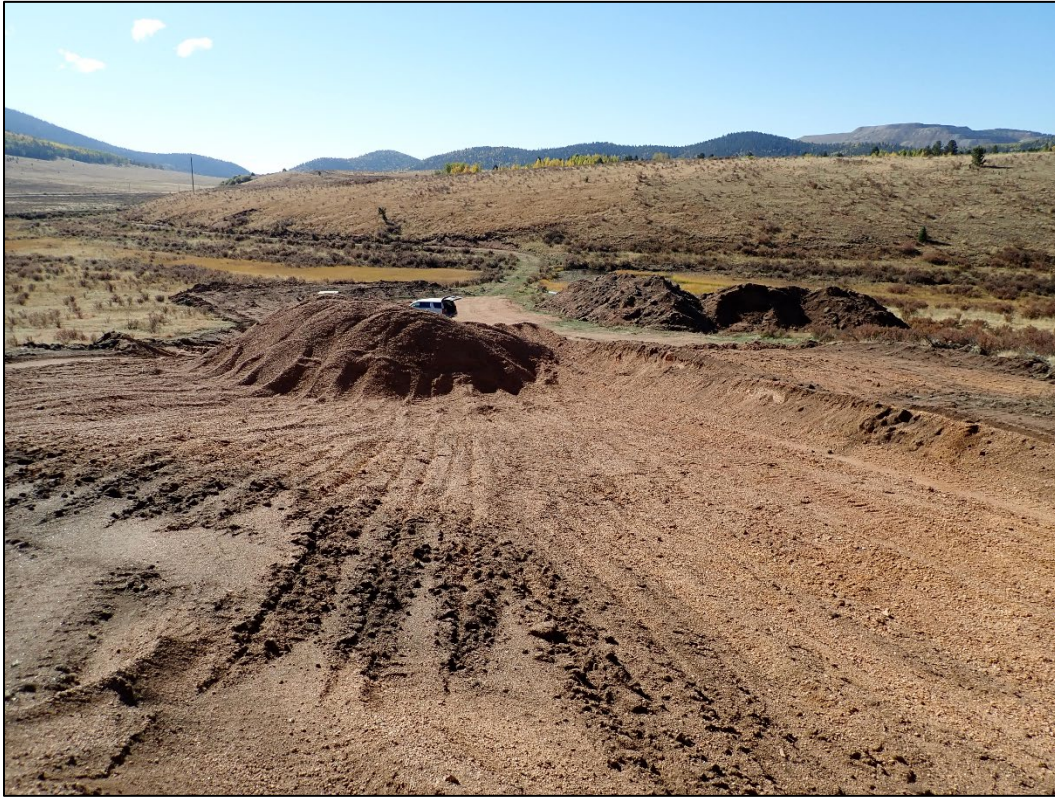
Photo 4. Excavation area; looking south.

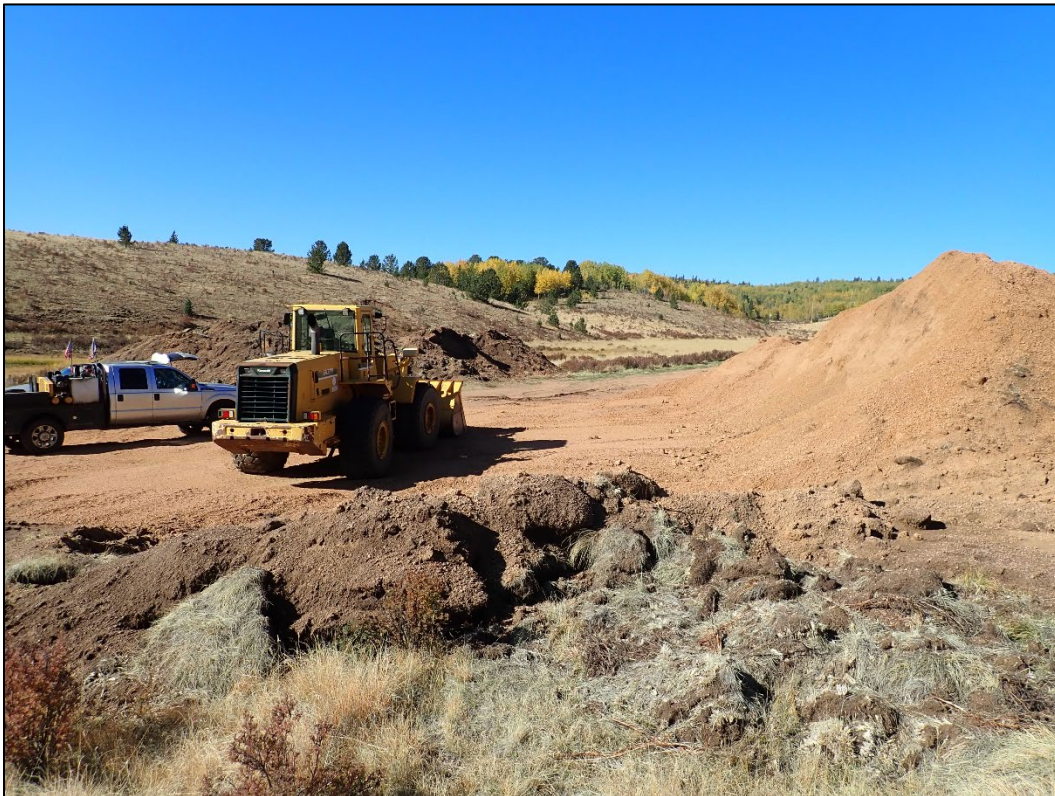
Photo 5. Product stockpile area; looking west.

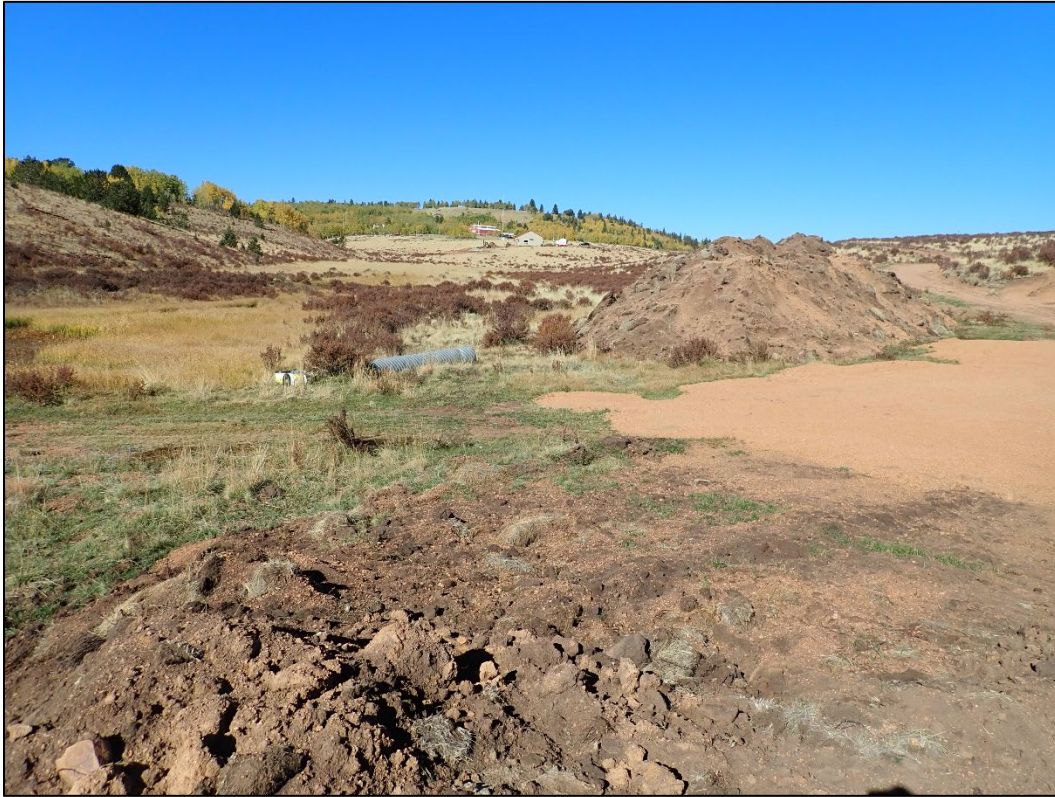
Photo 6. Lower topsoil stockpile area; looking west.

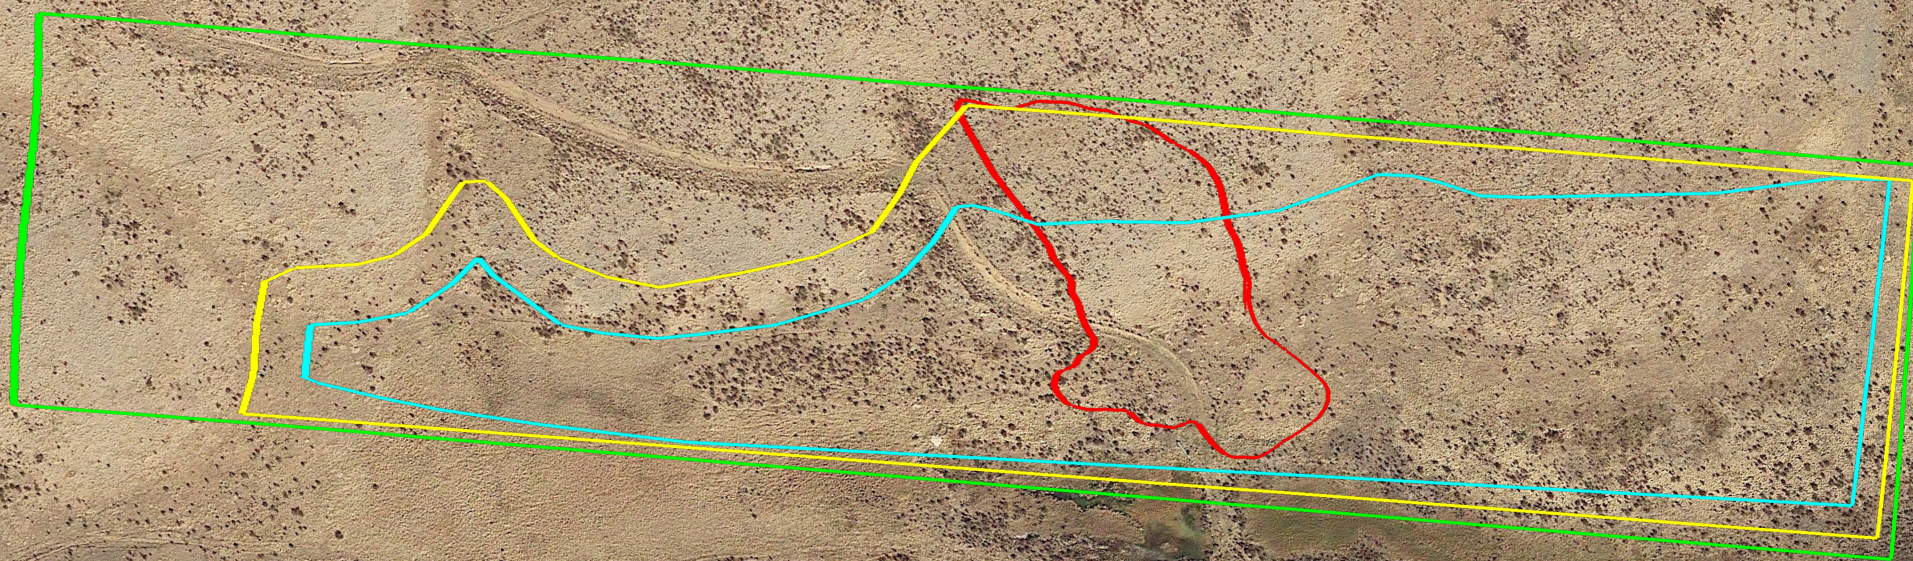
9-27-23 Inspection Map M2023031

The site consisted of a single excavated area into a south facing hill side just north of a drainage and small pond. A product stockpile was located at the toe of excavated slope with one topsoil stockpile located above the excavated area and two on the south side of the disturbed area near the drainage. The Division acquired GPS data with a Trimble Juno 3B and used Google Earth to determine the disturbance was approximately 1 acre in size. The Division has attached *9-27-23 Inspection Map M2023031* to this report which depicts the size of the disturbance area. The Division used the maps within the Site Plan, as well as information on the Teller County Assessor's online map viewer, to depict the approximate location and size of Mr. Brown's Wild Cat Claim parcel, the approximate disturbance footprint by comparing the Topographic Map – Current Surface to the Topographic Map – Shop/Work Area, and the flat pad area on the Division's inspection map.
