MINERALS PROGRAM INSPECTION REPORT
PHONE: (303) 866-3567

MINE NAME: Una Pit	MINE/PROSPECTING ID#: M-1980-080	MINERAL: Sand and gravel	COUNTY: Garfield
INSPECTION TYPE: Monitoring	WEATHER: Clear	INSP. DATE: January 31, 2024	INSP. TIME: 10:00
OPERATOR: Grand Junction Concrete Pipe Co.	OPERATOR REPRESENTATIVE: Jim Doody	TYPE OF OPERATION: 112c - Construction Regular Operation

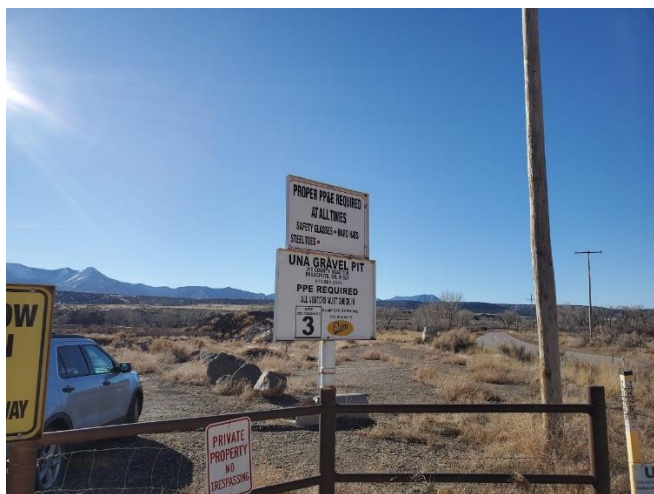
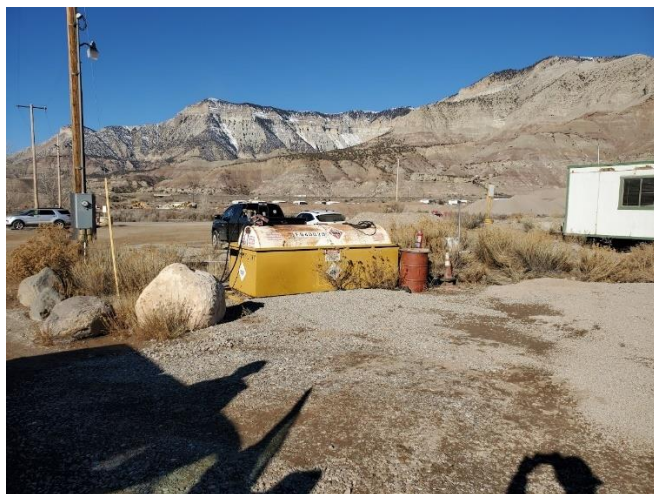
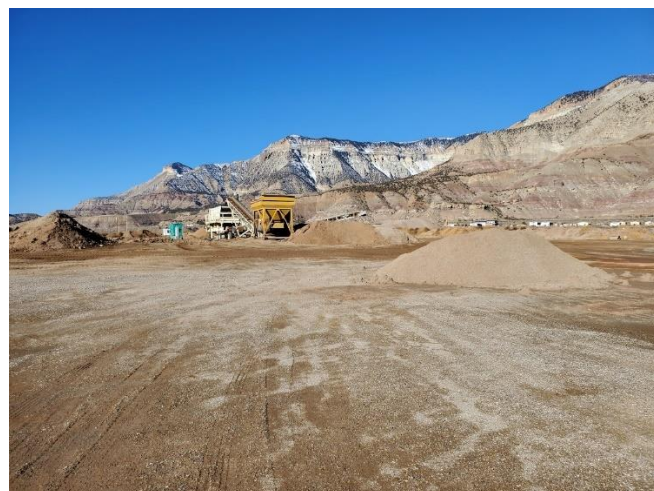
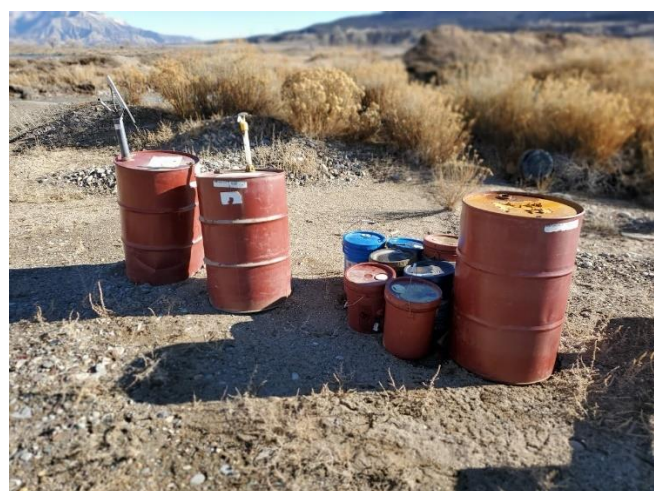
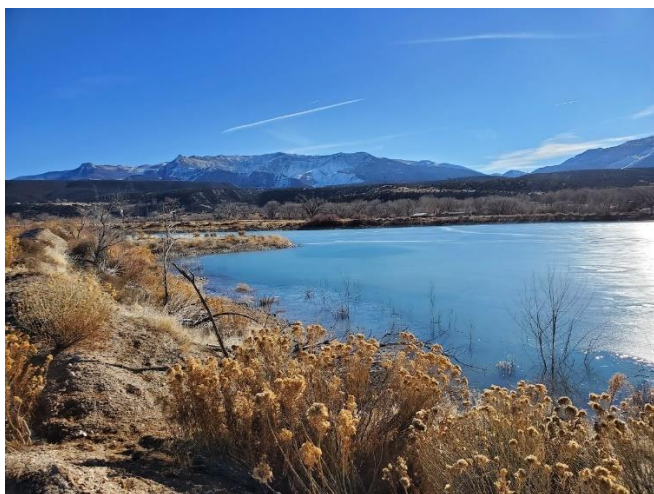
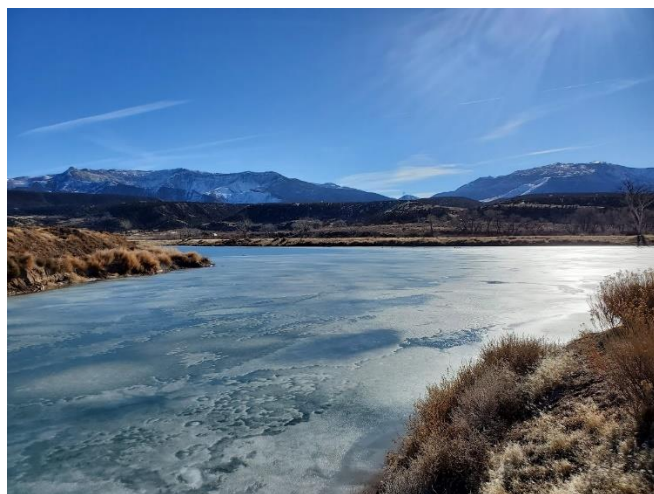
Three 55-gallon barrels and six 5-gallon buckets containing hydrocarbon products were observed on the east side of the stockpile area. There was no secondary containment observed. This has been noted as a problem. Please remove place the barrels in secondary containment or remove them from the site no later than March 13, 2024. Please provide the Division with photos of the completed maintenance item by March 13, 2024.

CORRECTIVE ACTIONS: All storage tanks, petroleum and any hazardous materials on site for any period of time shall have appropriate secondary containment. The site will also have to comply with all applicable SPCC requirements. Please supply photo documentation that any fuel or hazardous materials containers are stored properly - including applicable secondary containment structures by the corrective action date. Note that secondary containment structures shall consist of an impermeable containment which could contain all contents of the tanks and various containers (when full) plus 10% of the total capacity. The operator may also provide photo documentation that all containers have been removed from the site on or before the corrective action date.
