Report for Bowie #2

PERMIT INFORMATION

Permit Number: C-1996-083 Mine Name: Bowie No. 2 Mine Operator: Bowie Resources, LLC Operator Address: Mr. Basil Bear P.O. Box 1488 Paonia, CO 81428	County: Delta Operation Type: Underground Permit Status: Active Ownership: Private
	Operator Representative Present: None
Operator Representative Signature: (Field Issuance Only)

Inspection Start Date: February 13, 2024 Inspection Start Time: 13:40 Inspection End Date: February 13, 2024 Inspection End Time: 14:00		Inspection Type: Aerial Inspection Inspection Reason: Normal I&E Program Weather: Clear	
Joint Inspection Agency: None		Joint Inspection Contacts:	
Post Inspection Agency: None		Post Inspection Contacts:	
Inspector(s): Robert Zuber, P.E. Brock Bowles	Inspector's Signature:

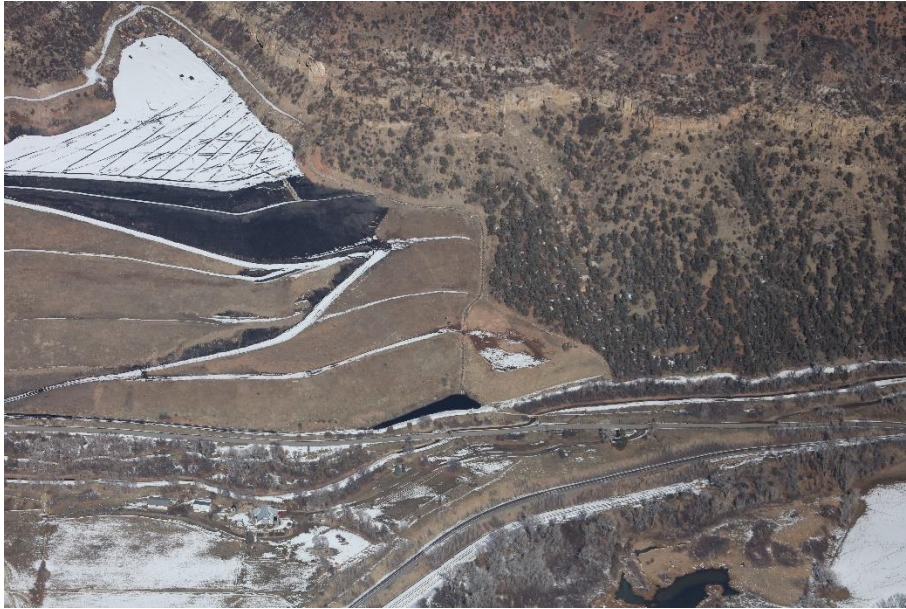
Gob Pile 2 and Pond F

The following ponds were inspected: B, C, D, F, J, and K. Most of these ponds contained or appeared to contain significant water, with Pond K being the exception. The vegetation in Pond J obscures the bottom, so it is difficult to determine the amount of water in it. No problems were identified with embankments or other features of the ponds.

No erosion, areas with ponded water, or other problems were identified on any of the gob piles.

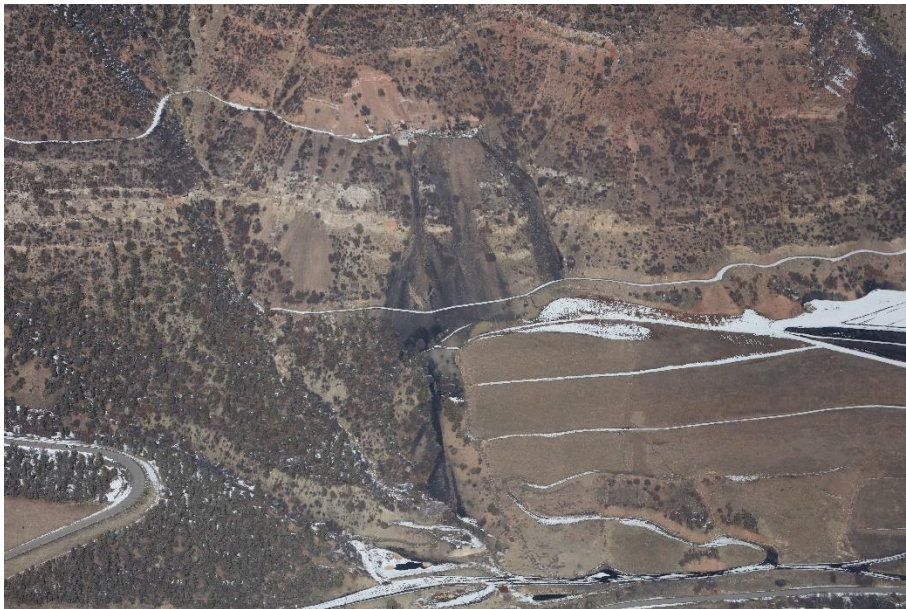
Gob Pile 4 and Ponds C and D

The repair of the blowout that occurred on Gob Pile #4 in the spring of 2023 appears stable.

Gob Pile #1, Gob Pile #4, and the reclaimed portion of Gob Pile #2 all appear to be in stable condition. In general, there is no erosion on the hillsides along the access road to the mine portals and Utility Bench, with exceptions noted in the Slides and Other Damage section of this report.

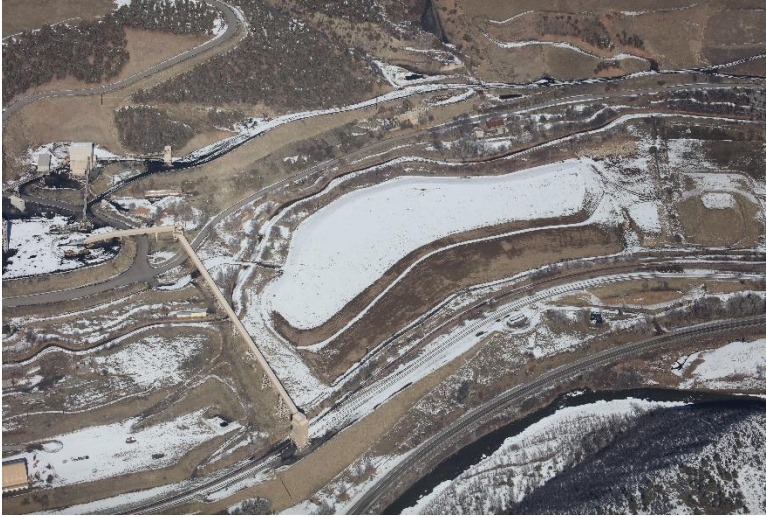
Gob Pile 3 and area below it

No problems were detected with any of the surface water control ditches. This includes the diversion ditches above Gob Pile #2 and Gob Pile #4 and the ditches between Gob Pile #3 and Pond J.

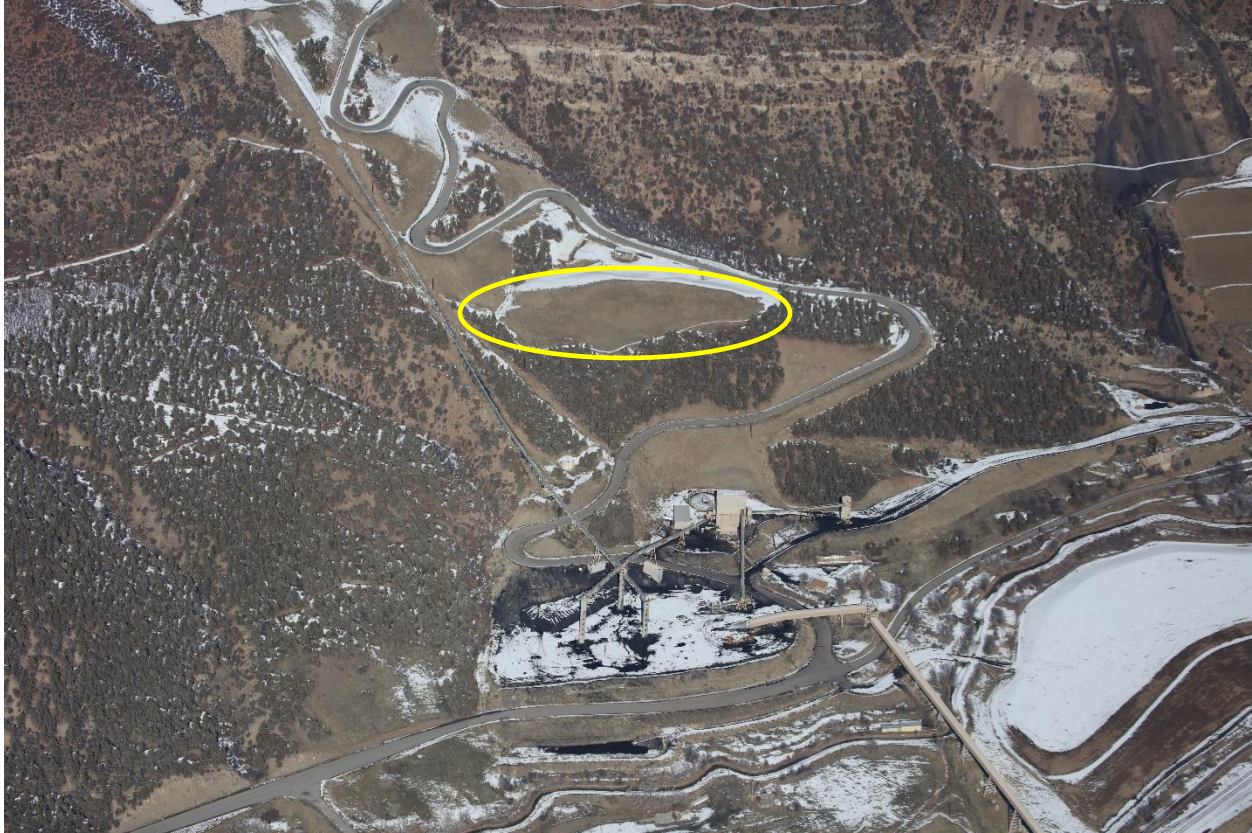
No erosion or other issues were identified at soil piles.

Pond B (front center), facilities area, lower haul road, lower conveyors, and Topsoil Stockpile A (circled)

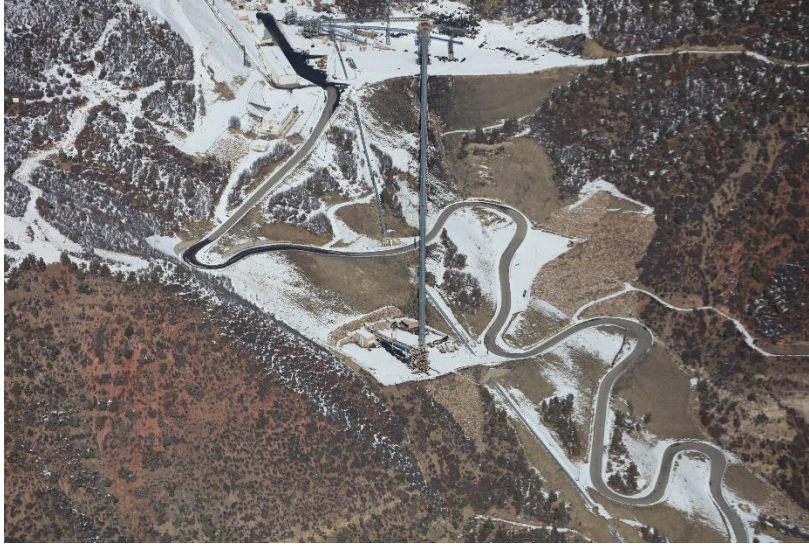
The slumps above the B Portal Bench, at Curve 10, at Curve 11, and above the road to the Utility Bench have not worsened in recent months.

B Portal Bench, slope below D Portal Bench, and upper conveyors

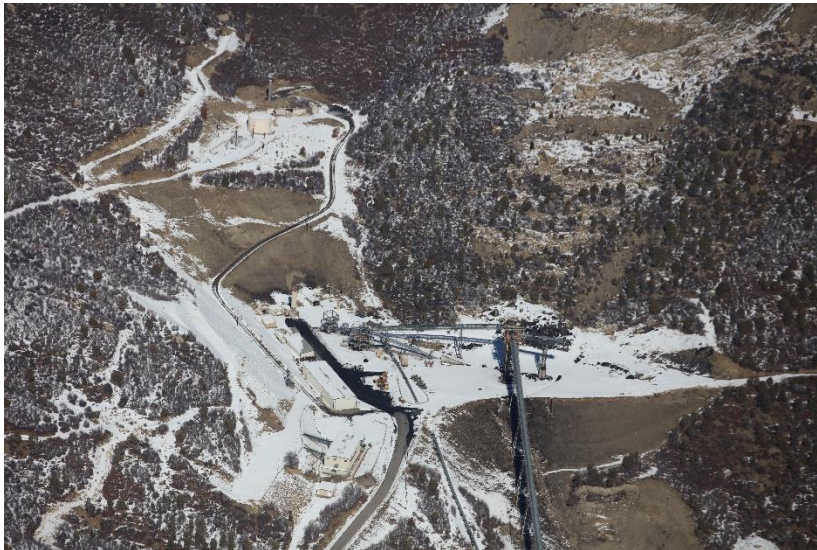
D Portal Bench and Utility Bench

No problems were identified with any facility areas, including the following: the Utility Bench, the D Portal Bench, the B Portal Bench, the Material Storage Area by TSS A, the Conveyor Corridor, the Coal Stockpile Pad, the office, the Preparation Plant area, the storage area and buildings near Pond D, the old power plant, the Pump House and Filter Building, the train loadout area, and the tracks near the train loadout.
