C1983059, Terror Creek Loadout, February Inspection Report (Aerial)

PERMIT INFORMATION

INSPECTION INFORMATION

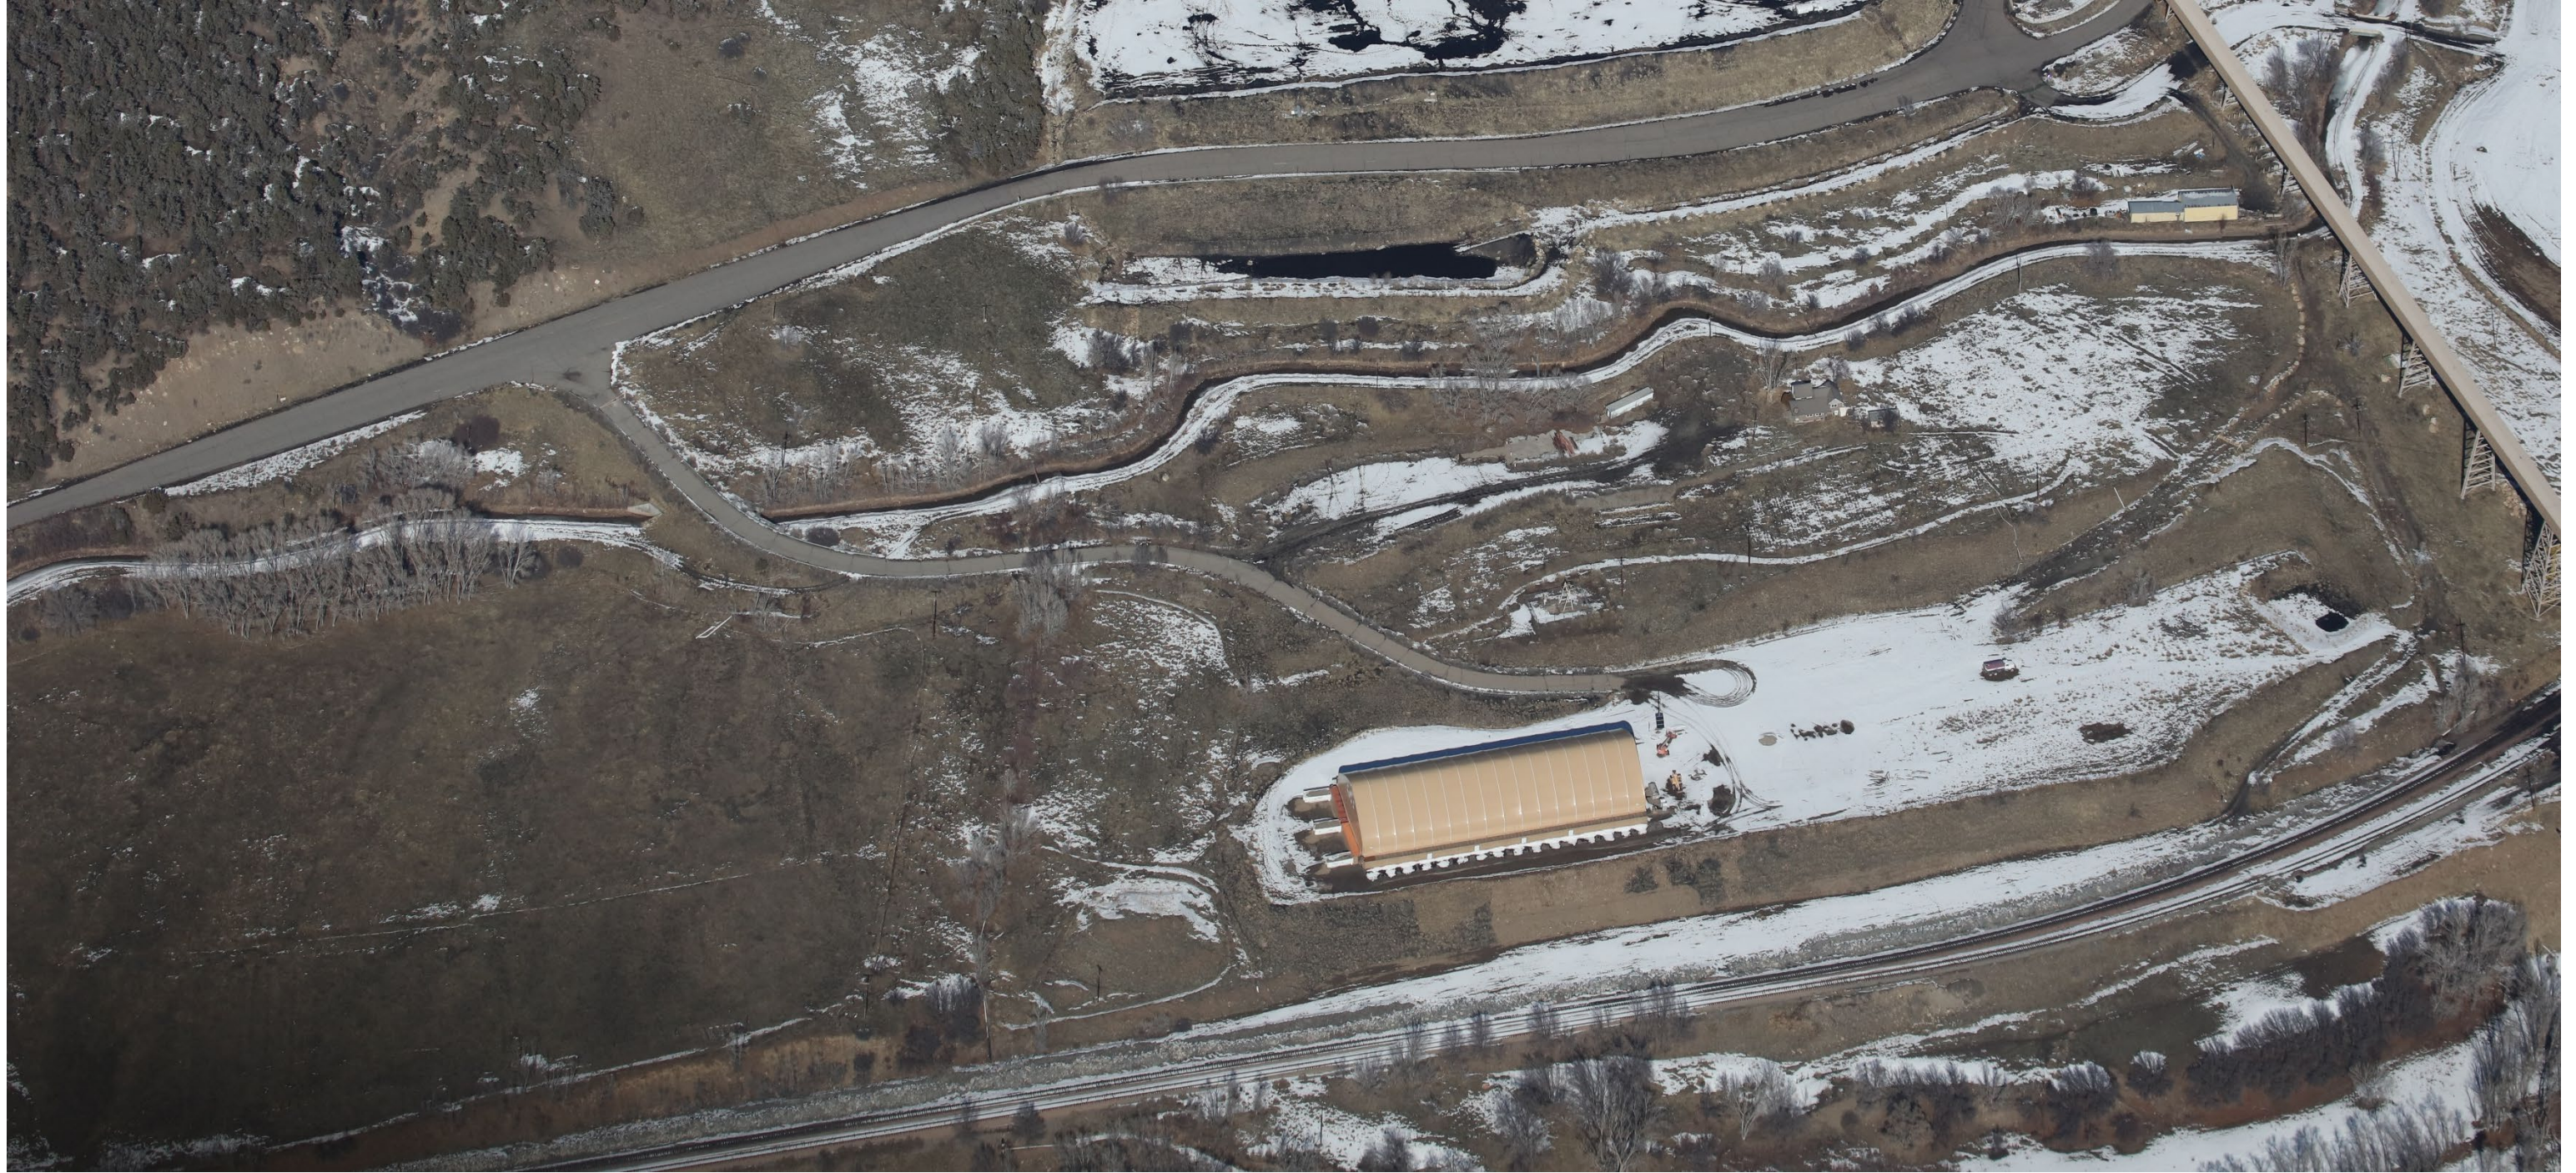
Figure 1: Terror Creek Loadout site from the south

Figures 1 and 2 show snow cover in shaded areas and on northerly aspects of the site, as well as over much of the lower pad. Some vehicle tracks can be seen, but generally it appears that there has been minimal activity at the site since the last inspection. The temporary building appears to be in good shape.
