MINERALS PROGRAM INSPECTION REPORT
PHONE: (303) 866-3567

| MINE NAME: Rolling Hills Gravel Pit | MINE/PROSPECTING ID#: M-2023-040 | MINERAL: Sand and gravel | COUNTY: Mesa |
| INSPECTION TYPE: Preoperation Inspection | WEATHER: Windy | INSP. DATE: February 13, 2024 | INSP. TIME: 10:00 |

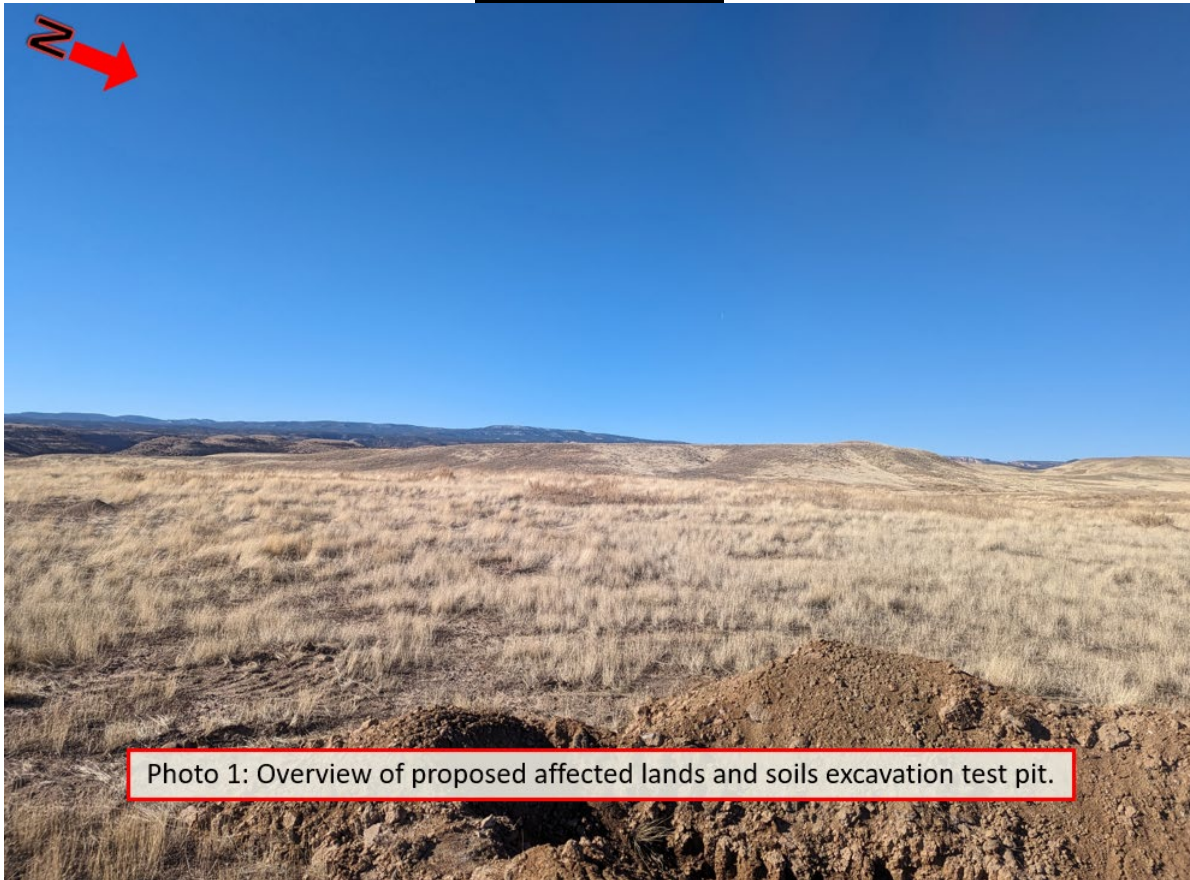
There is no evidence of historical manning or excavations which need to be taken into account for reclamation purposes. A small test pit was excavated near the site entrance to complete the soils analysis for the Geo-tech (Photo One). This are will become the access road.

Photo 1: Overview of proposed affected lands and soils excavation test pit.

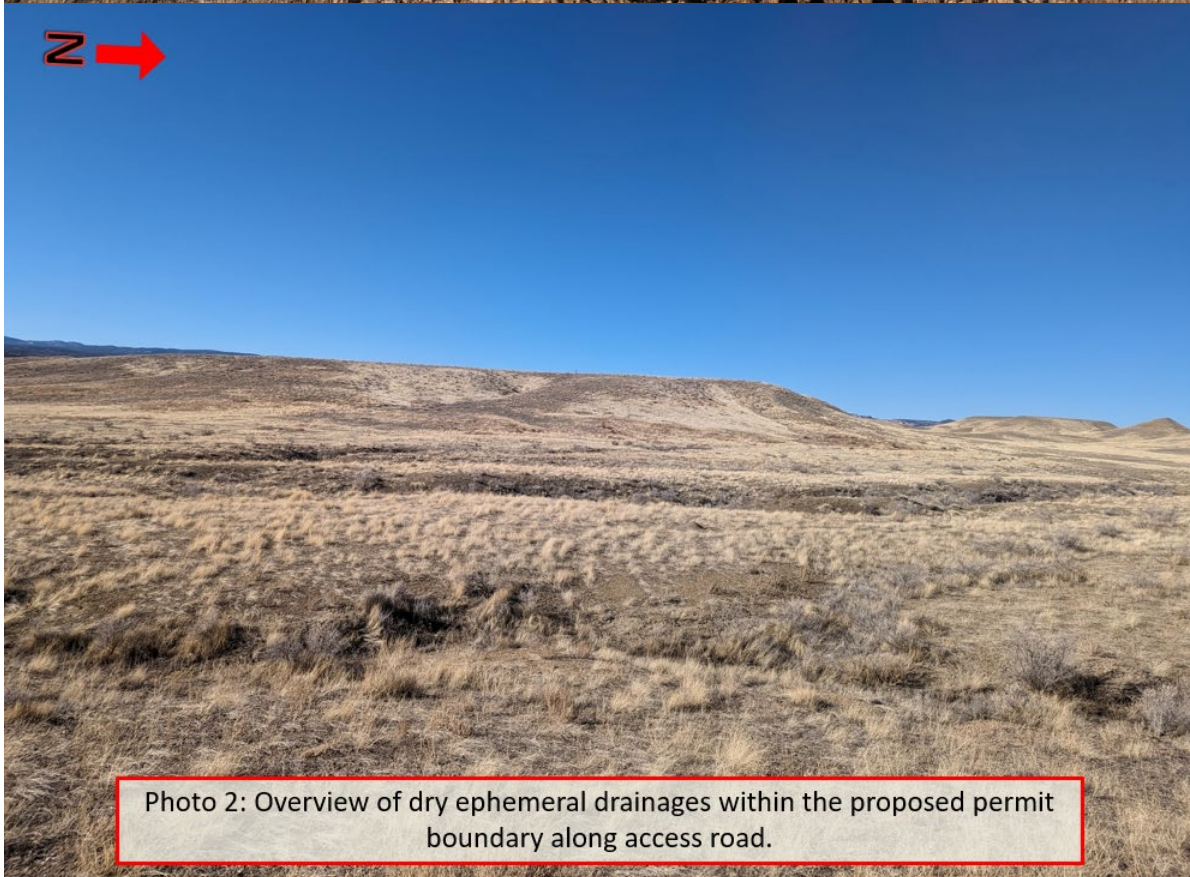
No exposed groundwater was observed. There were a handful of small dry ephemeral drainages observed that are likely the result of large/severe stormwater events. All of these drainages are located outside of the areas to be mine. The access road will bisect these drainages (Photo Two). The permit does state that 3 permanent culverts will be installed.

Photo 2: Overview of dry ephemeral drainages within the proposed permit boundary along access road.

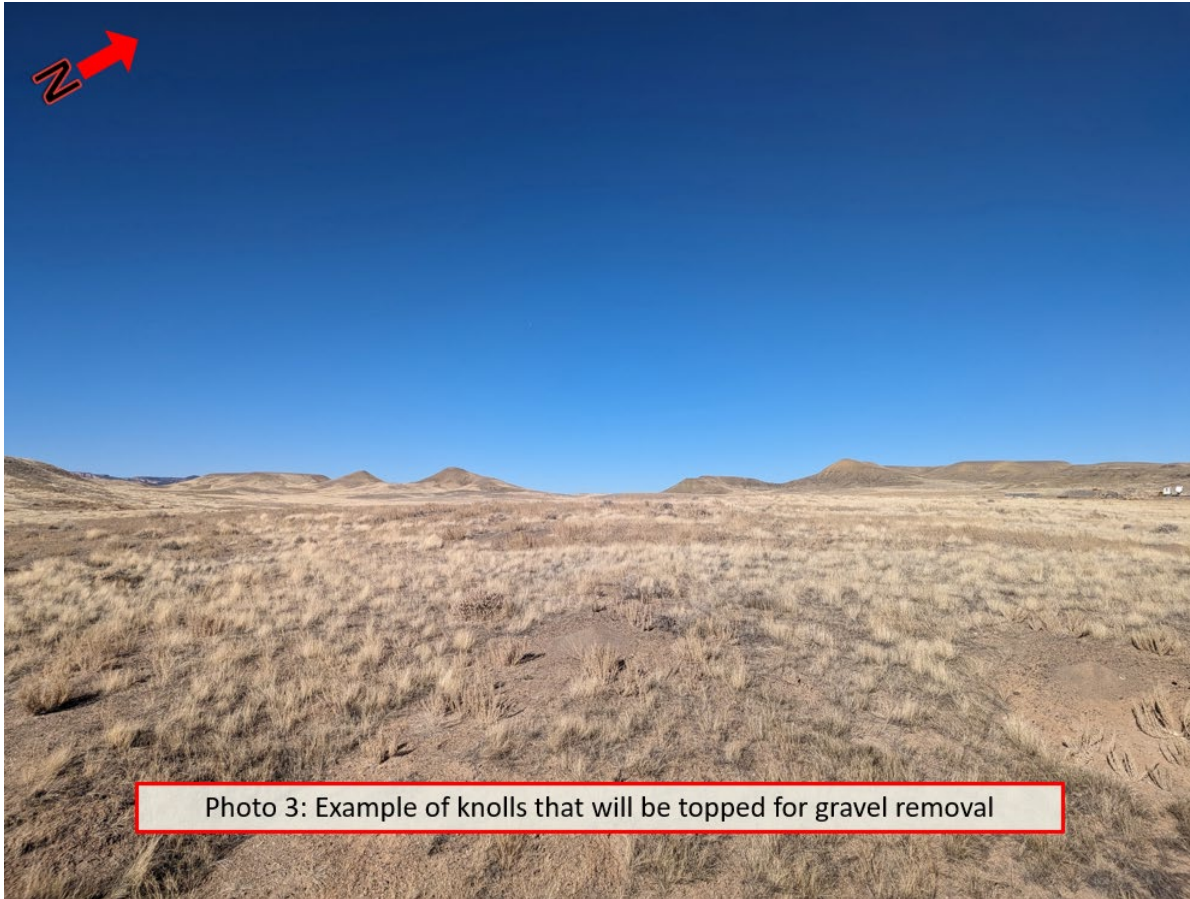
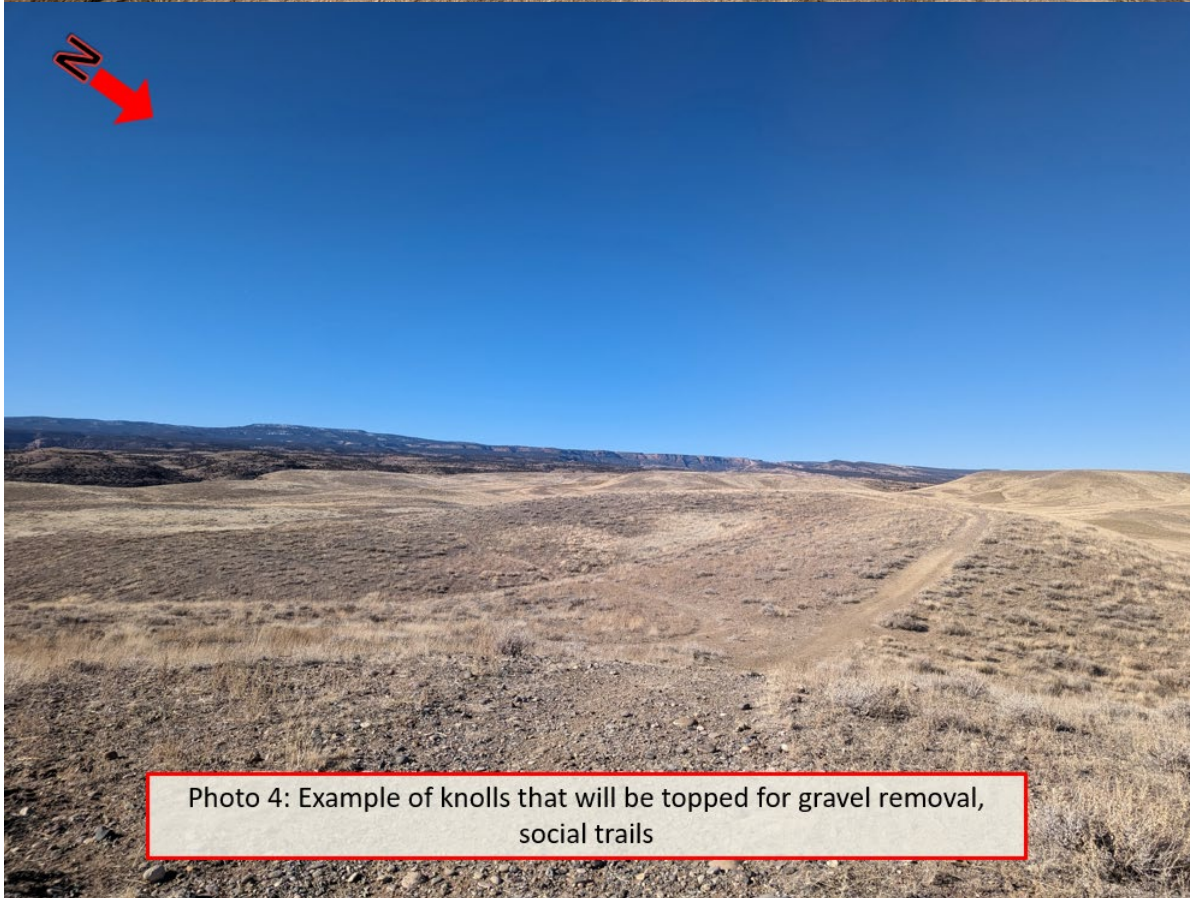
Generally the Mine Plan states that any topsoil and overburden will be stripped and salvaged. Gravel resources will then be excavated down to hardpan/ bedrock. Material may be processed on site (excluding washing). Once mining is completed soil materials will be replaced on mine phases. Most excavations are expected to daylight out, as mining will be taking the tops off of the knolls (Photos Three and Four).

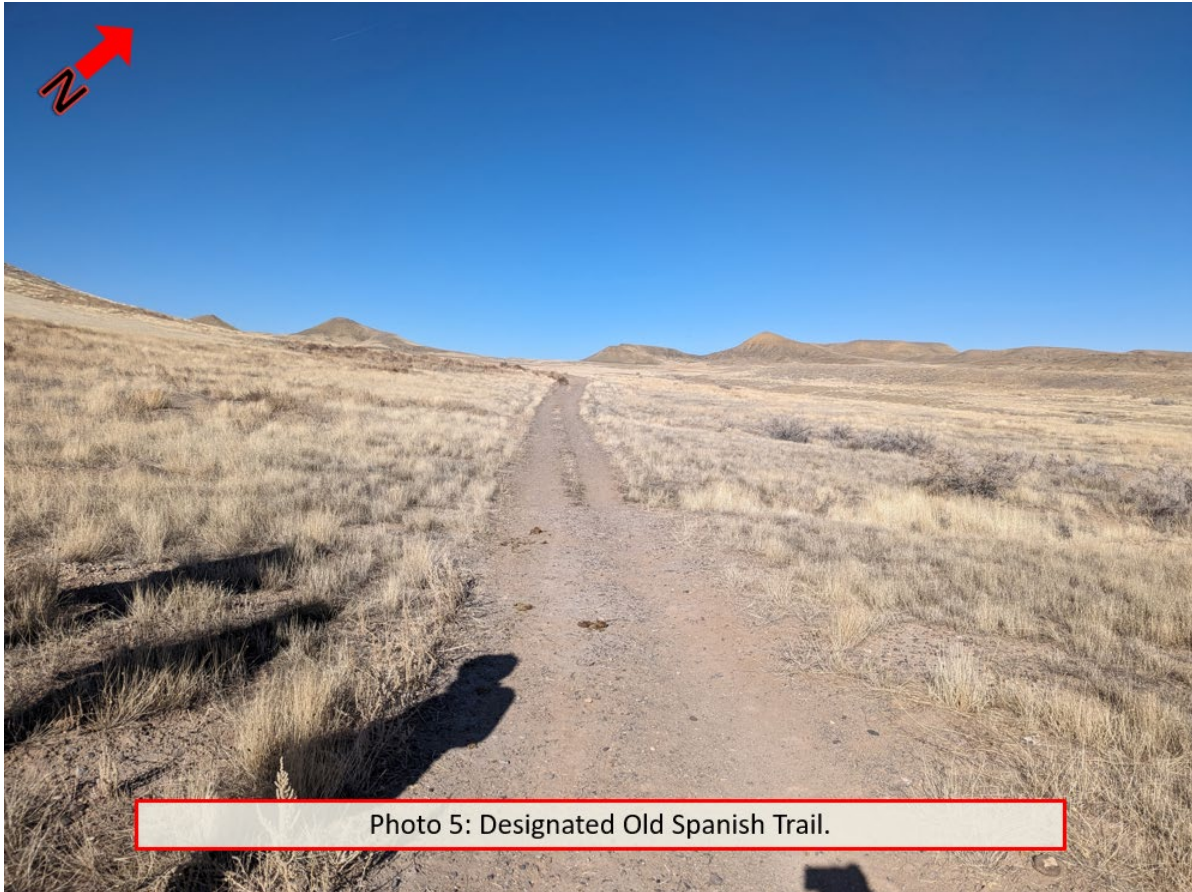
No permanent/designated roads currently exist within the proposed mine site. There is a designated trail, The Old Spanish Trail (Photo Five). This is for non-motorized traffic only and will bisect the mine access road. There are a hand full of other 'social trails' that cross through the private property and are the result of patrons going off trail in an area slow to self-reclaim (Photos Four and Six). These trails will likely be closed at the Applicants discretion to control access through the active mine site and private property.

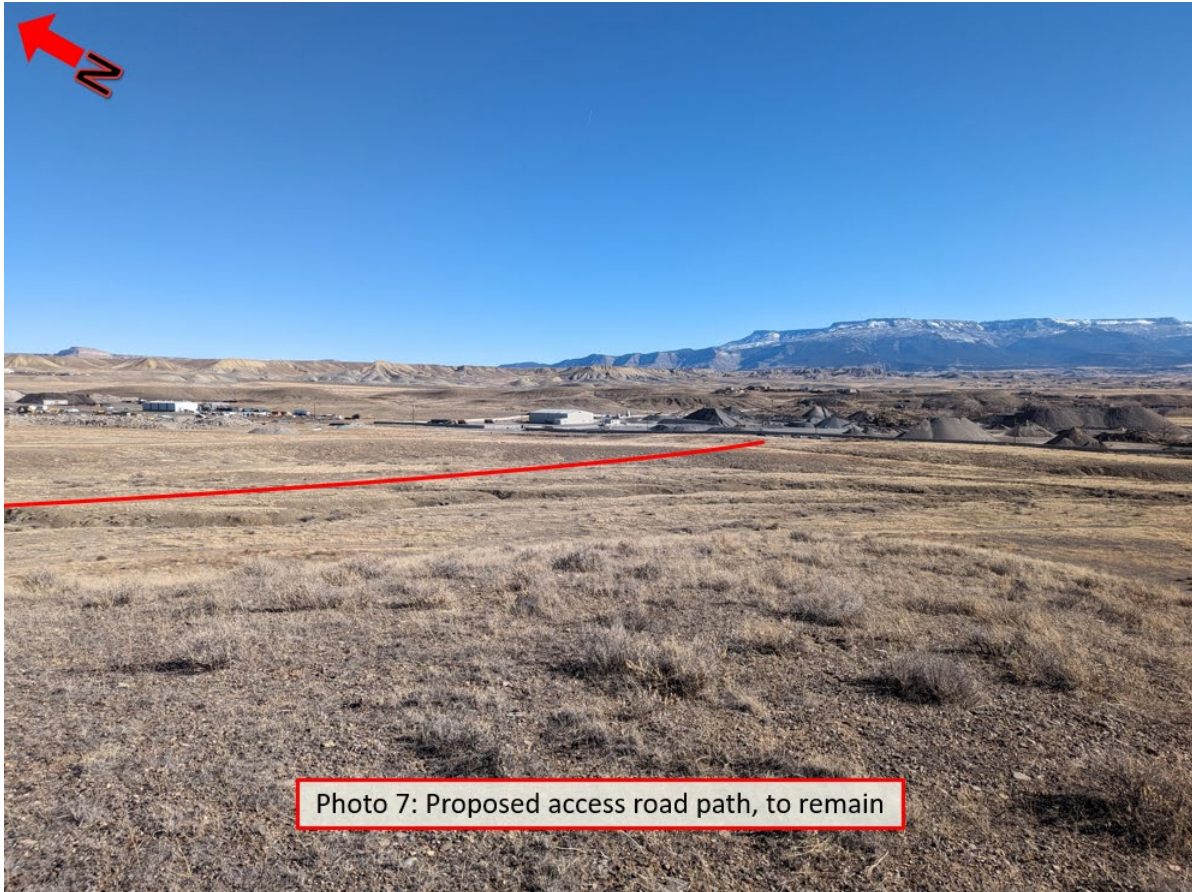
The post mine land use for this site will be Residential. Vegetation is proposed to stabilize the area until development occurs. The access road is to remain in place (Photo Seven).

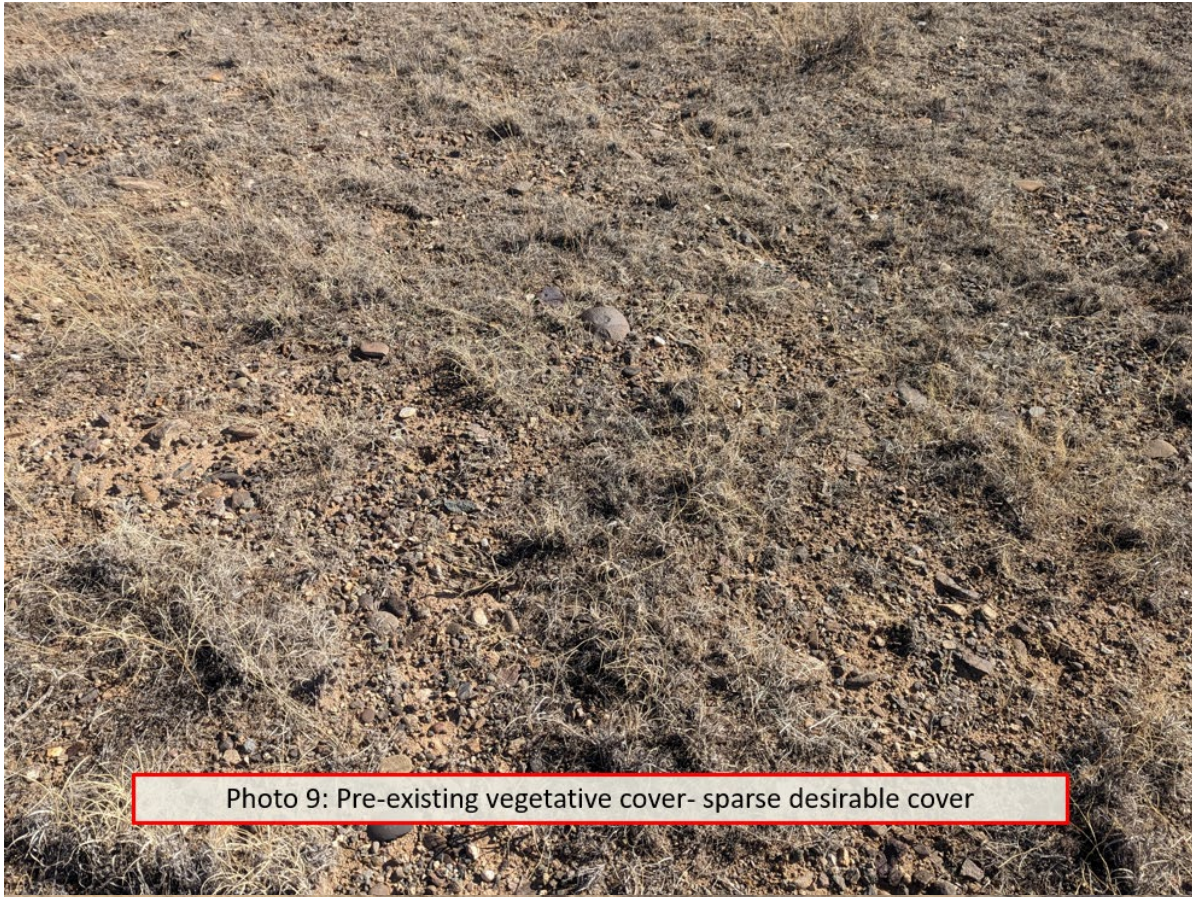
Overall preexisting vegetation is generally sparse and estimated to be approximately 30% cover or less (Photos Eight – Eleven). The primary desirable species are crested wheatgrass, saltbush, and a few cactus and sagebrush. Several noxious weed species were observed. Cheatgrass tends to exist in dense clusters. While Halogeton and Russian Thistle appeared to be sporadically intermixed. No T&E species were observed.

Photo 9: Pre-existing vegetative cover- sparse desirable cover

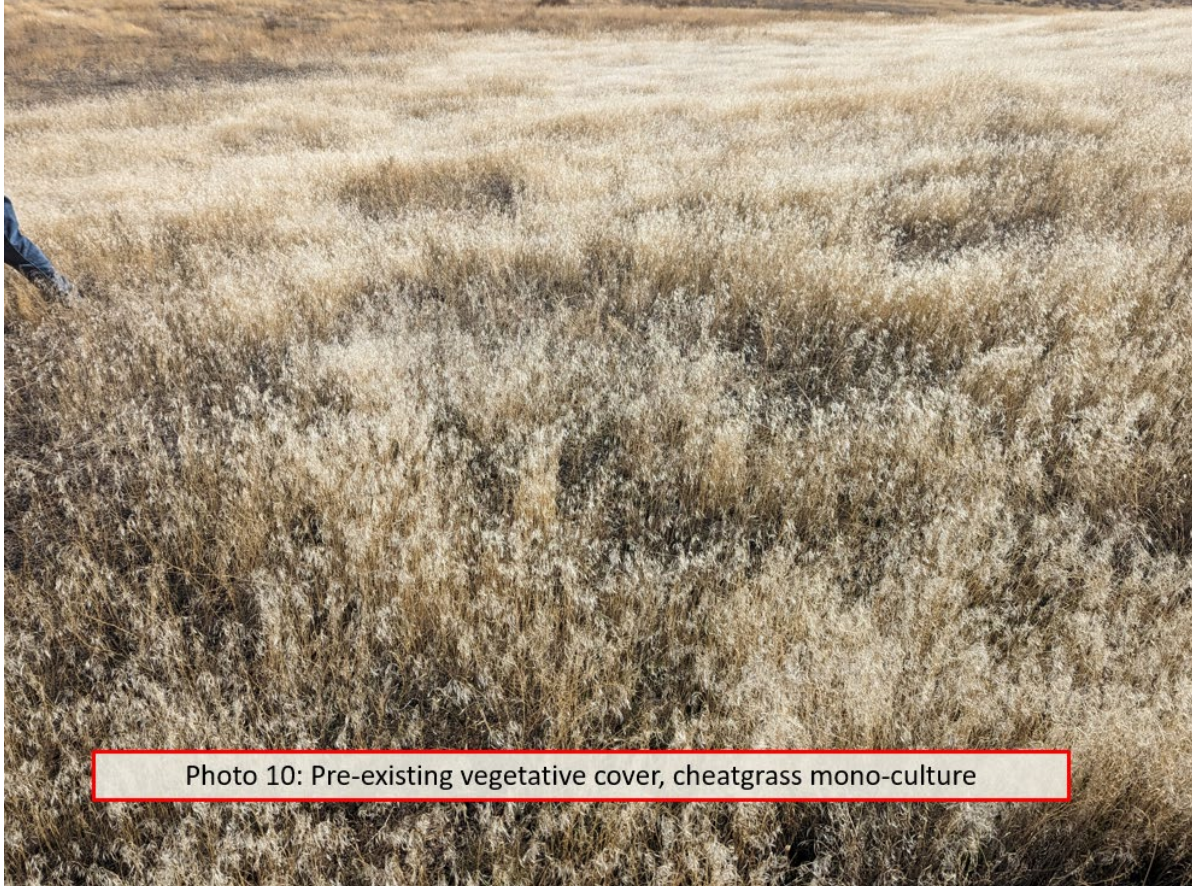
Photo 10: Pre-existing vegetative cover, cheatgrass mono-culture

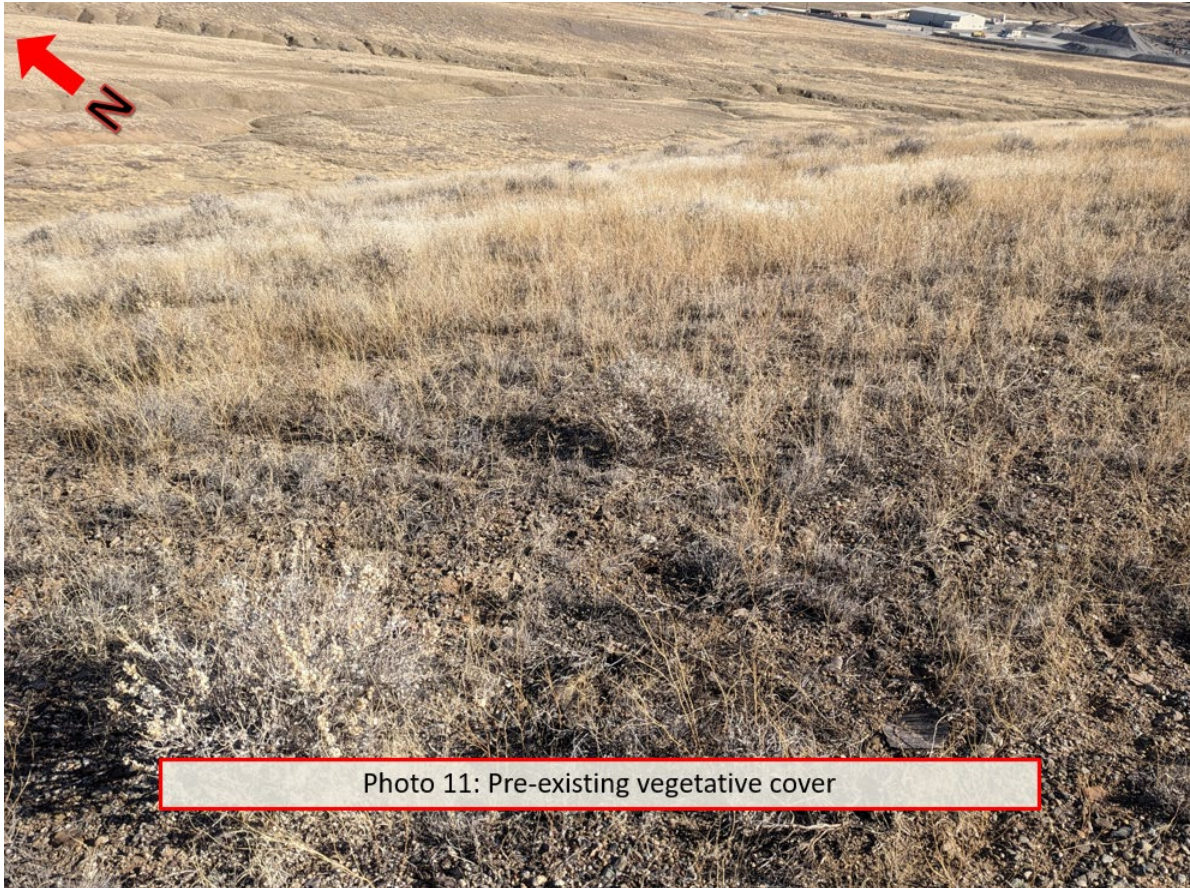
Photo 11: Pre-existing vegetative cover

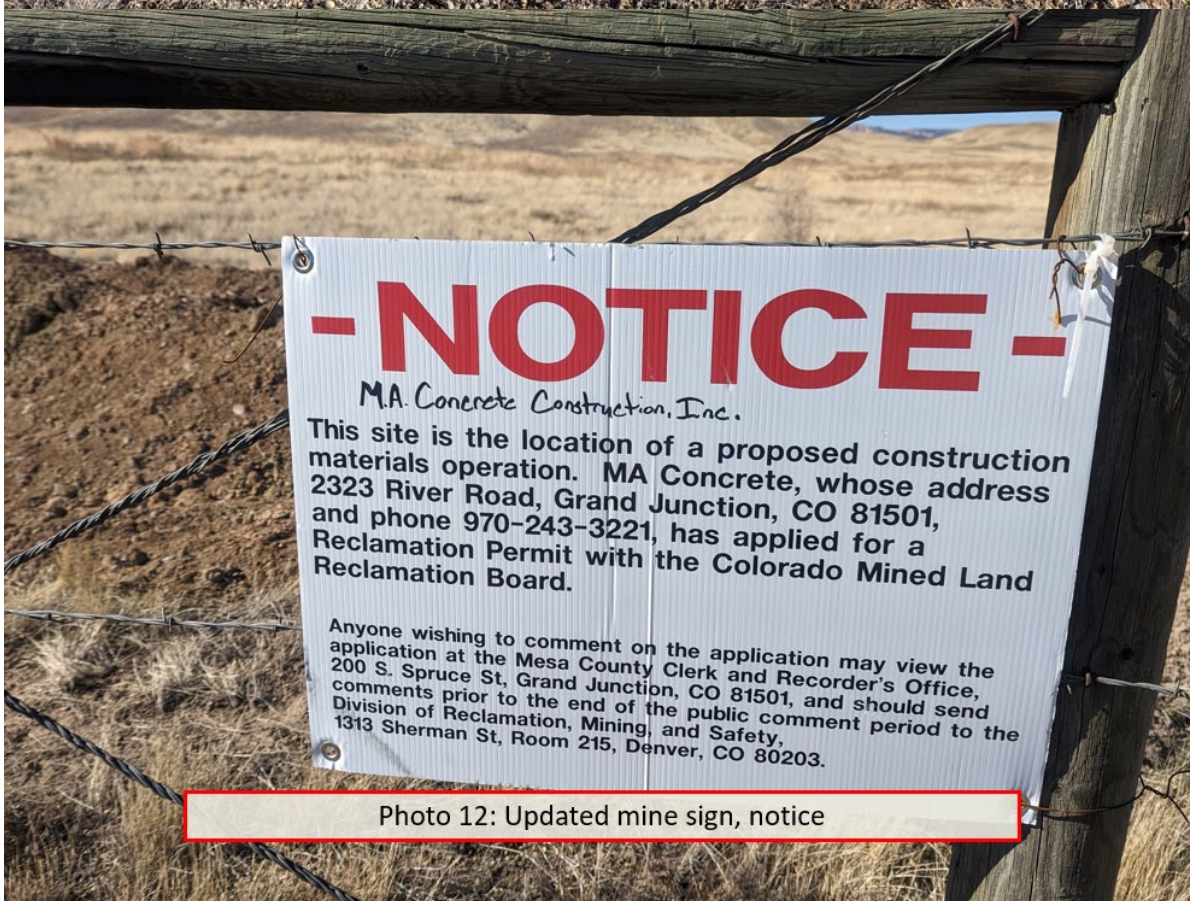
A sign was posted at the entrance to the mine site as required by Rule 1.6.2(1)(b). The information depicted was correct/ up to date and the sign was of sufficient size (Photo Twelve).

Photo 12: Updated mine sign, notice
