## C1981022, Elk Creek Mine, February Inspection Report (Aerial)

<b>Permit Number:</b> C-1981-022 <b>Mine Name:</b> Elk Creek Mine <b>Operator:</b> Oxbow Mining, LLC <b>Operator Address:</b> Mr Doug Smith 3737 Hwy 133 P. O. Box 535 Somerset, CO 81434	<b>County:</b> Delta, Gunnison <b>Operation Type:</b> Underground <b>Permit Status:</b> Active <b>Ownership:</b> Private
	<b>Operator Representative Present:</b>  None
<b>Operator Representative Signature: (Field Issuance Only)</b>

<b>Inspection Start Date:</b> February 13, 2024 <b>Inspection Start Time:</b> 12:00 <b>Inspection End Date:</b> <b>Inspection End Time:</b>		<b>Inspection Type:</b> Aerial Inspection <b>Inspection Reason:</b> Normal I&E Program <b>Weather:</b> Clear	
<b>Joint Inspection Agency:</b>  None		<b>Joint Inspection Contacts:</b>	
<b>Post Inspection Agency:</b>  None		<b>Post Inspection Contacts:</b>	
<b>Inspector(s):</b>  Leigh Simmons  Brock Bowles	<b>Inspector's Signature:</b>

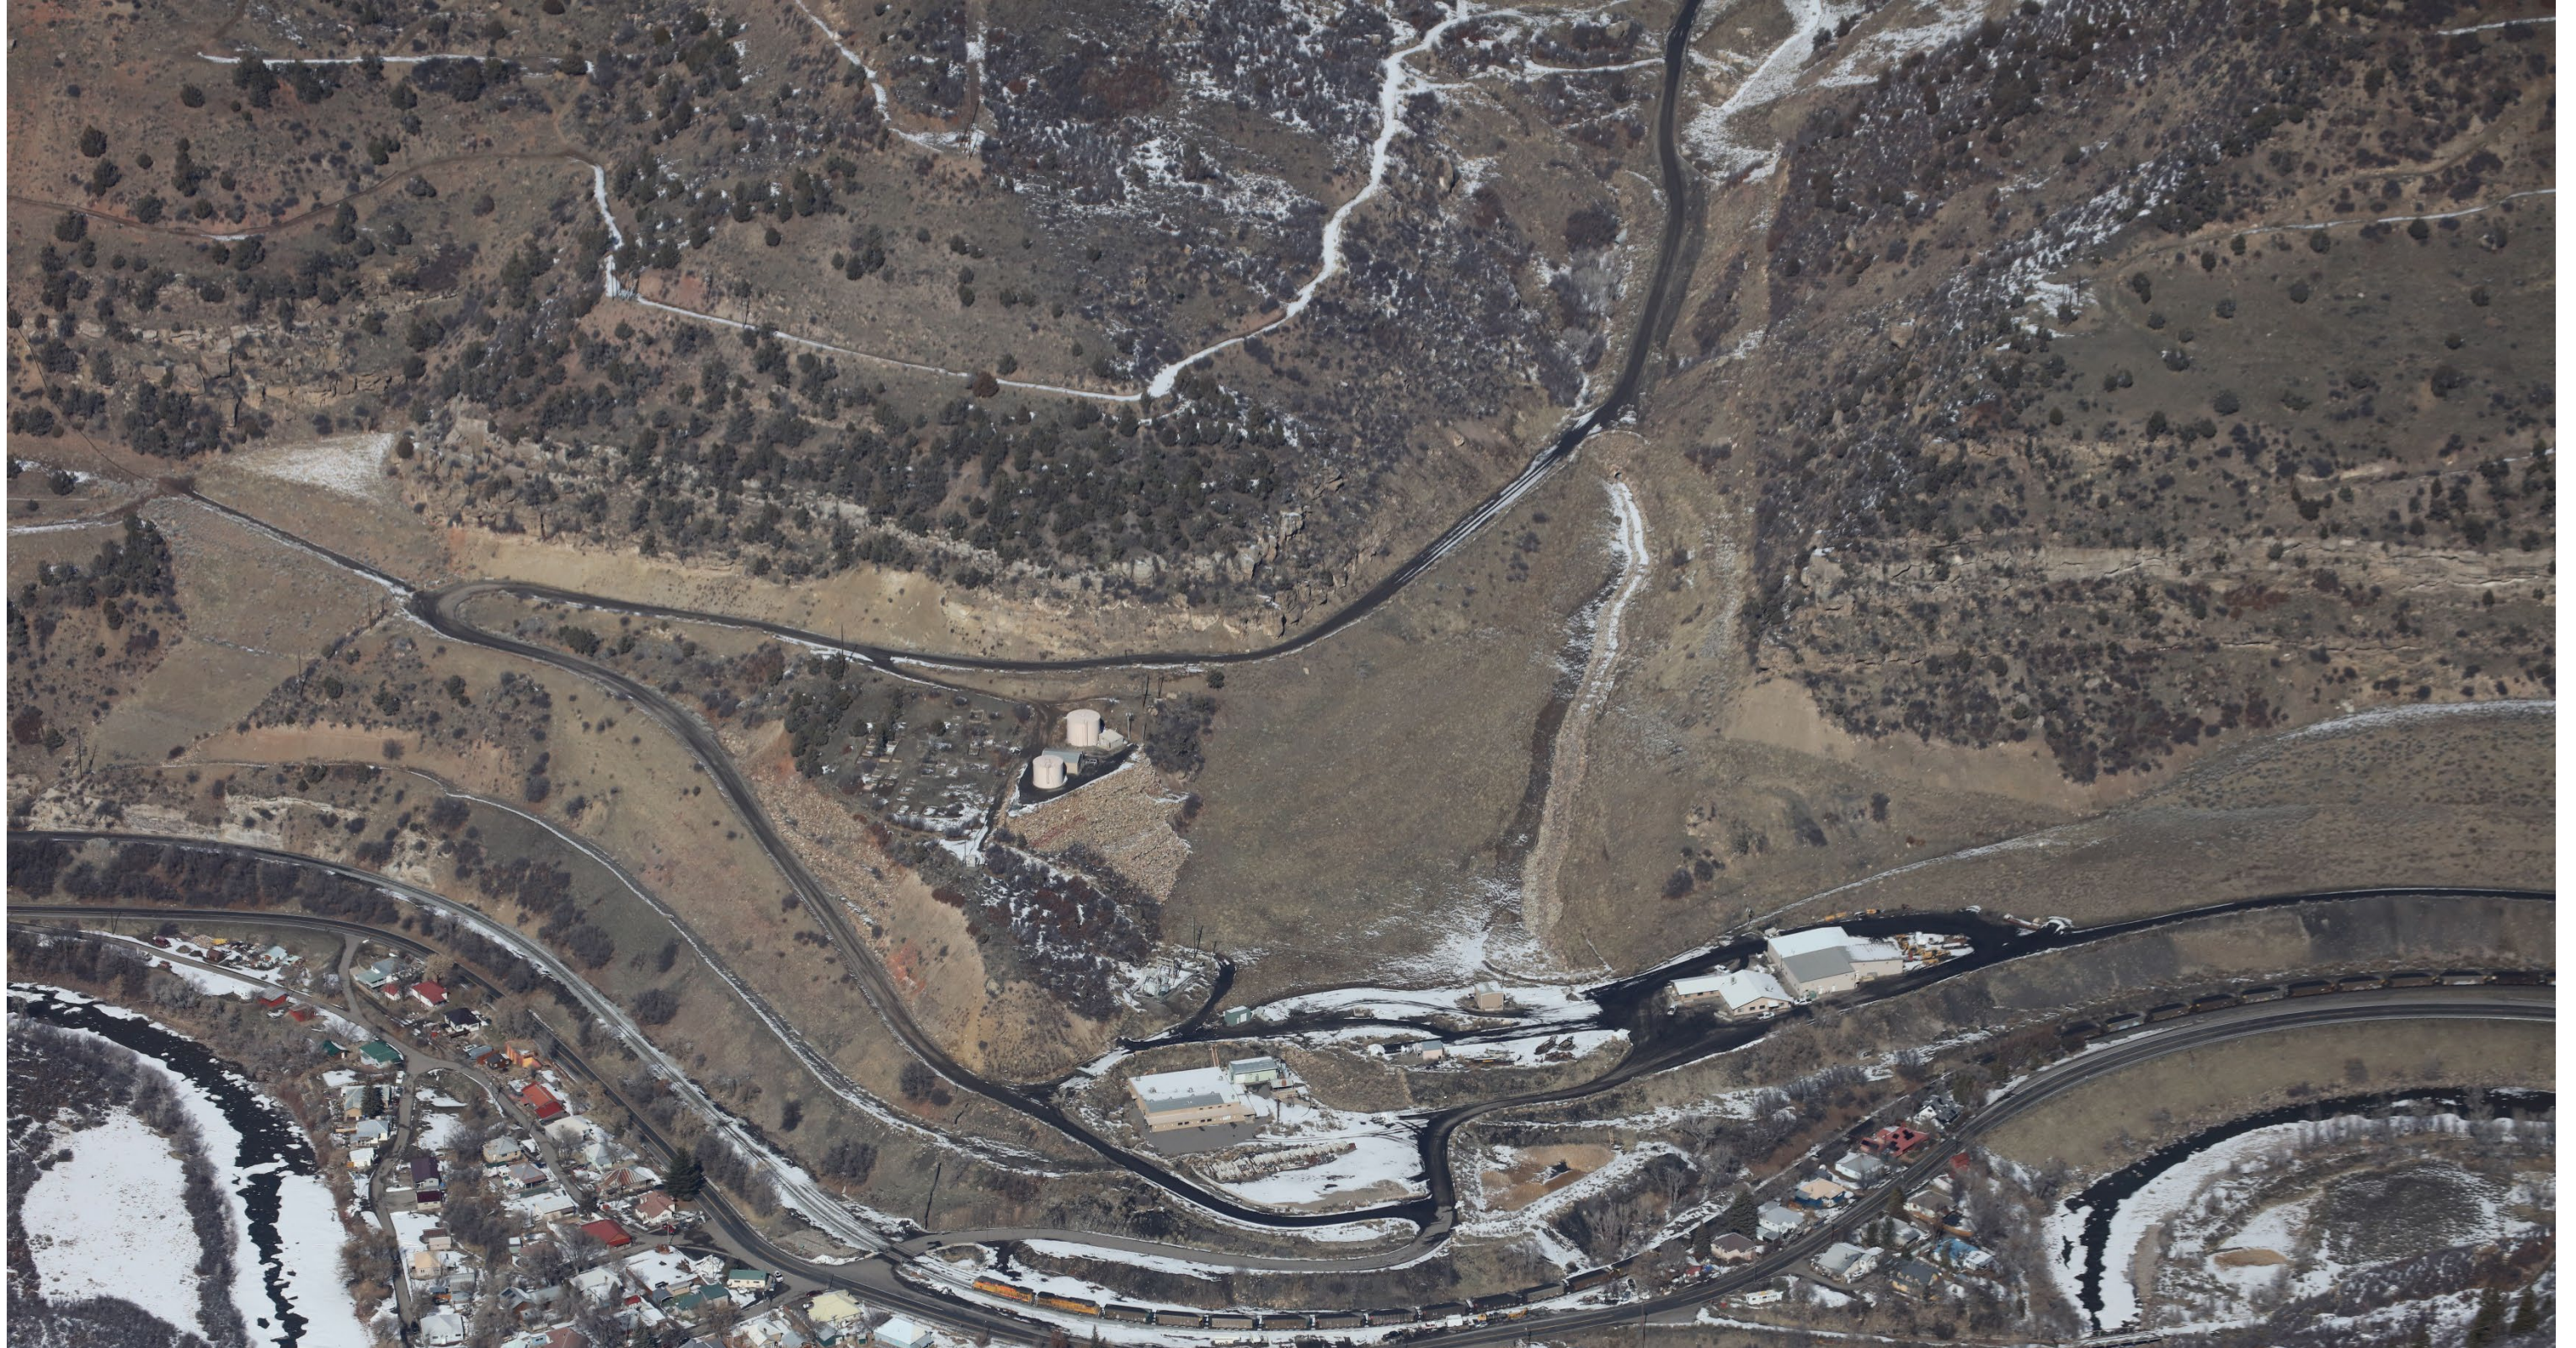
*Figure 1: Main facilities from the south*

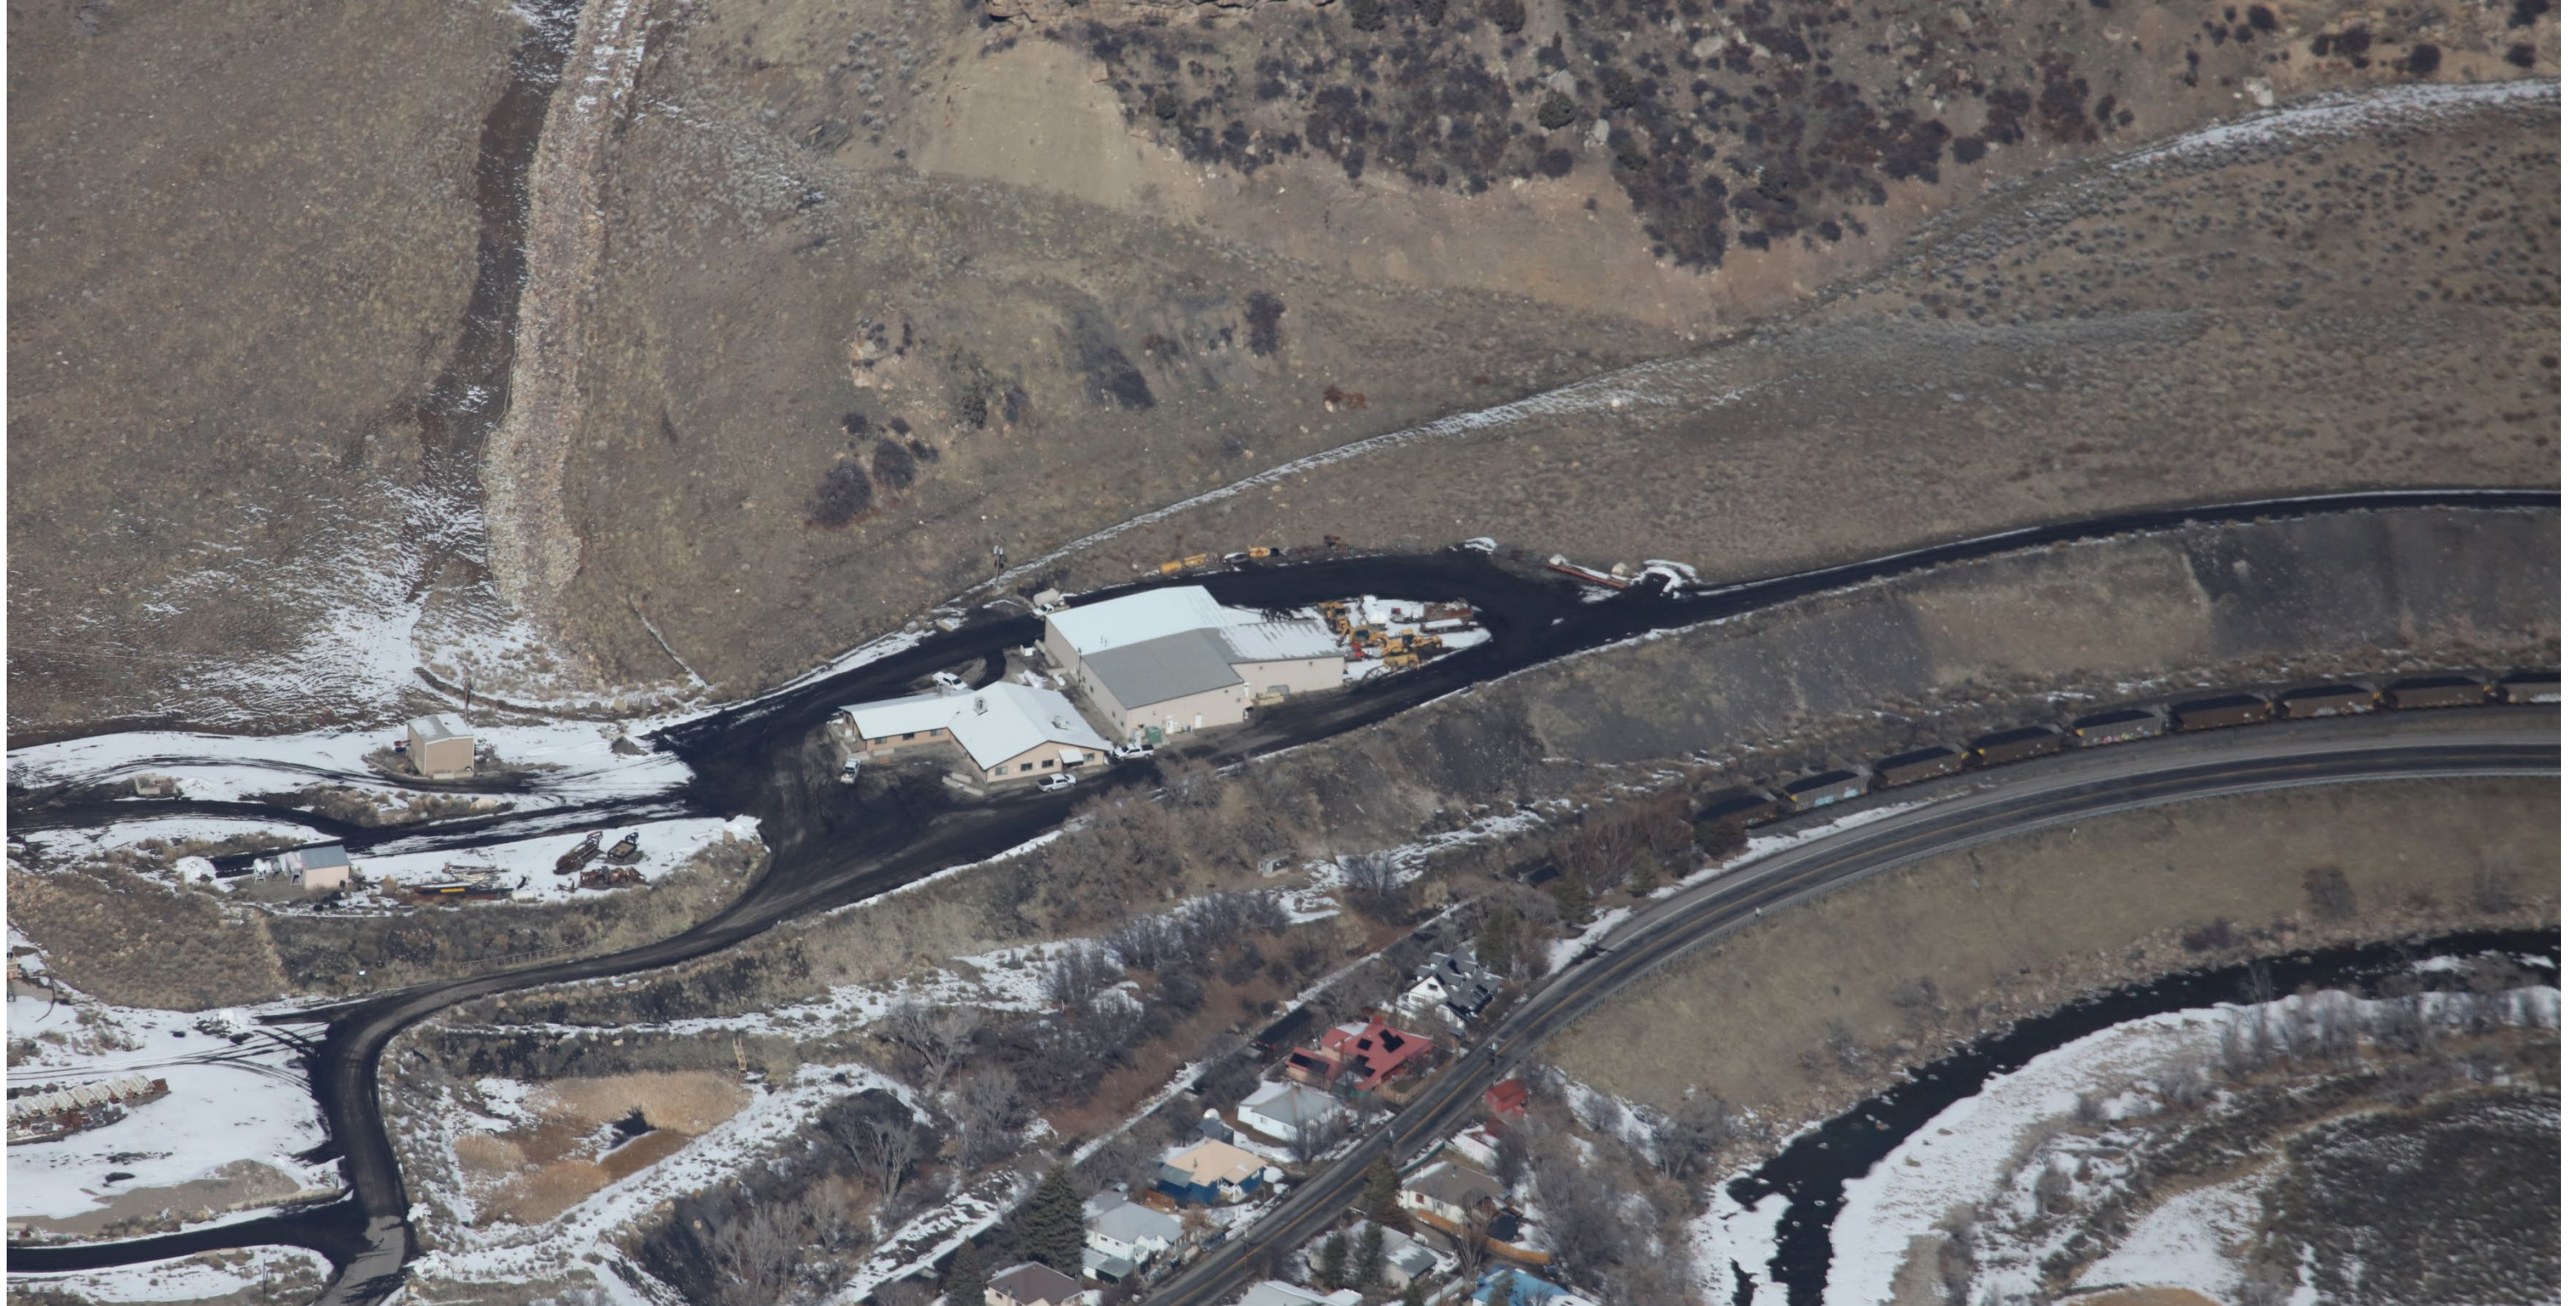
Figure 2: Office and shop, with Pond B in the lower left, and part of the reclaimed East Yard Fill in the upper right

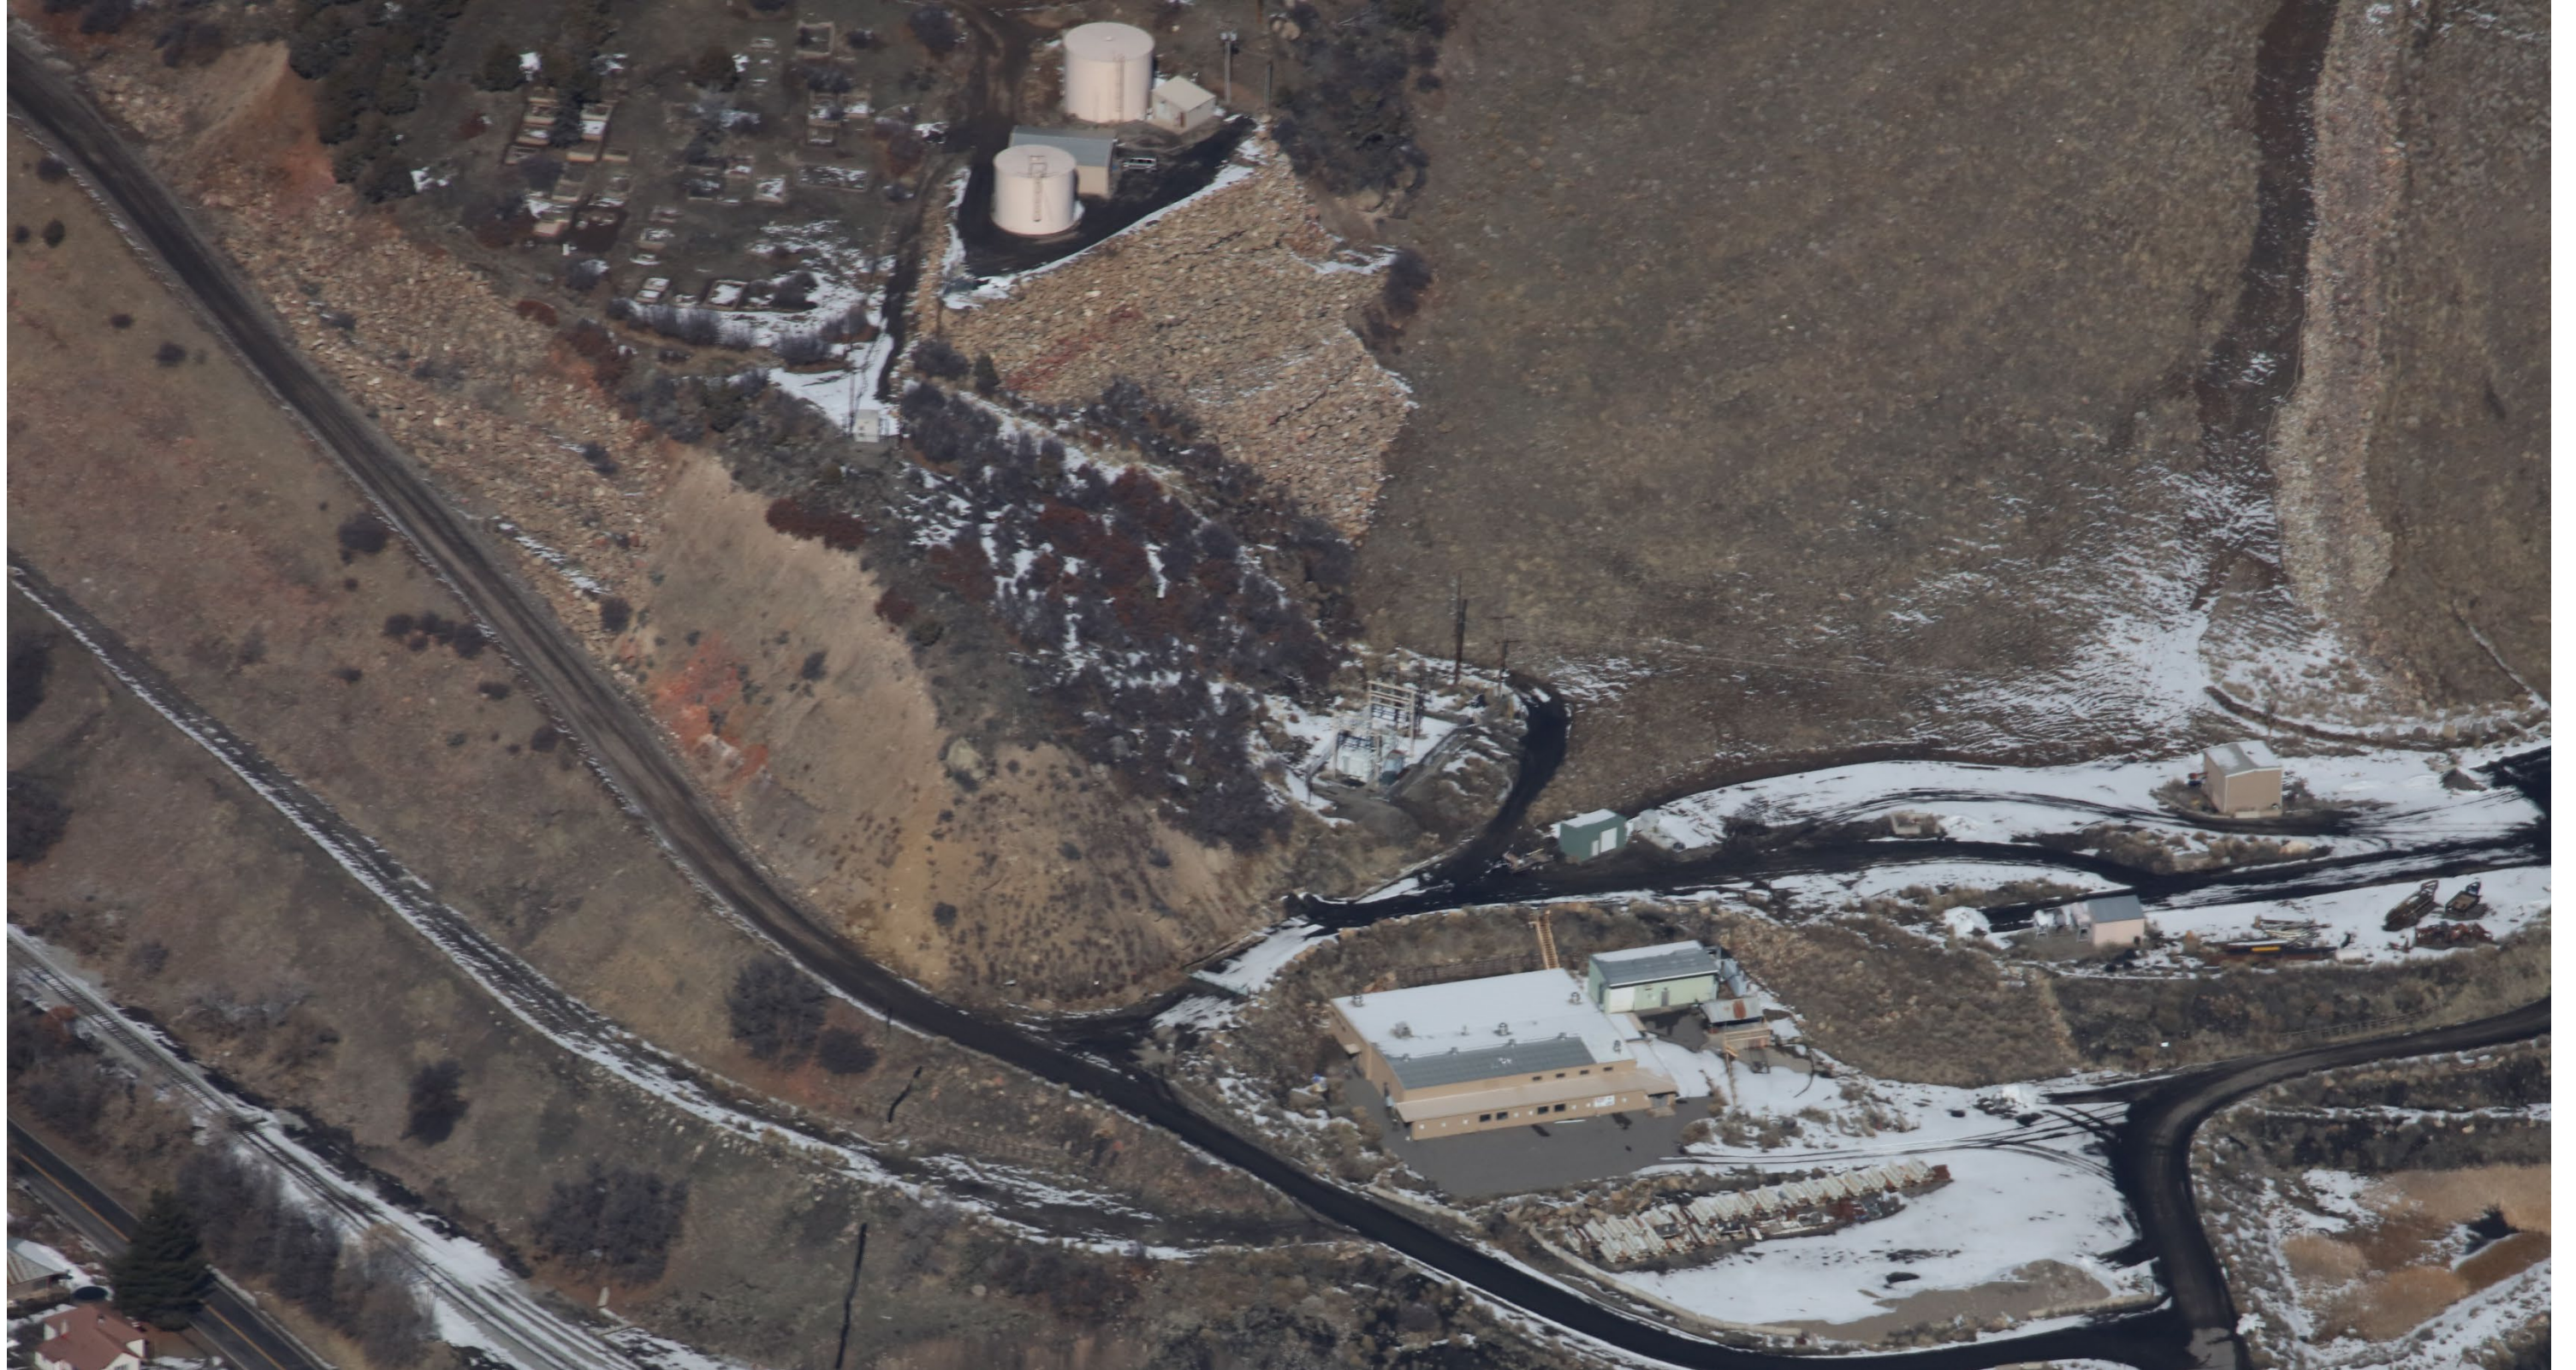
*Figure 3: Cemetery, water treatment plant, substation and bath house*

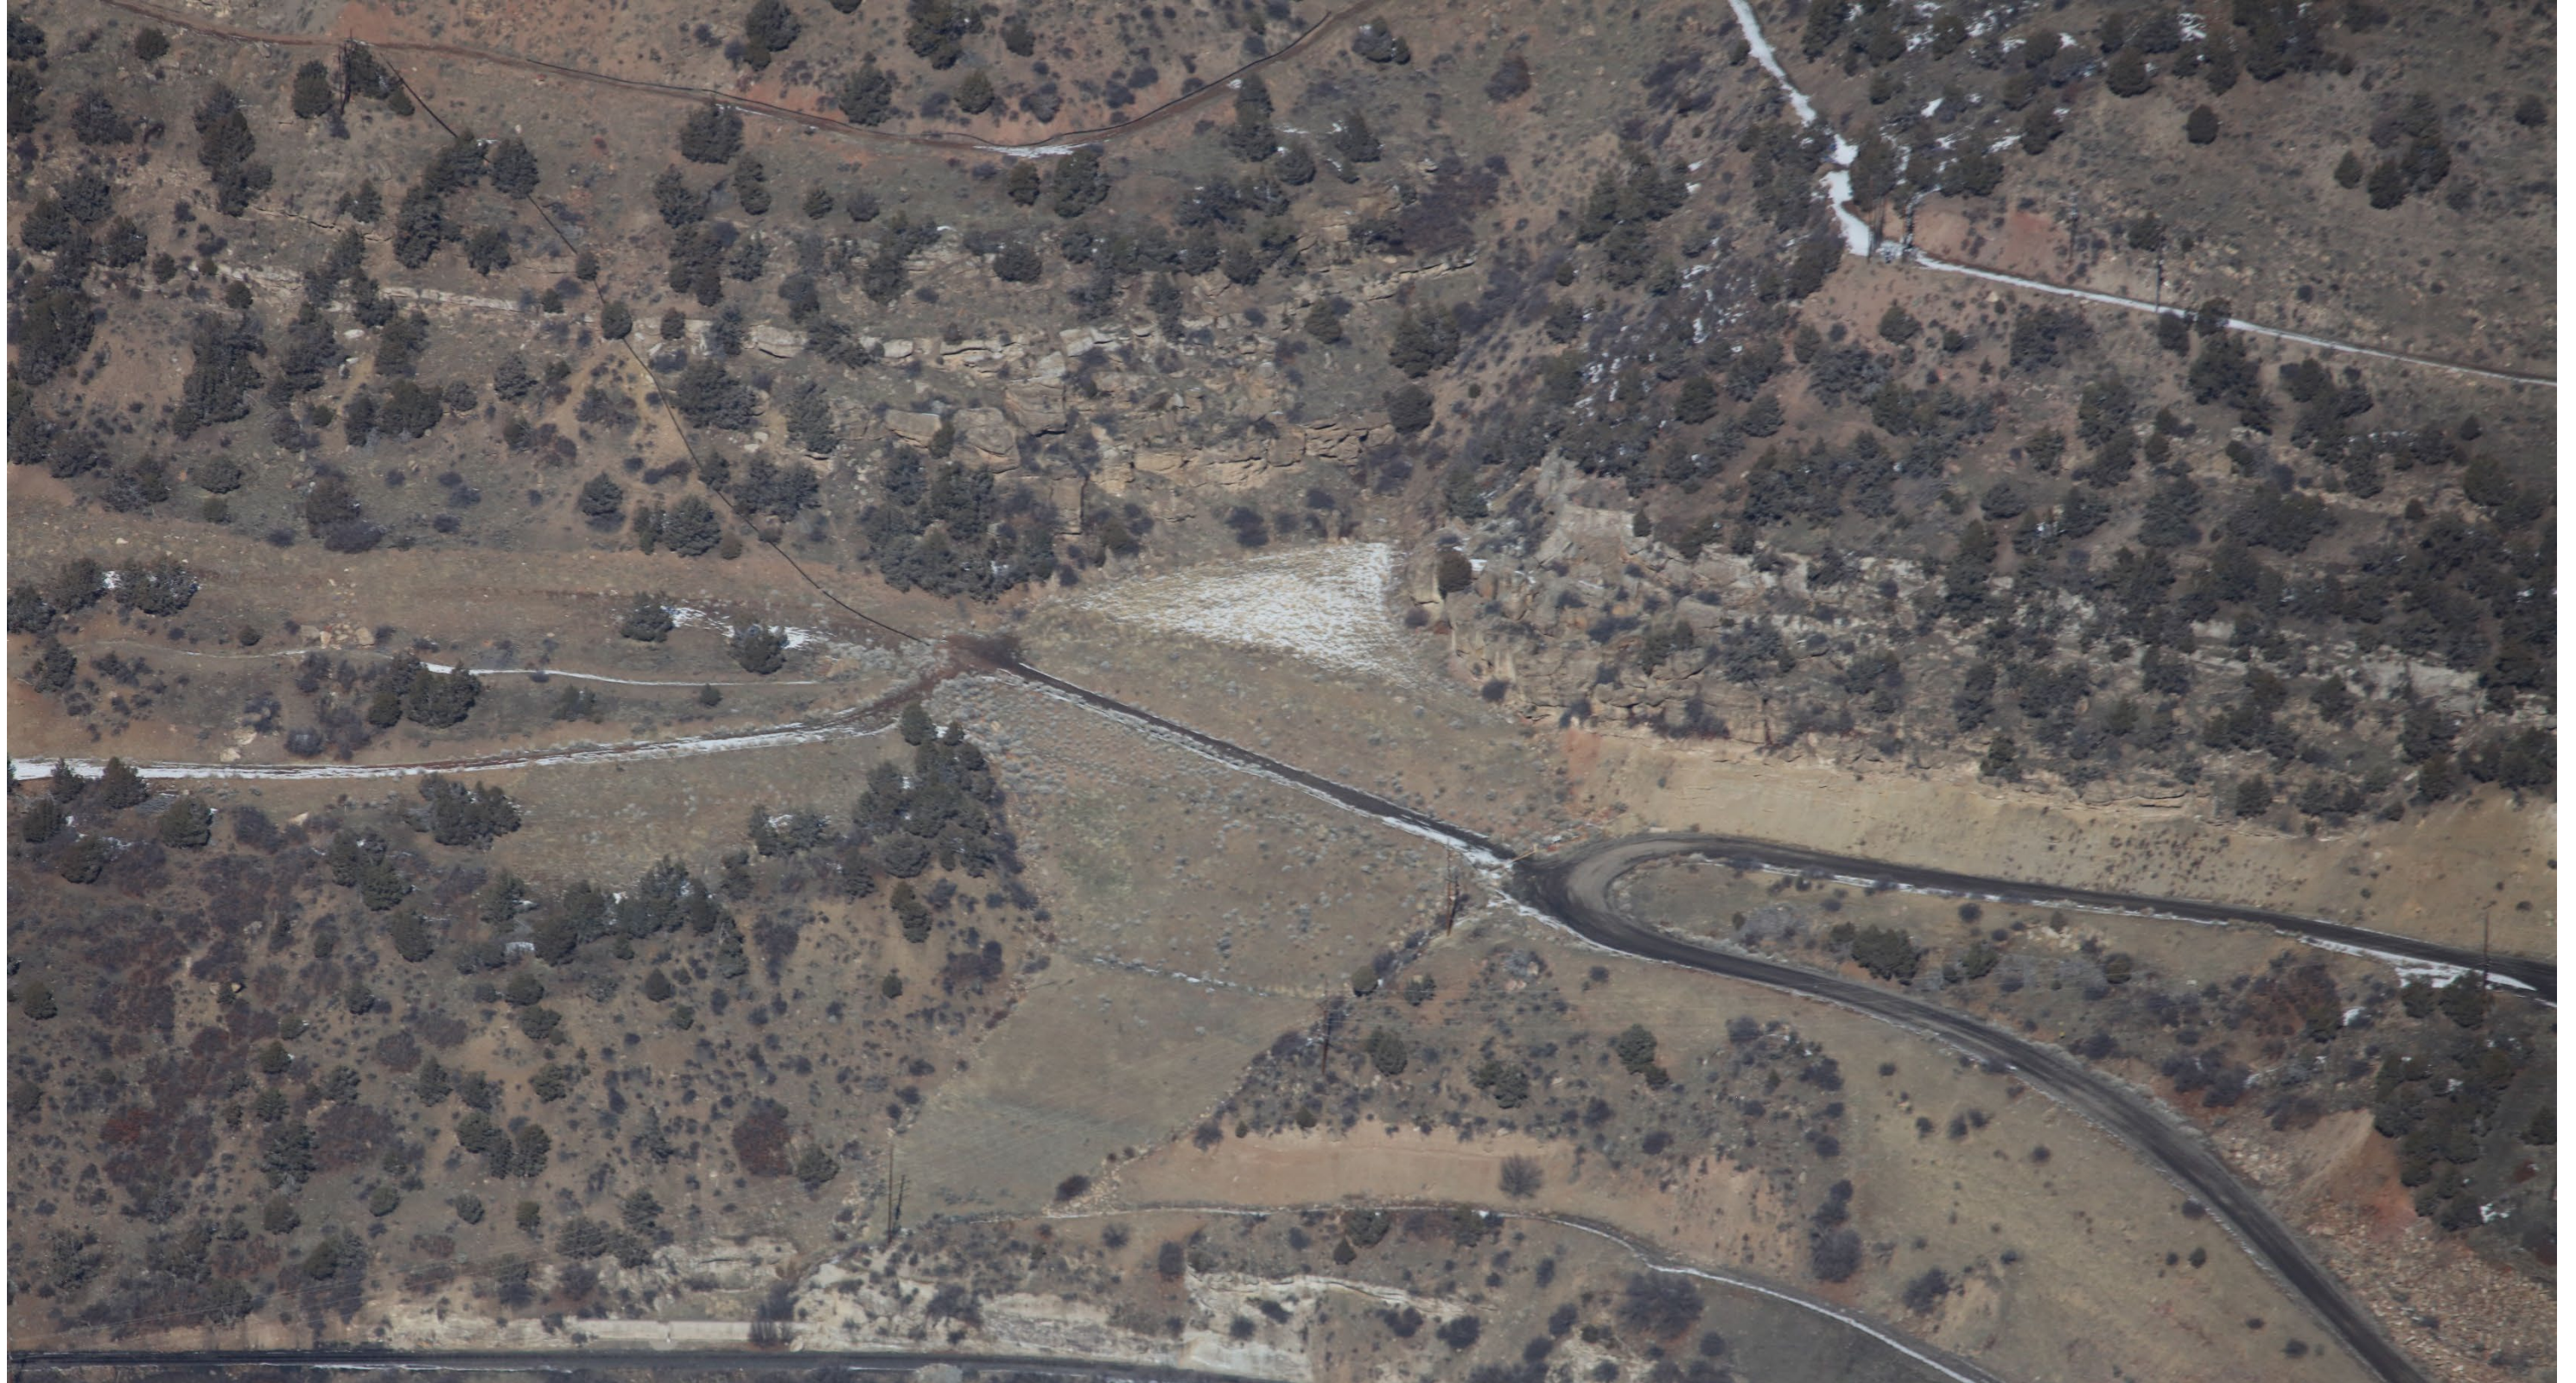
Figure 4: West Valley Fill and Pond C. The water pipeline installed by Gunnison Energy is visible in the upper left.

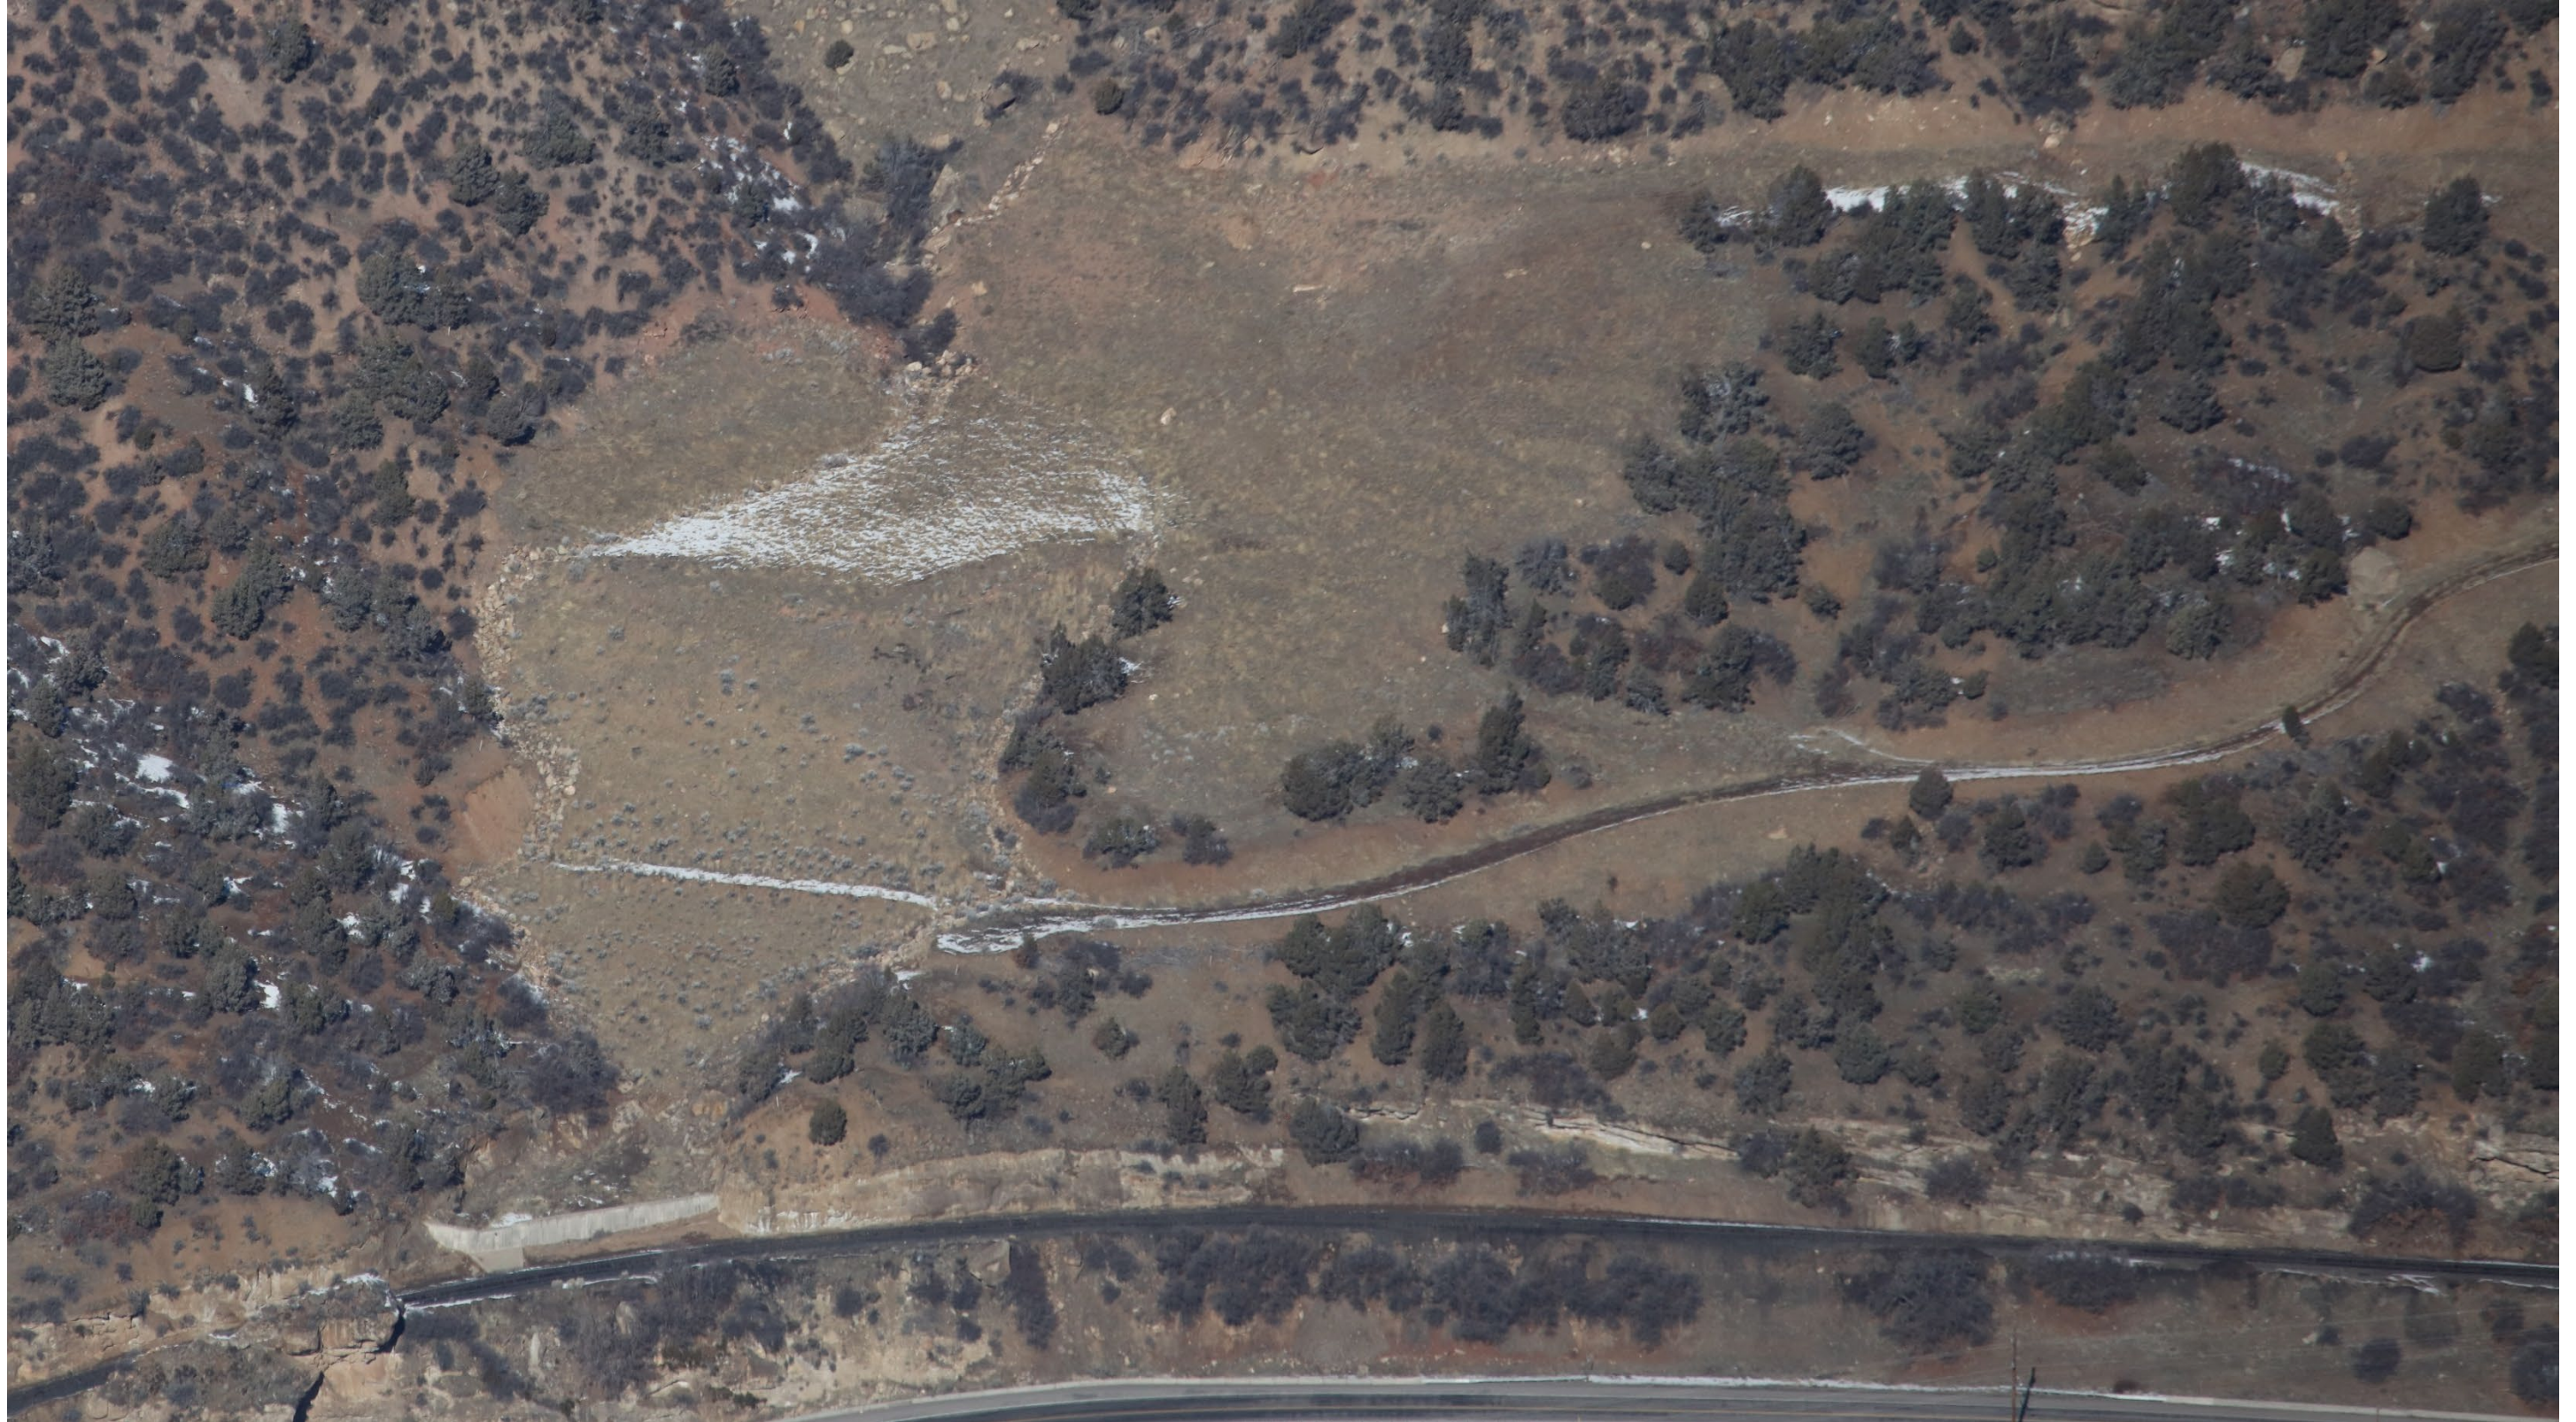
*Figure 5: II West Valley Fill and Pond E*

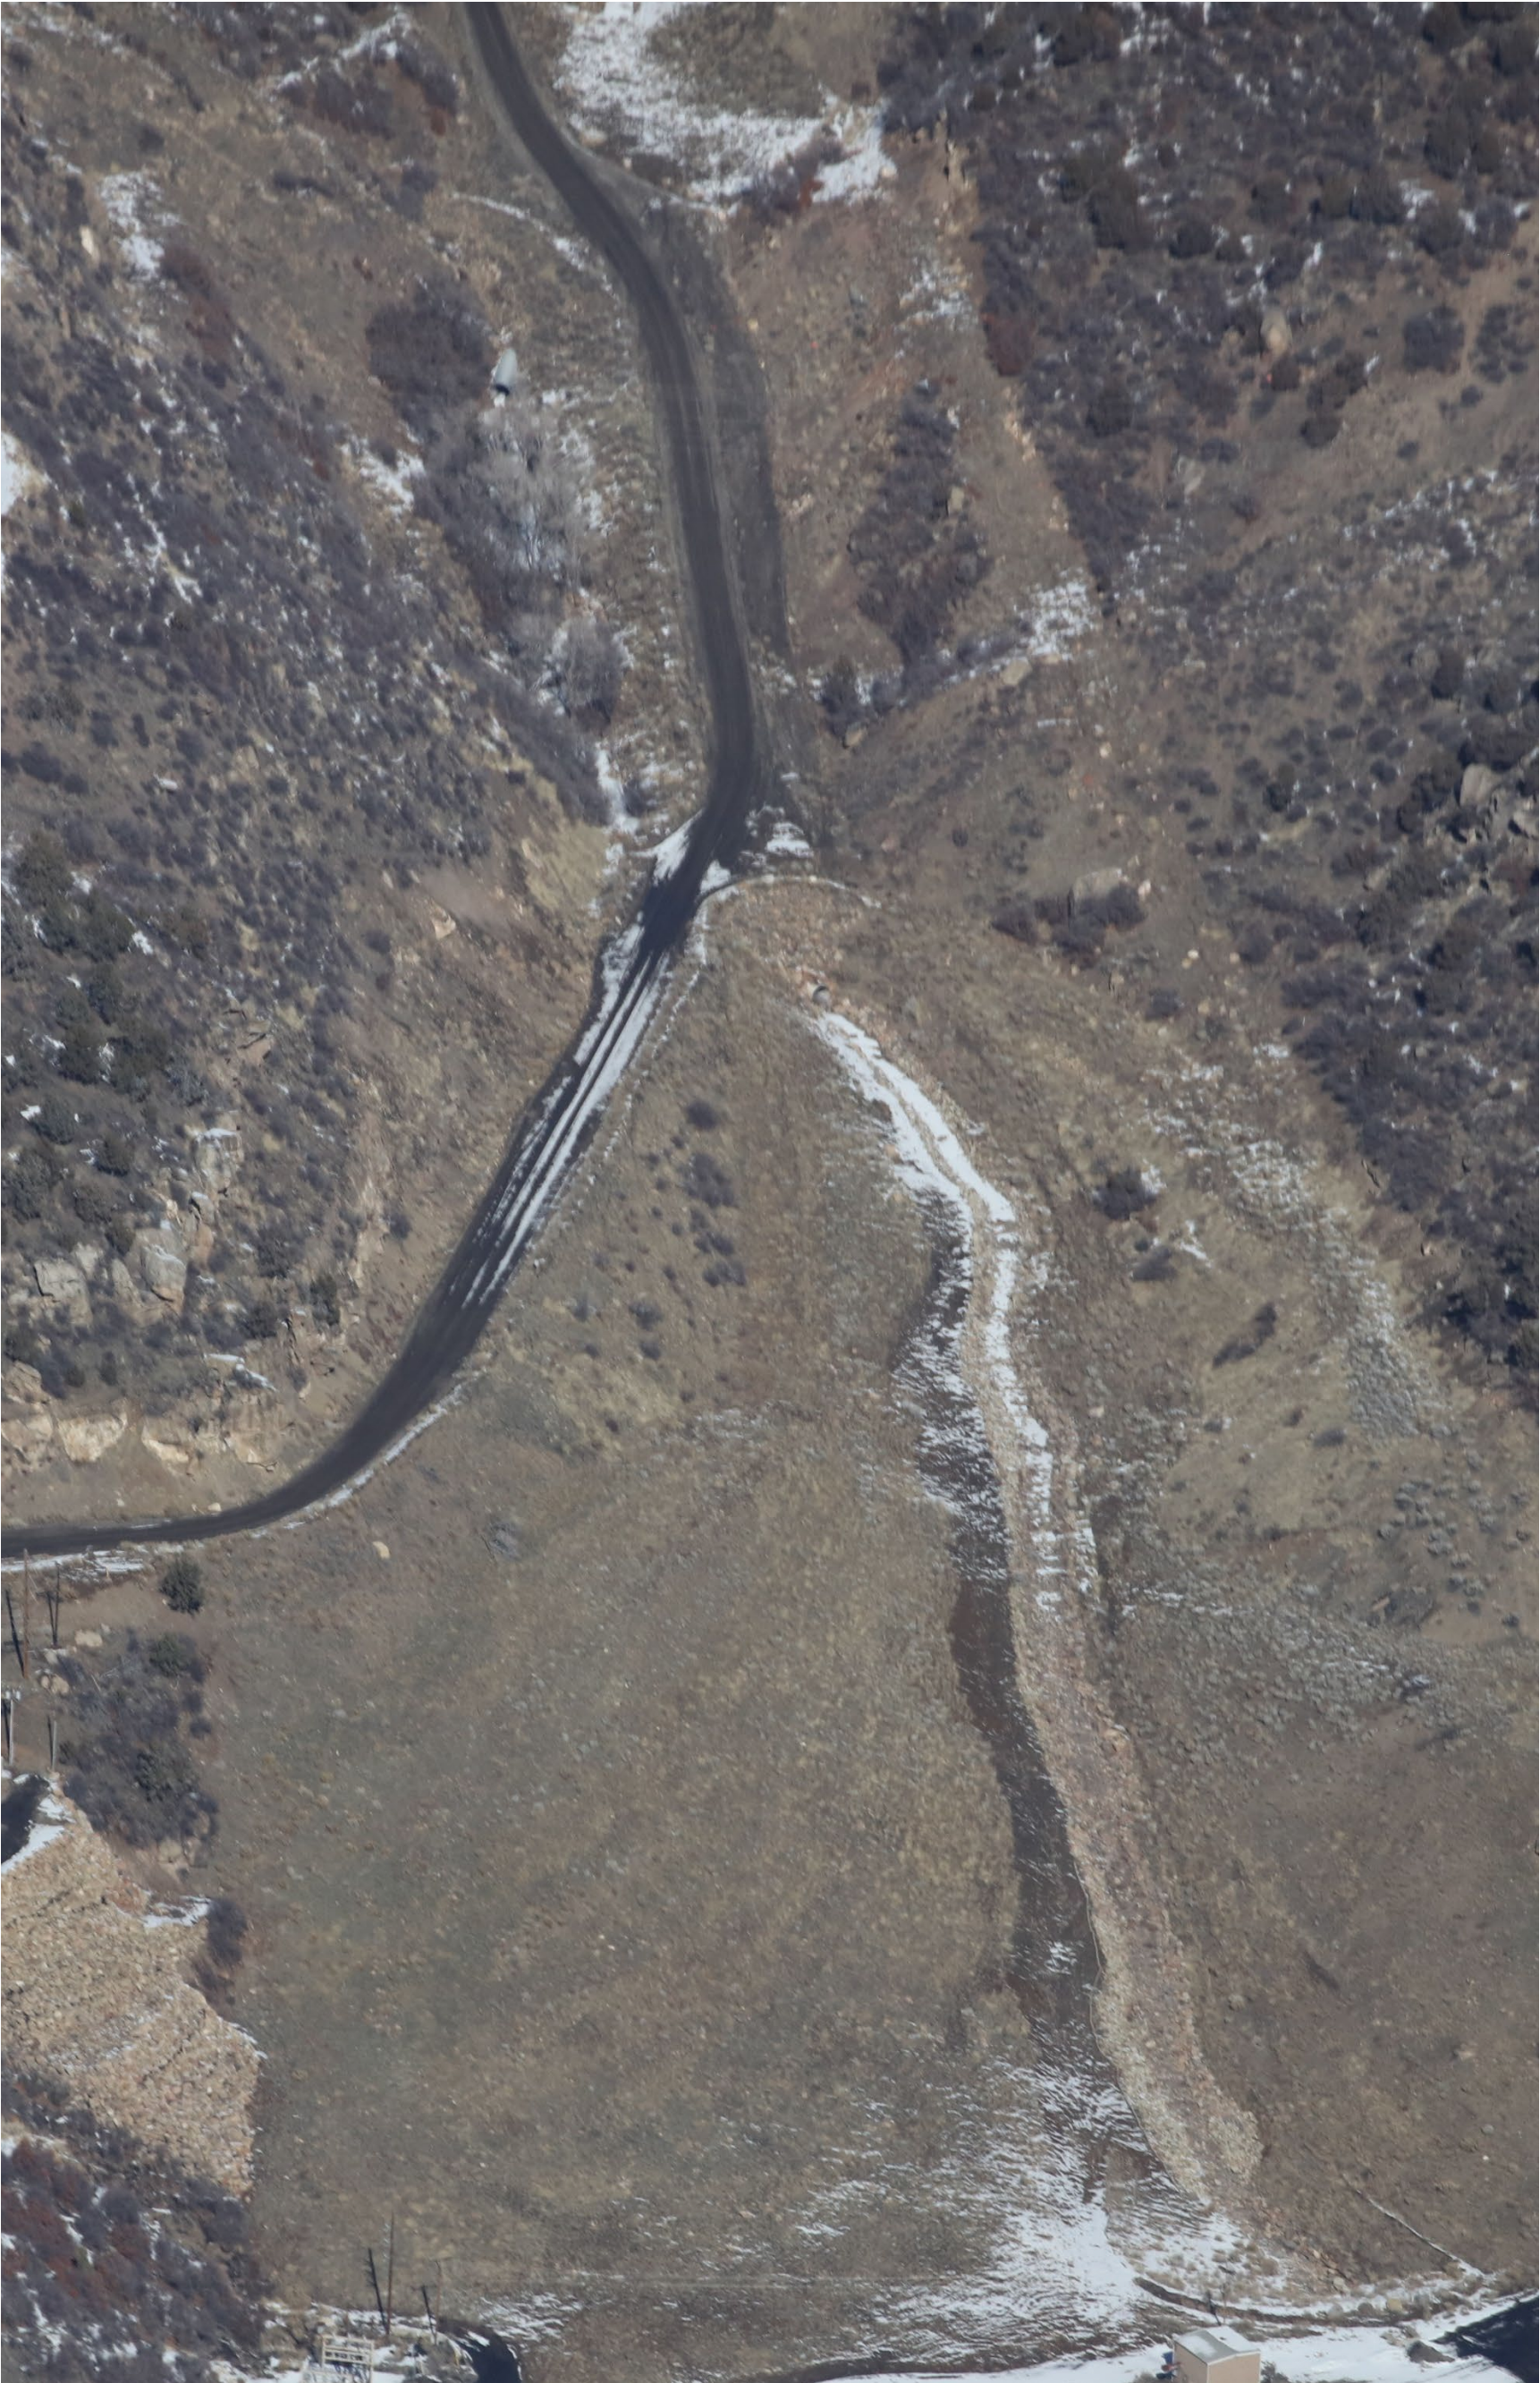
South facing slopes were clear, but otherwise the site was largely covered with snow. No sign of slides, damage or other instability was visible. Repairs to the lower section of the reclaimed Elk Creek channel were clearly visible.

*Figure 6: Lower section of reclaimed Elk Creek channel*
