## C1981022, Elk Creek Mine, February Inspection Report (Aerial)

<b>Permit Number:</b> C-1981-022 <b>Mine Name:</b> Elk Creek Mine <b>Operator:</b> Oxbow Mining, LLC <b>Operator Address:</b> Mr Doug Smith 3737 Hwy 133 P. O. Box 535 Somerset, CO 81434	<b>County:</b> Delta, Gunnison <b>Operation Type:</b> Underground <b>Permit Status:</b> Active <b>Ownership:</b> Private
	<b>Operator Representative Present:</b>  None
<b>Operator Representative Signature: (Field Issuance Only)</b>

<b>Inspection Start Date:</b> February 13, 2024 <b>Inspection Start Time:</b> 12:00 <b>Inspection End Date:</b> <b>Inspection End Time:</b>		<b>Inspection Type:</b> Aerial Inspection <b>Inspection Reason:</b> Normal I&E Program <b>Weather:</b> Clear	
<b>Joint Inspection Agency:</b>  None		<b>Joint Inspection Contacts:</b>	
<b>Post Inspection Agency:</b>  None		<b>Post Inspection Contacts:</b>	
<b>Inspector(s):</b>  Leigh Simmons  Brock Bowles	<b>Inspector's Signature:</b>

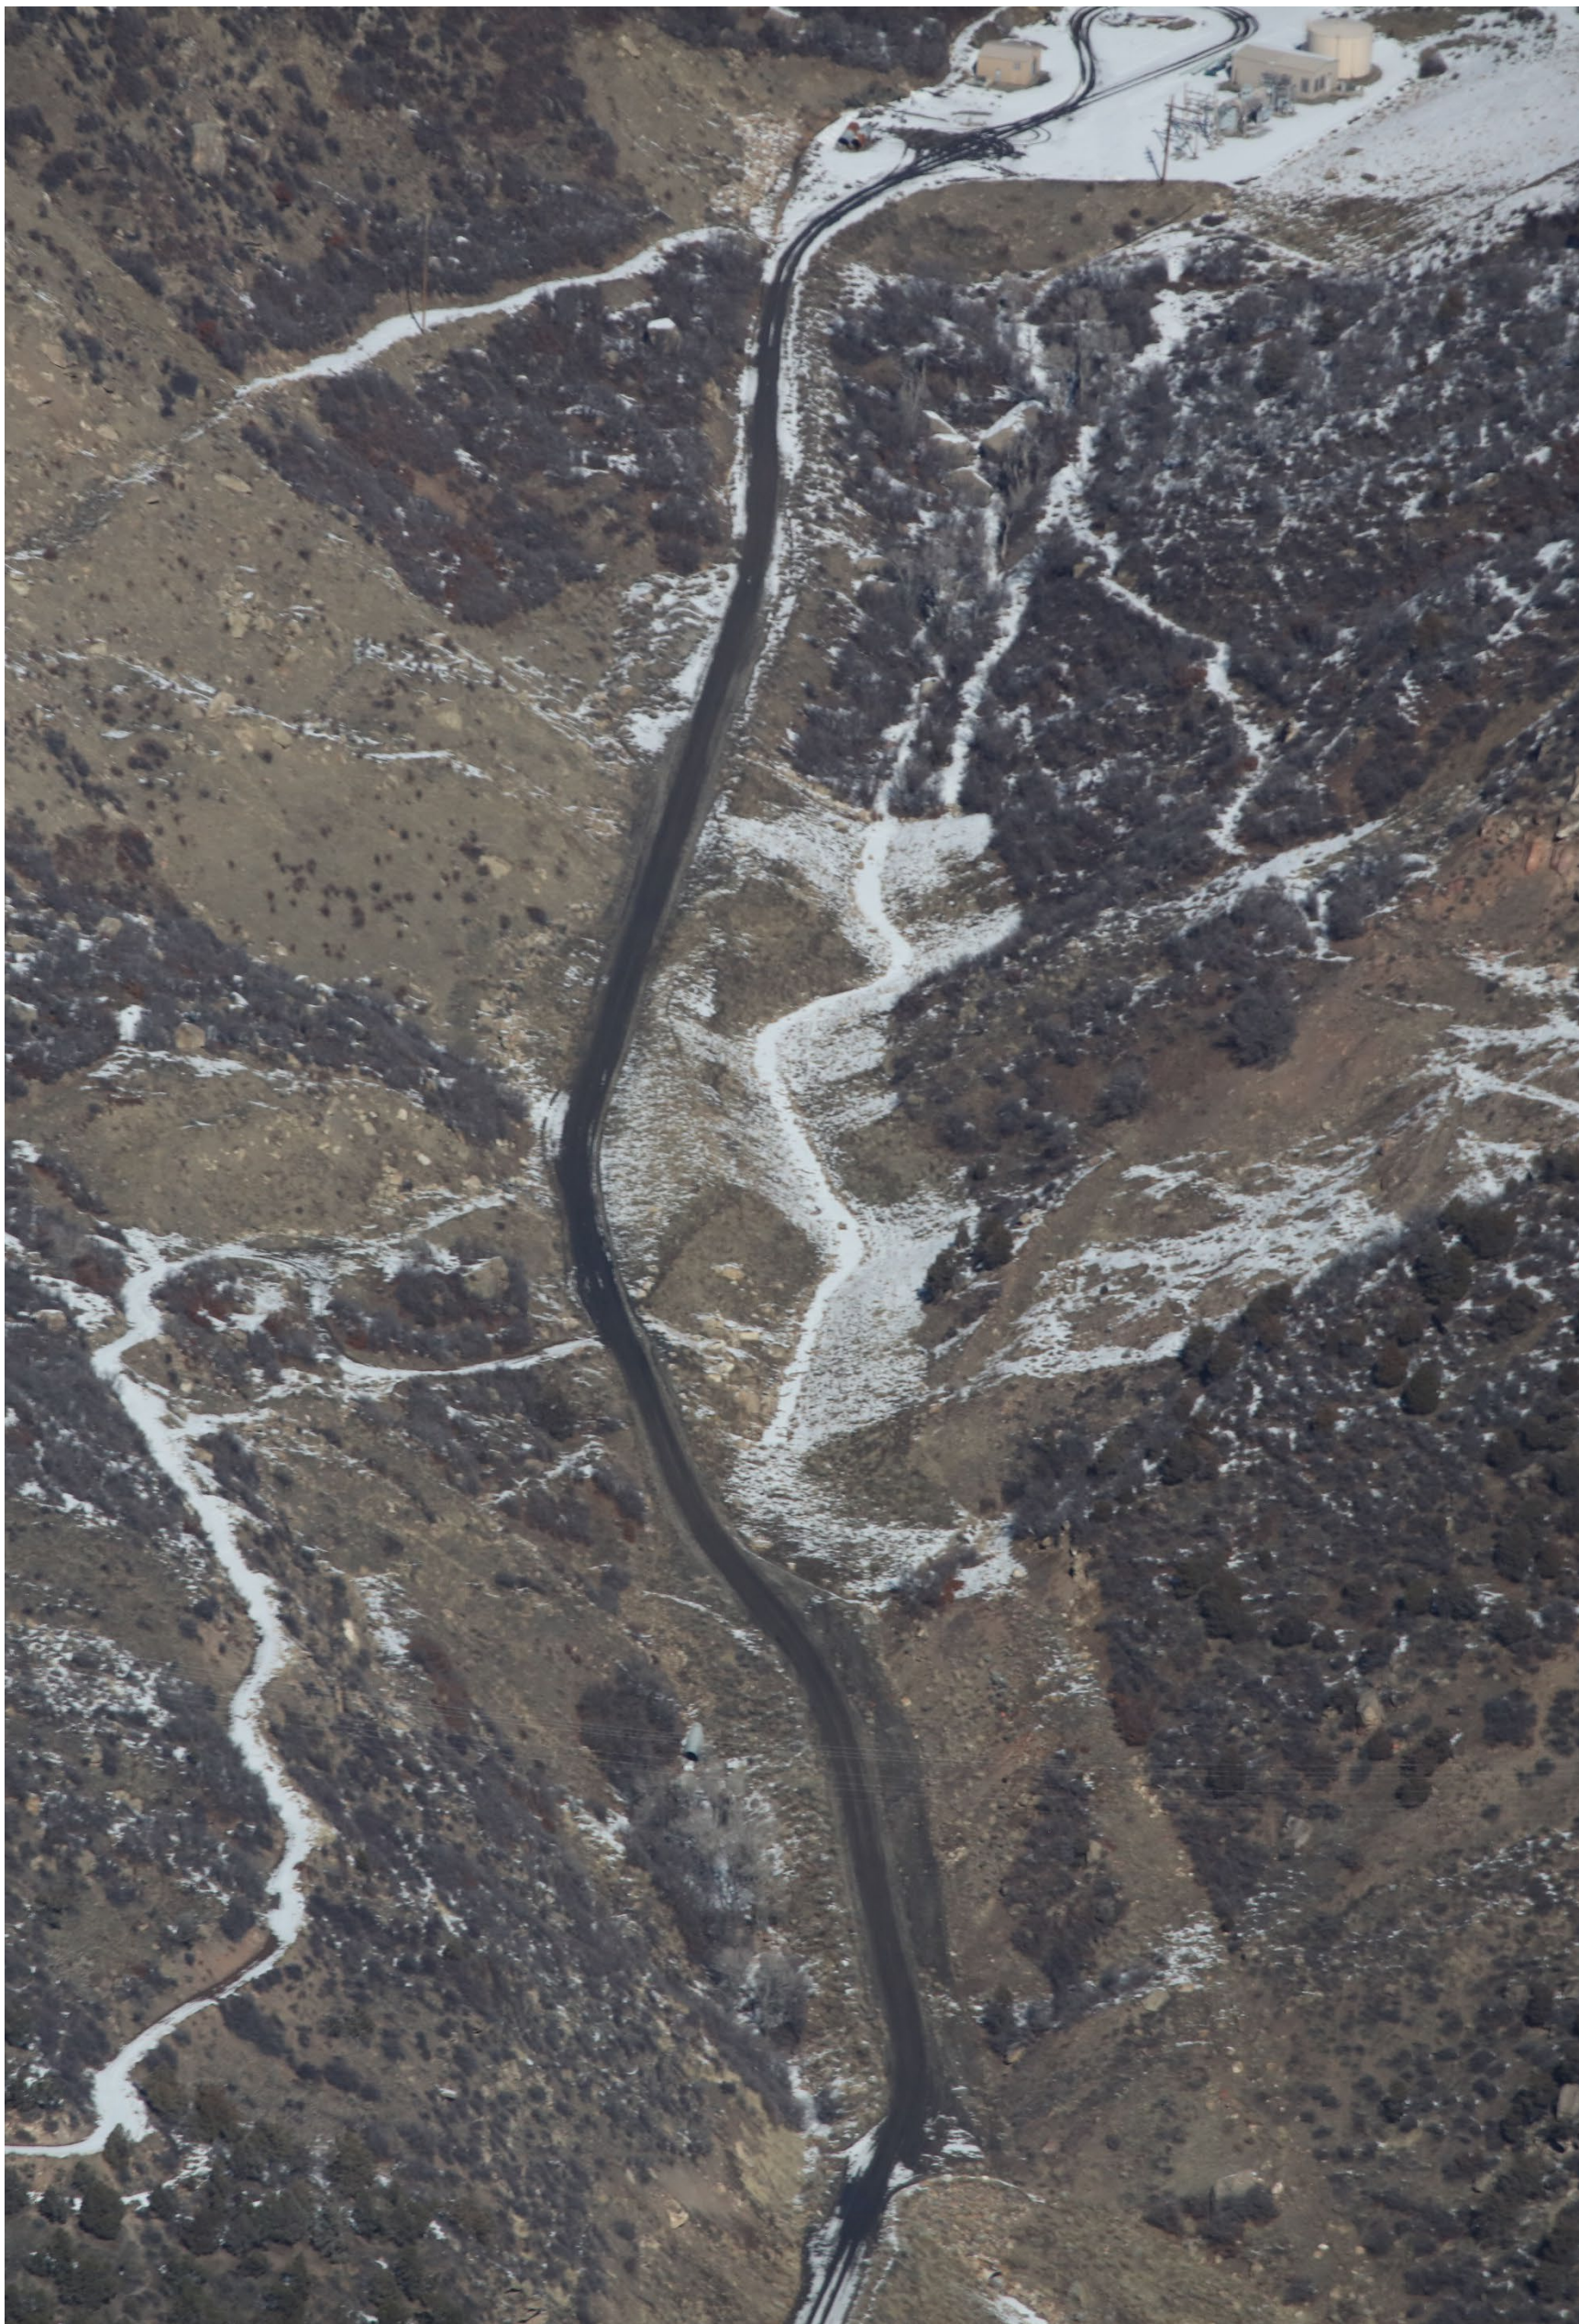
Figure 7: Upper section of reclaimed Elk Creek channel

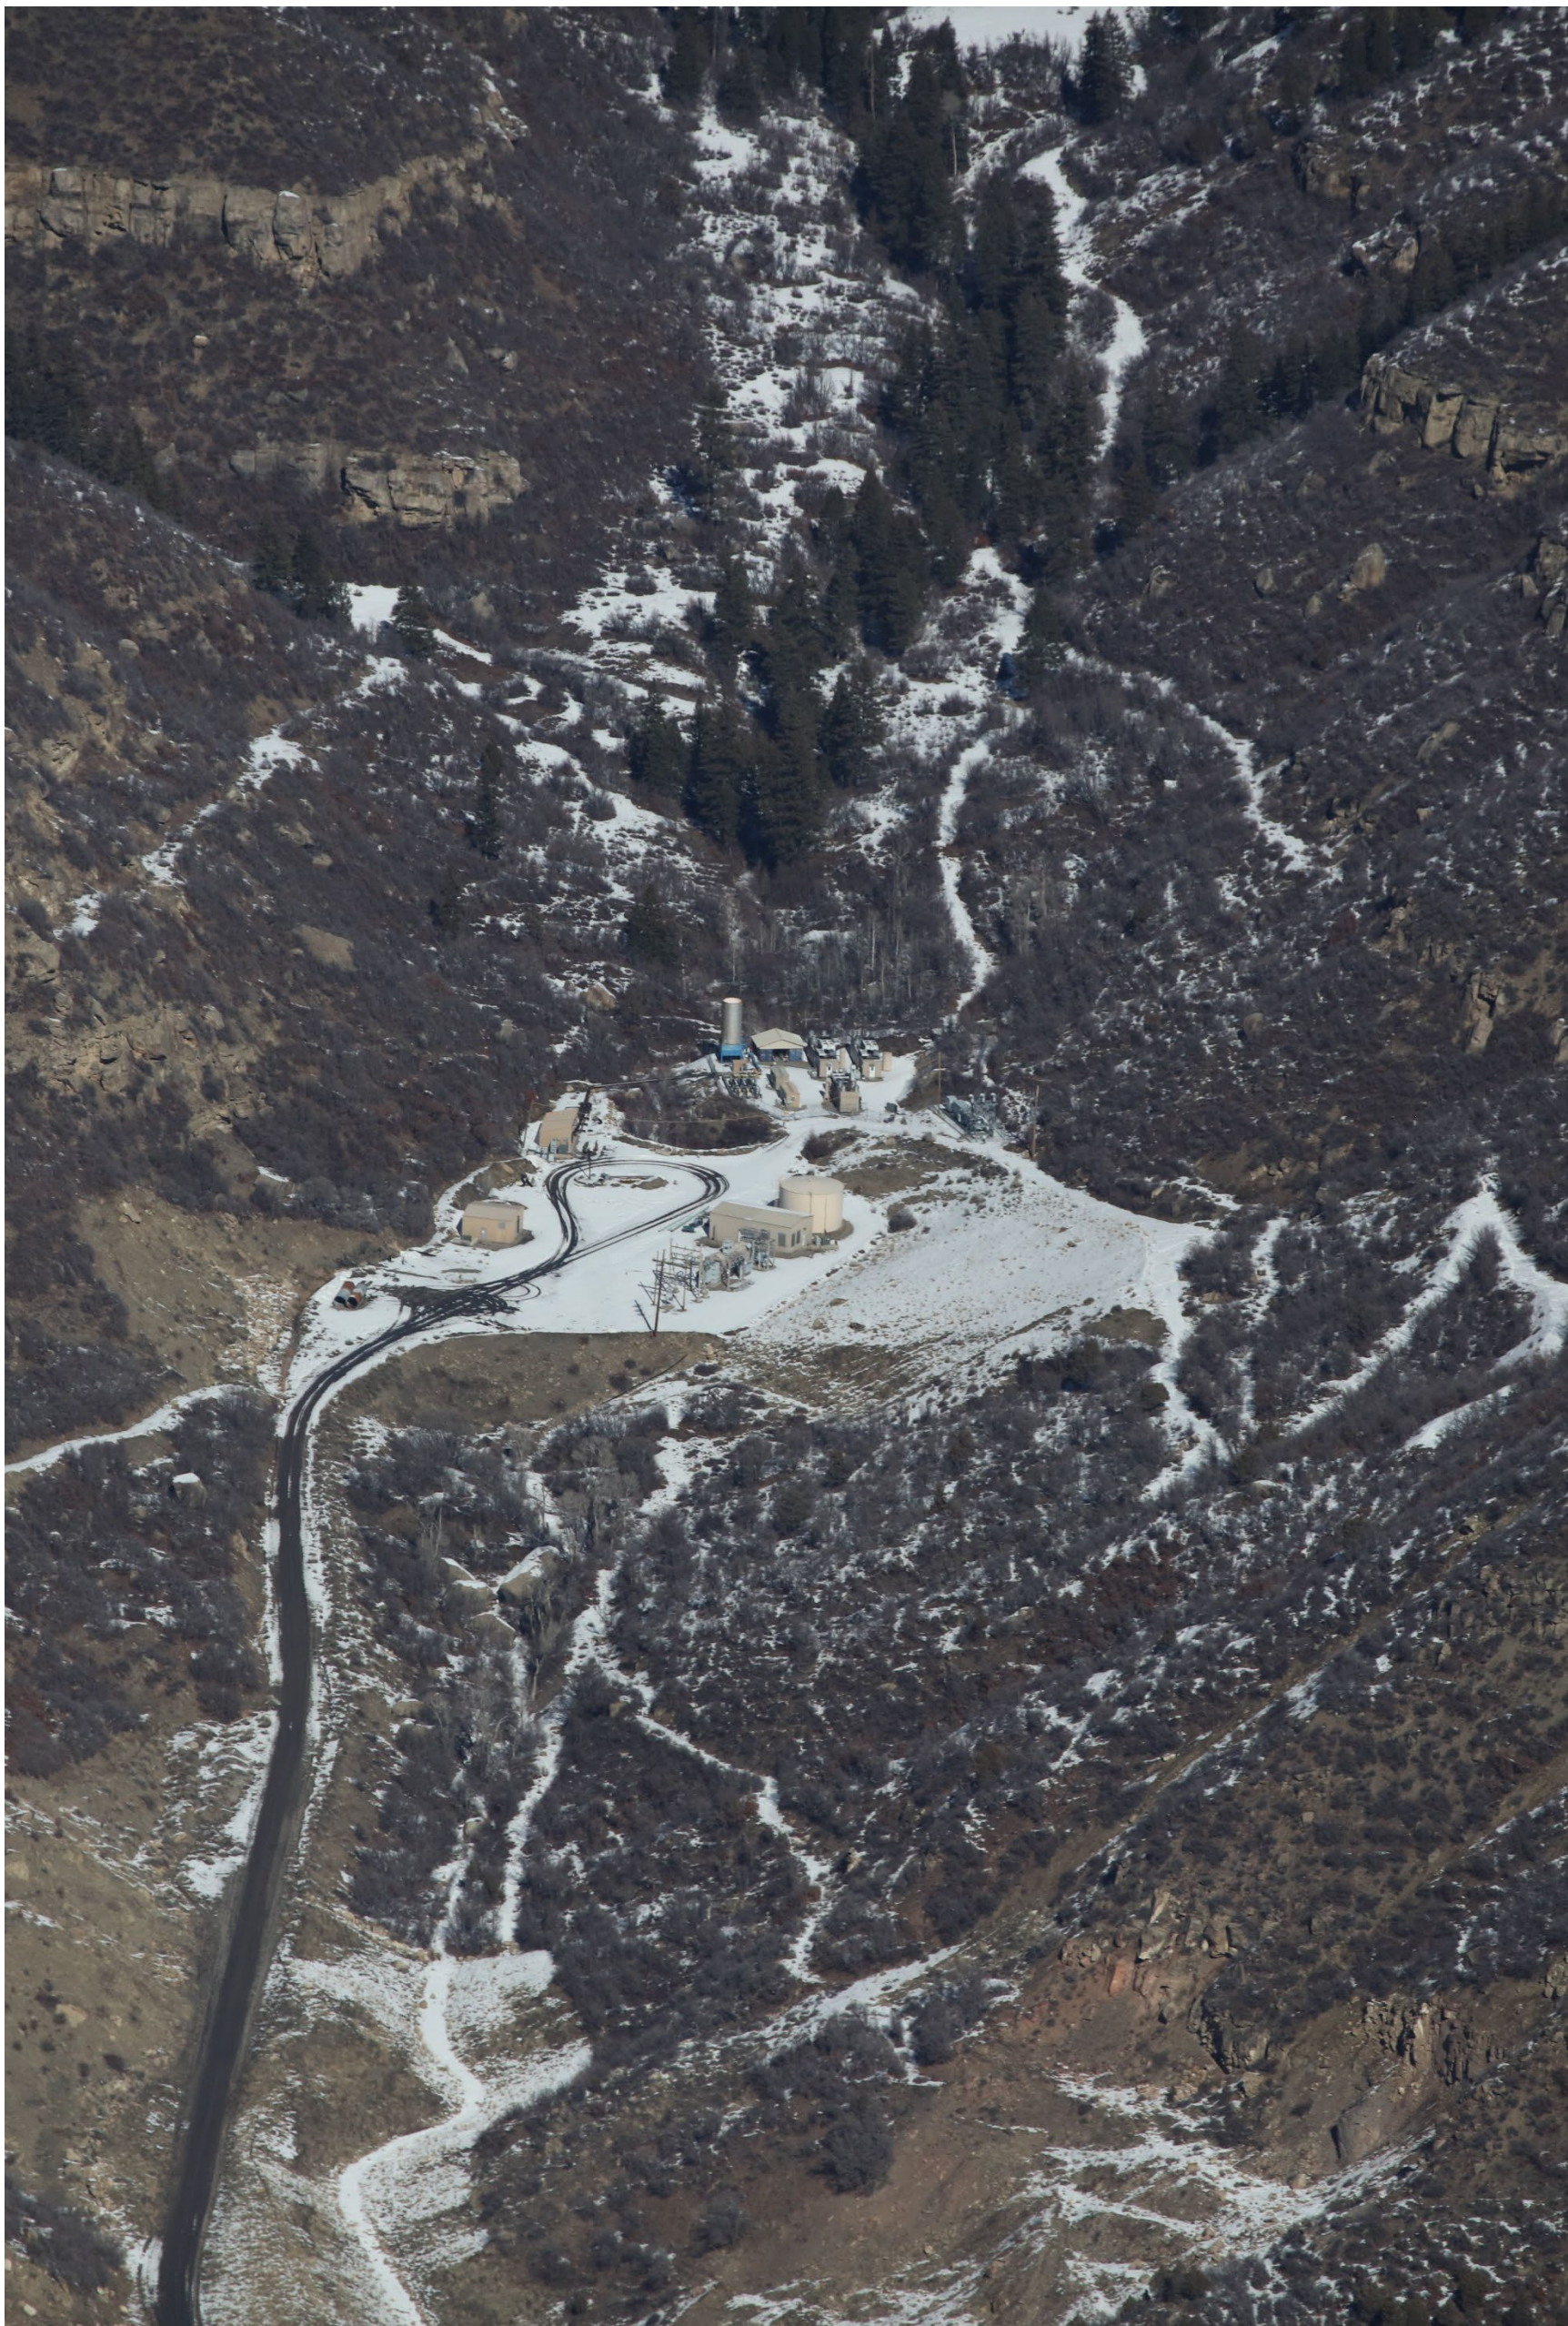
Facilities appeared to be in good order. No further work had been done to remove the substation from the upper pad.

Figure 8: Upper Elk Creek facilities pad

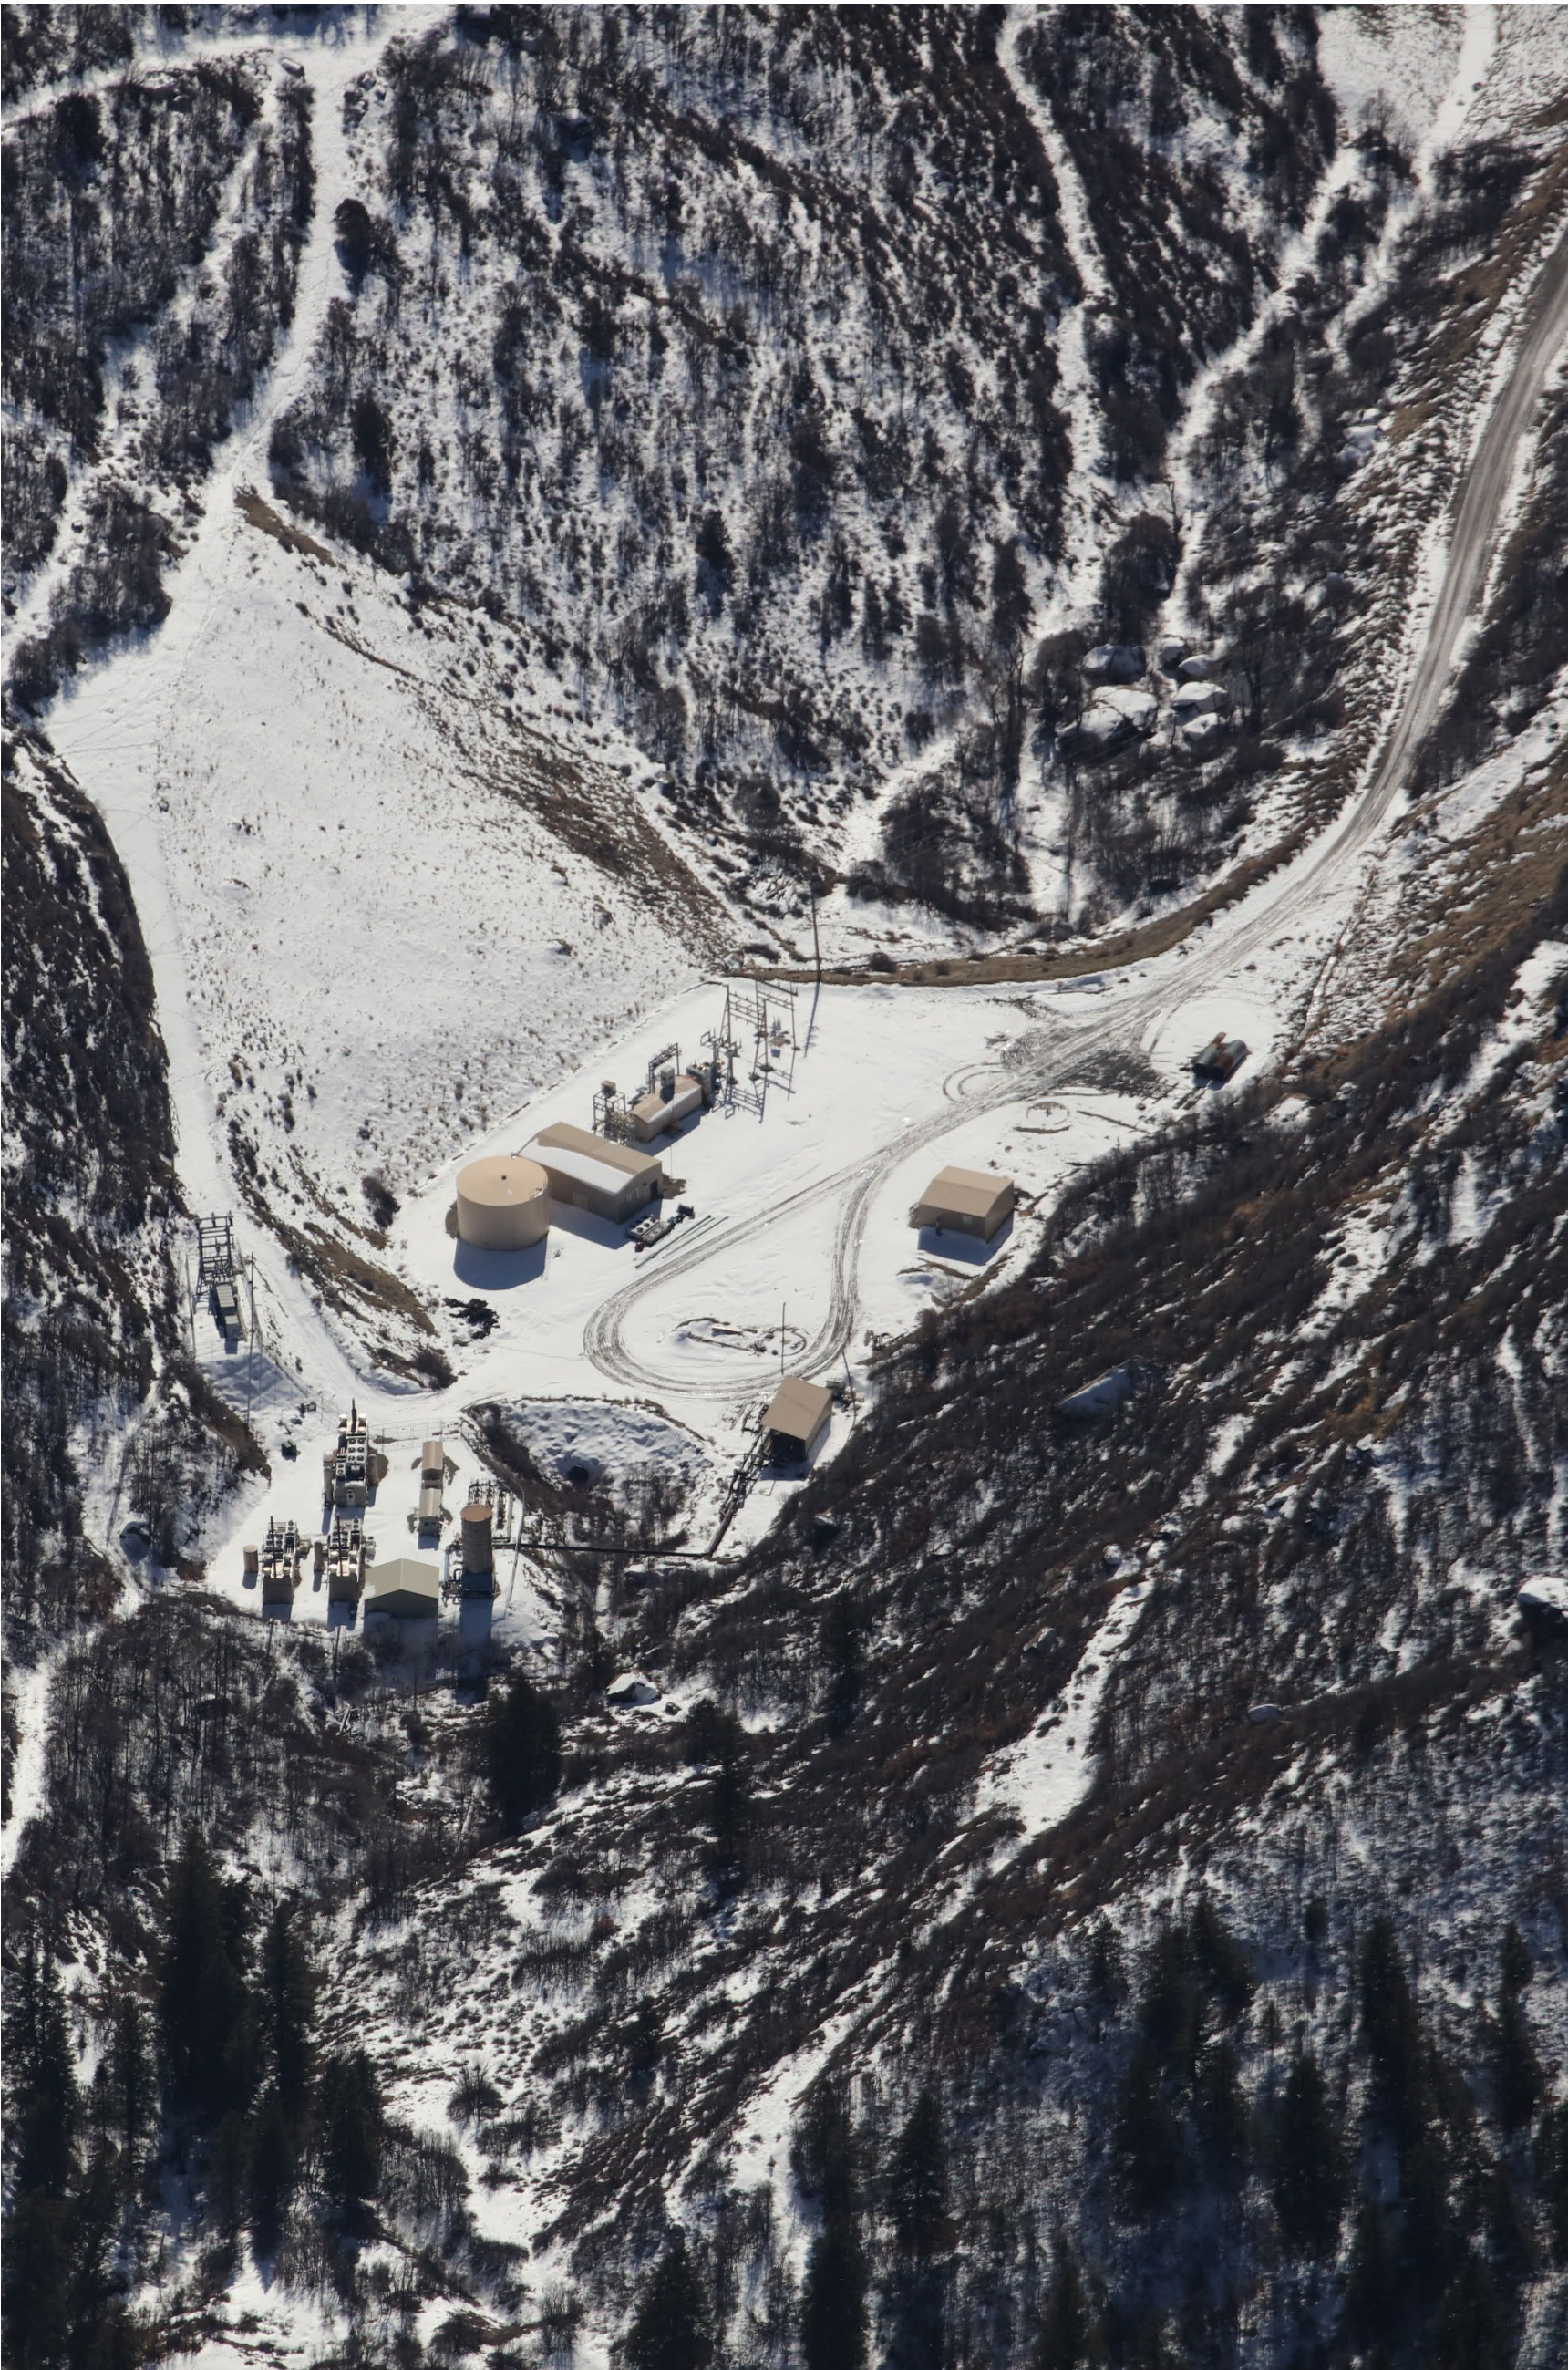
Figure 9: Upper Elk Creek facilities pad, from north

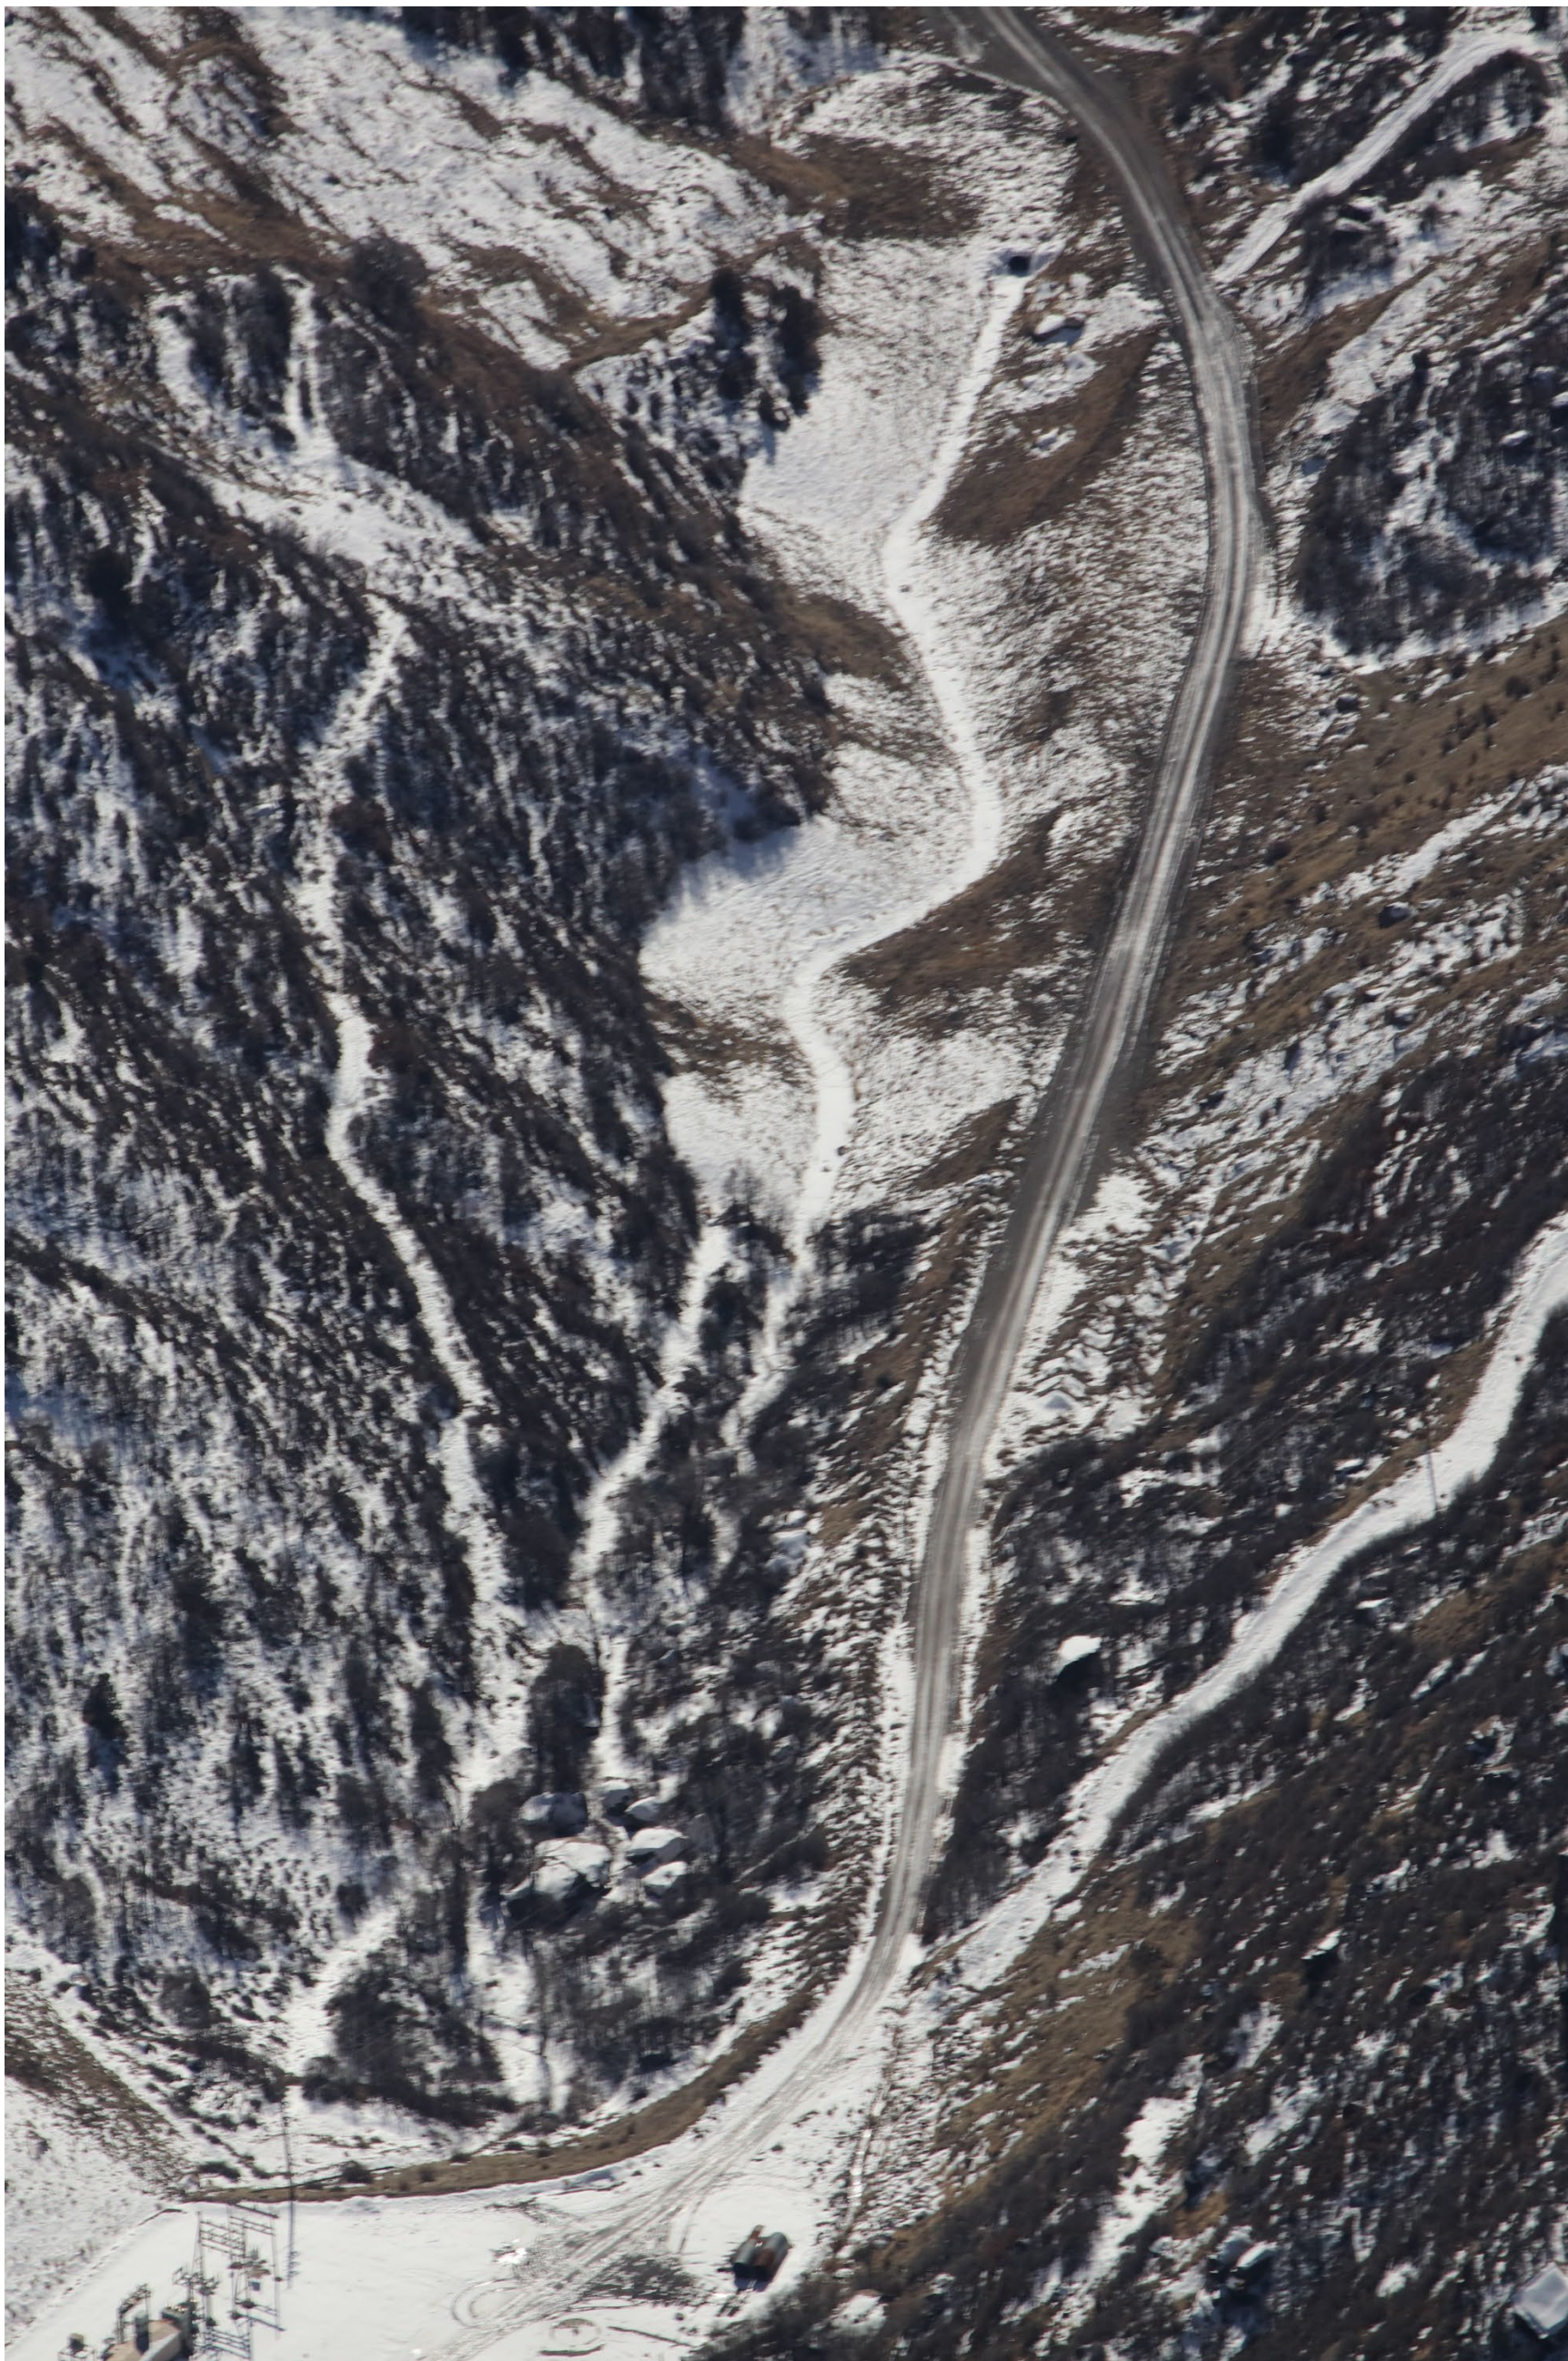
Figure 10: Upper section of reclaimed Elk Creek channel, from north

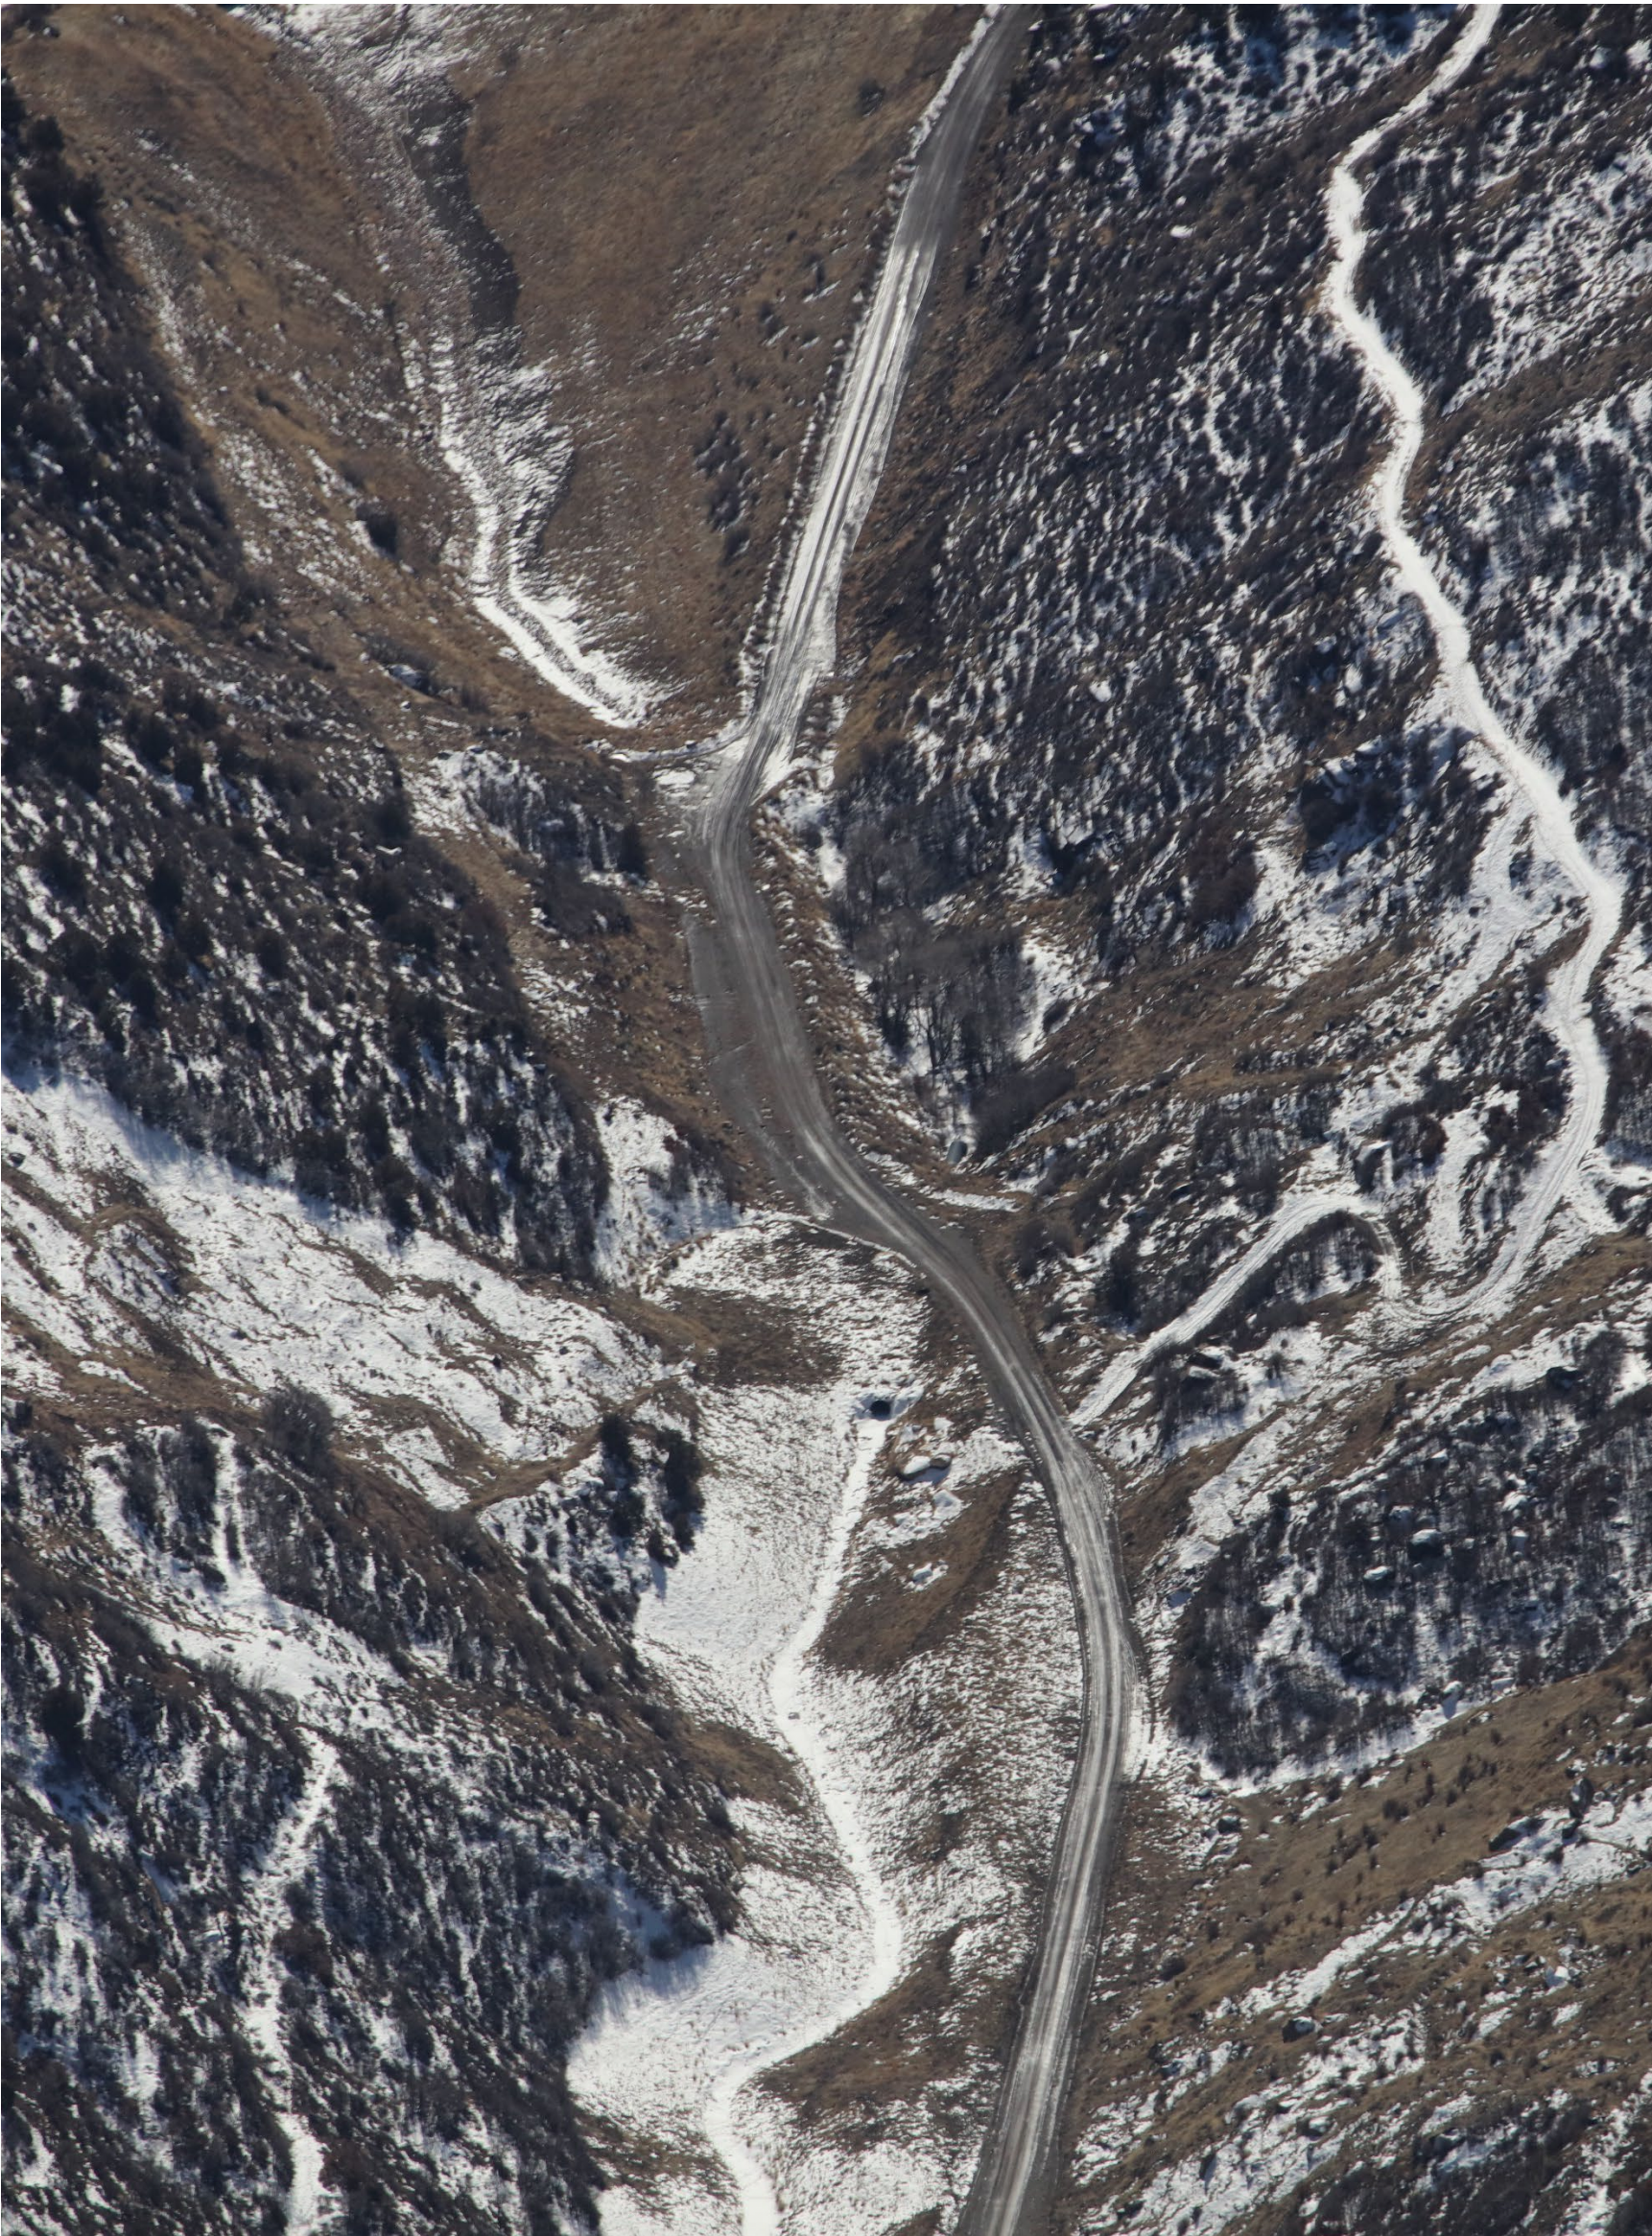
*Figure 11: Middle Section of Elk Creek culvert. Powerline road on right, with vehicle tracks visible.*

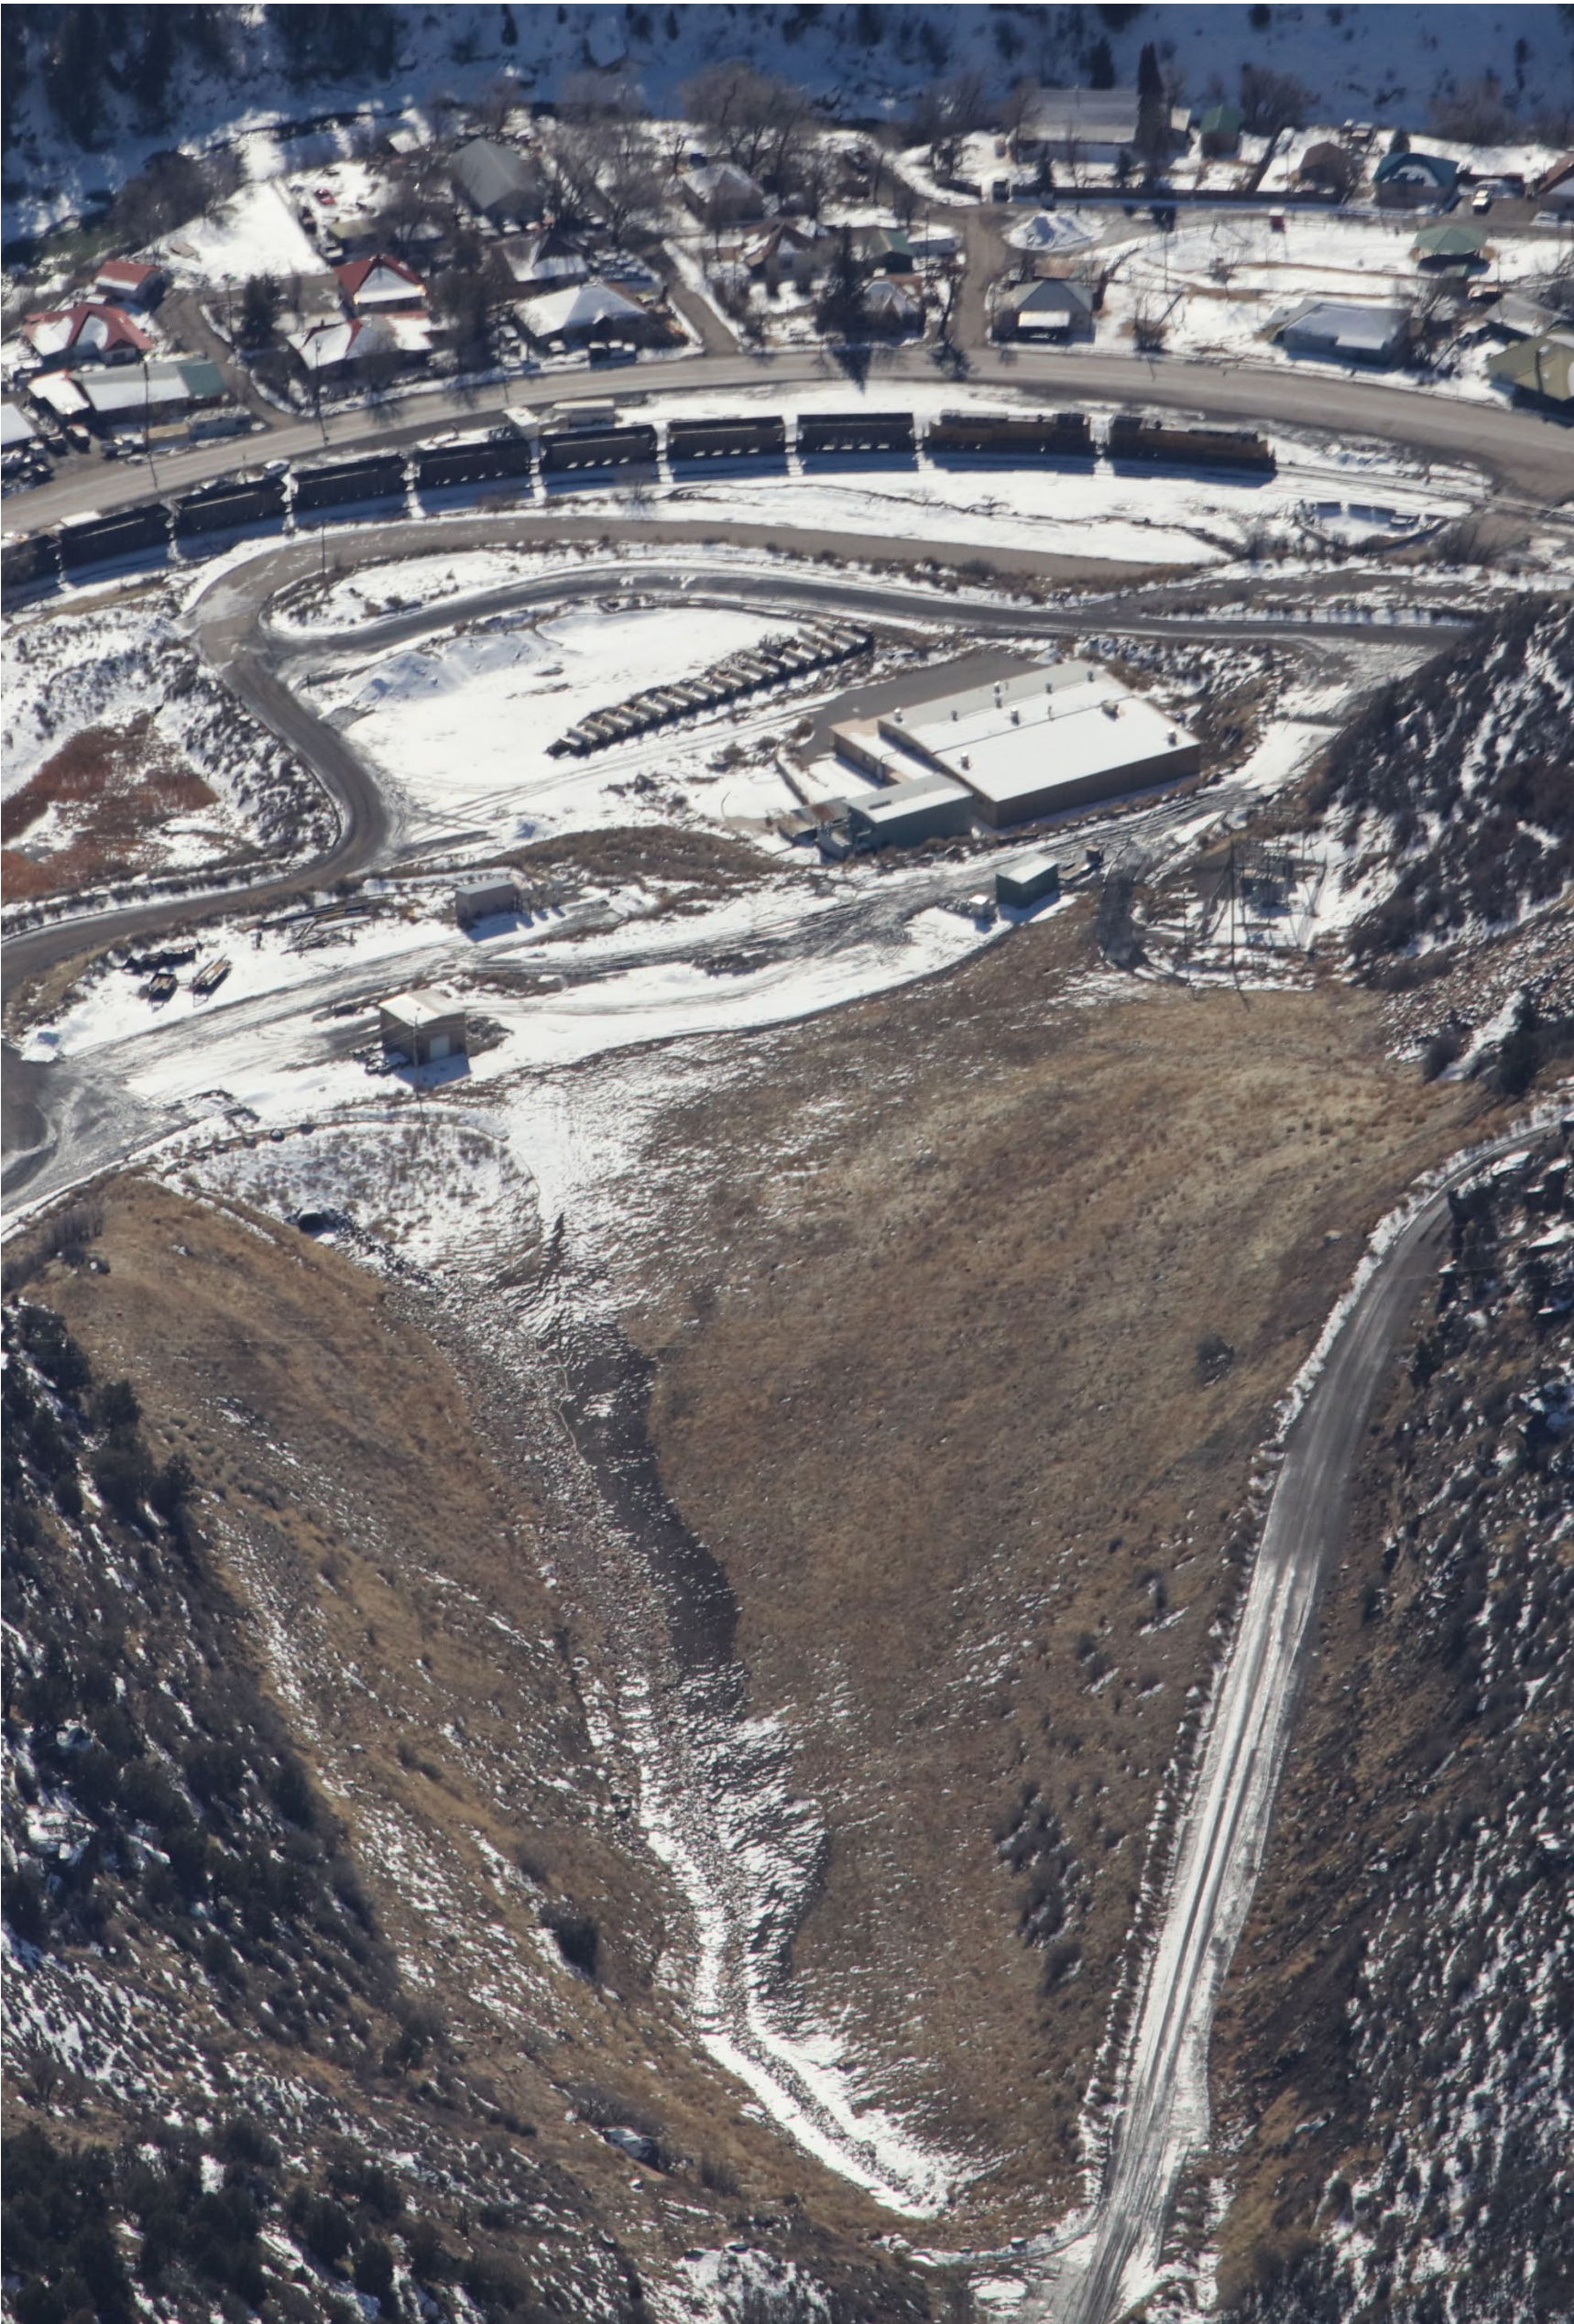
South facing slopes were clear, but otherwise the site was largely covered with snow. No sign of slides, damage or other instability was visible. Repairs to the lower section of the reclaimed Elk Creek channel were clearly visible.

Figure 12: Lower section of reclaimed Elk Creek channel, from north
